2023 ANNUAL INSPECTION REPORT
RANGE ROAD LANDFILL
ASH DISPOSAL FACILITY

BELLE RIVER POWER PLANT

China Township, Michigan

January 2024

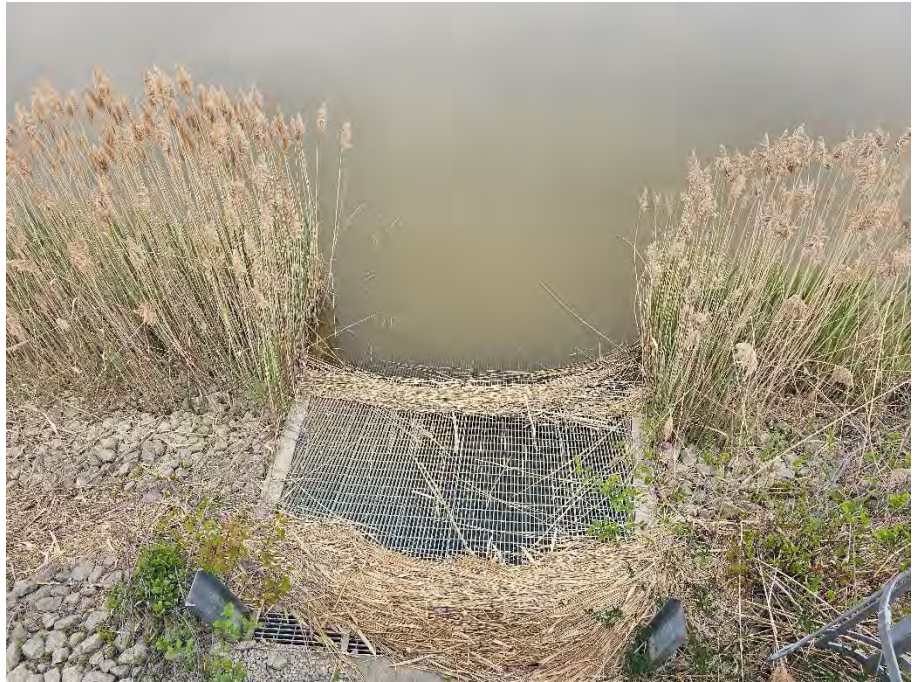
Photograph 4

Comments: The SDB was in good condition. Side slopes had been cleared of vegetation and no erosion was observed. The water quality within the SDB appeared to be appropriate for the NPDES.

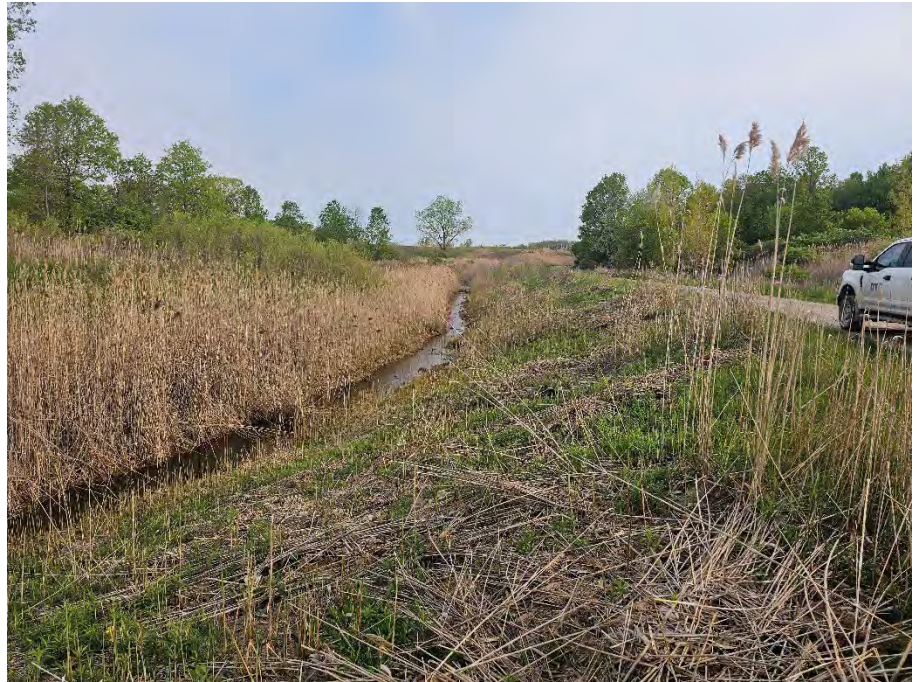
Photograph 6

Comments: Staff gauges were located and in satisfactory condition (typical) (staff gauge-07 shown). The perimeter ditch on the east side of the Landfill was clear of vegetation and no erosion was observed on the side slopes. No flow was observed within the perimeter ditch because of low water levels at the time of the visual inspection.

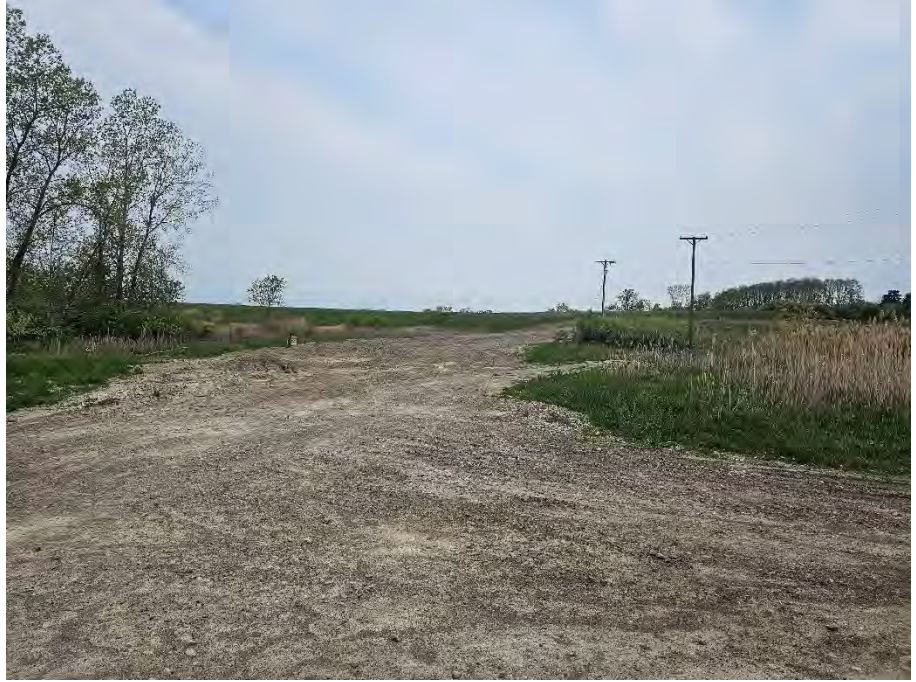
Photograph 10

Comments: The perimeter road on the east side of the Landfill was in good condition.

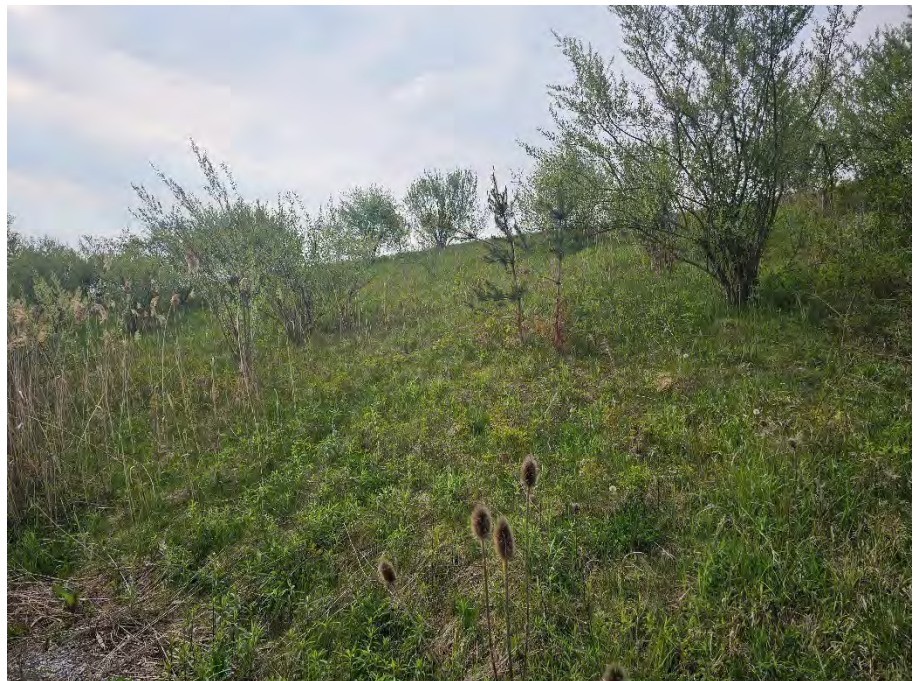
Comments: The lower perimeter ditch of the lift station at the northwest corner of the property was in good condition. The perimeter ditches on the northwest side of the Landfill were generally clear of vegetation and had riprap armoring the side slopes. No erosion of riprap was observed.

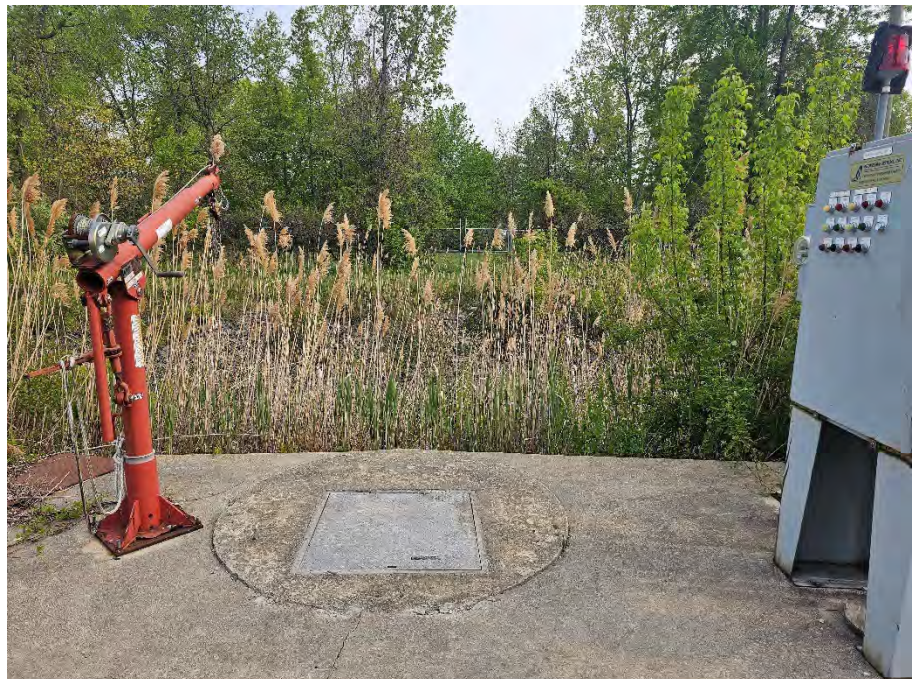
Comments: The concrete pad manhole and sump level controls of the lift station at the northwest corner of the property were in good condition. Pumps and hands-on switches were checked by DTE personnel and appeared to be operating correctly.

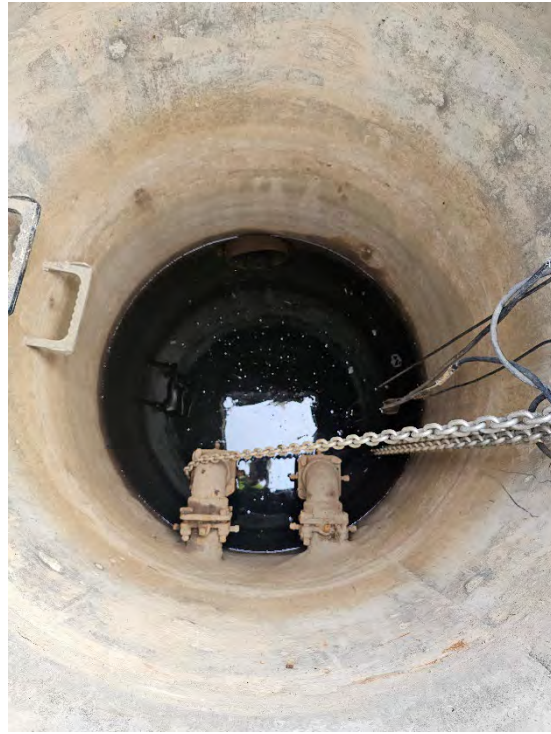
Photograph 20

13. The features associated with the lift station at the northwest corner of the property, where water is pumped from the lower perimeter ditch to the upper perimeter ditch, were observed to be in good condition. This includes the manhole on the upper perimeter ditch (Photograph #15), the control panel, hoist, concrete pad (Photograph #18), sump level controls (Photograph #19), and lower perimeter ditch (Photograph #17). Pumps and hands-on switches were checked by DTE personnel and appeared to be operating correctly. The perimeter road west of the manhole was observed to have a wet area (Photograph #20).

Comments: The perimeter road west of the manhole at the lift station was observed to have a wet area.

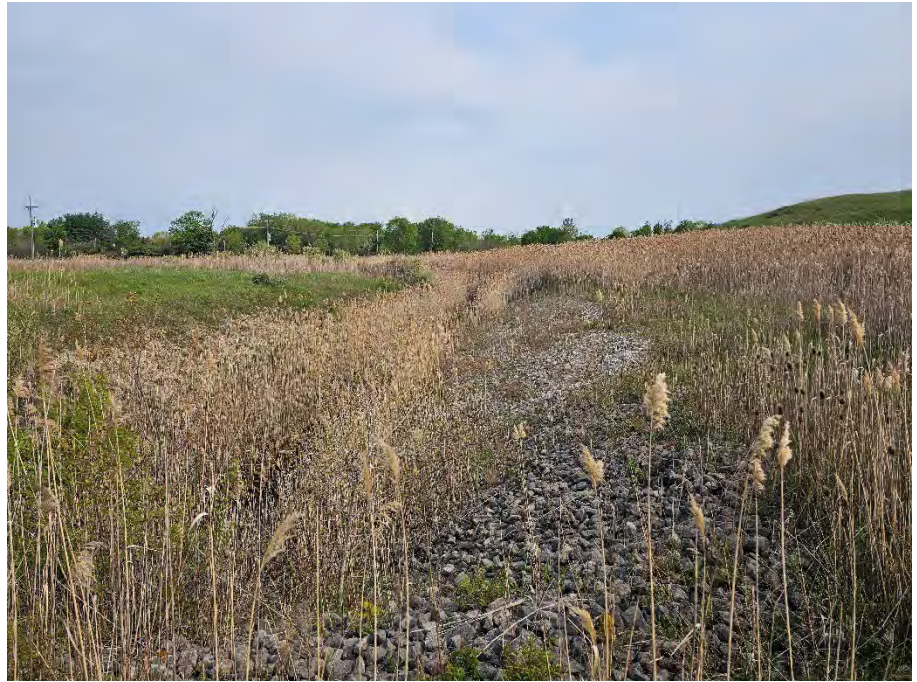
Photograph 28

15. The riprap-lined stormwater downchute at the southwest side of Area F1 had some vegetation within the chute (Photograph #28) and some small woody vegetation at the top of the chute (Photograph #31). No erosion was observed in the riprap and the mesh wiring was intact. Other stormwater downchutes at the southwest corner of Area B, northeast corner of Areas C and D1, and along the access road to Areas D3 and F3/D3 (Photograph #40) were in satisfactory condition.

1. The riprap-lined stormwater downchute at the boundary between Areas F1/F2 and Area G2 had vegetation within the chute on the slope. Larger woody vegetation was observed at the top of the chute. If the woody vegetation is not addressed and continues to grow, it could disrupt flows within the chute and/or displace or erode the riprap lining. This could lead to erosion of the underlying soils within the chute or the adjacent soil slopes.

Comments: The riprap-lined stormwater downchute at the southwest side of Area F1 had some vegetation within the chute. No erosion was observed in the riprap and the mesh wiring was in-tact.

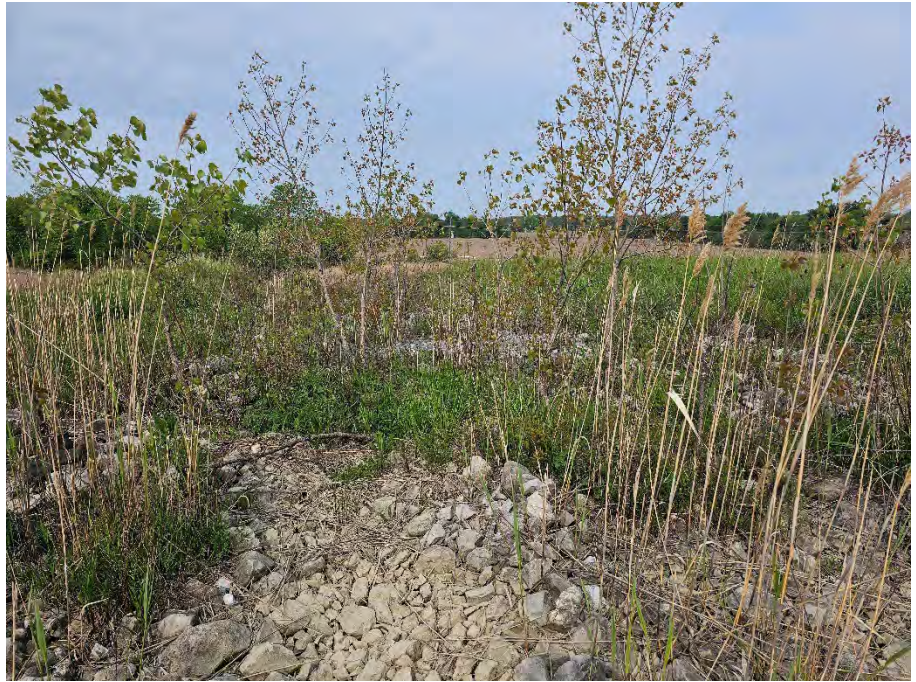
Photograph 32

Comments: The side slopes of the Area G2 Phase I closure were in good condition. The vegetation had become established and was well maintained.

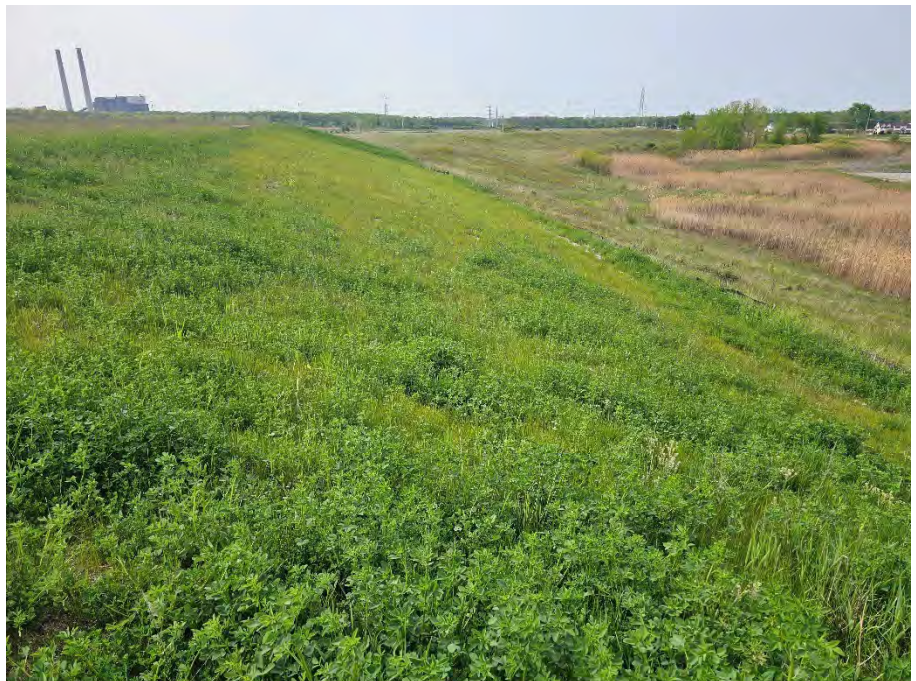
Comments: The erosion measures at the top of the side slopes of the Area G2 Phase I closure appear to have performed satisfactorily to allow vegetation to become established.

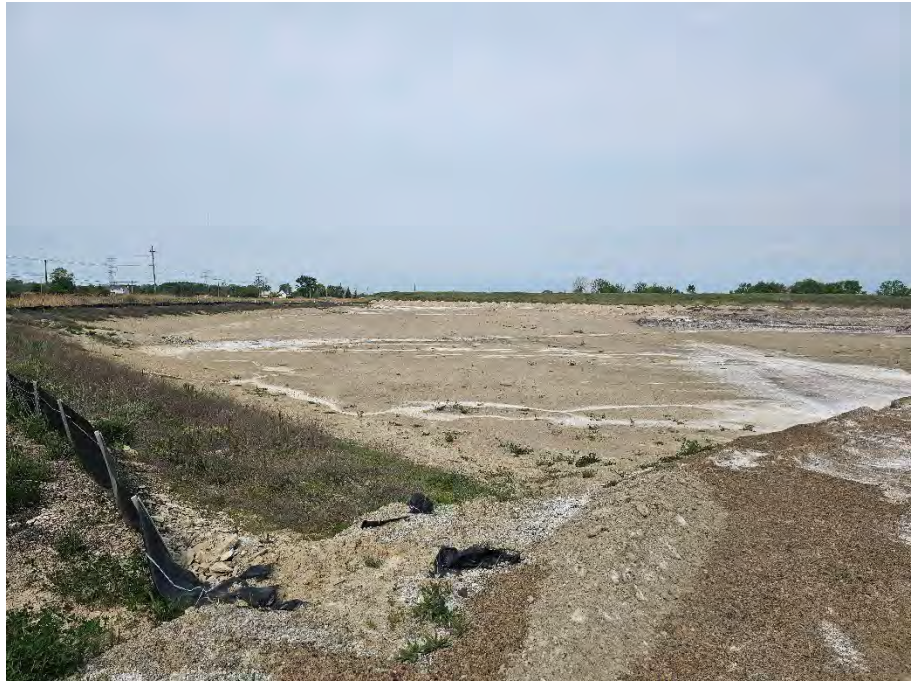
Photograph 44

Comments: The internal detention pond south of Area G2 was in good condition. The side slopes were covered in erosion protection and no erosion was observed.

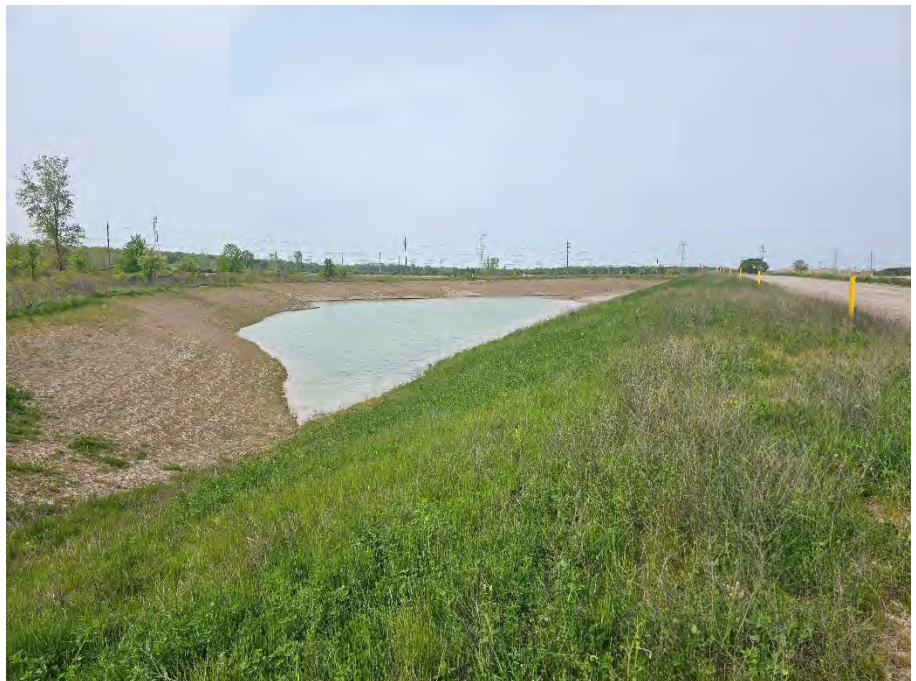
Comments: The perimeter road/access road to the south side of Area G2 was in good condition.
