DTE Electric Company
One Energy Plaza
Detroit, Michigan 48226

**2023 ANNUAL
INSPECTION REPORT
VERTICAL EXTENSION LANDFILL**

MONROE POWER PLANT

January 2024

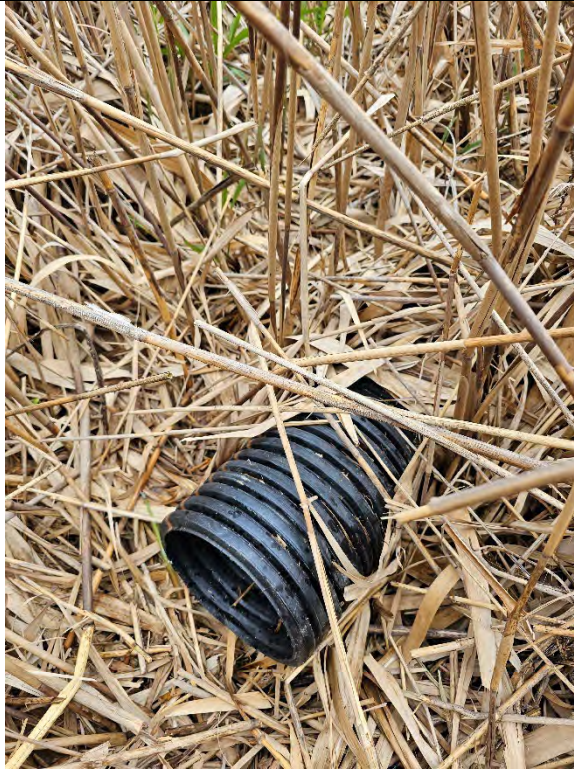
Comments: Pore pressure relief pipe outlet. Typically, minimal or no sediments and no flow were observed.

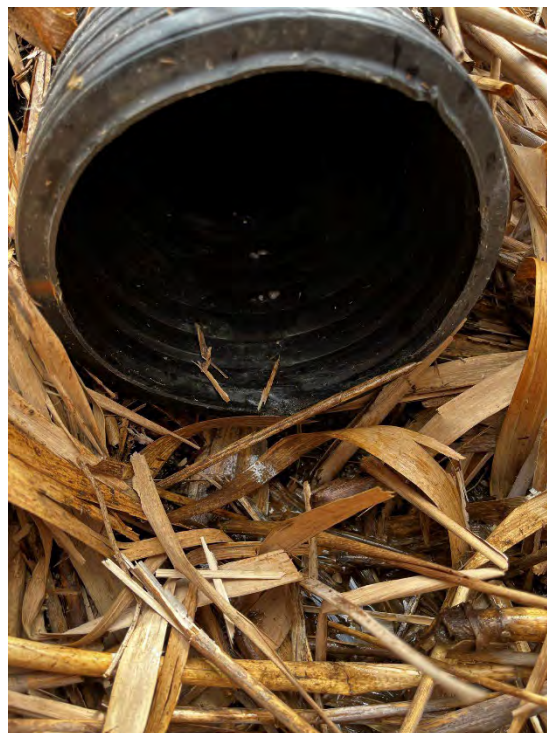
Photograph 2

Comments: Pore pressure relief pipe outlet. Typically, minimal or no sediments and no flow observed.

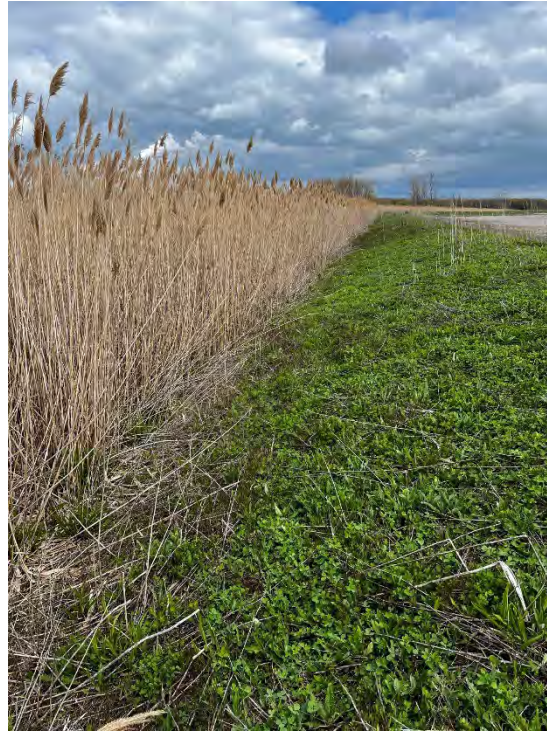
Comments: Perimeter berm slope and crest along the north and east sides of the Landfill. Perimeter berms were generally observed to be in good condition.

Perimeter swale R2 was heavily vegetated. Some standing water was observed in perimeter swale R2.

1. Clear vegetation within the perimeter swales to at least the toe of the perimeter berm. This should help in: (i) locating the pore pressure relief pipe outlets; (ii) reducing the vegetation and other debris that has migrated into the outlets; and (iii) facilitating flow of water and lowering water within the perimeter swales.
2. Replace desiccant canisters within the instrument boxes around the Landfill (i.e., DL-1 through DL-4) and apply new sealant within DL-1.

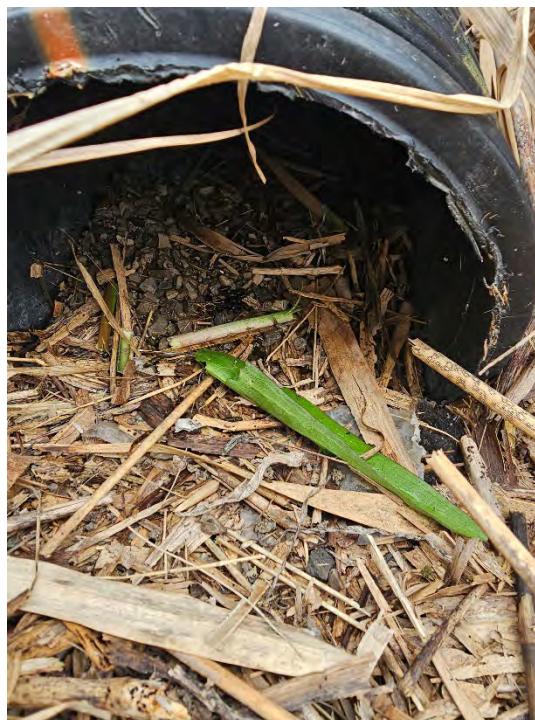
Photograph 4

Comments: Some pore pressure relief pipes were observed to have vegetation and other debris within the outlets. The vegetation and other debris did not appear to affect the drainage capacity of the pipes.

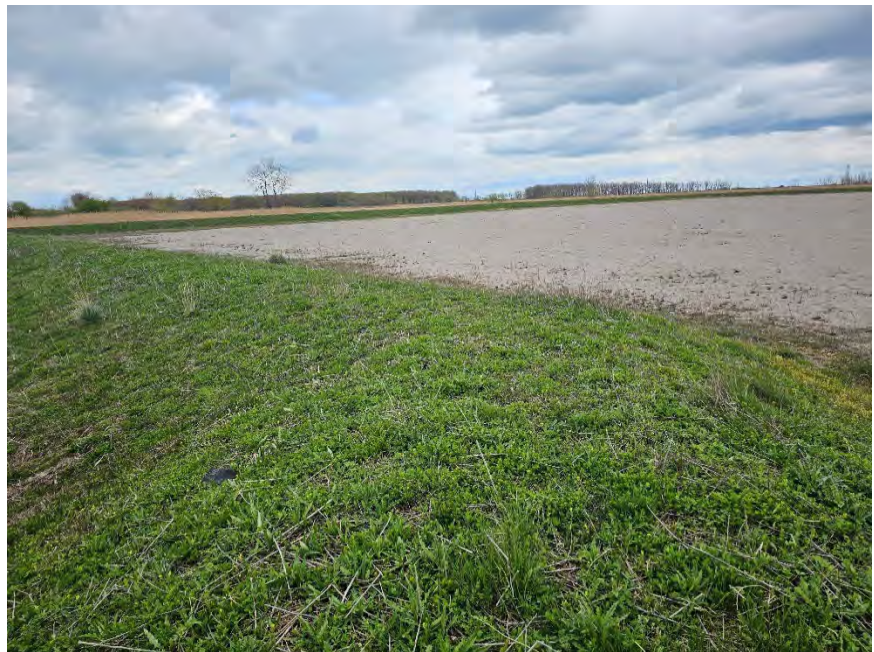
Comments: Phase 2 of the Landfill without CCR. The pressure relief layer was observed to be in good condition where no CCR has been placed.

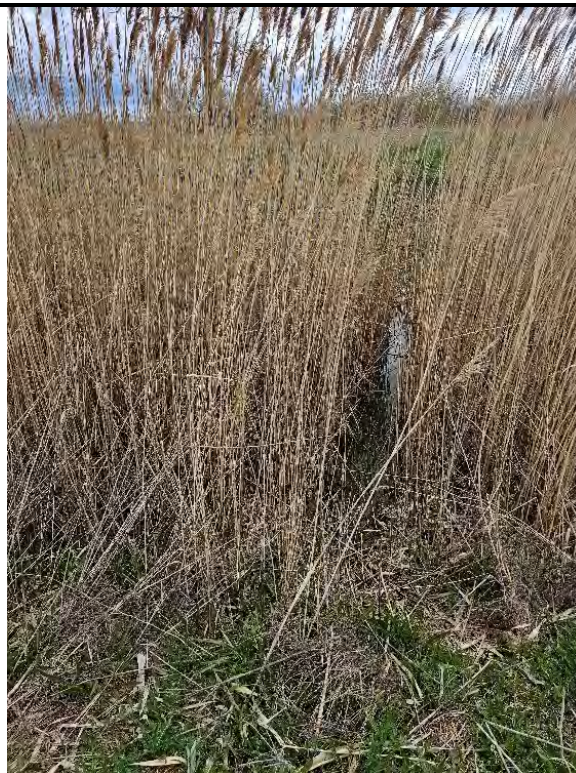
Photograph 6

Comments: Perimeter swale R2 was heavily vegetated. Some standing water was observed in perimeter swale R2.

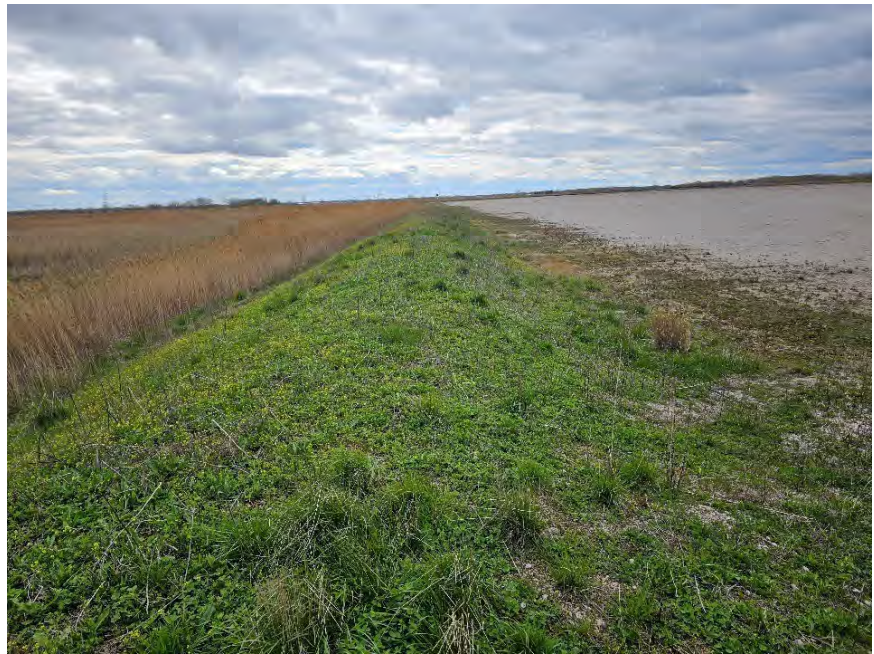
Comments: Perimeter berm slope and crest along south side of the Landfill. Perimeter berms were generally observed to be in good condition.

Perimeter swale R4 was heavily vegetated. Standing water was observed in perimeter swale R4.

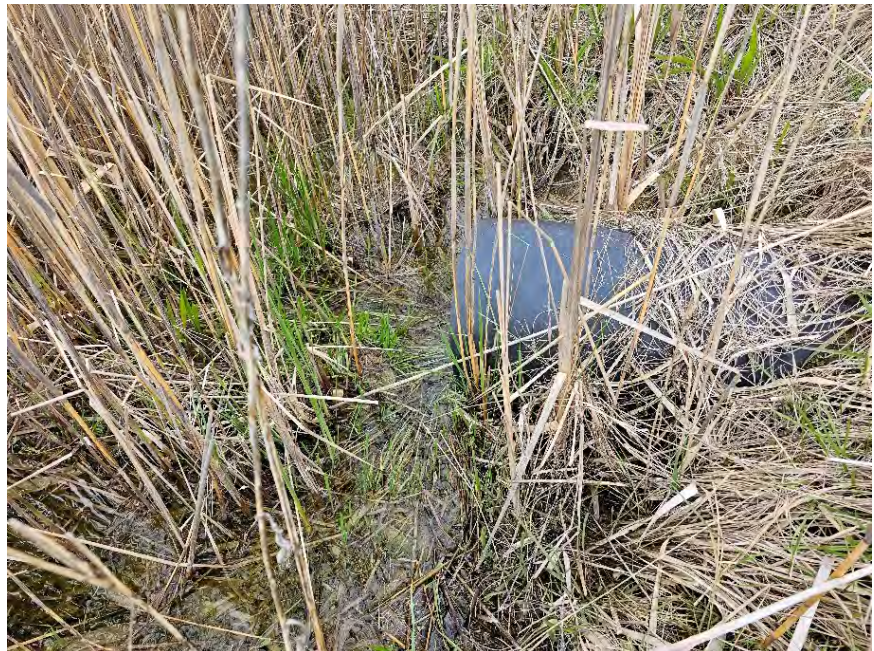
Photograph 8

Comments: Southeast culvert pipe at the end of the perimeter channel R4. Water observed in perimeter swale.

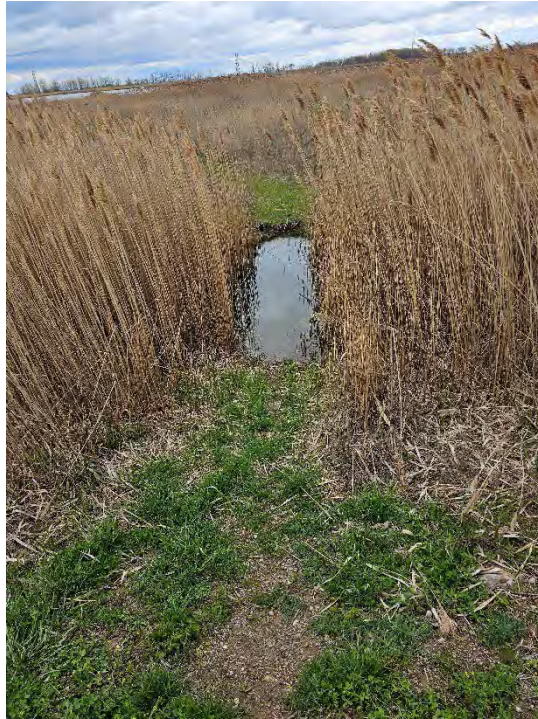
Comments: Perimeter swale R4 was heavily vegetated. Standing water was observed in perimeter swale R4.

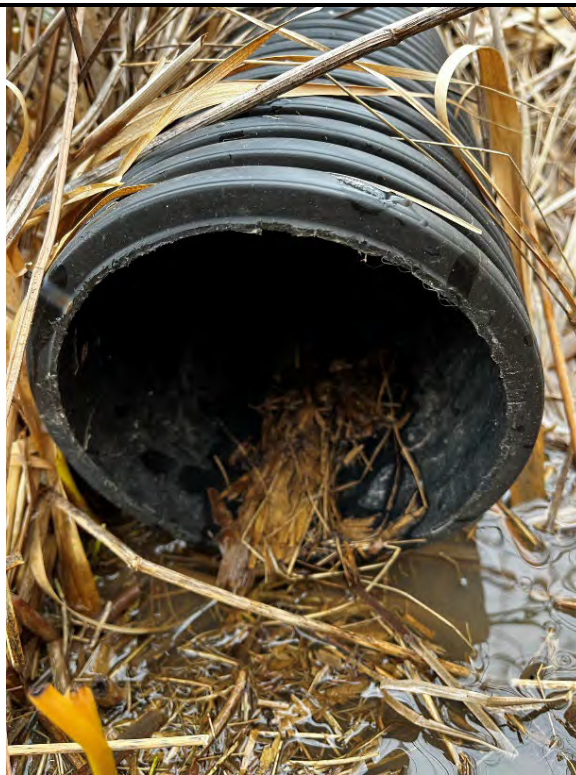
Photograph 10

Comments: Pore pressure relief pipe outlet. Typically, minimal or no sediments and no flow observed. Some outlets were wet, but not flowing during the inspection.

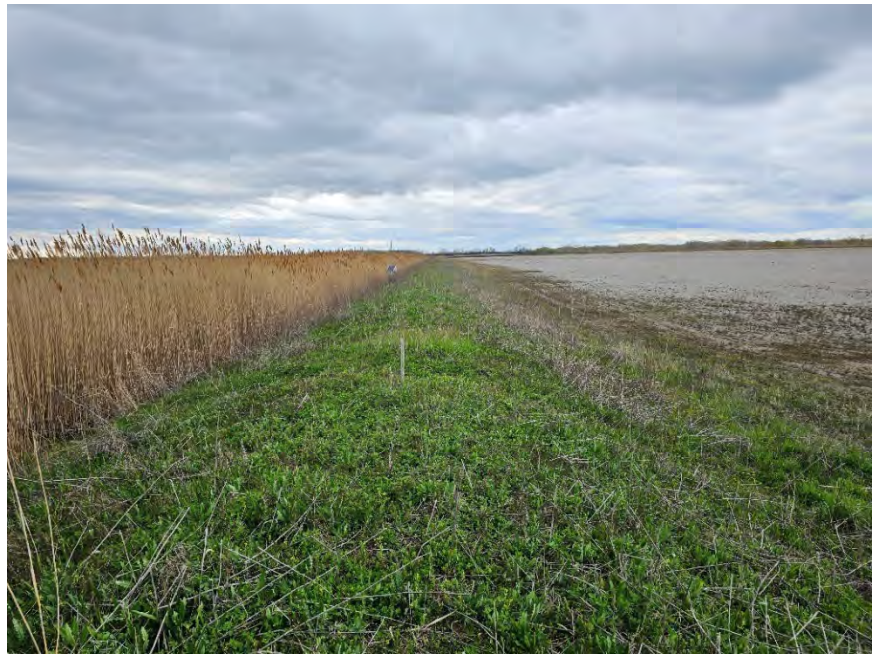
Comments: Perimeter berm slope and crest along south side of the Landfill. Perimeter berms were generally observed to be in good condition.

Perimeter swale R3 was heavily vegetated. Standing water was observed in perimeter swale R3.

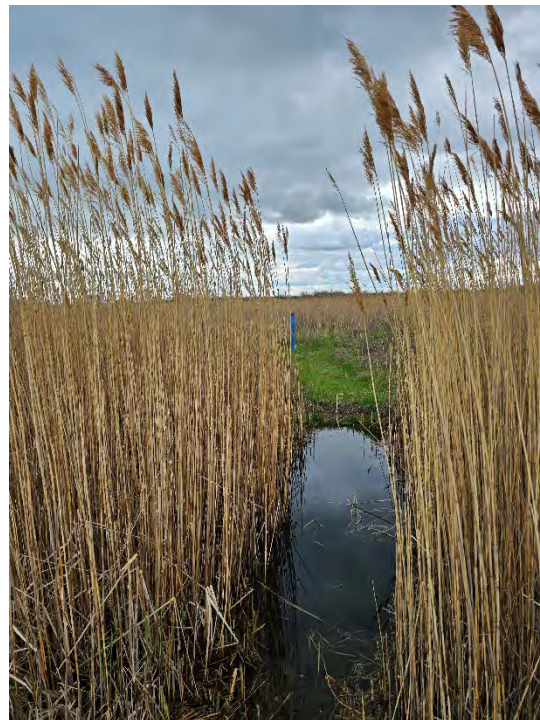
Photograph 12

Comments: Perimeter swale R3 was heavily vegetated. Standing water was observed in perimeter swale R3.

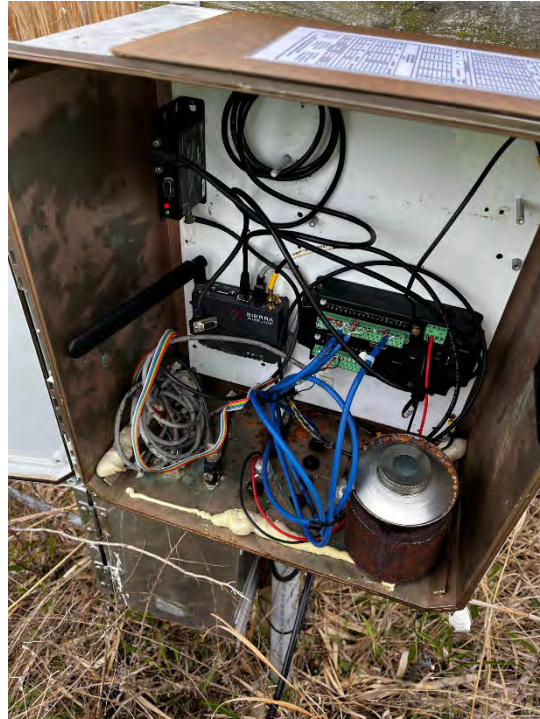
10. One continuous monitoring system box (datalogger [DL]-1) exhibited high moisture intrusion, and insects/ants were observed inside the box (Photograph 13). The desiccant canister inside the enclosure and sealing material were in poor condition. The other instruments observed during the inspection (DLs, slope inclinometers, piezometers, and settlement plates) appeared to be in good condition. Section 5 and Figure 2 present more details on the monitoring instruments at the Landfill.

Comments: Datalogger (DL)-1 had high moisture intrusion and insects/ants inside the box. The desiccant canister inside the enclosure and the sealing material were in poor condition.

Not Urgent - Replace desiccant canisters within the instrument boxes (DL-1 through DL-4) and apply new sealant within DL-1.

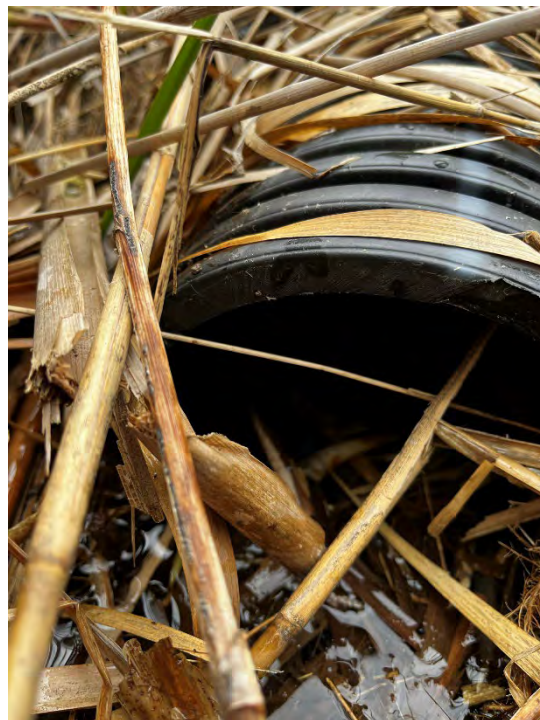
Photograph 14

Comments: The water level in portions of the southern swales towards the east end of R3 was above the bottom of the pressure relief pipe outlets. The water level did not appear to affect drainage capacity of the pipes.

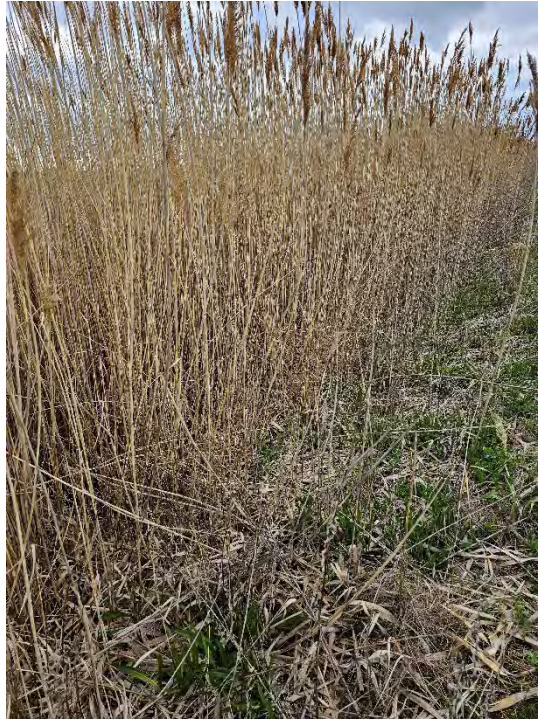
Comments: Several outlets could not be located due to heavy vegetation and water levels within the perimeter swales, particularly the south perimeter swales (R3 shown).

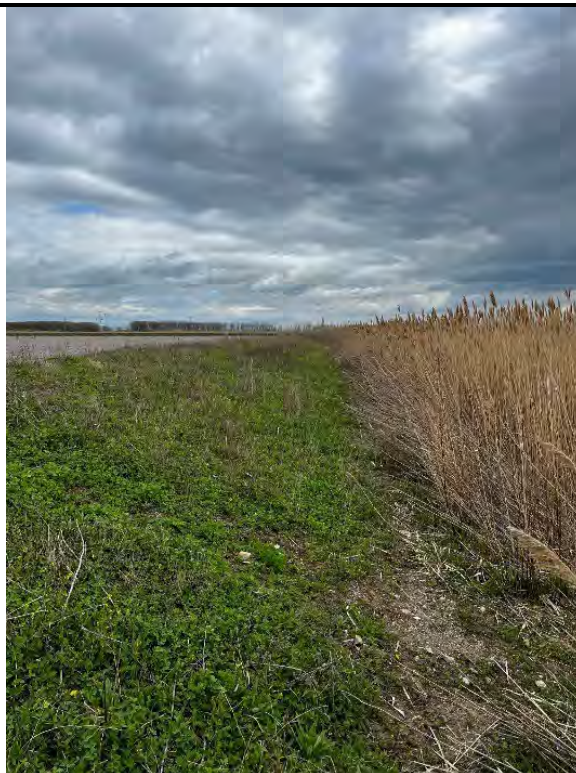
Photograph 16

3. Are there indications of erosion on the landfill perimeter berm? X Yes No
If 'Yes', describe what type and its condition (rill, gully, dimensions, etc.) _____
Minor surface erosion was observed on the toe of the berm on the south side (Photograph 16). Adequate vegetation observed on majority of the perimeter berms (Photographs 3, 7, 11, and 19).

Comments: Perimeter berm slope and crest along south side of the Landfill. Minor erosion of the grass was observed on the toe of the berm.

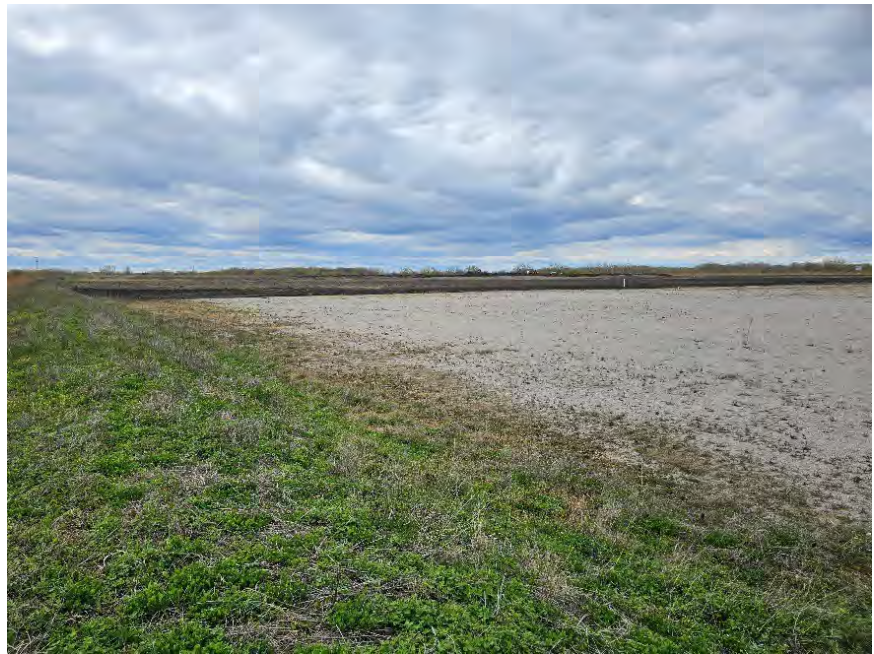
Comments: CCR placed in Phase 1 and Phase 2 of the Landfill. The CCR appeared to be placed and stacked in accordance with generally accepted engineering practices. The pressure relief layer was observed to be in good condition where no CCR has been placed.

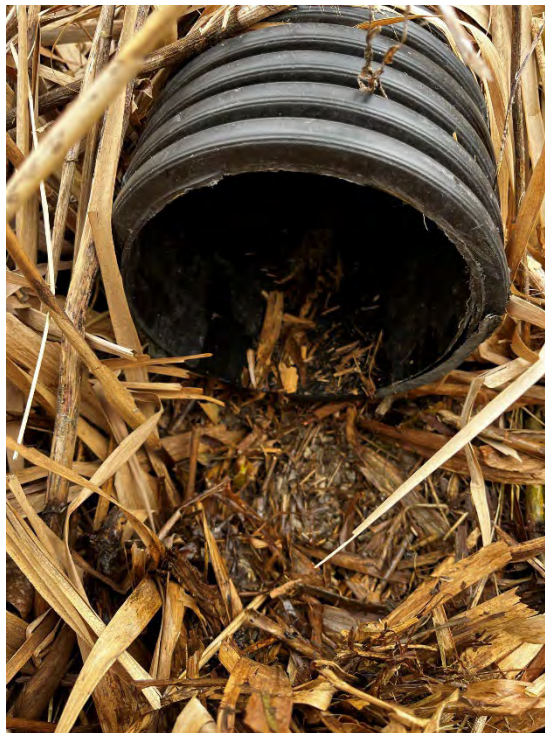
Photograph 18

Comments: Pore pressure relief pipe outlet. Typically, minimal or no sediments and no flow observed. Some outlets were wet, but not flowing during the inspection.

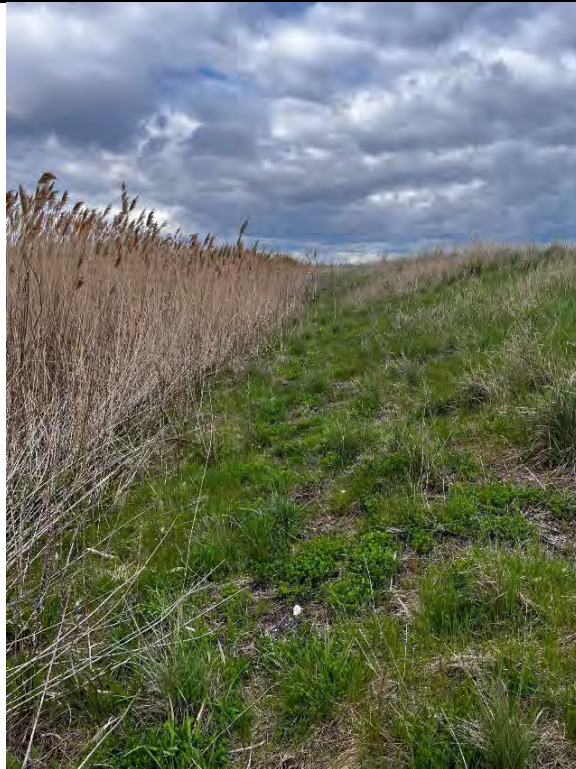
Comments: Perimeter berm slope and crest along the west and north sides of the Landfill. Perimeter berms were generally observed to be in good condition.

Perimeter swale R1 was heavily vegetated. Some standing water was observed in perimeter swale R1.

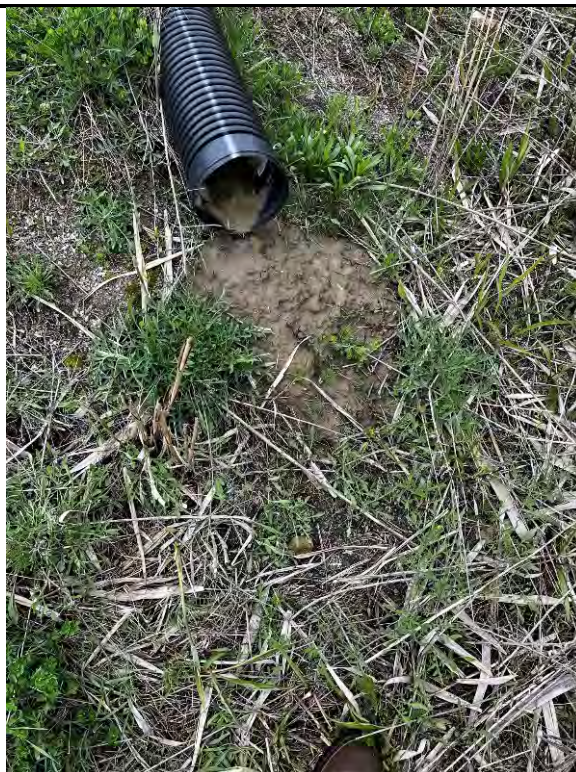
Photograph 20

Comments: One pore pressure relief pipe on the west side of the Landfill, where CCR has been placed, had some sediments within the pipe and below the outlet. The sediments did not appear to affect the drainage capacity of the pipe.

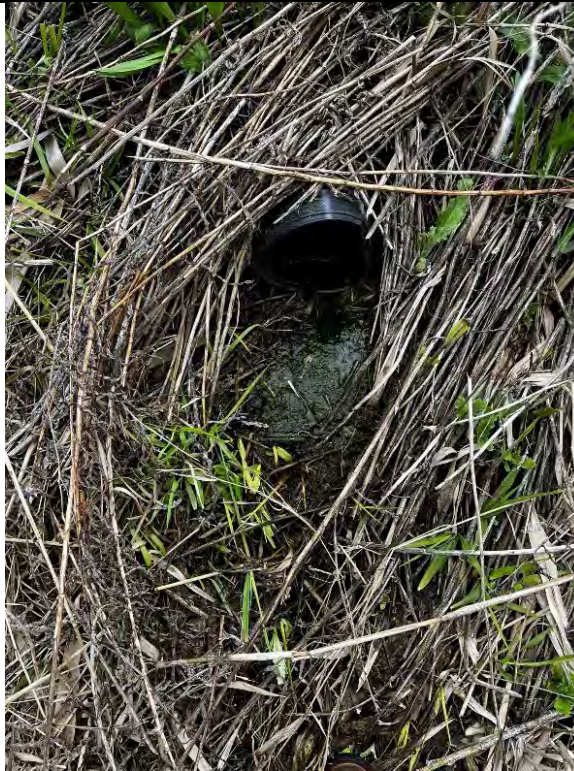
Comments: One pore pressure relief pipe was observed to be actively flowing, though flow was minimal. There was some algae growth around the outlet. This pipe is located on the northwest side of the Landfill where CCR has been placed.

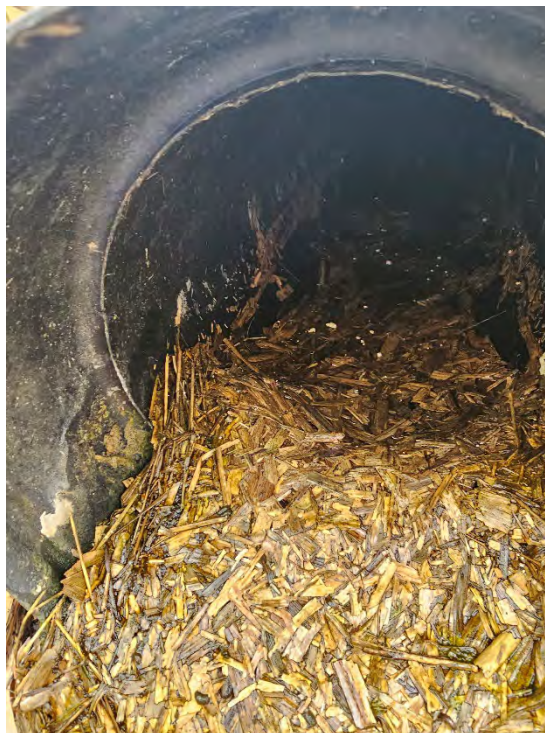
Photograph 22

Comments: Some pore pressure relief pipes were observed to have vegetation and other debris within the outlets. The vegetation and other debris did not appear to affect the drainage capacity of the pipes. Some outlets were wet, but not flowing during the inspection.

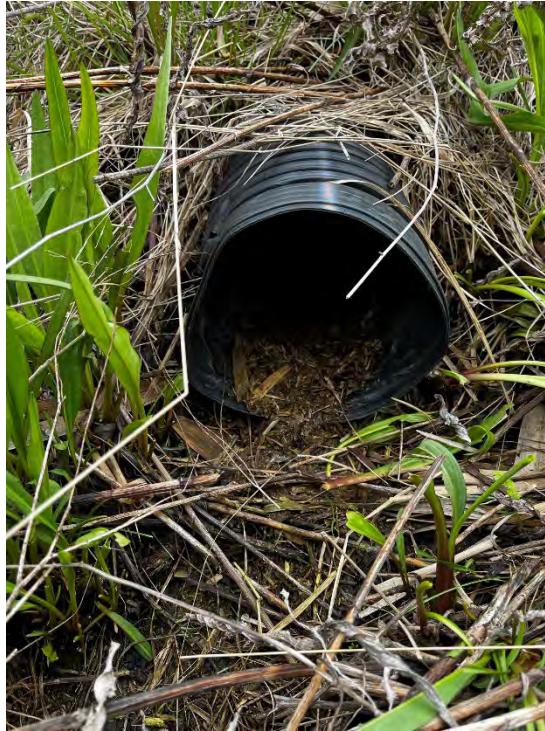
Comments Some pore pressure relief pipes were observed to have vegetation and other debris within the outlets. The vegetation and other debris did not appear to affect the drainage capacity of the pipes. Some outlets were wet, but not flowing during the inspection.

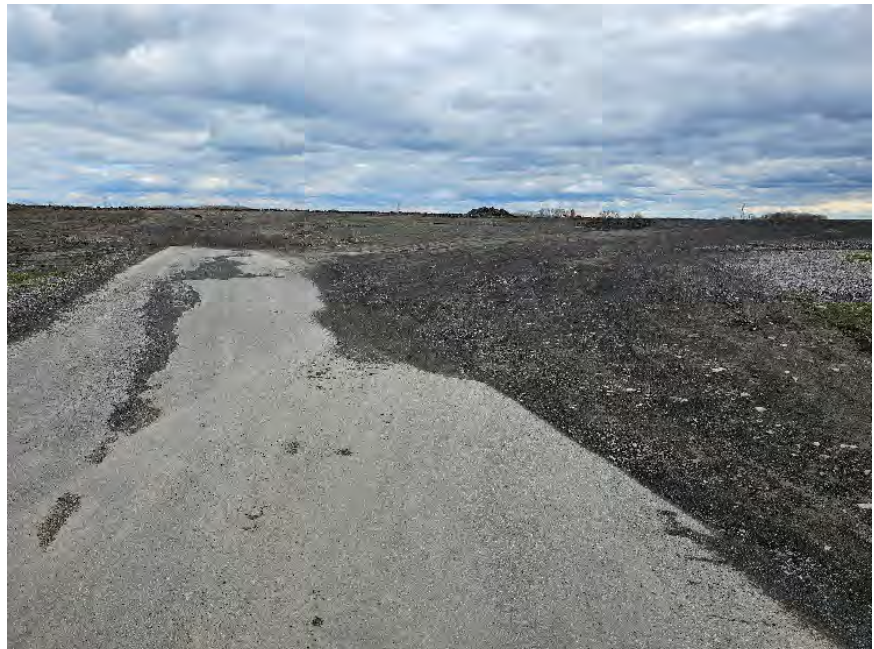
Photograph 24

Comments: The access road on the north side of the Landfill was observed to be in good condition.

CCR placed in Phase 1 of the Landfill. The CCR appeared to be placed and stacked in accordance with generally accepted engineering practices.

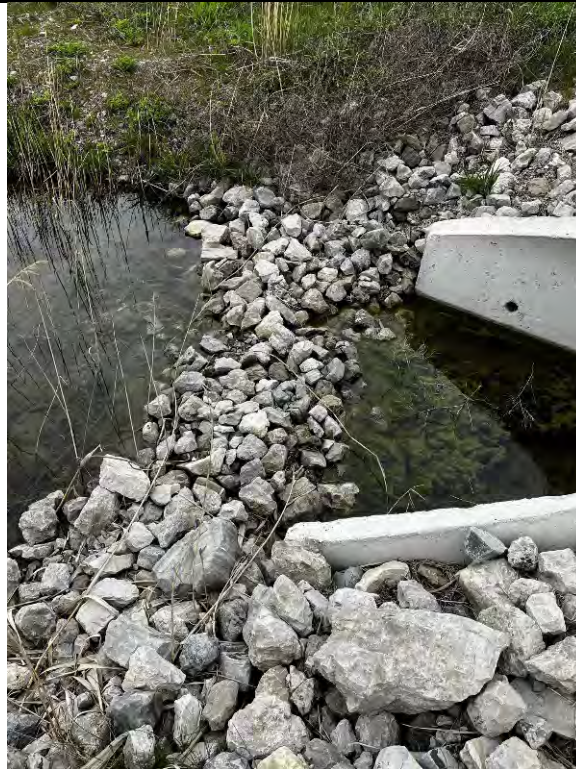
Comments The reinforced concrete culvert beneath the access road on the north side of the Landfill. The culvert and riprap were in good condition without sediments.

Some standing water was observed in perimeter swale R1.

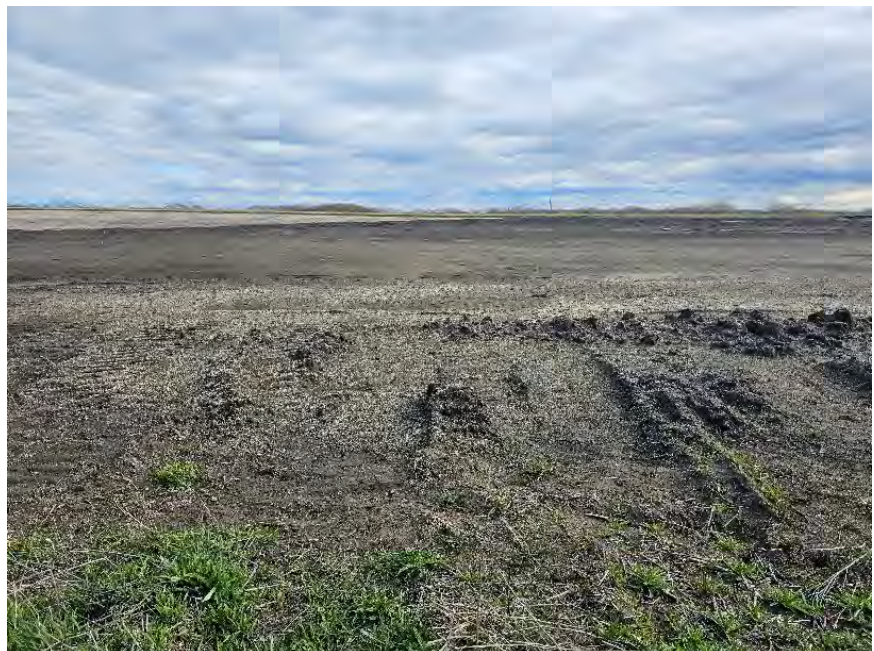
Photograph 26

Comments: CCR placed in Phase 2 of the Landfill. The CCR appeared to be placed and stacked in accordance with generally accepted engineering practices.
