DTE Electric Company
One Energy Plaza
Detroit, Michigan 48226

**2023 ANNUAL
INSPECTION REPORT
FLY ASH BASIN**

MONROE POWER PLANT

January 2024

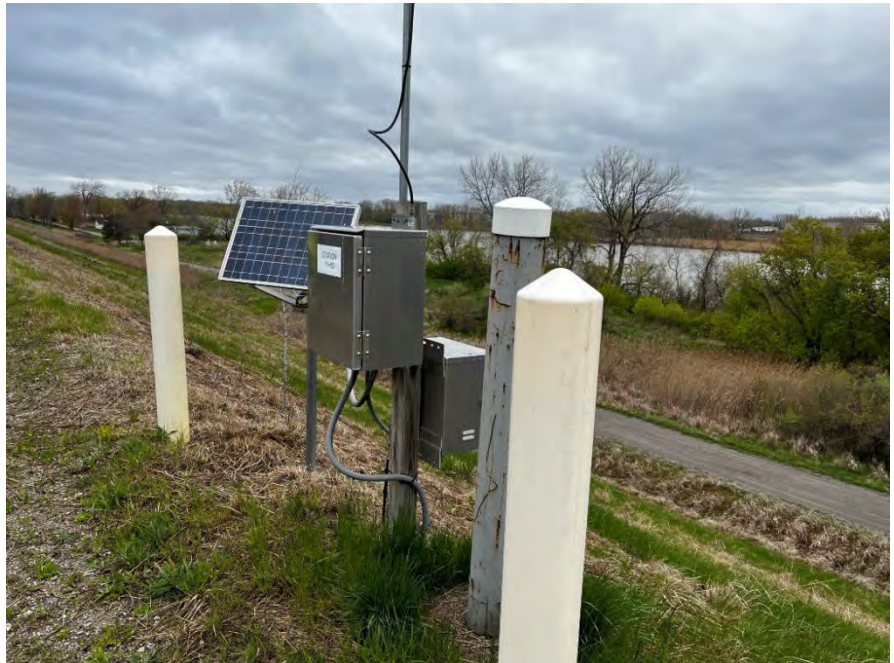
Comments: The instrumentation monitoring equipment including the equipment boxes and wiring were in good condition. The desiccant canisters in the equipment boxes were degraded (circled) (typical conditions shown).

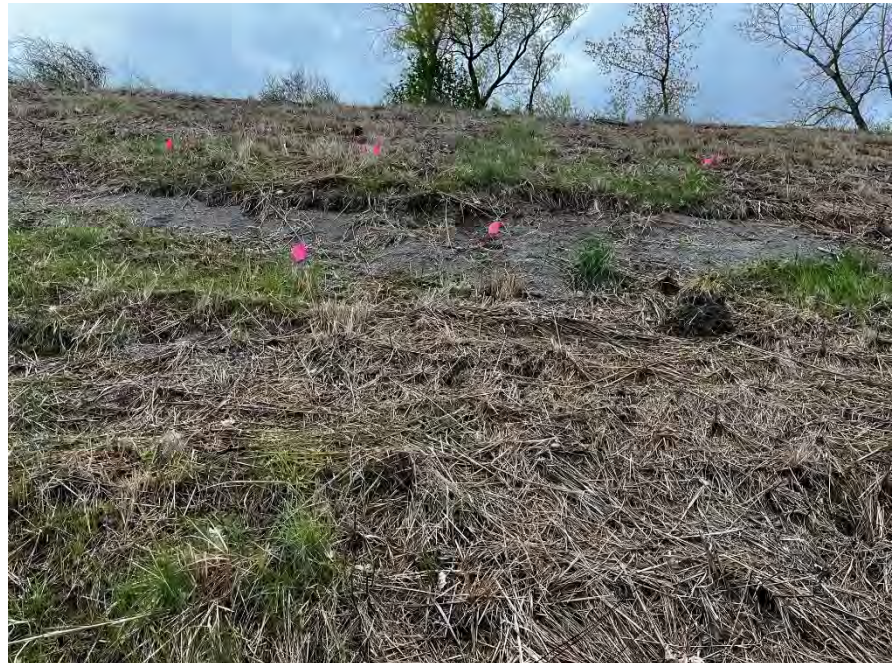
Comments: Surficial movements appeared to be causing “bunching” of materials at the toe of the embankment where the crack/slough near approximate Station 12+00 had reopened after being repaired.

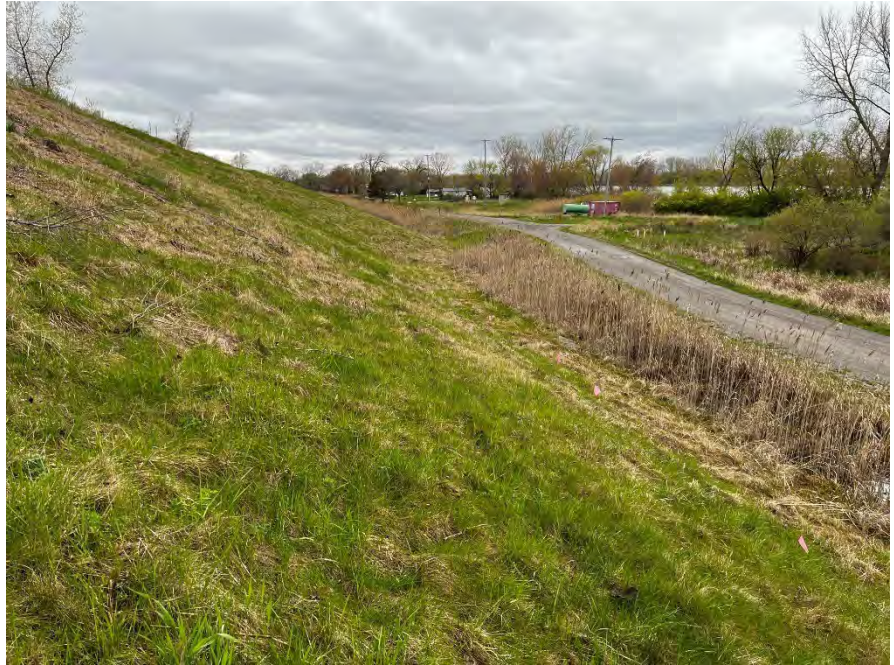
Photograph 8

Comments: Small, mossy areas observed at a couple locations on the northeastern perimeter embankment slopes (typical conditions shown). No water was observed flowing out of these areas.

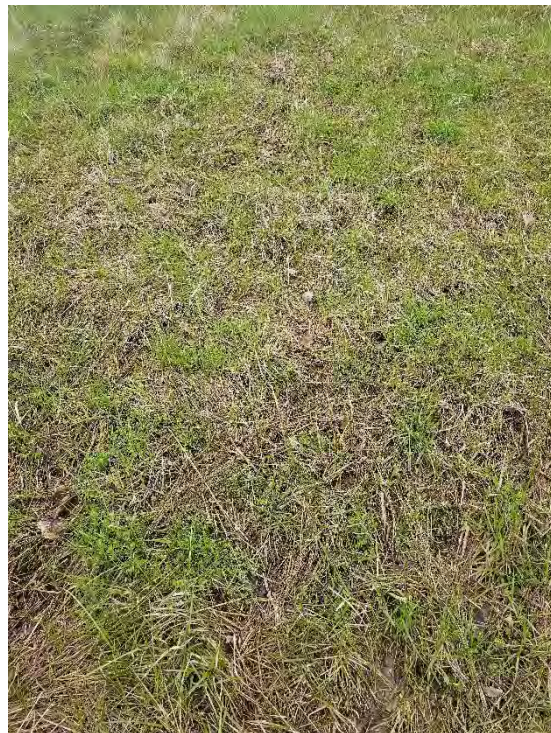
Comments: Cut vegetation from general maintenance operations was observed within the SmartDitches® throughout the site (typical conditions shown). The vegetation did not appear to affect the functionality of the SmartDitches to conduct sufficient stormwater flow.

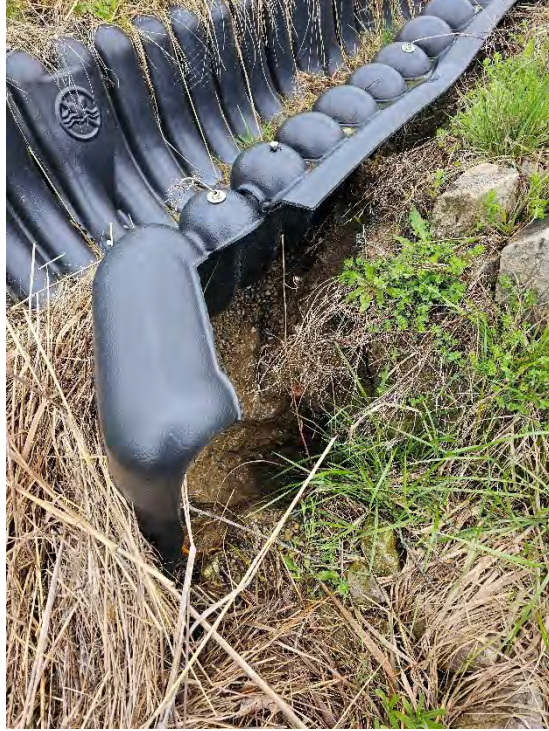
Photograph 12

Comments: Water had eroded a hole below the SmartDitch near the outlet at approximate Station 18+00 and was observed flowing into the hole.

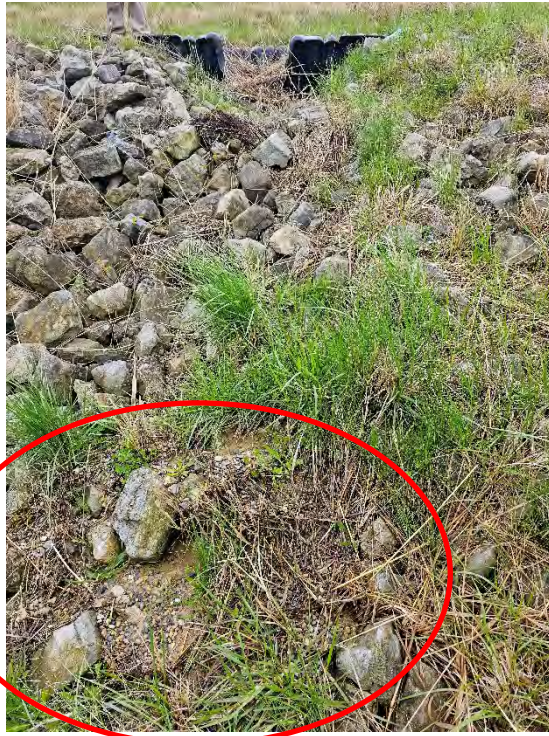
Photograph 14

Comments: The riprap downchutes were generally in satisfactory condition (i.e., minimal erosion of riprap, minimal vegetation) (typical conditions shown) (downchute at approximate Station 18+00 shown). No adverse conditions were identified that appeared to affect the functionality of the riprap downchutes to convey stormwater.

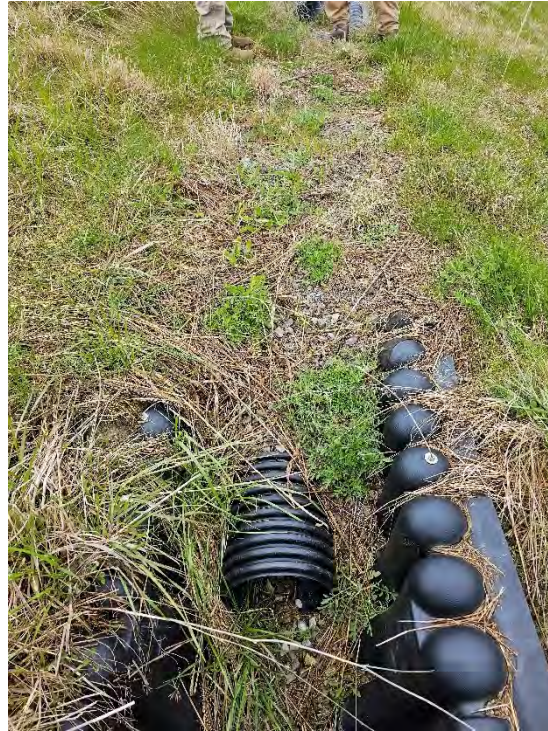
Photograph 16

Comments: The covered high density polyethylene (HDPE) drain pipes connecting portions of the SmartDitches were observed to have minimal sediments and vegetation and were overall in good condition (typical conditions shown).

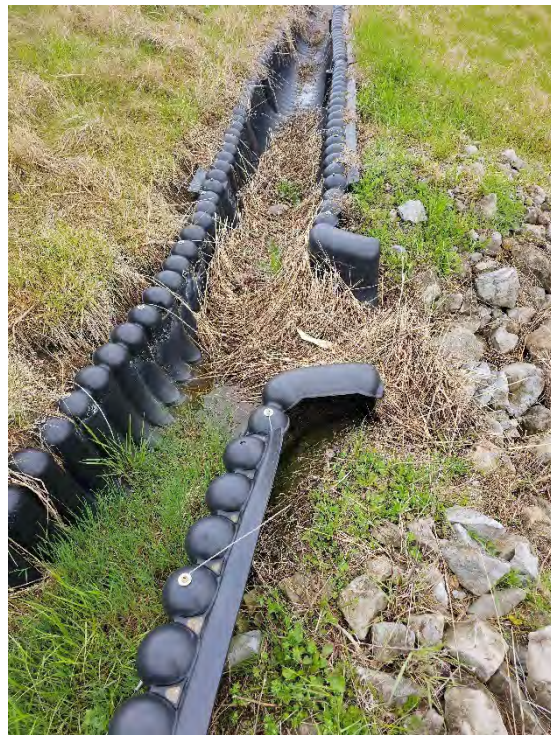
Comments: Over one foot of riprap appeared to have eroded from below the SmartDitch outlet into the riprap downchute at approximate Station 32+00. The geotextile fabric was exposed and torn below the SmartDitch outlet (circled).

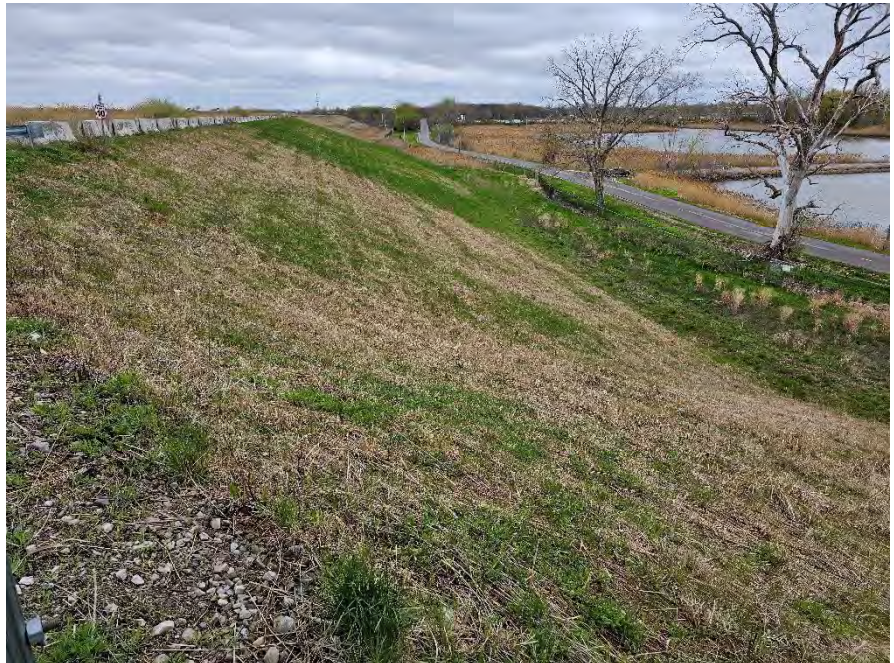
Comments: Bentonite and sand repair made to crack near approximate Station 65+00 was in satisfactory condition. No indications of additional movement were observed.

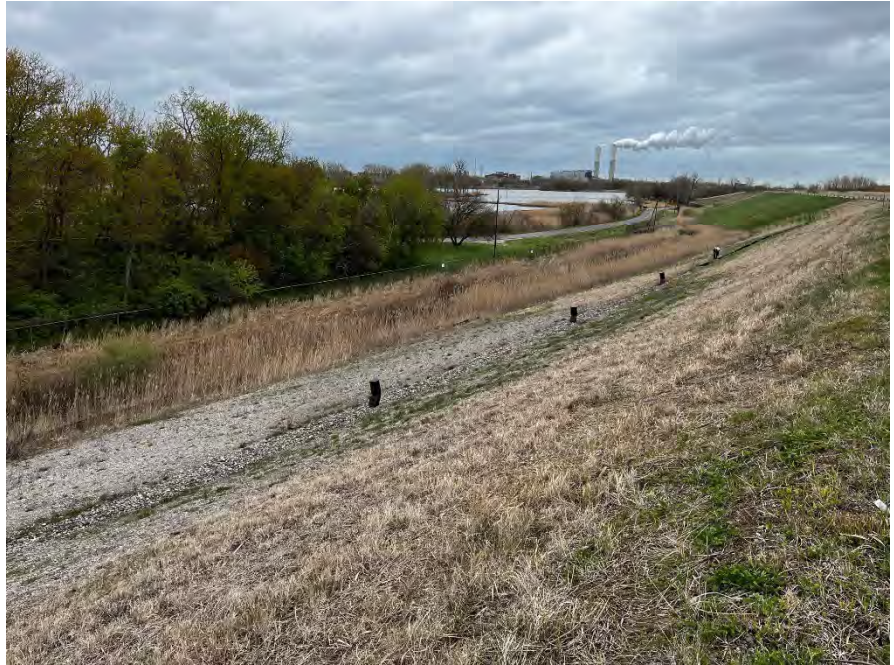
Photograph 26

Comments: Gravel placed on the perimeter embankment slopes at approximate Station 67+00 appeared to have raveled from the upper portion of the slope to the lower portion of the slope. Portions of the slotted high-density polyethylene pipe were exposed as a result.

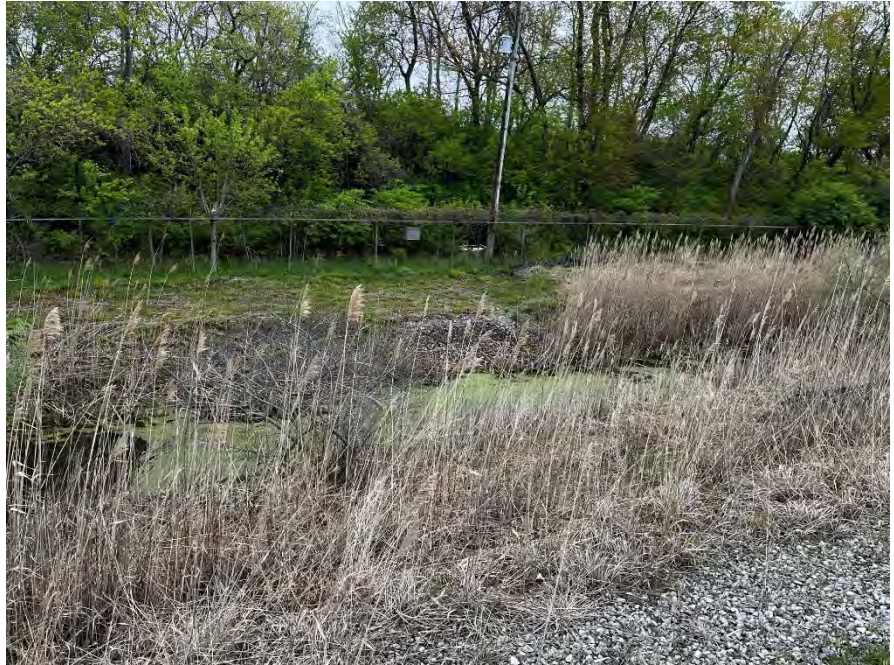
Photograph 28

Comments: Some vegetation observed in the riprap downchute near Station 70+00. No adverse conditions were identified that appeared to affect the functionality of the riprap downchutes to convey stormwater.

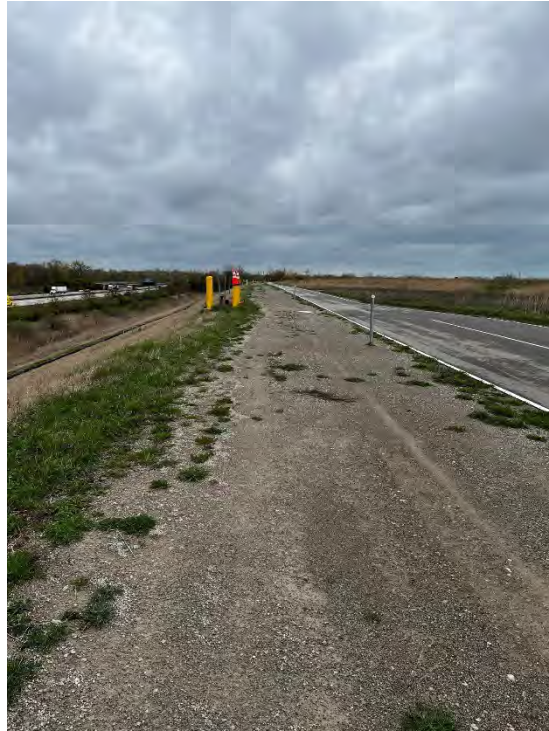
Photograph 30

Comments: Bentonite and sand repair made to crack near approximate Station 78+00 was in satisfactory condition. No indications of additional movement were observed.

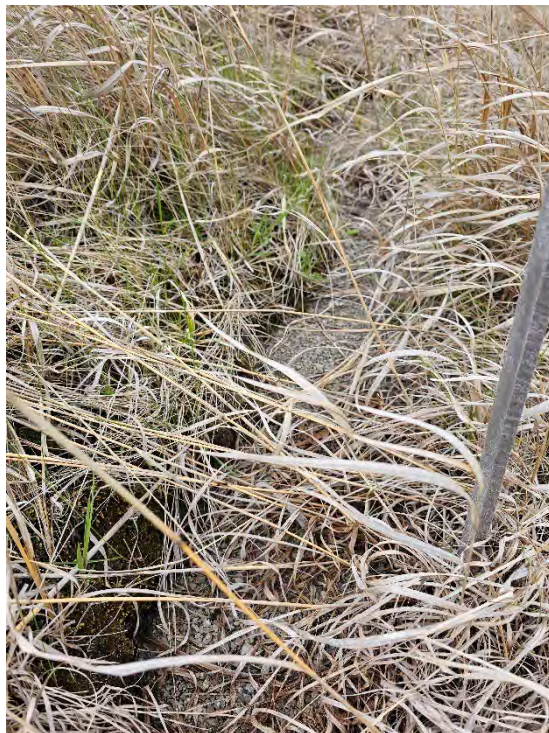
Comments: A fire burned vegetation on the perimeter embankment slopes between approximate Stations 82+50 and 91+00. The vegetation appeared to be starting to re-establish along this portion of the embankment.

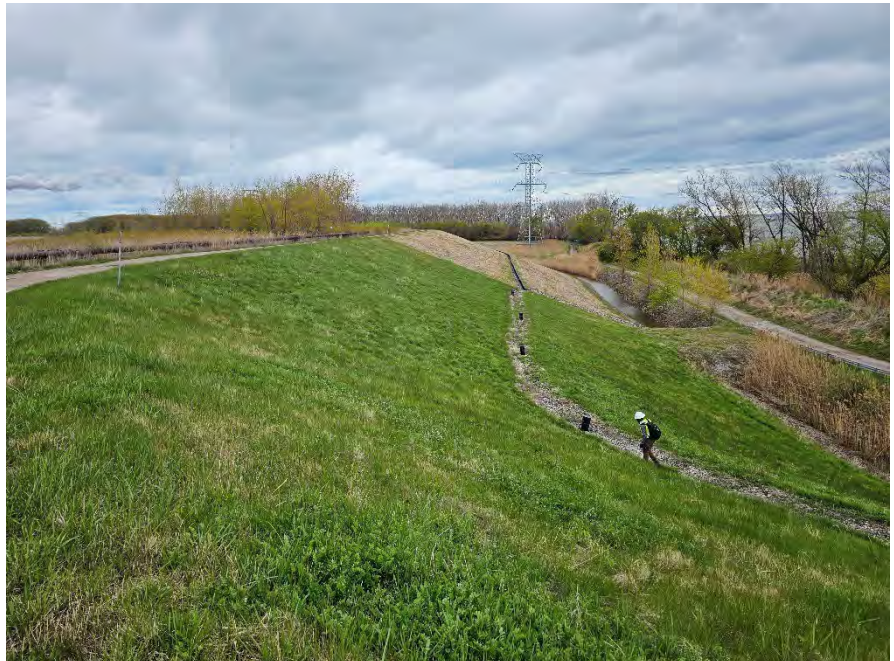
Comments: One of the inspection ports for the covered HDPE pipe near approximate Station 143+00 was missing a cover.

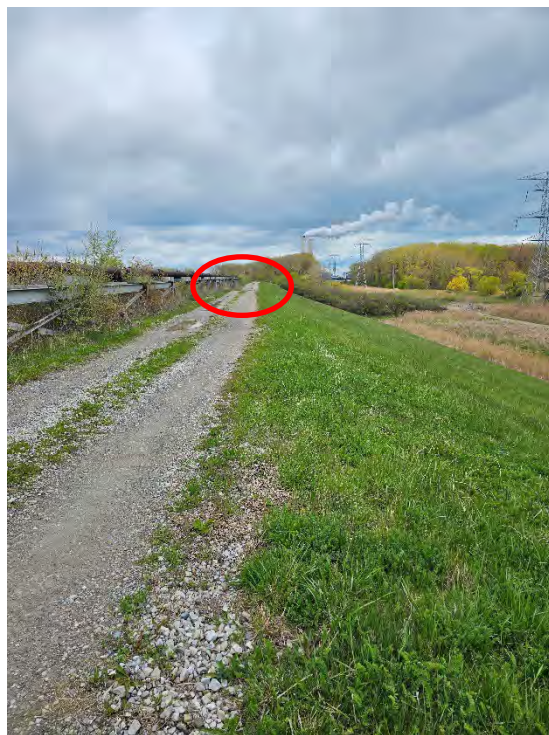
Comments: A prior wet area filled with gravel near approximate Stations 175+00 to 177+00 was not observed to be wet.
