**2023 ANNUAL
INSPECTION REPORT
SIBLEY QUARRY LANDFILL**

TRENTON CHANNEL POWER PLANT

Trenton, Michigan

January 2024

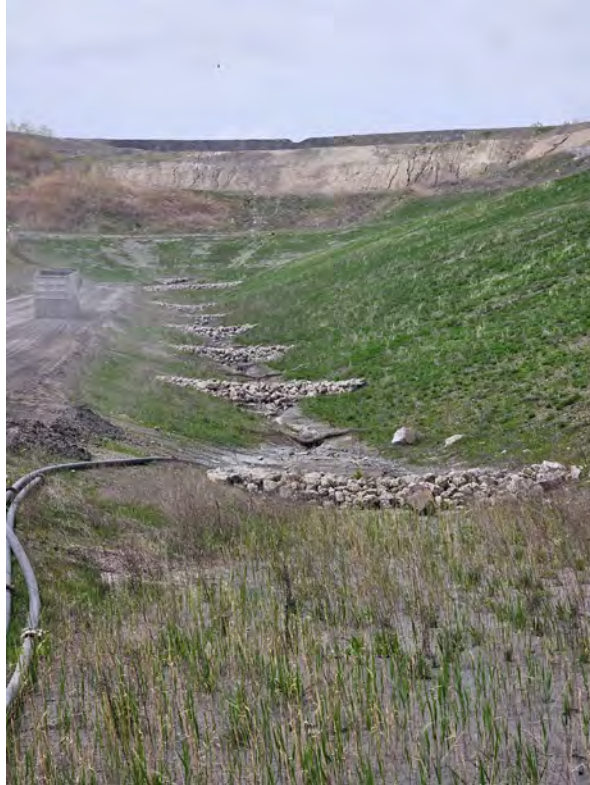
Photograph 14

- 5) Erosion rills and gullies were observed on the Switchback 2 and northern CCR slopes during the inspection (Photographs #14, #17, #19, #20). Due to the incised nature of the Landfill, these erosion features do not represent an existing concern to the safety and operation of the Landfill.

- 2) Eroded sediments were noted behind the check dams in the drainage channel at the bottom of the Switchback 2 slopes. While it currently does not pose an issue, these sediments might restrict the flow of water to the bottom of the quarry or cause water to flow over the Switchback 2 roads over time.

Comments: Erosion rills on the lower slope of the Switchback 2 haul road and eroded materials behind a check dam. Erosion features should continue to be monitored. Eroded materials should be cleared from the check dam. (Northeast)

- 2) As much of the sediments behind the check dams in the drainage channel at the bottom of the Switchback 2 haul road should be removed as possible without comprising the check dams or toe of the slopes. This will allow stormwater to flow within the drainage channel to the bottom of the quarry and prevent water from flowing over the Switchback 2 haul road.
- 3) Damaged coir logs at the top of the diversion berm along the Switchback 2 haul road should be replaced to prevent uncontrolled flow on the haul road slopes and limit soil erosion and the formation of rills and gullies, which could decrease the stability of the slopes.
- 4) Additional riprap, gravel, and sand should be placed below the pipe outfalls from the upper ponds, conveyance channel, and Settling Pond #4 to replace eroded material and limit continued erosion in these areas.

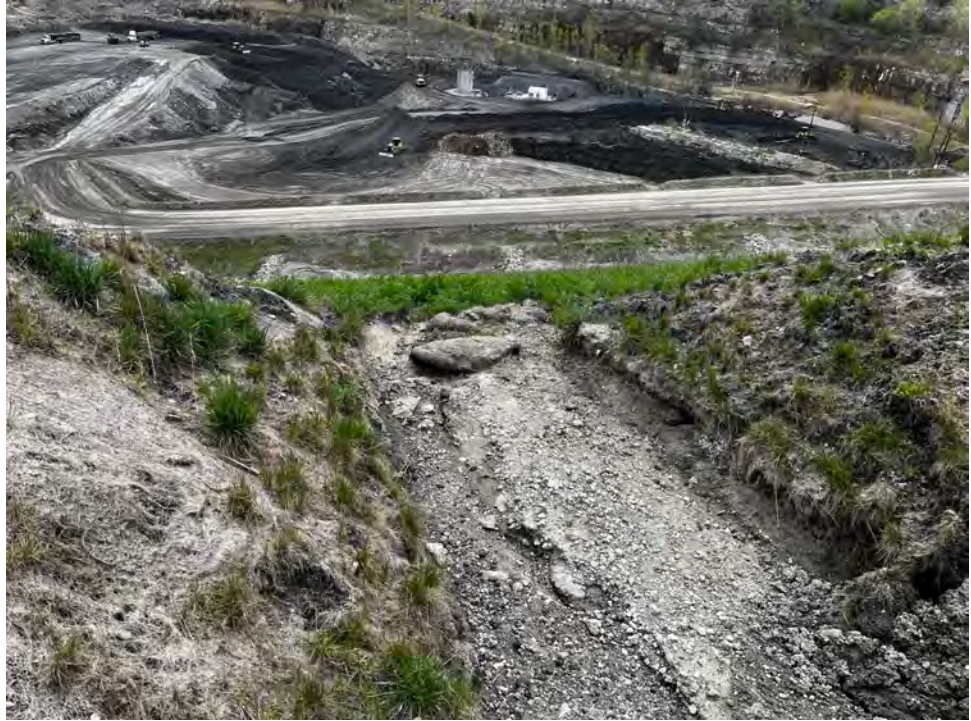
Photograph 18

Comments: Drainage channel and diversion berm along the Switchback 2 haul road. (South)

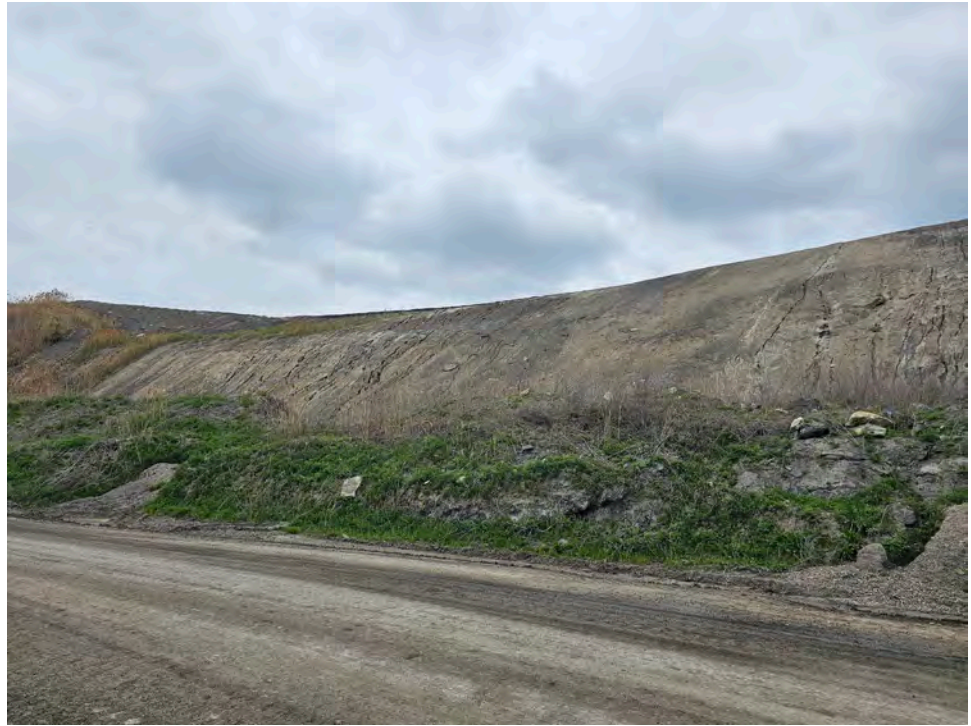
Photograph 20

Comments: Erosion rills and gully on the northern CCR slopes above the quarry. (Northwest)

- 1) The northern CCR slopes and Switchback 2 slopes should continue to be monitored to assess the need for maintenance/repair of expansion of rills and gullies. If these erosion features continue to develop or expand, Geosyntec recommends DTE work with a professional engineer to develop additional stormwater management measure(s).

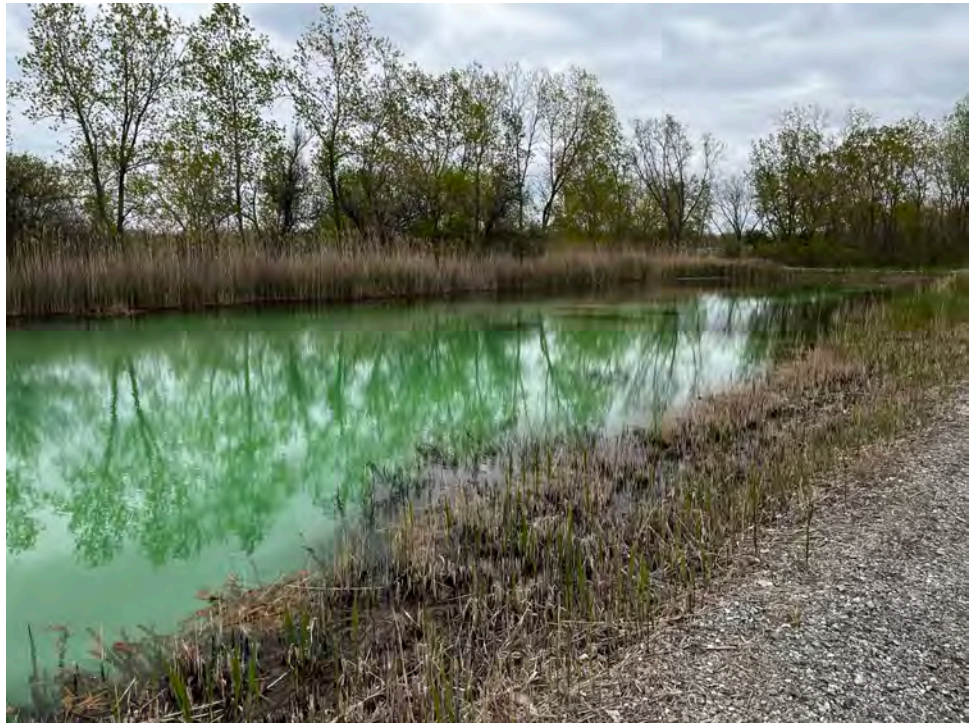
Photograph 22

Comments: Discharge into south upper pond. (Southwest)

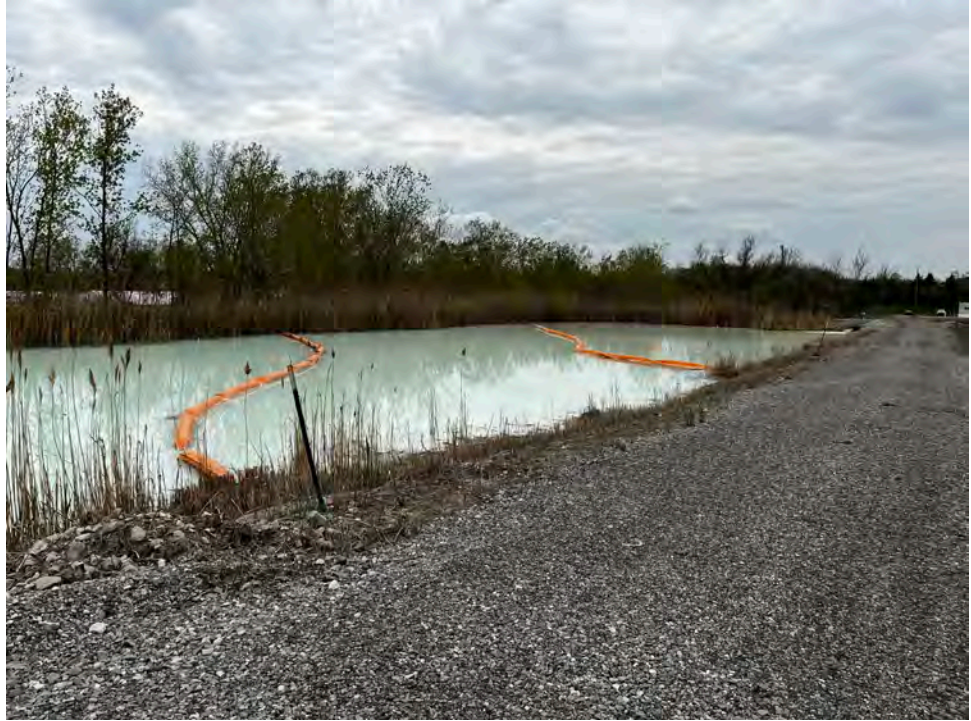
Photograph 24

- 10) Outfalls of the pipes from the upper ponds into the conveyance channel (Photograph #24), the conveyance channel to Settling Pond #4 (Photograph #26), and Settling Pond #4 to Settling Pond #3 (Photograph #27) were observed to have some erosion of the riprap and surrounding soils.

Comments: Discharge from upper ponds into conveyance channel. Some erosion is observed beneath the pipe. (North)

Not Urgent - Replace damaged coir logs at the cuts in the diversion berm along the top of the switchback two haul road slopes.
Not Urgent - Place additional riprap, gravel, and sand below the pipe outfalls from the upper ponds, conveyance channel, and Settling Pond #4.

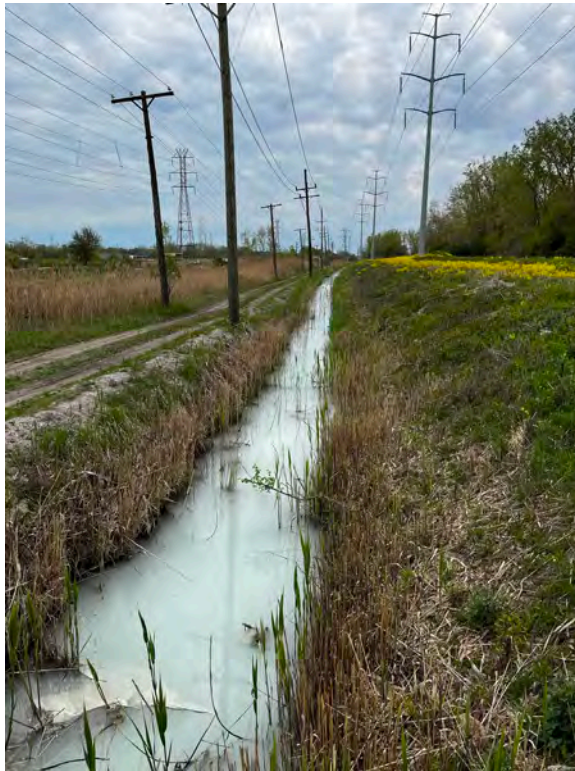
Photograph 26

Comments: Discharge
from conveyance
channel into Settling
Pond #4. Some
erosion is observed
beneath the pipe.
(Southwest)
