DTE ENERGY

Bottom Ash Impoundment Annual Inspection Report - 2025

DTE Monroe Power Plant

August 29, 2025

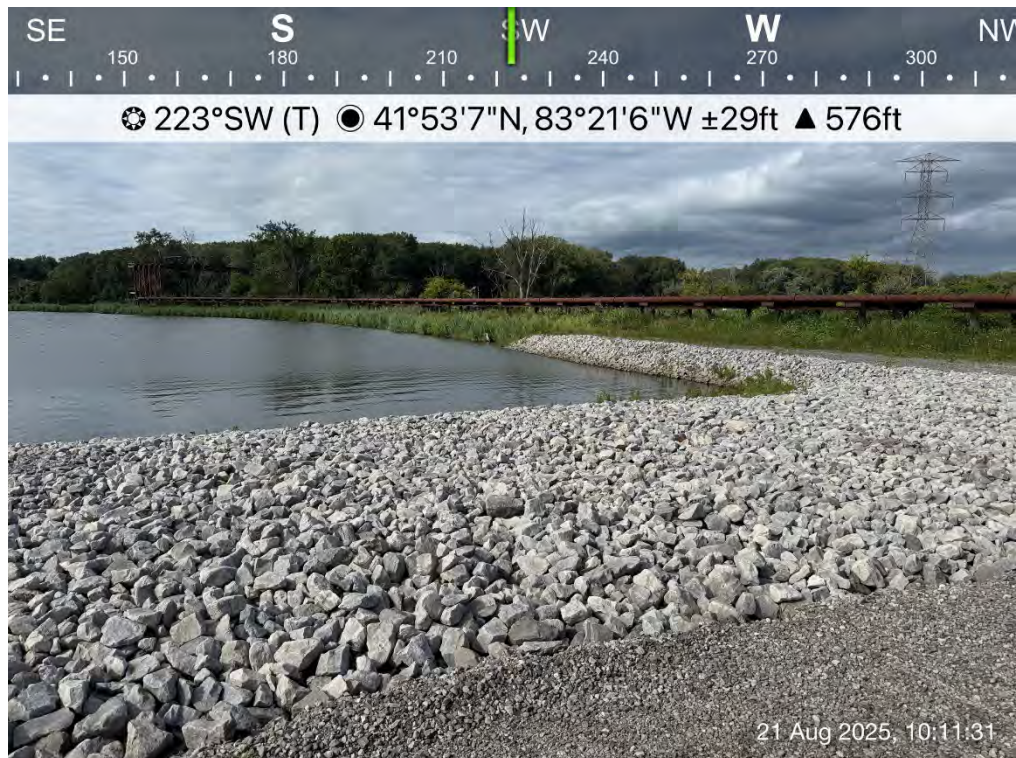
Northwest corner of impoundment with finished closure surface

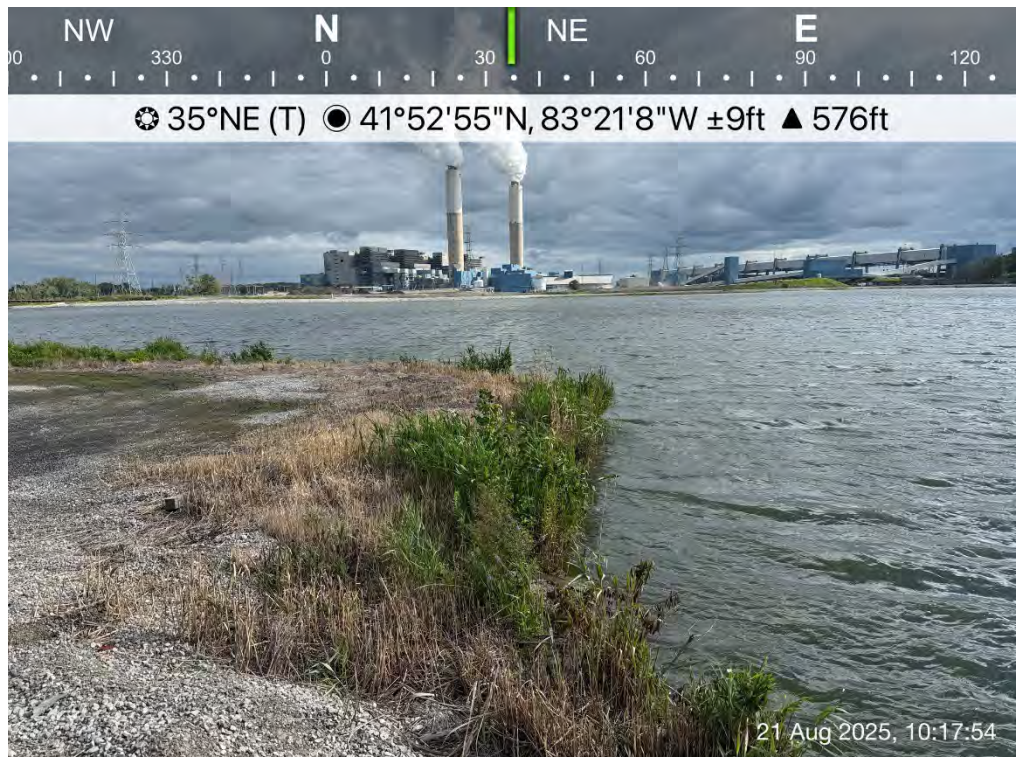
Interior slope of impoundment north of weir

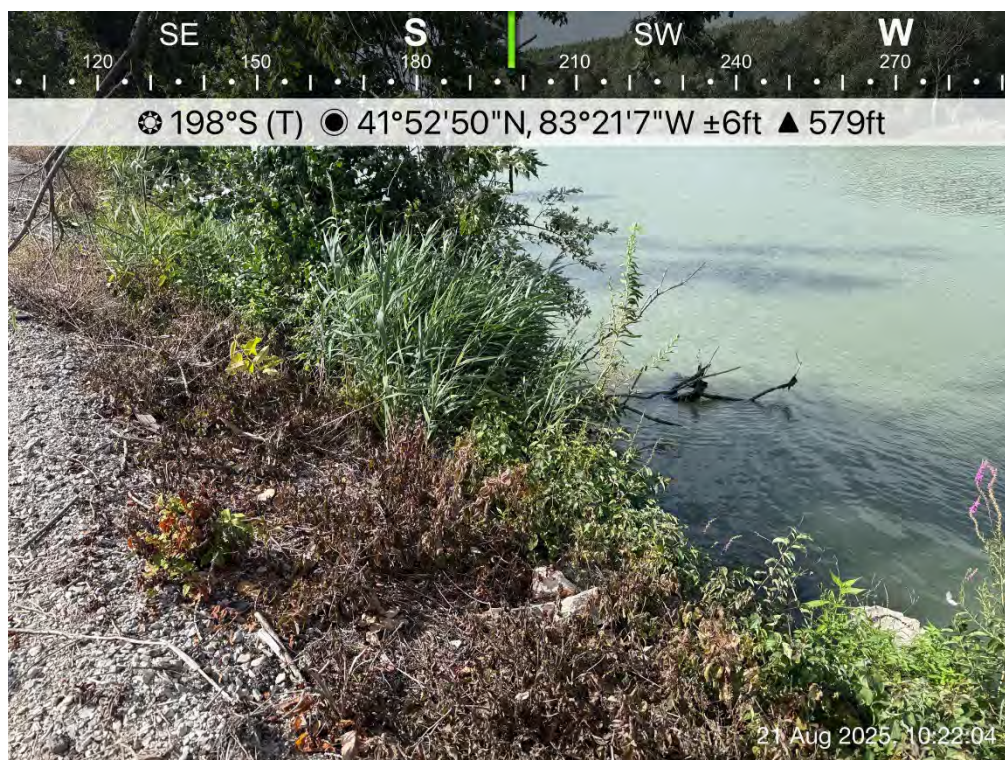
Exterior slope of impoundment south of weir

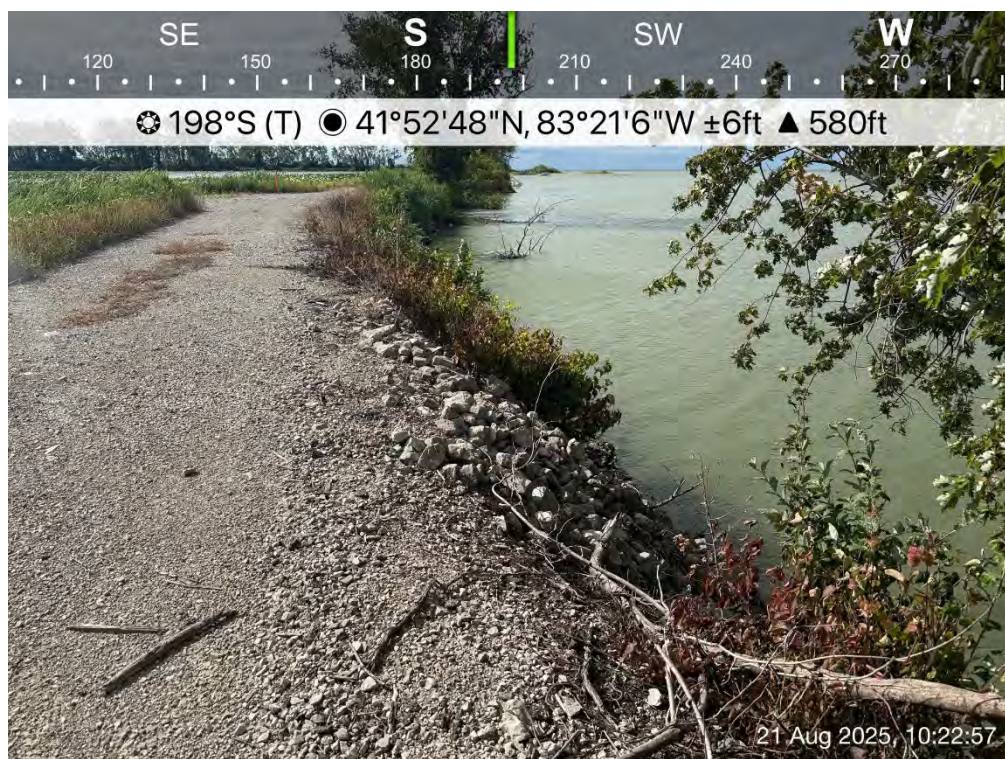
Rip-rap armoring along western exterior embankment

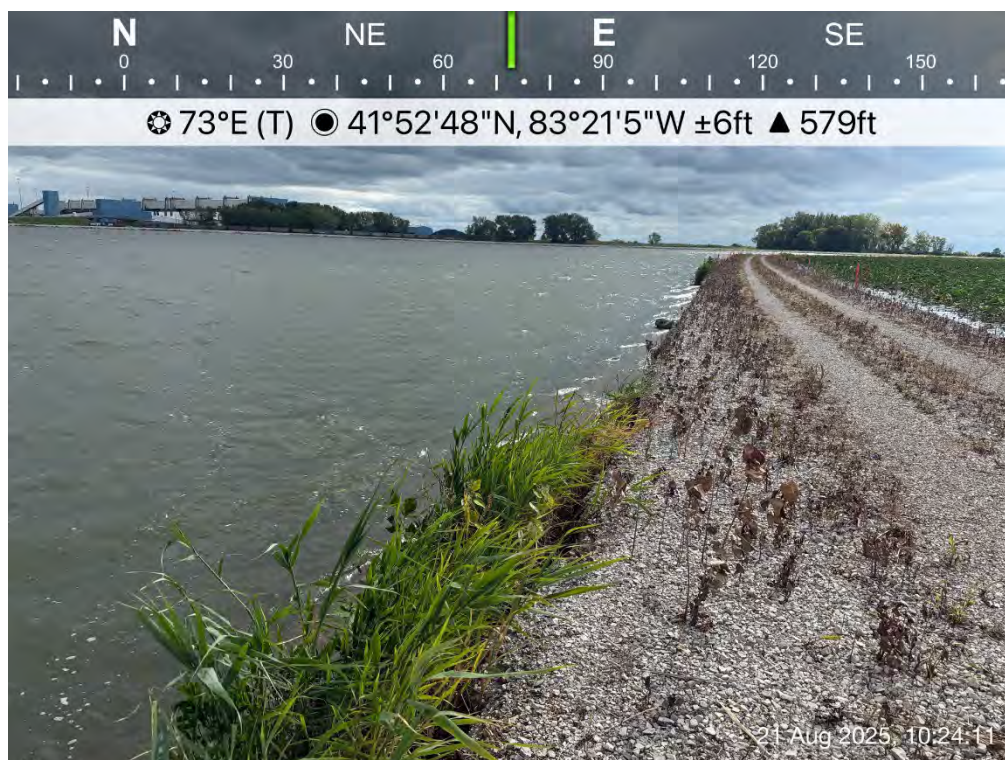
Vegetation along western perimeter consists of brush and trees that contribute to stability - no action recommended.

Vegetation along separation berm – western edge

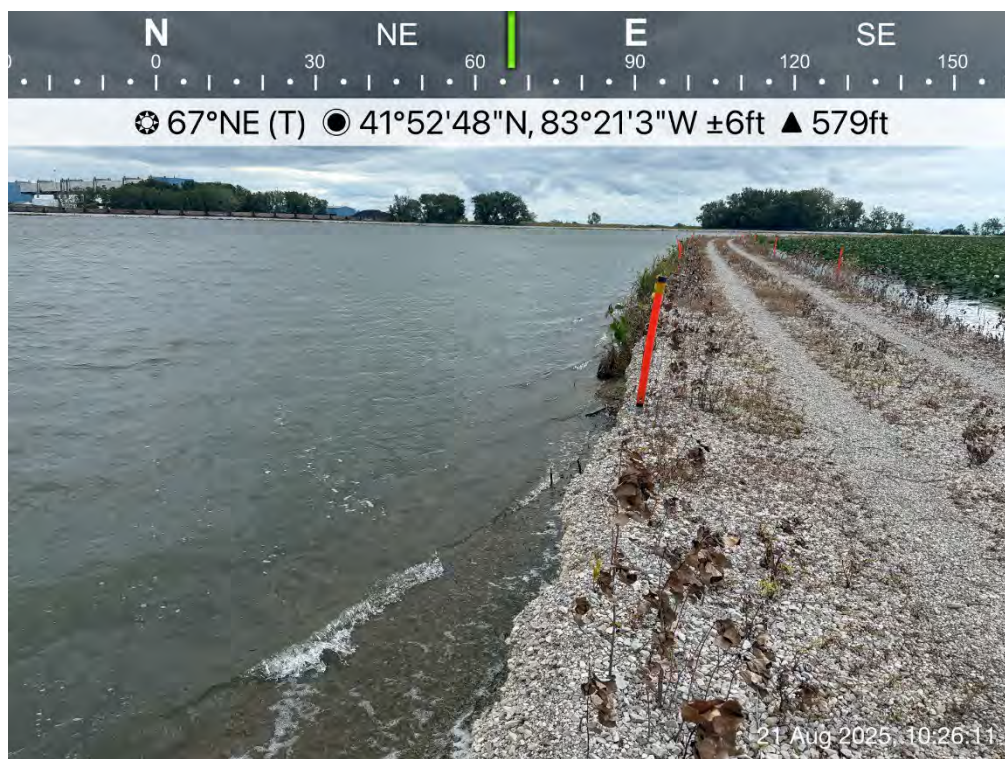
- 1) The following conditions were observed and should be addressed. The northern/upstream face side of the separation berm continues to show signs of erosion and sloughing, as noted in previous reports; this is especially visible on the western portion for a length of approximately 100-150' where plastic bollards have been impacted – impacts are now visible along with surficial cracking for a length of 700'. This sloughing has occurred likely due to wave action and previous undercutting from dredging in these areas associated with closure.

Sloughing along separation berm

Based on our inspection of the Bottom Ash Impoundment (BAI), we recommend repairing the northern face of the southern separation berm. While the observed sloughing is not an immediate structural threat (approximately 20 feet of crest width remains), the repairs should be scheduled to coincide with or immediately follow the completion of the closure project. Furthermore, DTE should close the separation berm to vehicle traffic as a precautionary measure.

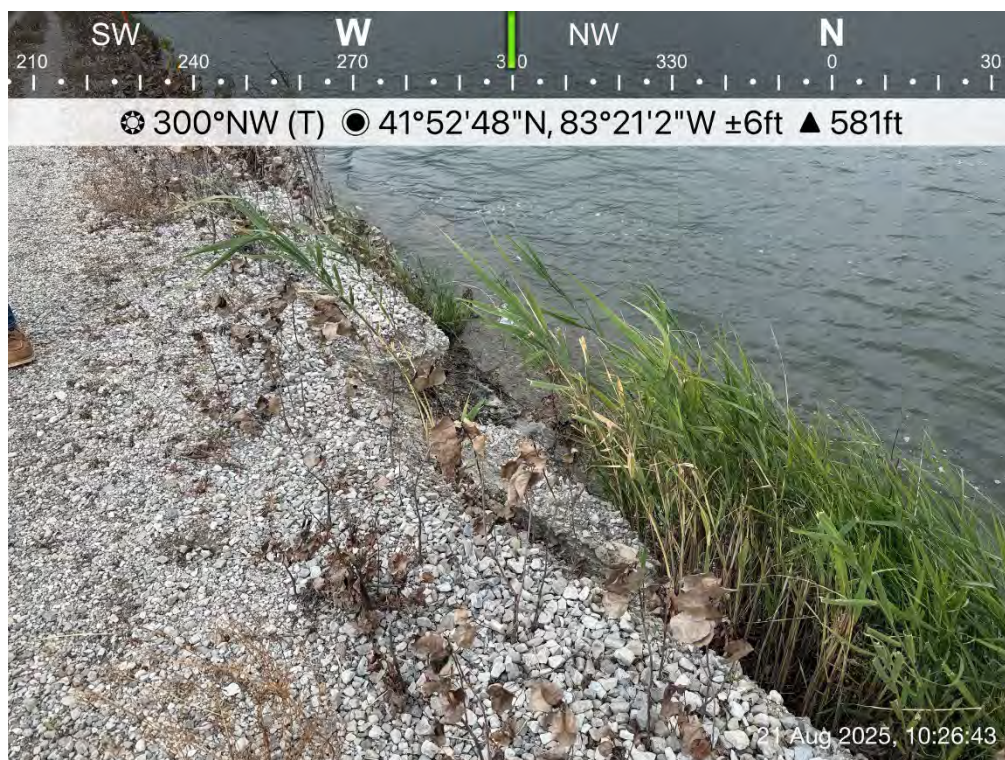
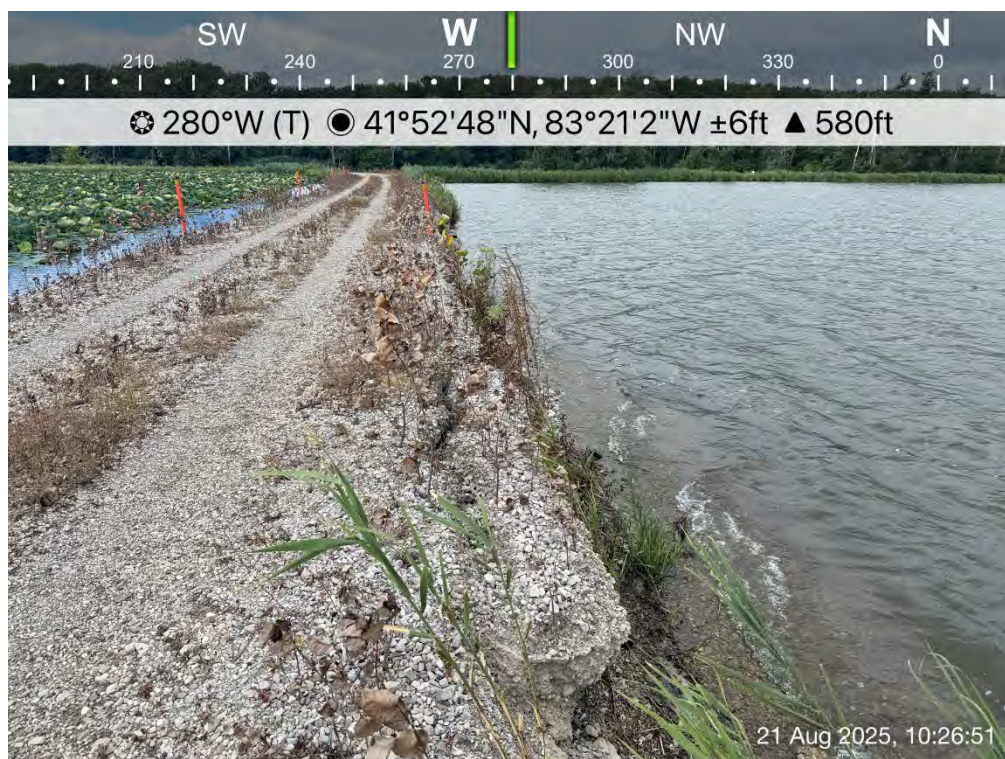
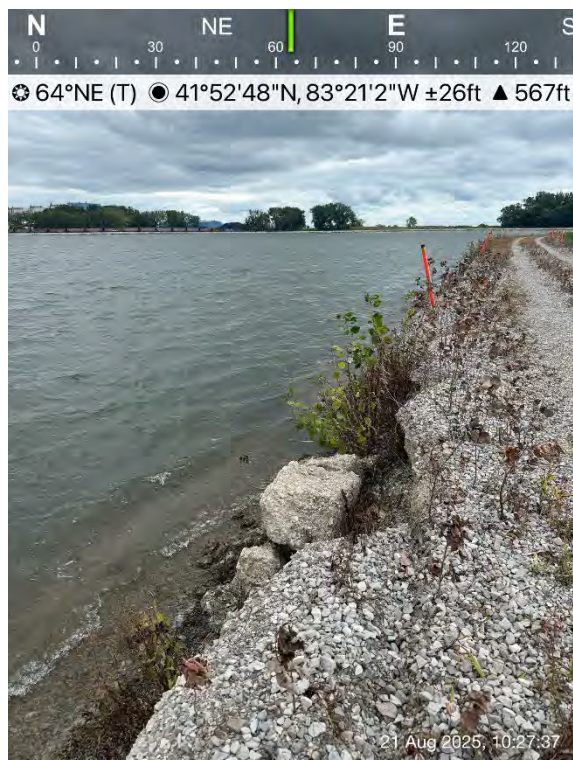
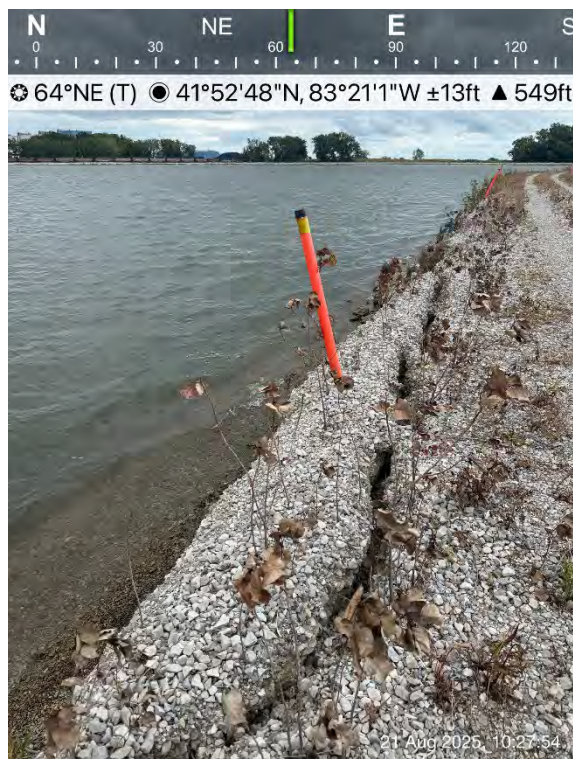
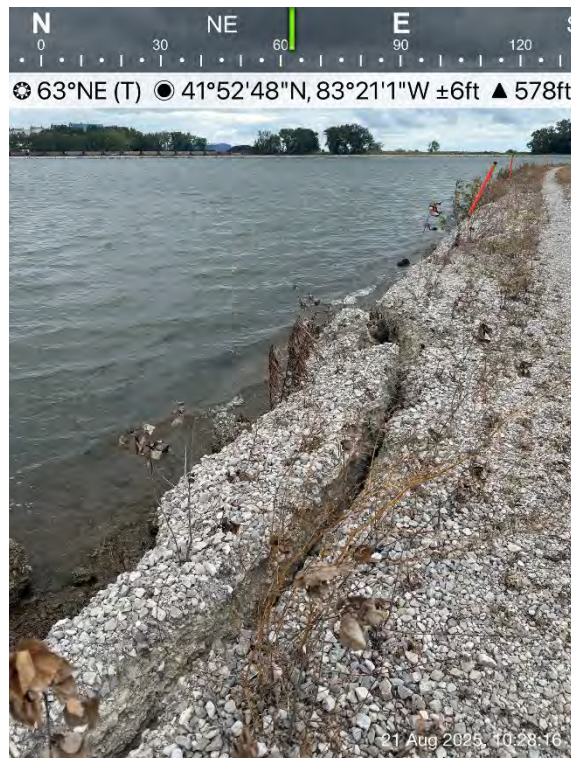
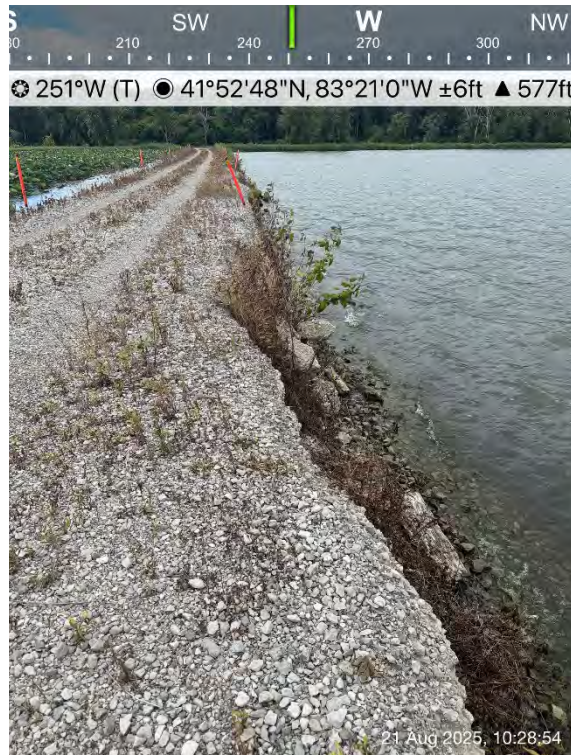
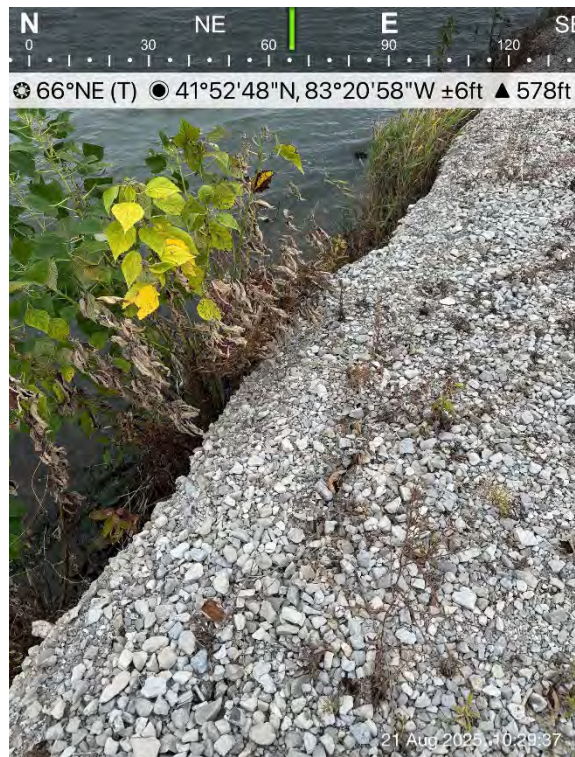
Surficial cracks and sloughing along separation berm

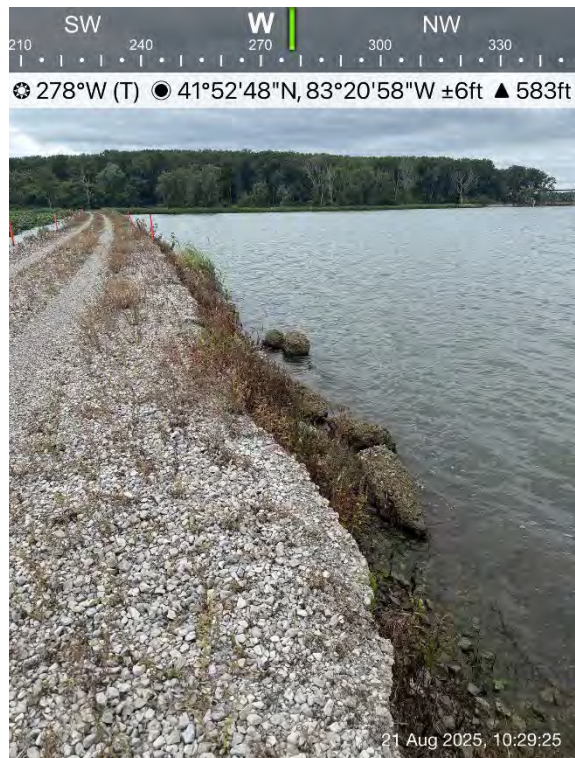
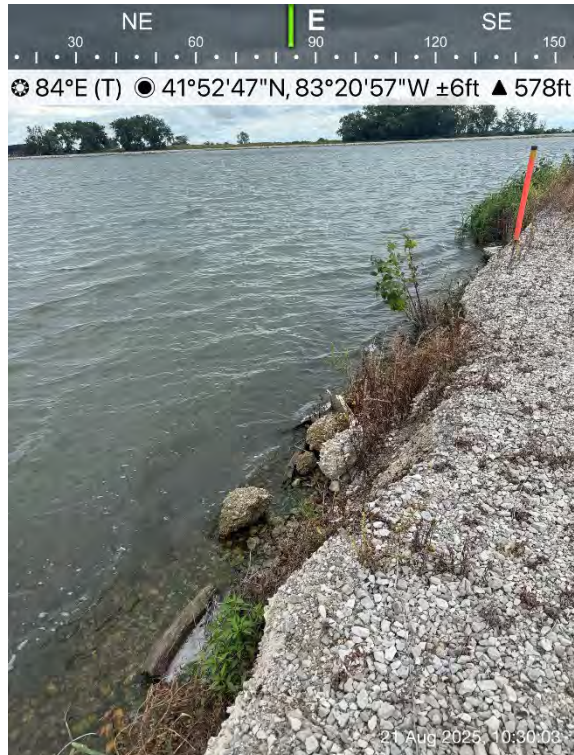
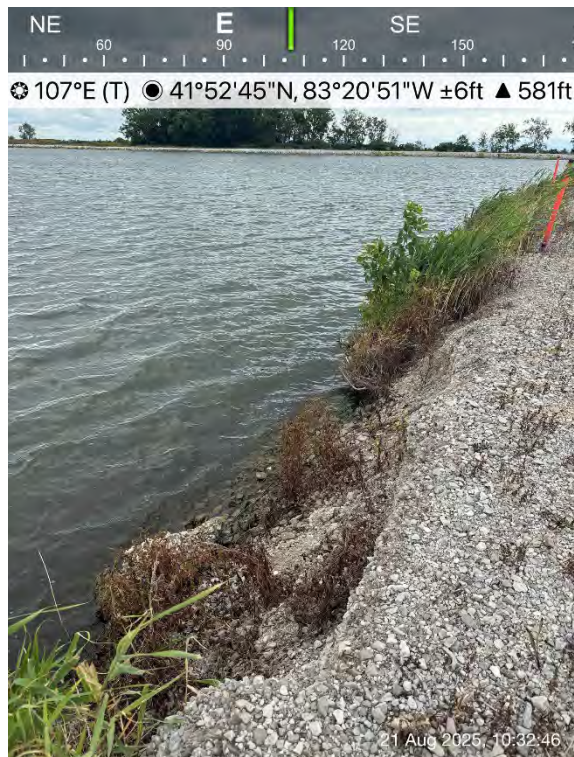
Sloughing along separation berm

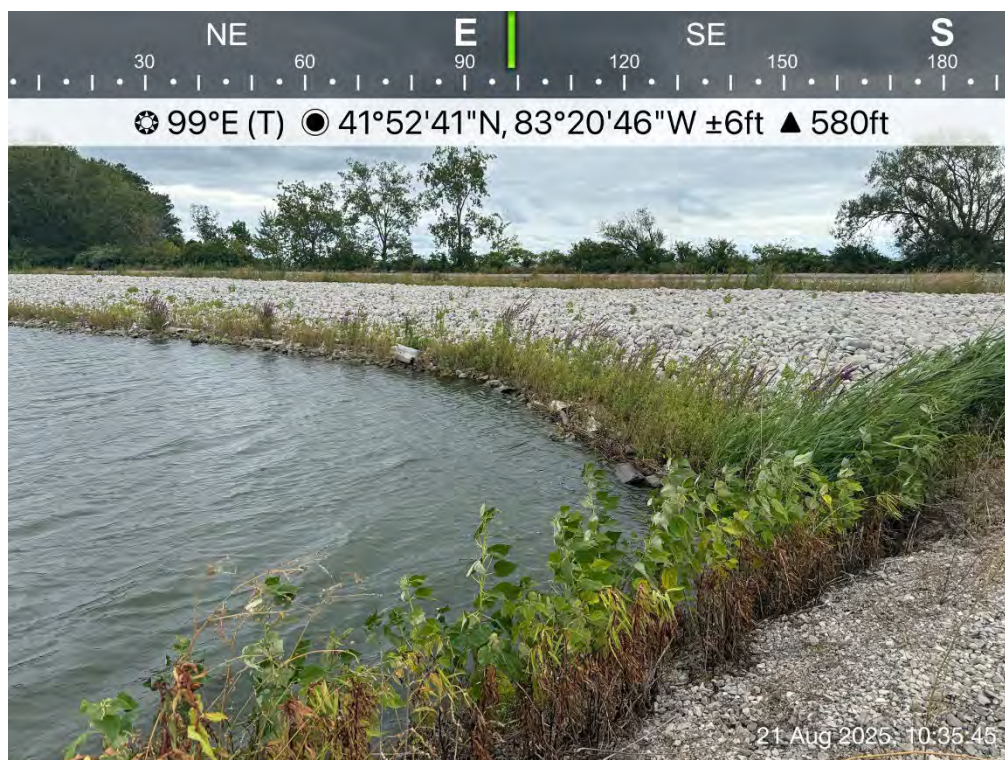
Southeast corner of impoundment with finished closure armoring and vegetation

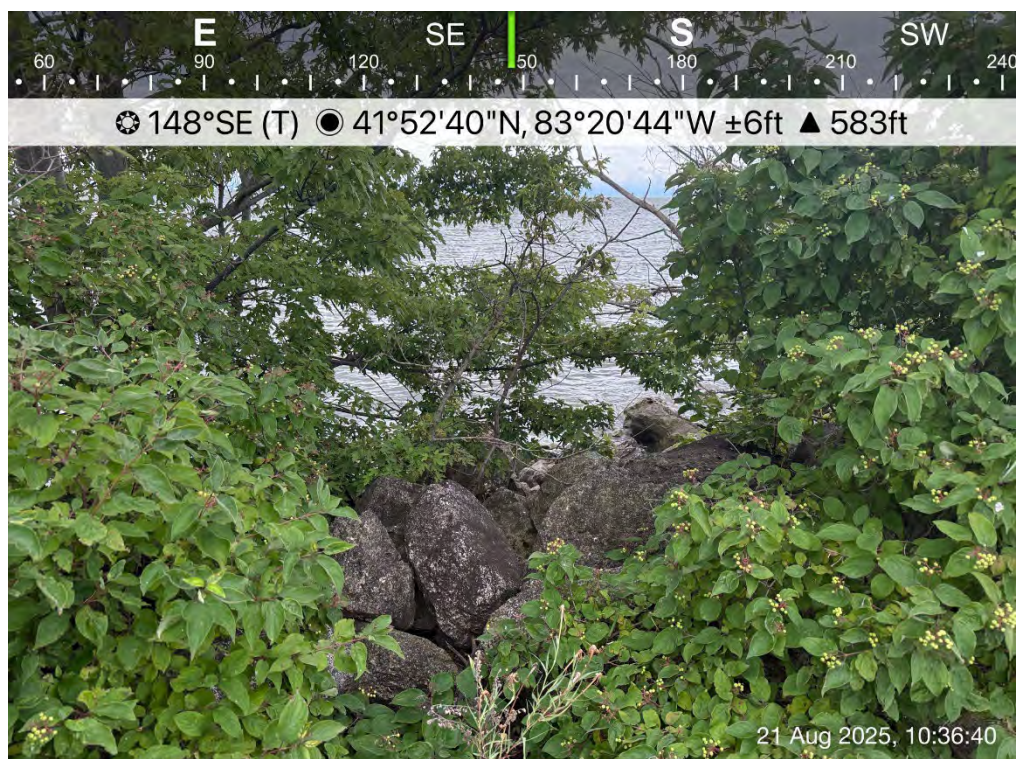
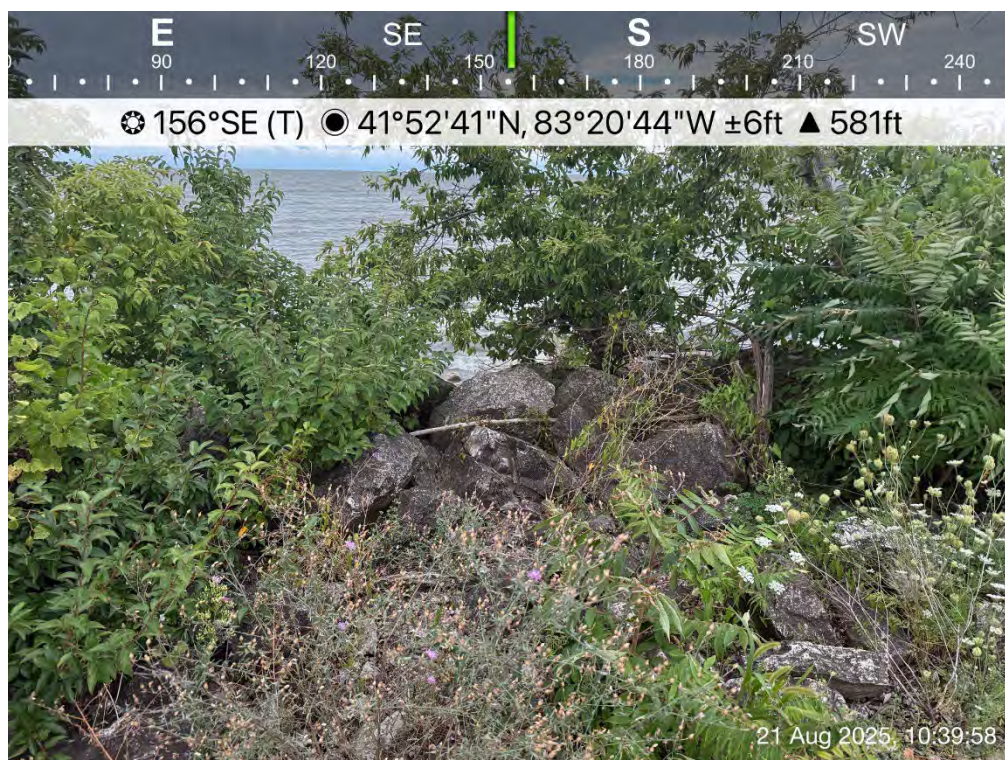
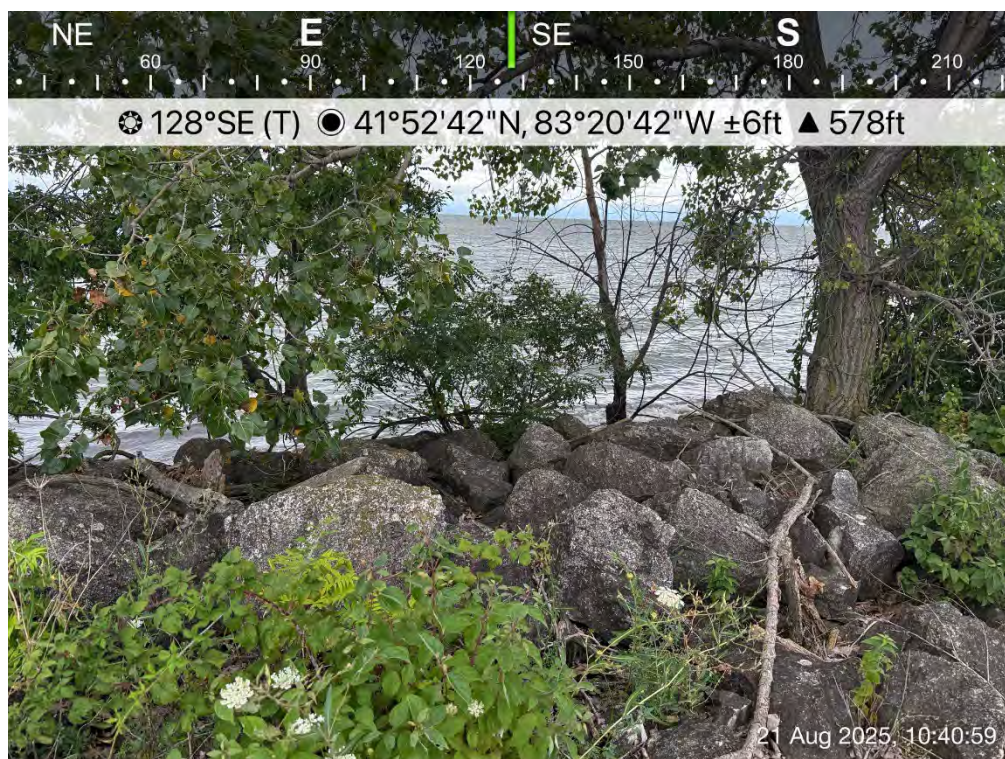
Perimeter dike along Lake Erie

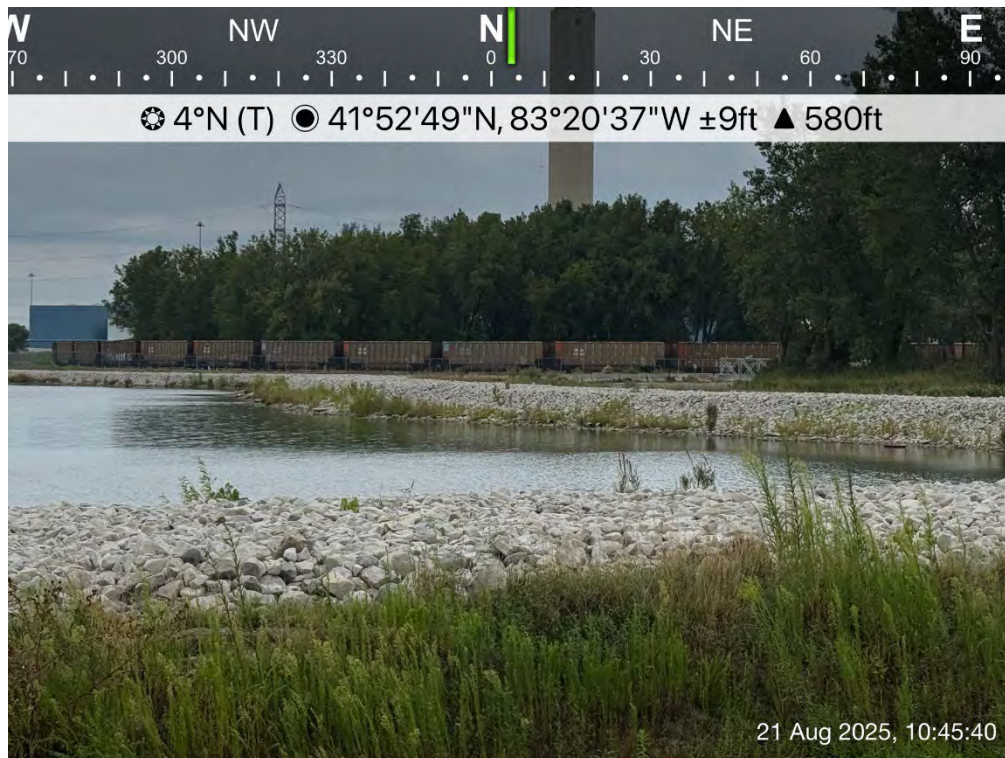
Eastern perimeter of impoundment with finished closure armoring and vegetation

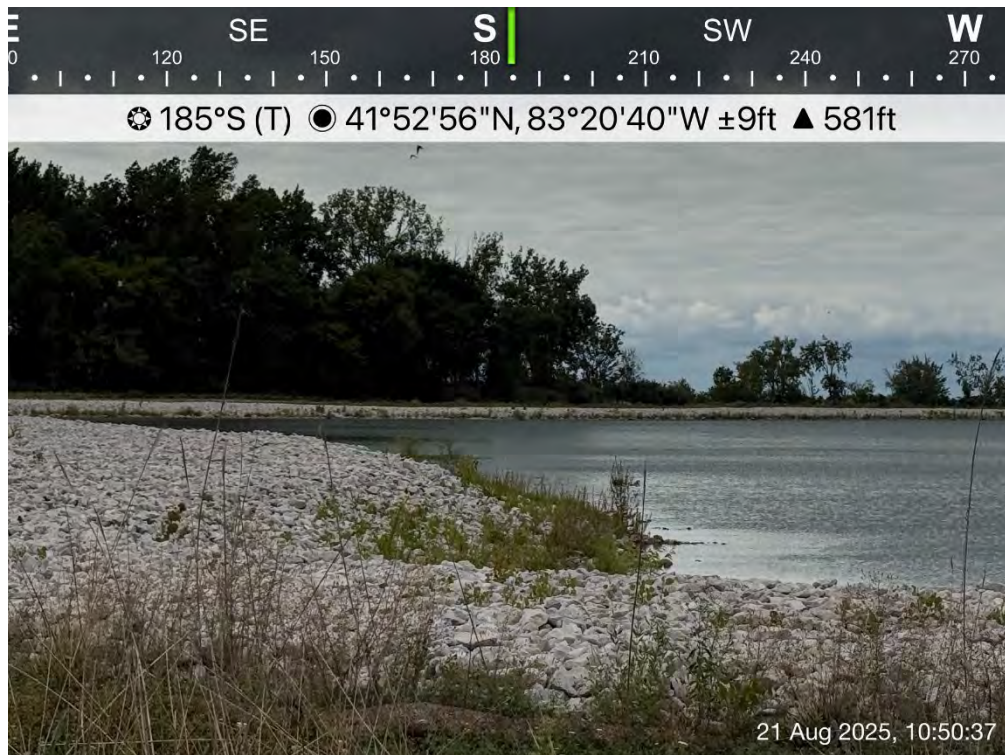
Finished north and eastern closure armoring with vegetation

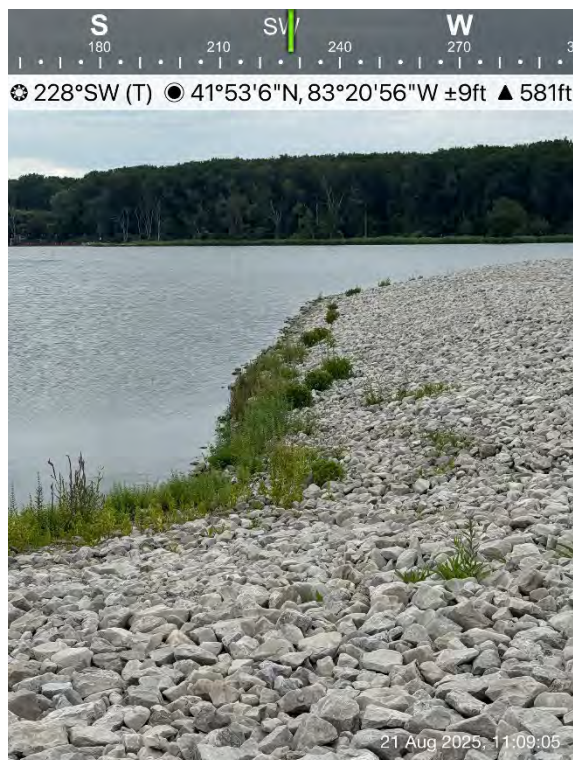
Finished construction armor along northern perimeter

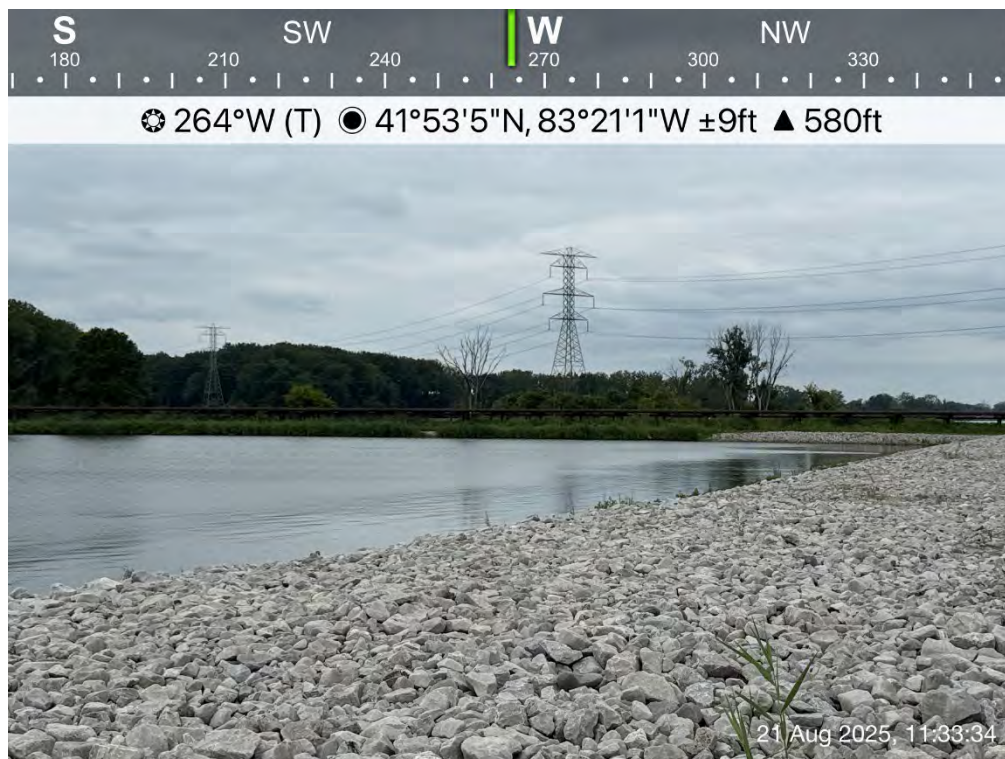
Finished construction armoring along northern perimeter
