2024 ANNUAL INSPECTION REPORT VERTICAL EXTENSION LANDFILL

MONROE POWER PLANT

Monroe, Michigan

January 2025

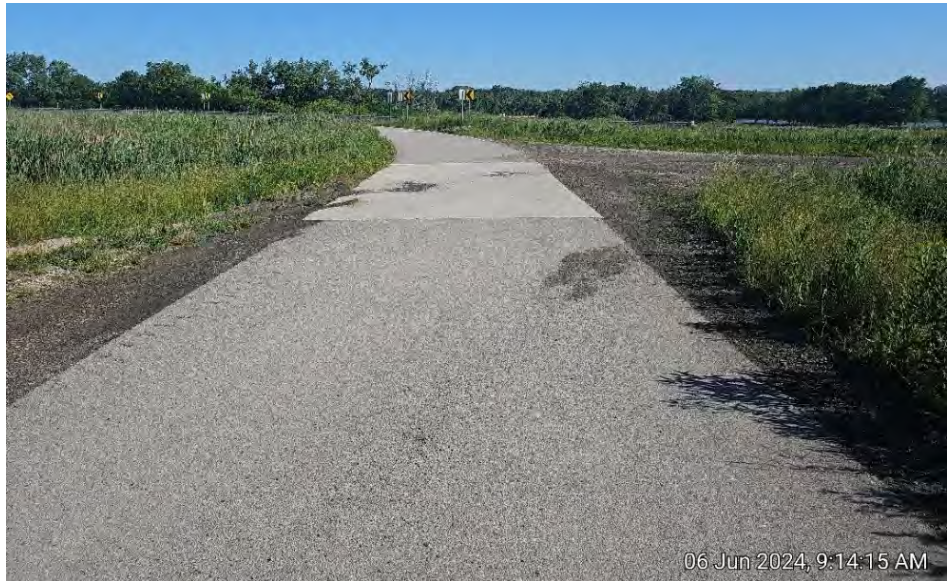
1. The paved access road near the northwest corner of the Landfill (Photograph 1) and the reinforced concrete culvert beneath the paved access road (Photograph 2) were in good condition. The riprap around the inlet and outlet of the culvert had some vegetation but was generally in good condition with no signs of erosion. Minimal flow was observed through the culvert during the inspection.

Comments: The paved access road near the northwest corner of the Landfill was observed to be in good condition.

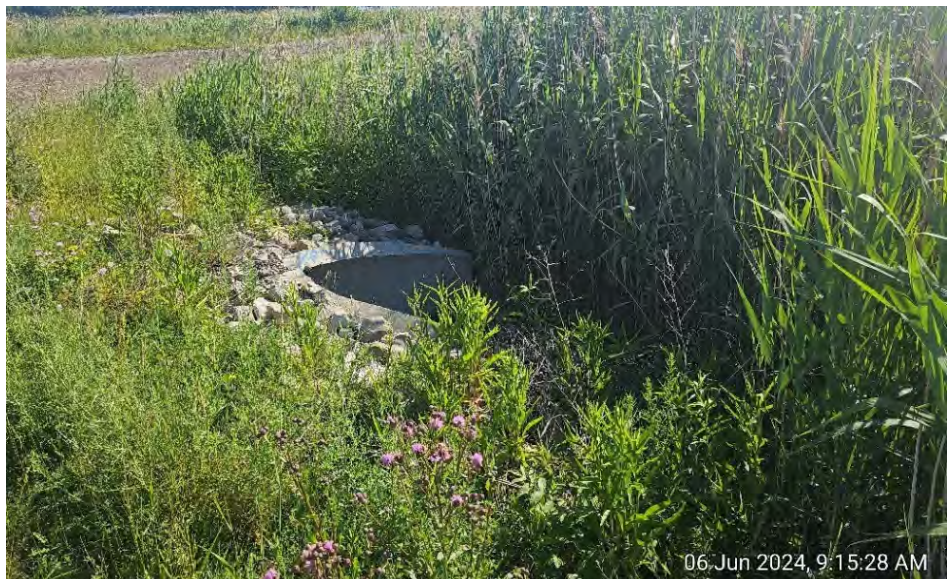
Photograph 2

Comments: The reinforced concrete culvert beneath the paved access road (culvert and riprap around the inlet and outlet) was generally in good condition. Some vegetation was observed in the riprap. Minimal flow was observed through the culvert and in the perimeter swale. Dense vegetation was observed within perimeter swale R1 along the north side.

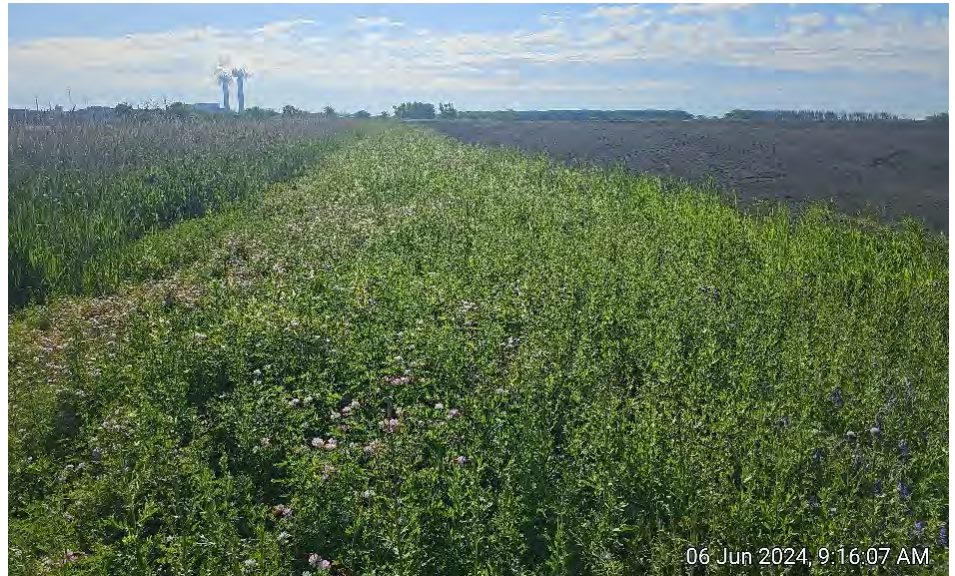
Comments: Dense vegetation within the perimeter swale (R1) and on the perimeter berm along the north side of the Landfill were observed. No apparent signs of slope instability or erosion along the perimeter berm were observed.

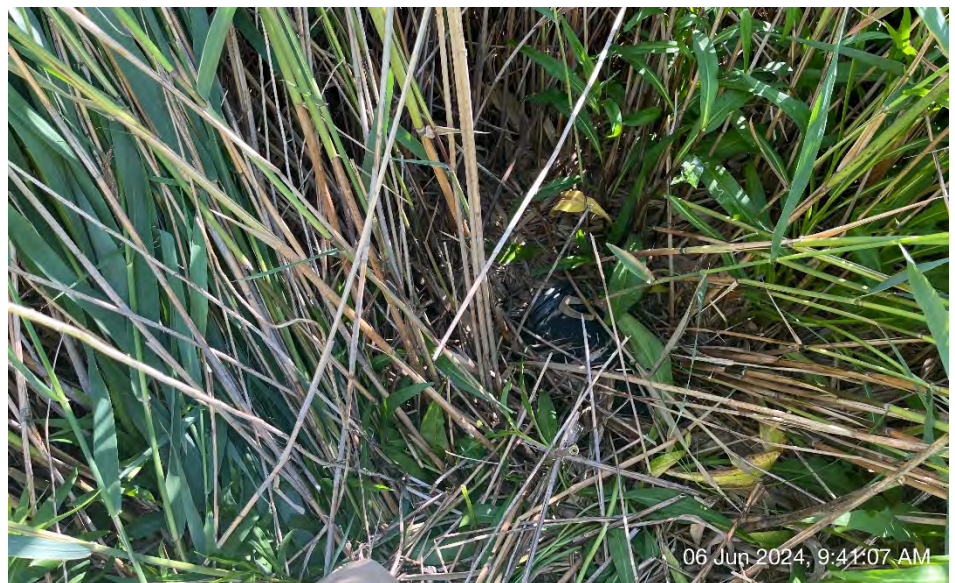
Photograph 4

Comments: Only six pore pressure relief pipe outlets were able to be located due to the dense vegetation and water levels within the perimeter swales. The water level in the north perimeter swales (R1 and R2) was lower than the pore pressure relief pipe outlets. (typical)

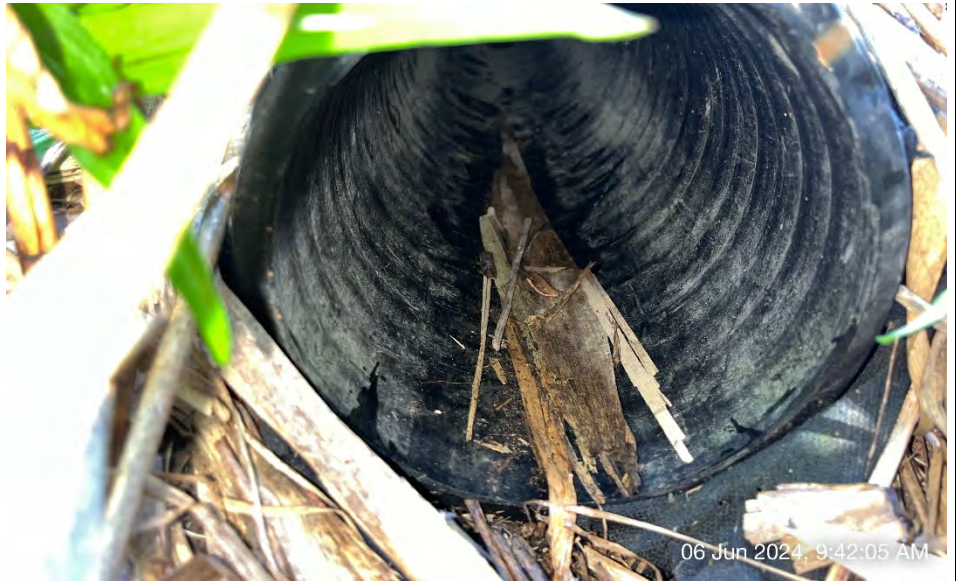
- Minimal sediments and/or vegetation was observed in the pore pressure relief pipe outlets that could be located (Photograph 5).

Comments: Minimal sediments or vegetation were observed in the pore pressure relief pipe outlets that could be located. (typical)

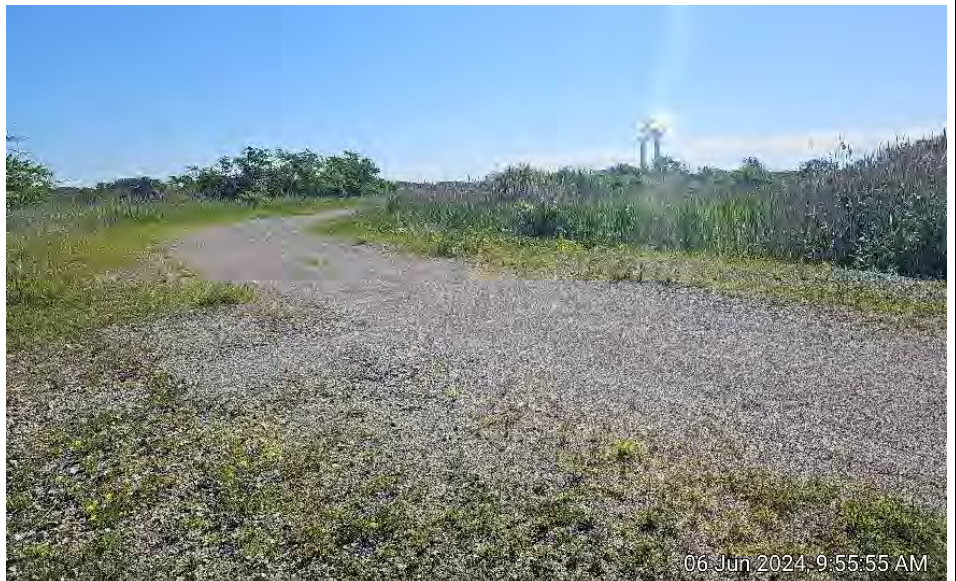
Photograph 6

6. The aggregate access road on the north side of the Landfill (Photograph 6) was in good condition with no ruts and minimal erosion.
7. The pore pressure relief layer constructed for Phase 2 of the Landfill was in good condition with minimal vegetation (Photograph 10).

Comments: The aggregate access road on the north side of the Landfill was in good condition with no ruts and minimal erosion.

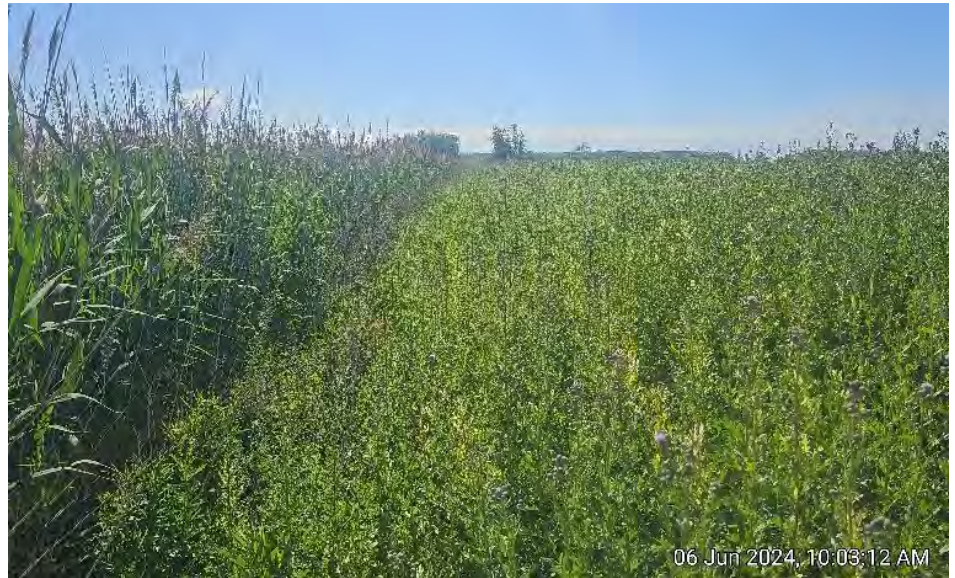
Comments: Dense vegetation within the perimeter swale (R2) and on the perimeter berm along the north side of the Landfill were observed. No apparent signs of slope instability or erosion along the perimeter berm were observed.

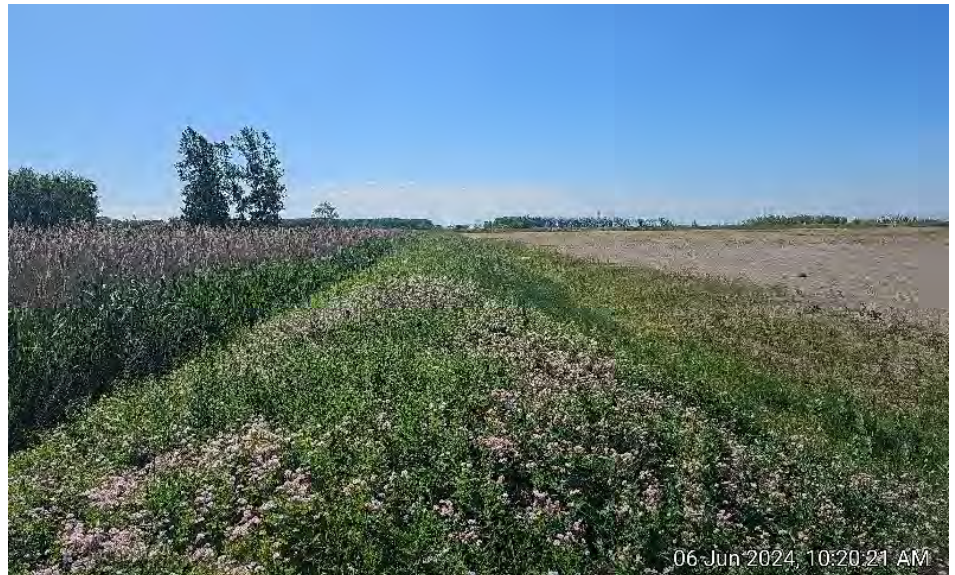
Photograph 8

Comments: Dense vegetation within the perimeter swale (R2) and on the perimeter berm along the north side of the Landfill were observed. No apparent signs of slope instability or erosion along the perimeter berm were observed.

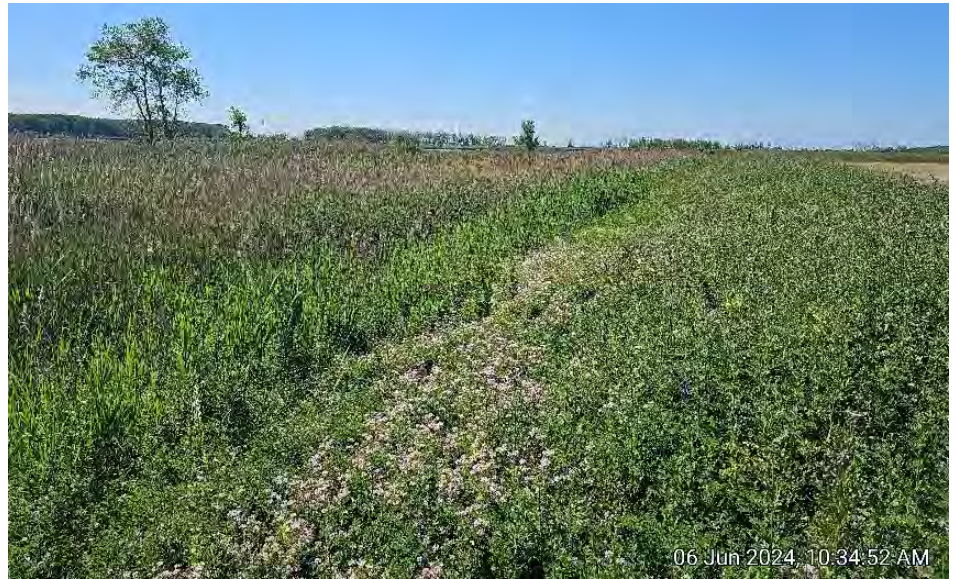
Comments: Dense vegetation within the perimeter swale (R2) and on the perimeter berm along the east side of the Landfill were observed. No apparent signs of slope instability or erosion along the perimeter berm were observed.

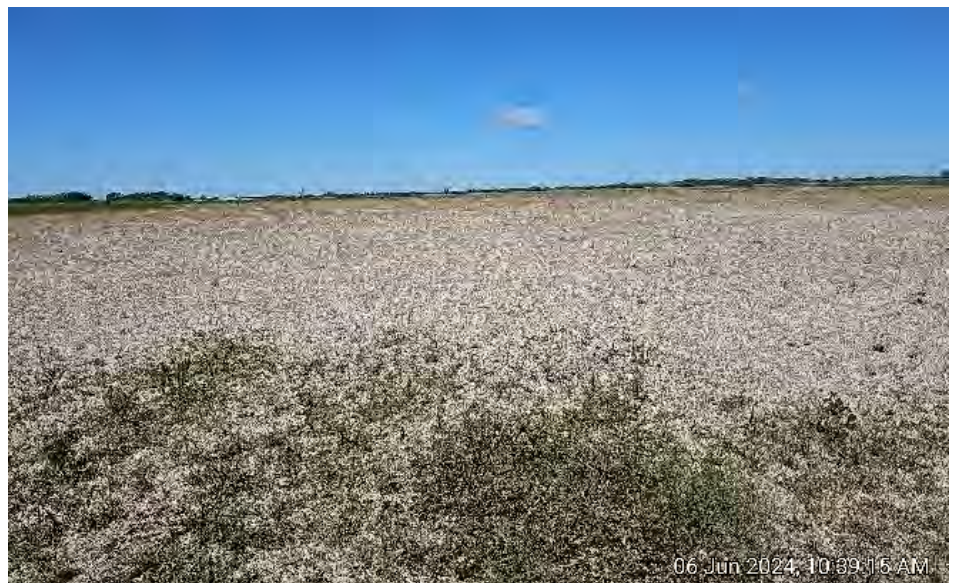
Photograph 10

Comments: The pore pressure relief layer constructed for Phase 2 of the Landfill was in good condition with minimal vegetation.

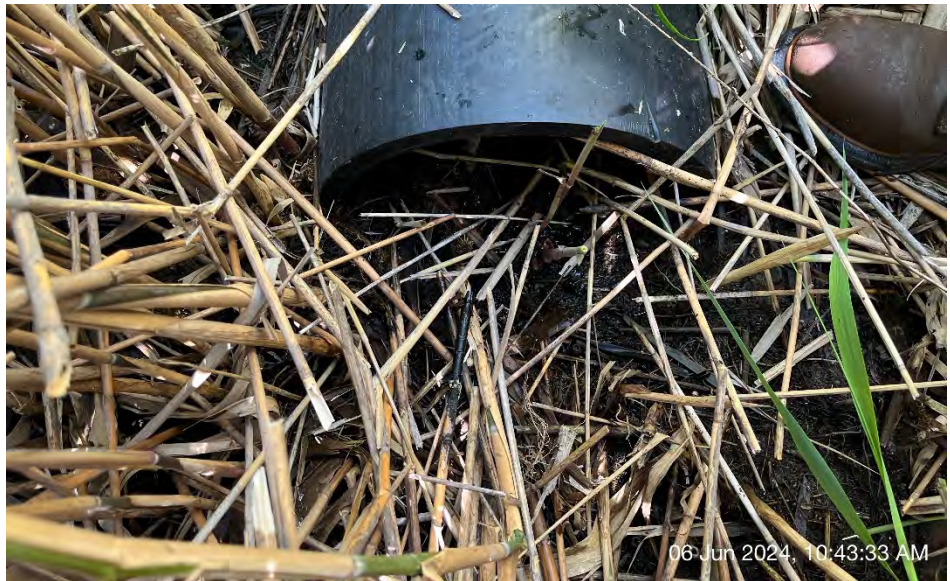
8. The culvert at the southeast corner of the Landfill appeared to be in good condition (Photograph 11). Dense vegetation was observed within the perimeter swales (R2 and R4) adjacent to the culvert; however, the vegetation did not appear to impact the ability of the culvert to convey water to the Ash Basin. Minimal flow was observed through the culvert during the inspection.

Comments: The culvert at the southeast corner of the Landfill was in good condition. Dense vegetation was observed within the perimeter swales adjacent to the culvert; however, the vegetation did not appear to impact the ability of the culvert to convey water to the Ash Basin. Minimal flow was observed through the culvert during the inspection.

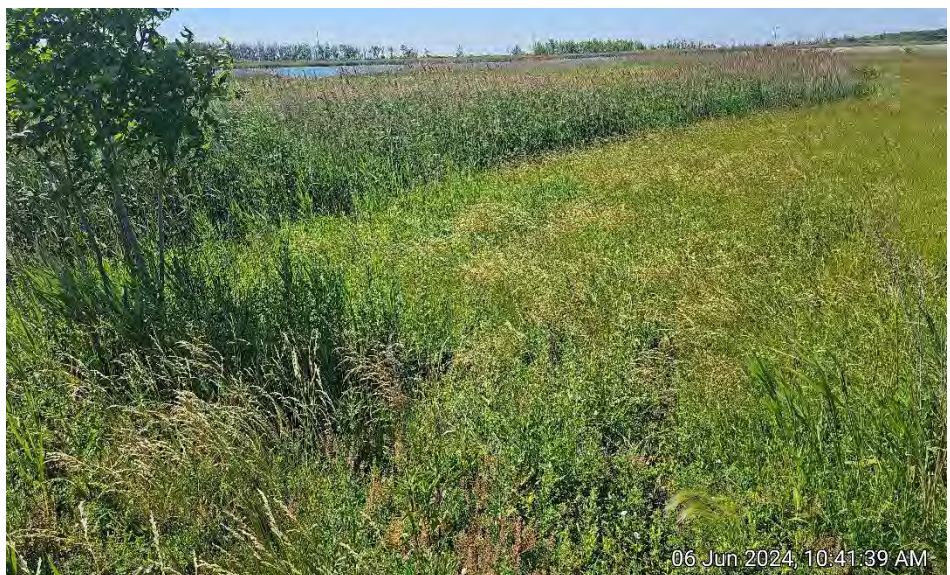
Photograph 12

Comments: The access road above the culvert at the southeast corner of the Landfill had vegetation and some small, woody vegetation. No apparent signs of slope instability or erosion were observed along the access road.

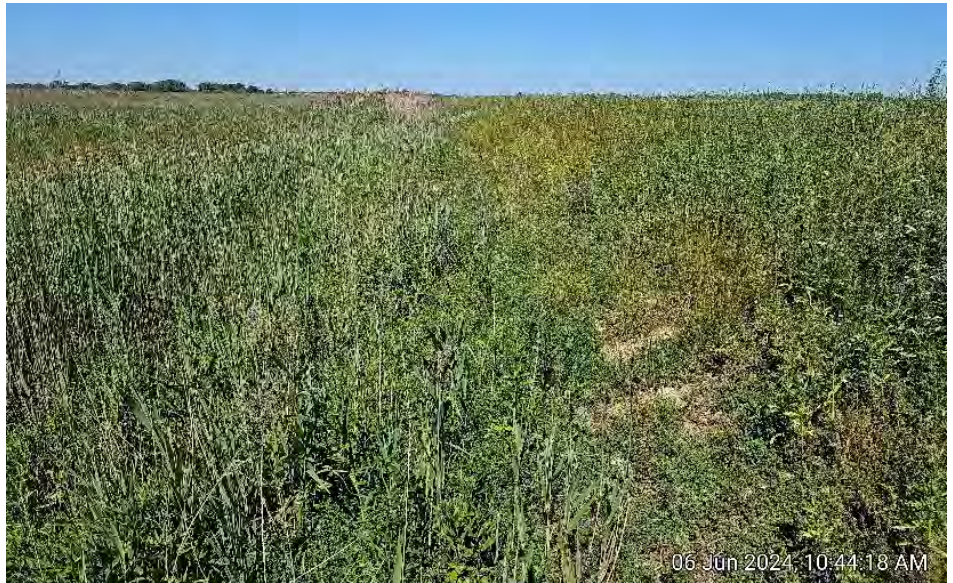
Comments: Dense vegetation within the perimeter swale (R4) and on the perimeter berm along the south side of the Landfill were observed. No apparent signs of slope instability or erosion along the perimeter berm were observed.

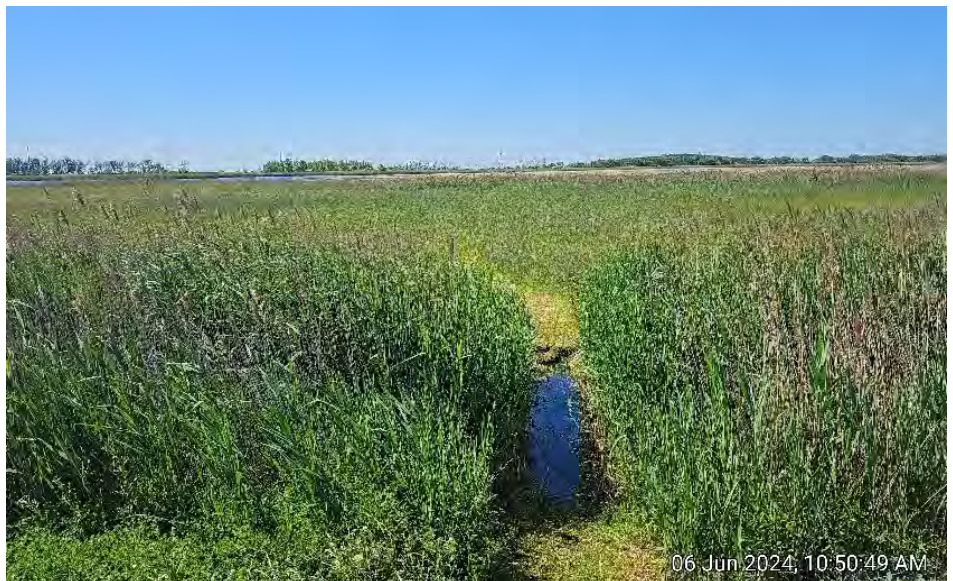
Photograph 14

Comments: Dense vegetation within the perimeter swale (R4) along the south side of the Landfill was observed. Minimal flow was observed in perimeter swale R4.

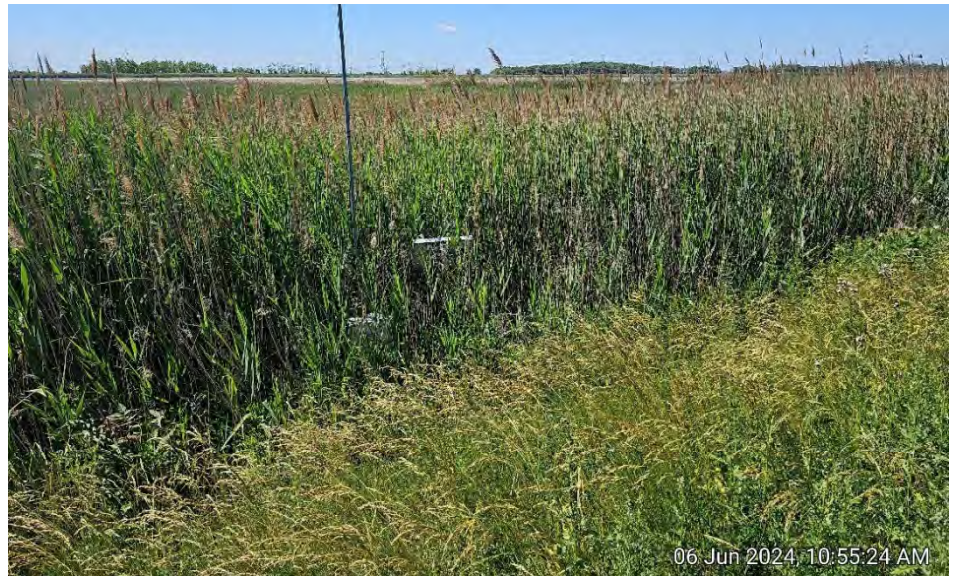
3. Datalogger instrument enclosures DL-2 and DL-3 were surrounded by dense vegetation that could potentially block the solar panels used to power their batteries. This could also affect the ability of the instruments to communicate collected data to the online server. All the datalogger instrument enclosures had significant moisture intrusion and some (DL-2 and DL-3) had ants. The desiccant canisters within the instrument enclosures were in poor condition. These conditions could lead to the instrument components being damaged and no longer functioning properly. However, the electronic components within the datalogger instrument enclosures appeared to be functional during the visual inspection.

Comments: Dataloggers 1 (DL-1) and 2 (DL-2) were surrounded by dense vegetation. The vegetation had the potential to block the solar panels used to power the batteries for DL-1 and DL-2. (DL-2 shown)

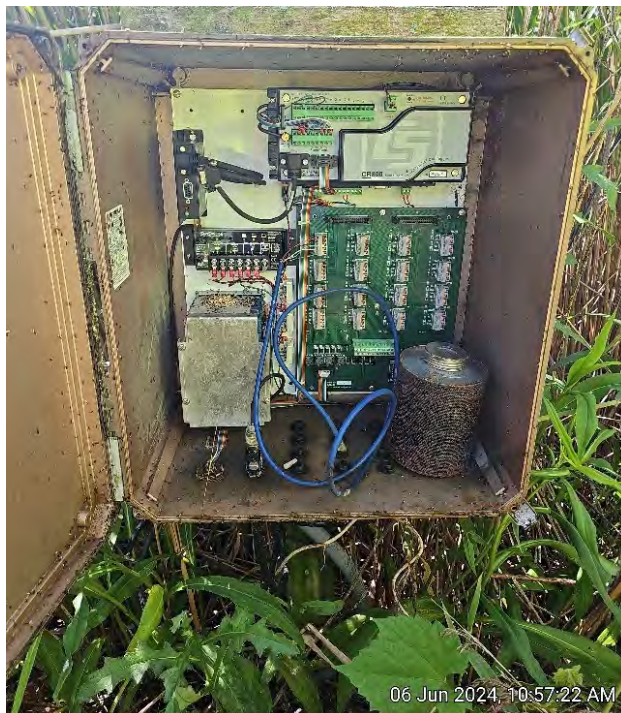
Photograph 16

11. The instrument enclosures for DL-2 and DL-1 had significant moisture intrusion and ants (Photograph 16). The desiccant canisters within the enclosures were in poor condition.

Comments: The instrument enclosures for DL-1 and DL-2 had significant moisture intrusion and ants. The desiccant canisters within the enclosures were in poor condition. (DL-2 shown)

Not Urgent - Replace desiccant canisters and insect traps within the instrument enclosures and apply new sealant around the outside of the instrument enclosures. (Addressed by DTE August 2024)

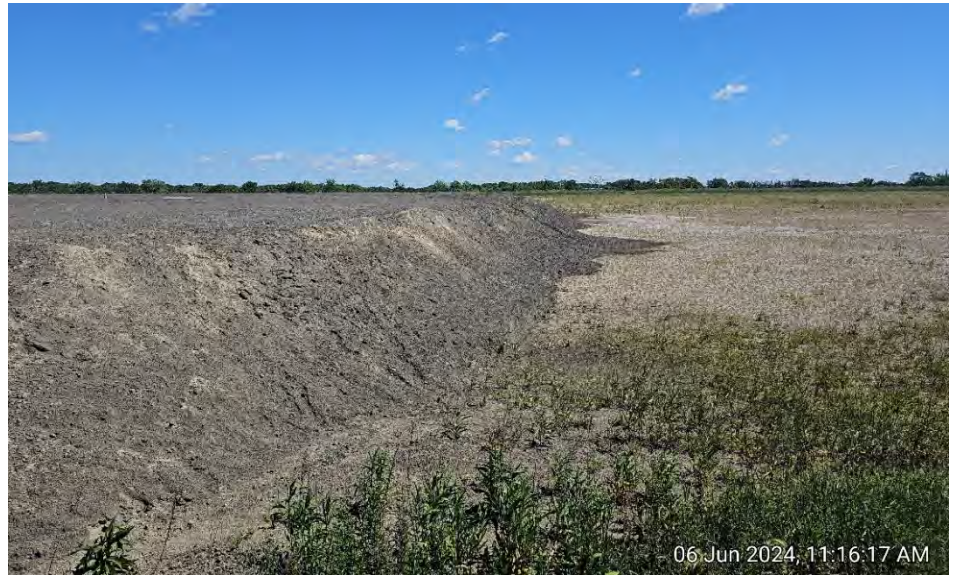
Comments: The CCR placed within the Landfill appears to have been placed and stacked in accordance with generally accepted engineering practices.

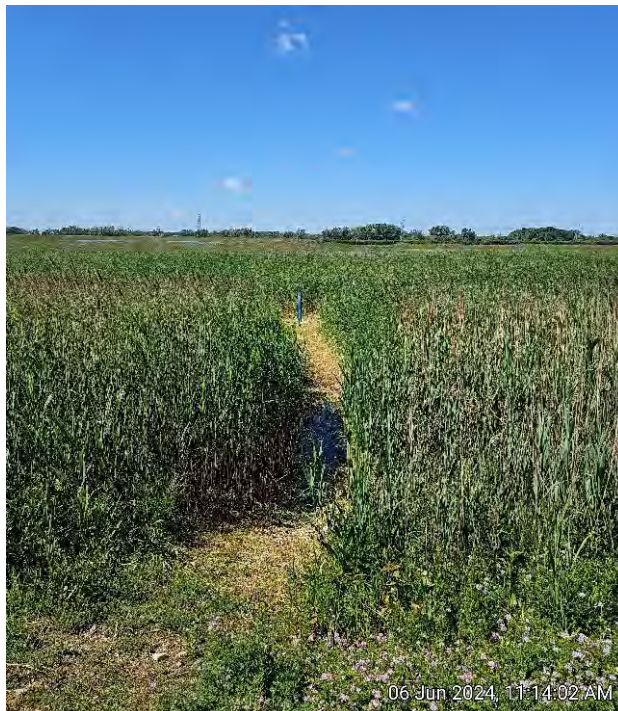
Photograph 18

Comments: Dense vegetation within the perimeter swale (R3) along the south side of the Landfill was observed. Minimal flow was observed in perimeter swale R3.

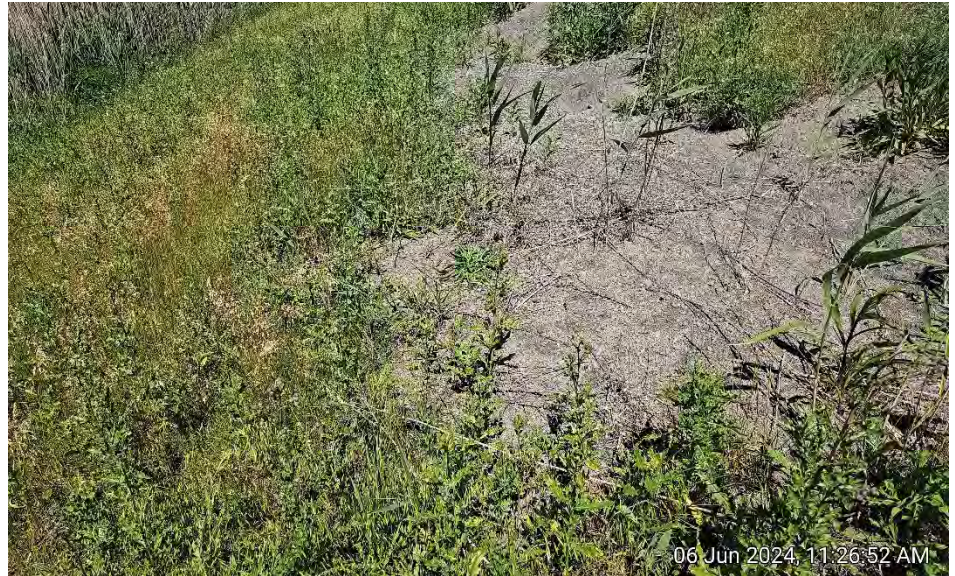
Comments: There was a location near the southwest corner where the CCR placed within the Landfill had eroded onto the crest of the perimeter berm. It did not appear that the CCR material had eroded into perimeter swale R3 at the time of the inspection.

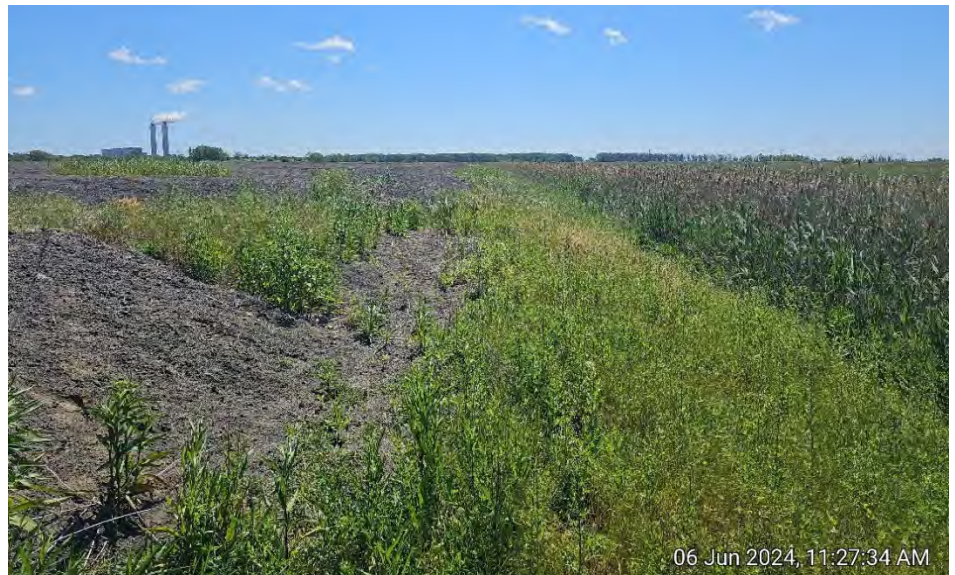
Photograph 20

Comments: There was a location near the southwest corner where the CCR placed within the Landfill had eroded onto the crest of the perimeter berm. It did not appear that the CCR material had eroded into perimeter swale R3 at the time of the inspection.

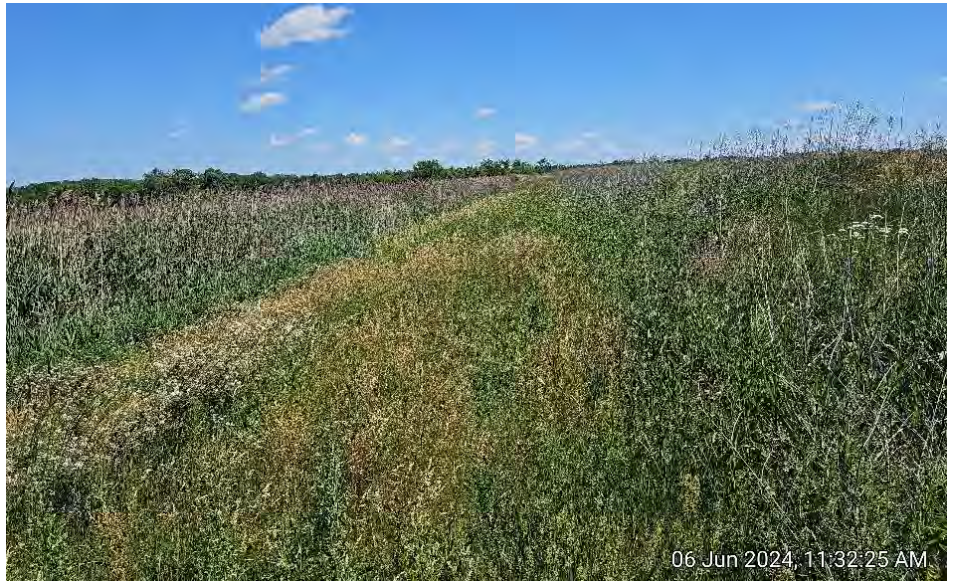
Comments: Dense vegetation within the perimeter swale (R1) and on the perimeter berm along the west side of the Landfill were observed. No apparent signs of slope instability or erosion along the perimeter berm were observed.

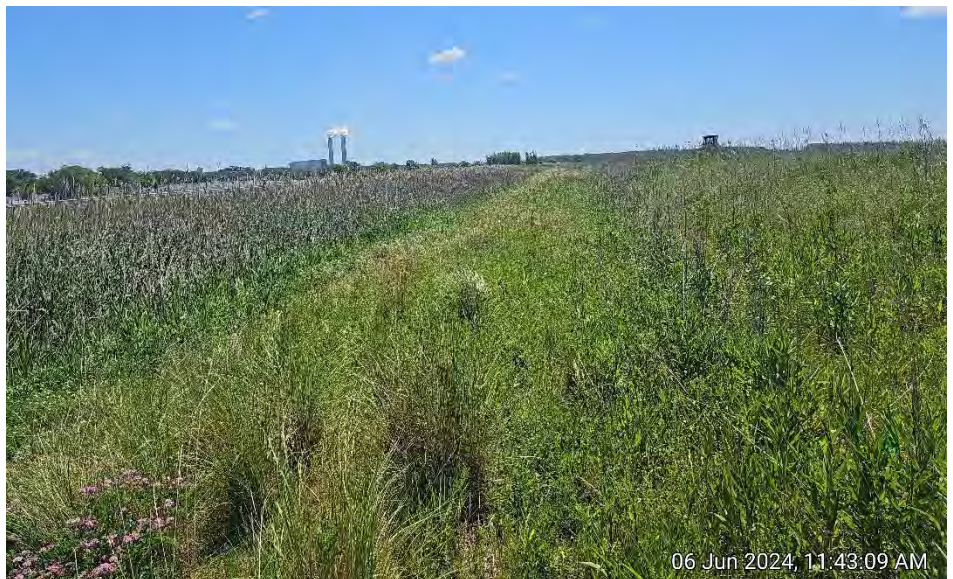
Photograph 22

Comments: Dense vegetation within the perimeter swale (R1) and on the perimeter berm along the north side of the Landfill were observed. No apparent signs of slope instability or erosion along the perimeter berm were observed.

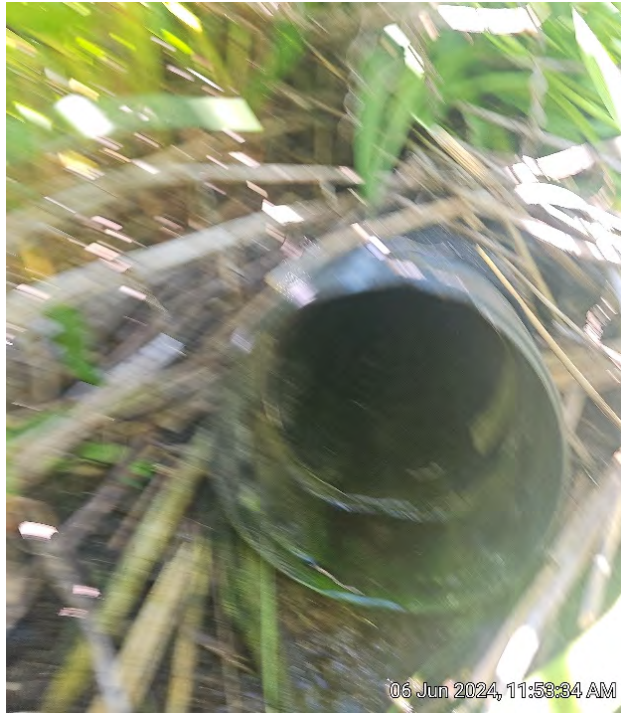
- Only one pore pressure relief pipe was observed to be actively flowing during the inspection, though the flow was minimal (Photograph 23). This pipe is located below Phase 1, where CCR material has been placed, and has historically been the only pipe with any observed flow. There was some algae growth within the outlet of this pipe (Photograph 23).

Comments: Only one pore pressure relief pipe was observed to be actively flowing during the inspection, though the flow was minimal. The pipe is located below Phase 1 of the Landfill, where CCR material has been placed, and has historically been the only pipe with any observed flow. There was some algae growth within the outlet of this pipe.

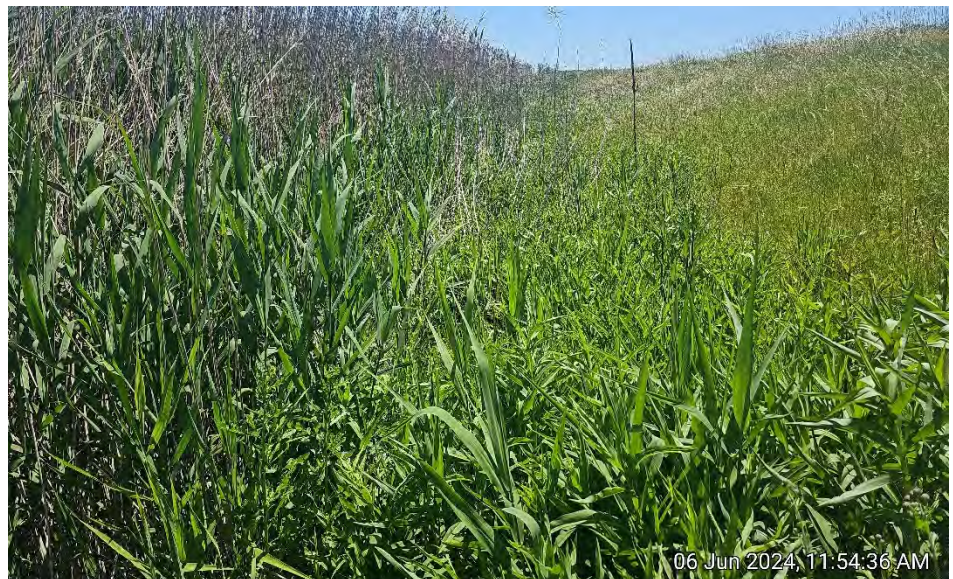
Photograph 24

Comments: Dense vegetation within the perimeter swale (R1) and on the perimeter berm along the north side of the Landfill were observed. No apparent signs of slope instability or erosion along the perimeter berm were observed.

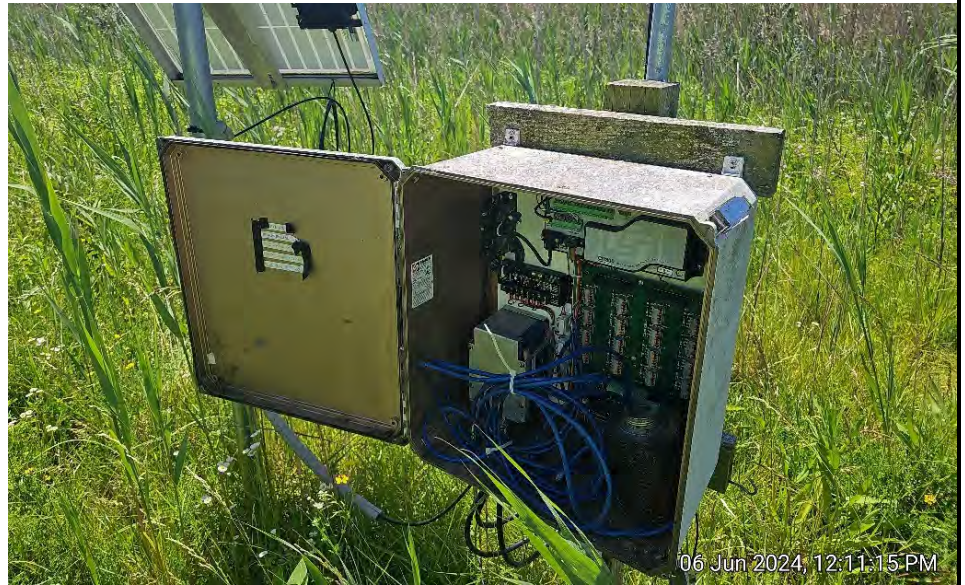
14. DL-4 and DL-3 were surrounded by some vegetation, but the solar panels did not appear to be blocked (Photograph 25). The instrument enclosures for DL-4 and DL-3 had significant moisture intrusion and the desiccant canisters were in poor condition (Photograph 25).

Comments: DL-3 and DL-4 were surrounded by some vegetation, but the solar panels did not appear to be blocked. The instrument enclosures had significant moisture intrusion and the desiccant canisters were in poor condition. (DL-3 shown)
