2024 ANNUAL INSPECTION REPORT

FLY ASH BASIN

MONROE POWER PLANT

Monroe, Michigan

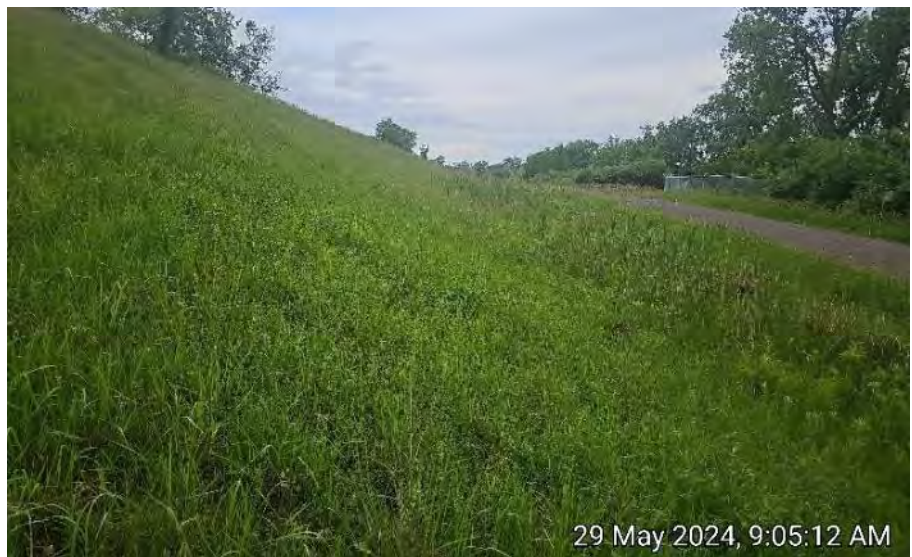
- a. Sloughing/cracking of the exterior slopes and previous repairs that have failed were noted on the perimeter embankment near Station 12+00. The sloughing/cracking was initially observed during the 2022 annual inspection and again in 2023. Each time, the slough/crack was repaired. In 2024, DTE personnel observed the slough/crack again and Geosyntec inspected the area in early May 2024 and then during the annual inspection. The previous repairs had failed, and the crack reopened (Photograph #6). During this year's annual inspection, the largest scarp was observed to have a height of 1.5 feet and length of approximately 45 feet (Photograph #6), and "bunching" of materials at the toe of the embankment was observed (Photograph #5). However, the slope inclinometer at Station 11+50 did not indicate significant ground movements (i.e., less than 1.0 inch of cumulative movement), suggesting that only surficial movement has occurred.

- The slough/crack observed on the perimeter embankment slope near Station 12+00 reopened after repairs made in 2023 failed. The slough/crack was believed to be the result of the freezing and thawing cycle of the surficial soils because no movements were observed in the adjacent instrumentation monitoring. Therefore, the crack was judged not to be indicative of an existing structural weakness in the perimeter embankment. However, additional movements have occurred since the 2023 annual inspection and the crack has reopened, exposing the exterior slopes to surface water infiltration and erosion. Corrective action was taken at the exterior slope near Station 12+00 in September 2024 after the visual inspection (Photograph #52); it was regraded and the sloughing/cracking was filled with a sand-bentonite mix.

Comments: Sloughing was observed on the exterior slopes of the perimeter embankment near Station 12+00. Sloughing has caused "bunching" of materials at the toe of the embankment. Sloughing has been observed at this location in 2022 and 2023 and been repaired.

1. Repairs were made to the perimeter embankment slopes near Station 12+00 (slough/crack).

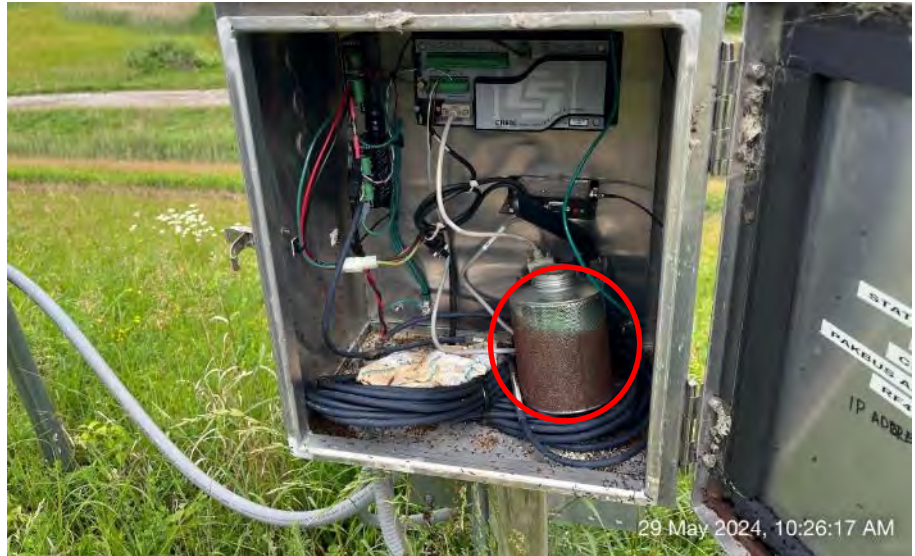
Photograph 8

Comments: The instrumentation monitoring equipment including the slope inclinometer casings, equipment boxes, solar panels, and antennae were in good condition (typical conditions shown).

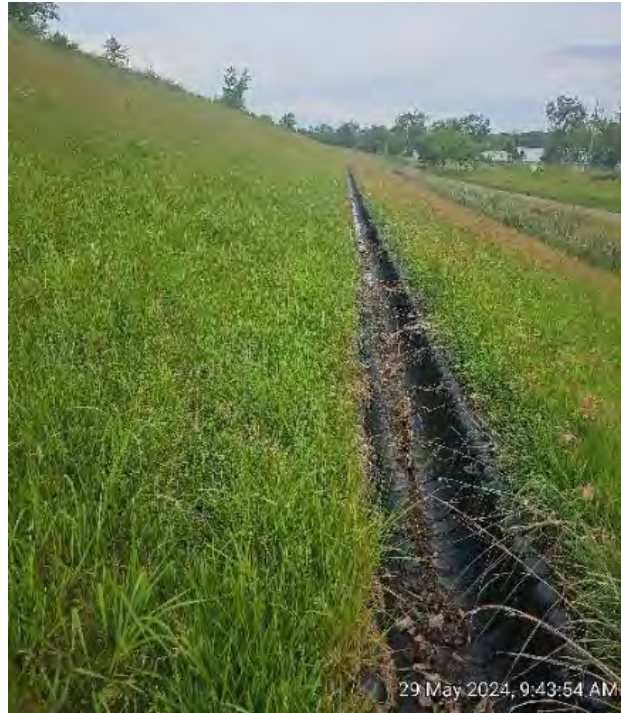
Photograph 10

- b. Significant cut vegetation was observed within the SmartDitch outlets at Stations 18+50, 26+50, 32+50, 70+00, and 139+50 (Photographs #10, #18, #39). The vegetation could impede conveyance of stormwater flows.

Comments: Significant cut vegetation was observed within many SmartDitch outlets (Stations 18+50, 26+50, 32+50, 70+00, 139+50), which could impede conveyance of stormwater flows (typical conditions shown).

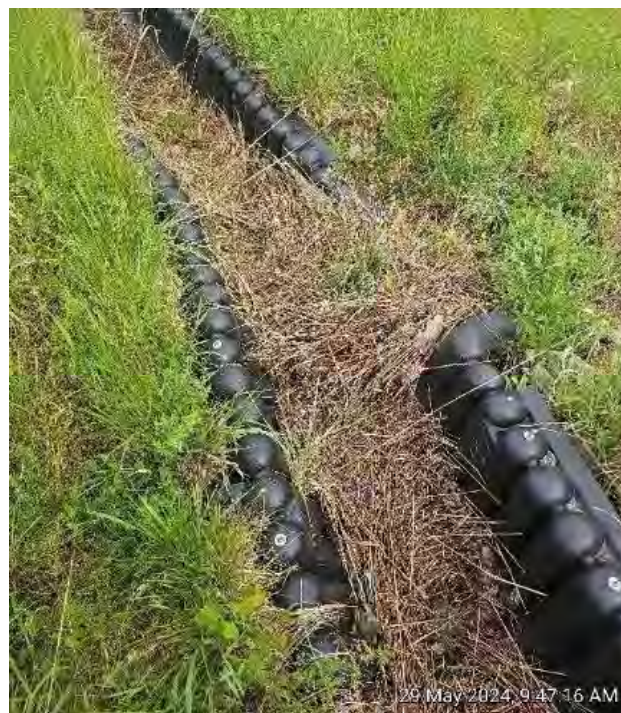
- i. At Station 18+50, concentrated flow beneath the outlet has eroded over one foot of riprap and resulted in a hole (Photographs #11, #12). No flow into the hole was observed during the inspection. Finer sediments were observed within the riprap downchute of this SmartDitch outlet (Photograph #14).

Comments: Over one foot of riprap has eroded from below the SmartDitch outlet at Station 18+50.

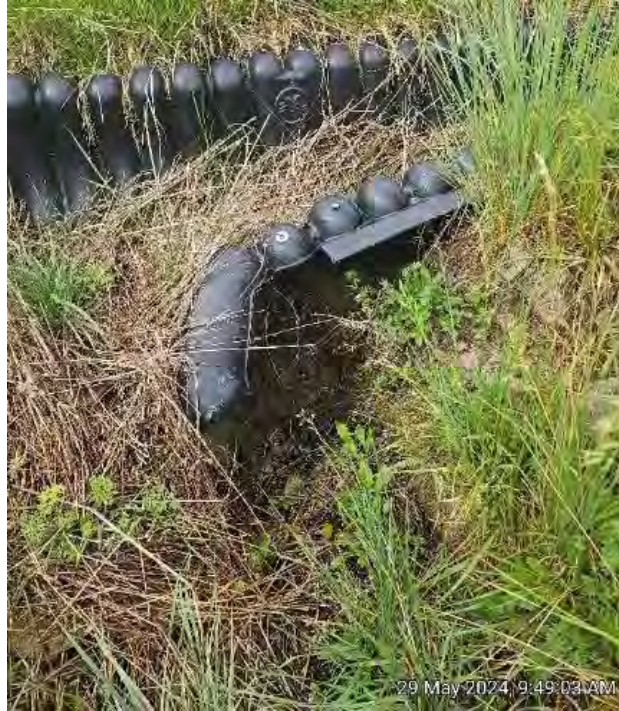
Photograph 12

- Erosion was observed below all the SmartDitch outlets; multiple locations had over one foot of erosion. At Station 18+50, a hole has formed from water flowing below the SmartDitch outlet and finer sediments were observed downslope within the riprap downchute. The erosion at Station 32+50 has exposed and torn the geotextile fabric below the SmartDitch outlet. The erosion below the SmartDitch outlets at multiple stations have caused the outlets to settle and distort. The erosion at these locations could act as preferential pathways for continued erosion and enlarge these areas and lead to potential structural weaknesses if not addressed. Therefore, the SmartDitch outlets should be repaired: damaged portions of SmartDitch should be removed and damaged geotextile fabric and eroded riprap should be replaced. Geosyntec has been tasked with developing corrective action recommendations for repairs.

Comments: Water has eroded a hole below the SmartDitch outlet at Station 18+50. The geotextile fabric below the SmartDitch has been exposed (right side of photo). Water was not observed flowing into the hole at the time of the inspection.

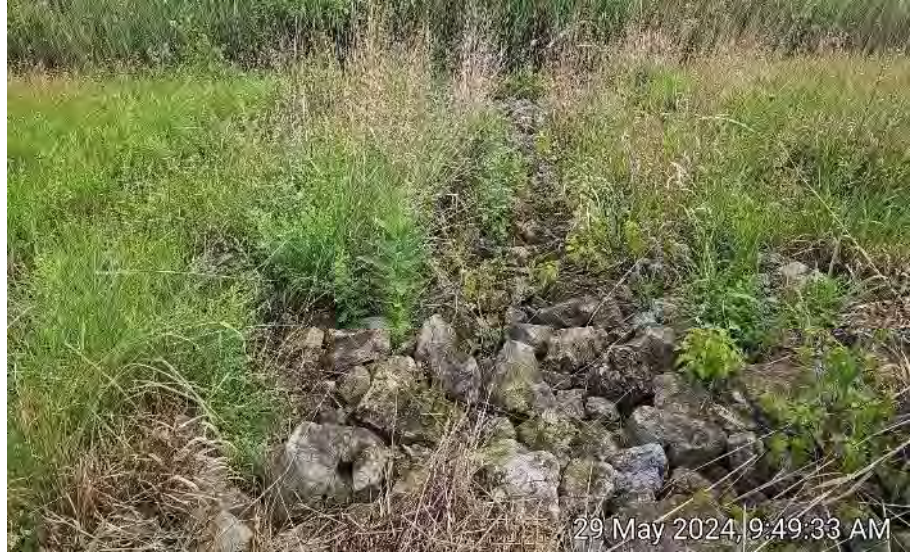
Photograph 14

Comments: Finer sediments were observed within the riprap downchute downslope of the hole below the SmartDitch outlet at Station 18+50.

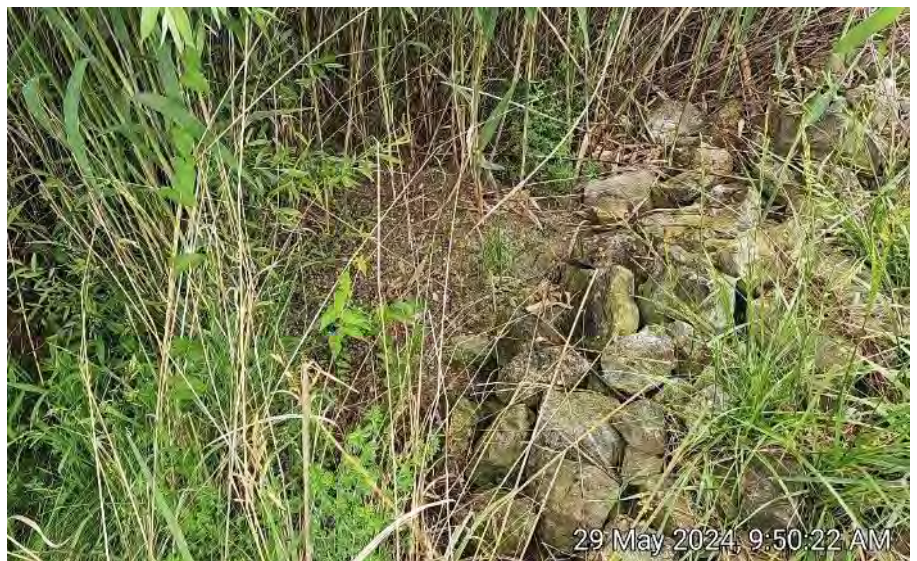
Comments: The covered high-density polyethylene (HDPE) drainpipes connecting sections of the SmartDitch were generally in good condition with minimal sediments and cut vegetation near the outlets. Minimal erosion was observed in the aggregate for the vehicle crossing. (typical conditions shown).

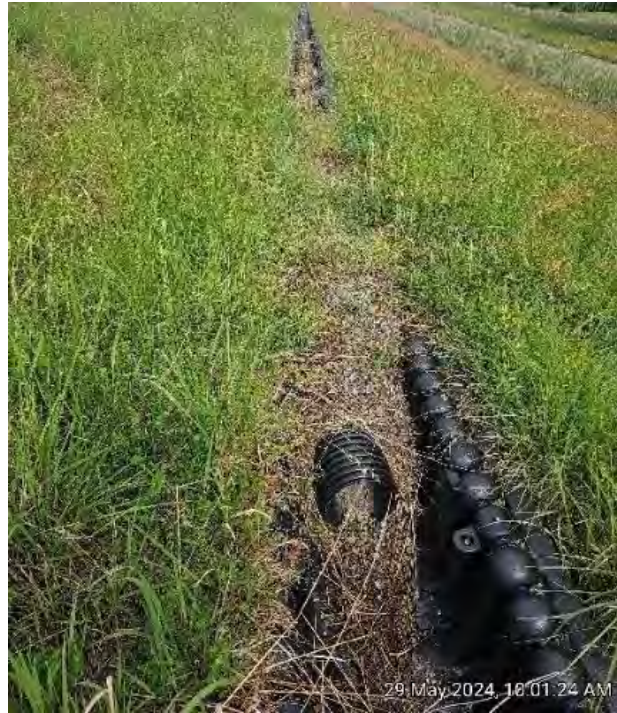
Photograph 16

Comments: The covered HDPE drainpipes connecting sections of the SmartDitch had minimal sediments and vegetation within the pipes that are not expected to impede conveyance of stormwater through the pipes (typical conditions shown).

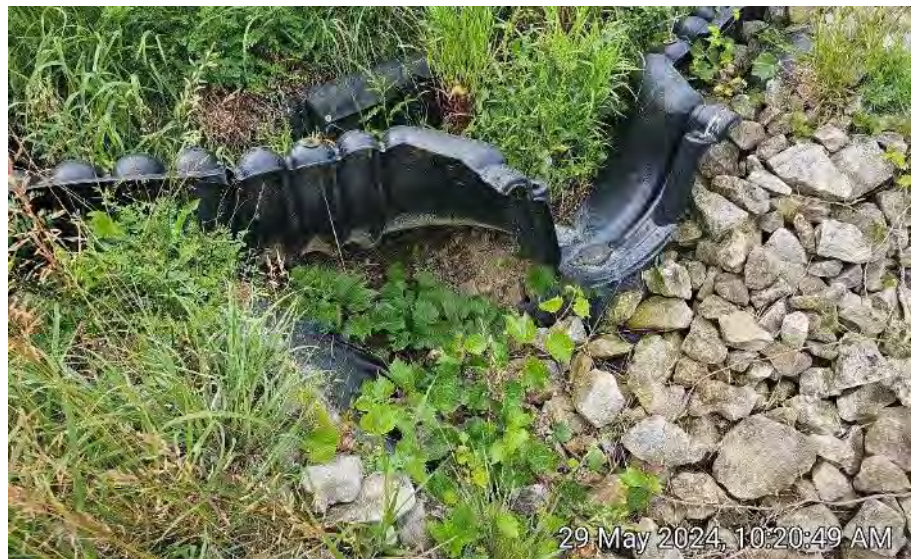
Comments: Over one foot of riprap has eroded from below the SmartDitch outlet at Station 32+50. The geotextile fabric below the SmartDitch has been exposed and is torn.

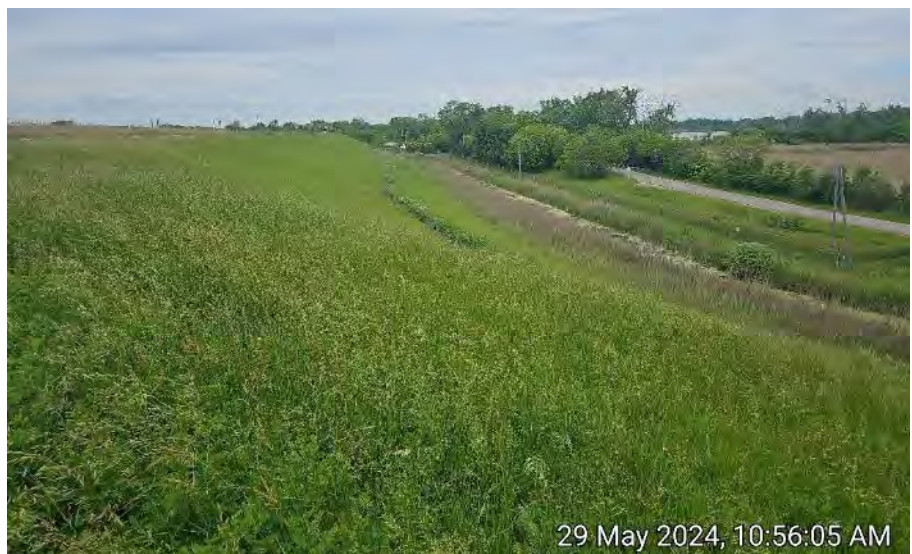
Comments: Denser vegetation was observed on the upslope sides of the SmartDitch (approximate Station 62+00 shown). In some locations, small, woody vegetation was observed.

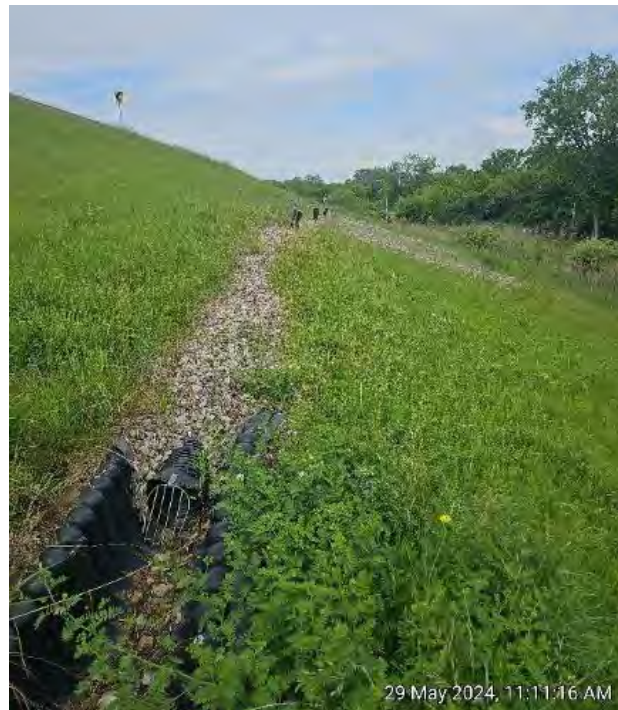
Comments: Gravel placed on the perimeter embankment slopes near Station 67+00 has shown signs of erosion from the upper slope to the lower. Portions of the slotted HDPE pipe have become exposed as a result. The HDPE pipe and the check ports were in good condition.

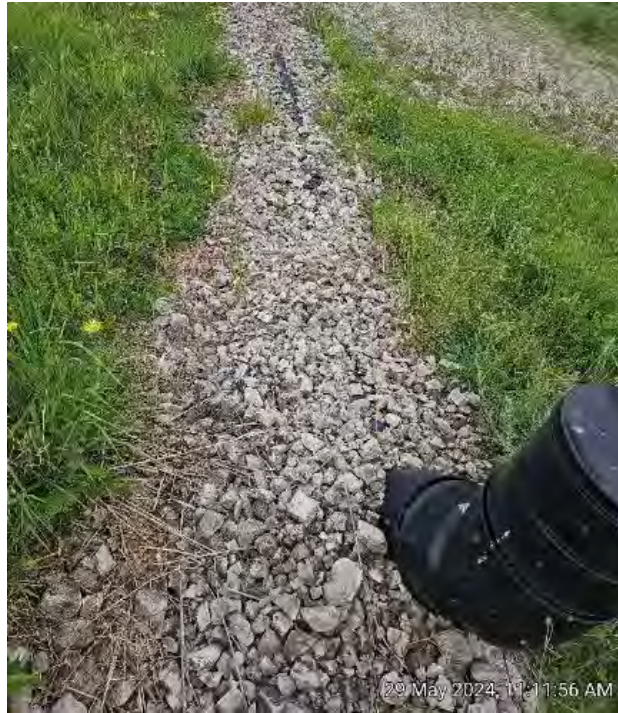
Photograph 26

Comments: Exterior slopes of the perimeter embankment on the west side (Stations 68+50 to 88+50) were in satisfactory condition.

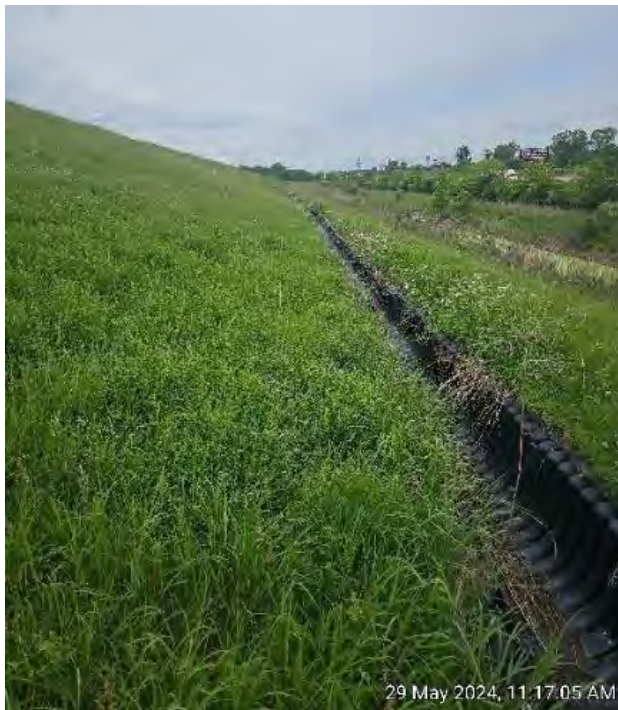
Comments: Small, woody vegetation was observed in the riprap downchutes at Station 70+00 (shown) and 76+00.

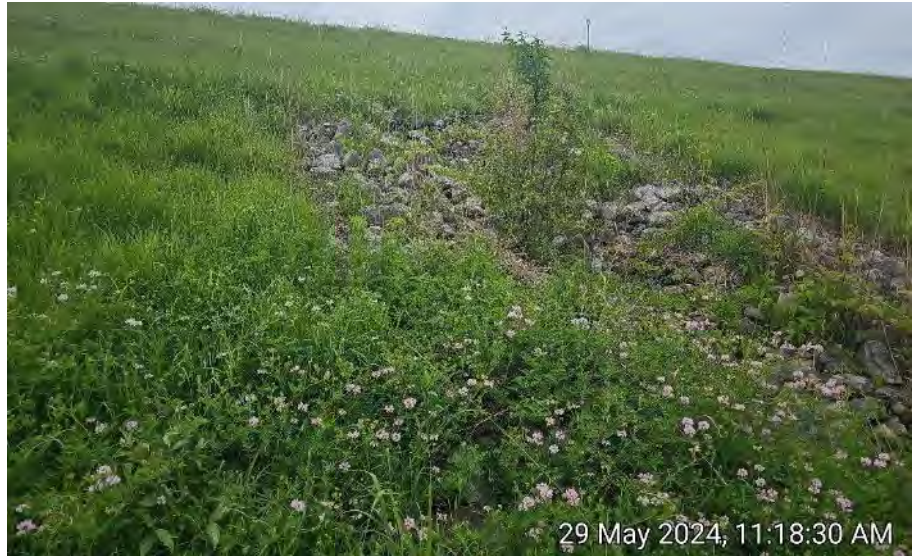
Photograph 28

Comments:
Approximately one foot of riprap has eroded from below the SmartDitch outlet at Station 76+00. The outlet appeared to have been distorted due to settlements.

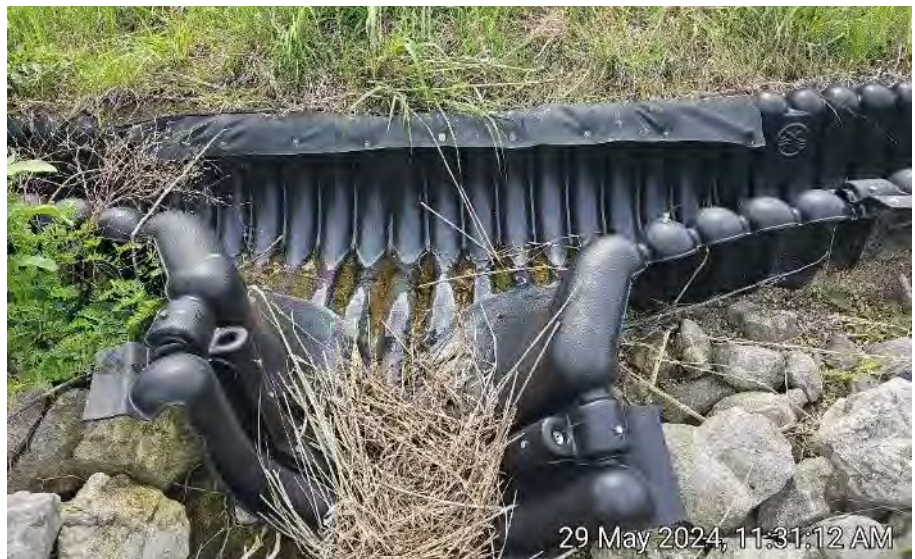
Comments:
Approximately one foot of riprap has eroded from below the SmartDitch outlet at Station 82+00. The outlet appeared to have been distorted due to settlements.

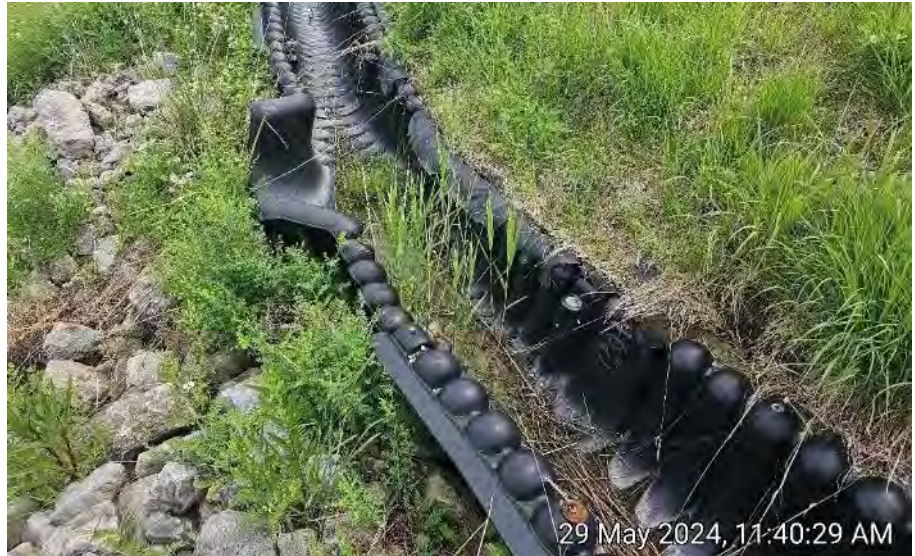
Photograph 30

Comments: Previous repairs to a crack near Station 78+00 were observed to be in good condition.

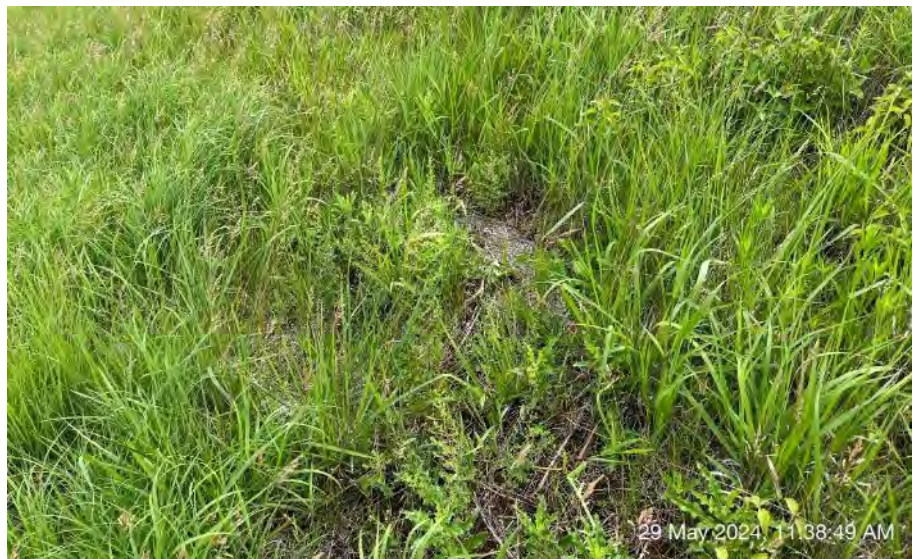
Comments: Vegetation was sparser at some locations on the exterior slopes of the perimeter embankment on the west side (Station 82+00 shown). A fire burned vegetation on the perimeter embankment on the west side in early 2023. The vegetation has improved in this area.

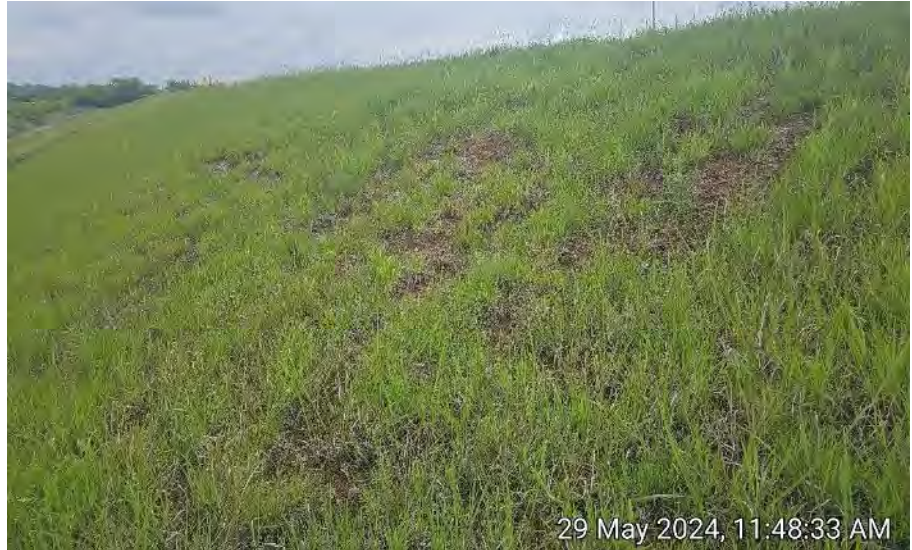
Photograph 32

Comments: Perimeter road atop the perimeter embankment and the asphalt access road on the west side were in good condition with no erosion, minimal rutting, and no cracks observed. Exterior slopes of the perimeter embankment on the west side were in satisfactory condition.

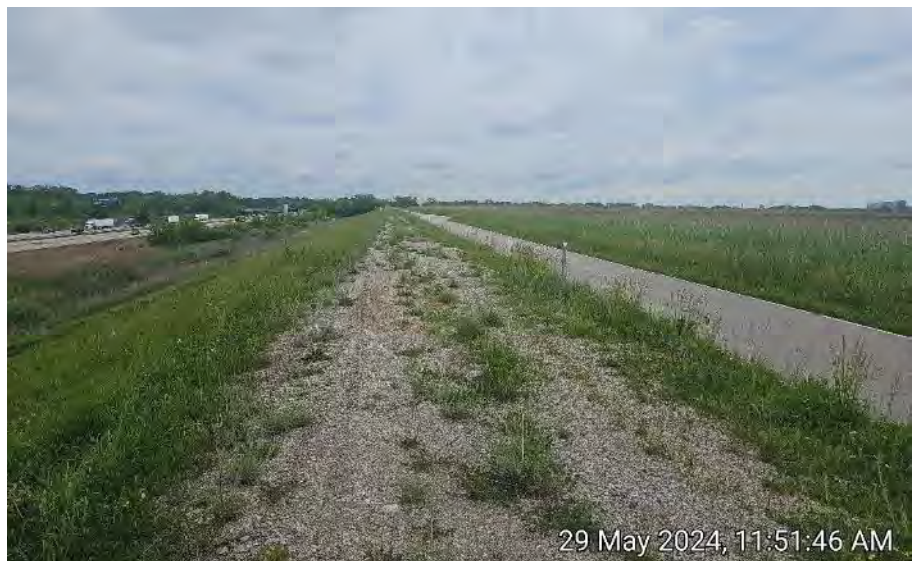
Comments: Exterior slopes of the perimeter embankment on the southwest side (Stations 88+50 to 104+50) were in satisfactory condition. The asphalt access road was in good condition with no cracks observed.

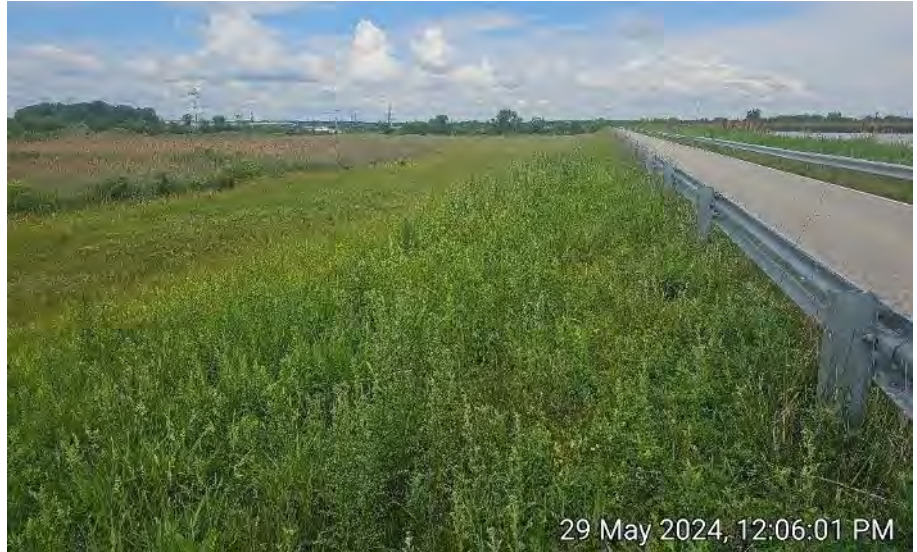
Photograph 34

Comments: The asphalt access road to the perimeter road atop the perimeter embankment by the south entrance was in good condition. The stormwater drainage channel and check dams were in satisfactory condition. Denser vegetation was observed by the north check dams. Exterior slopes of the perimeter embankment (Stations 104+50 to 112+00) were in satisfactory condition.

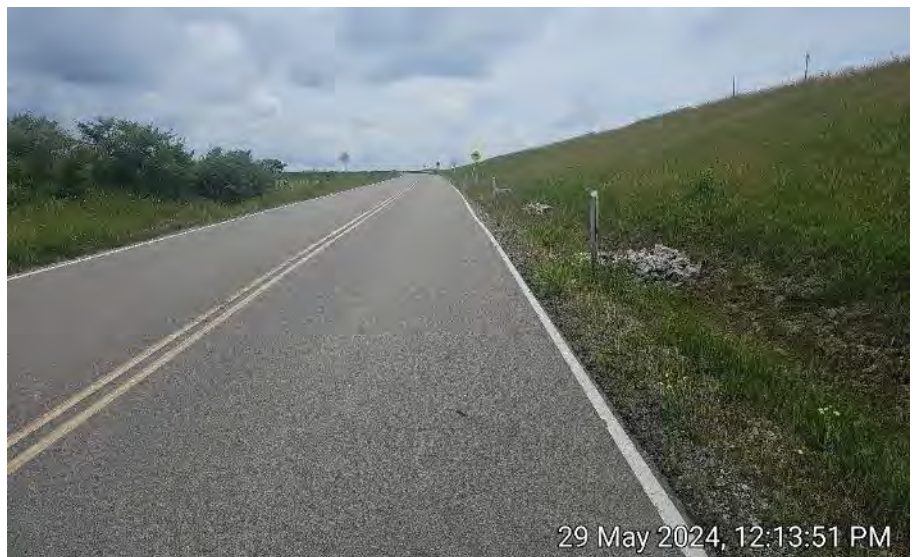
Comments: Exterior slopes of the perimeter embankment on the south side (Stations 112+00 to 139+50) were in satisfactory condition.

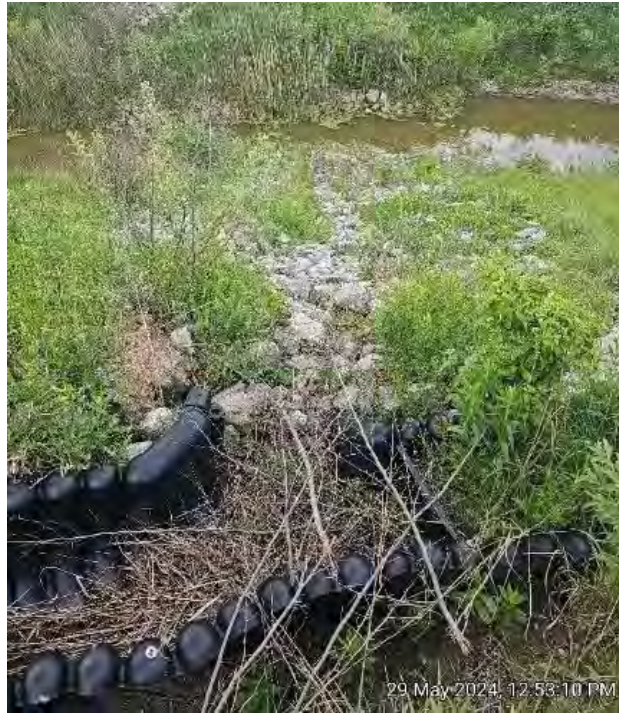
Photograph 40

Comments: Approximately half of a foot of riprap has eroded from below the SmartDitch outlet at Station 151+00. The outlet appeared to have been distorted due to settlements.

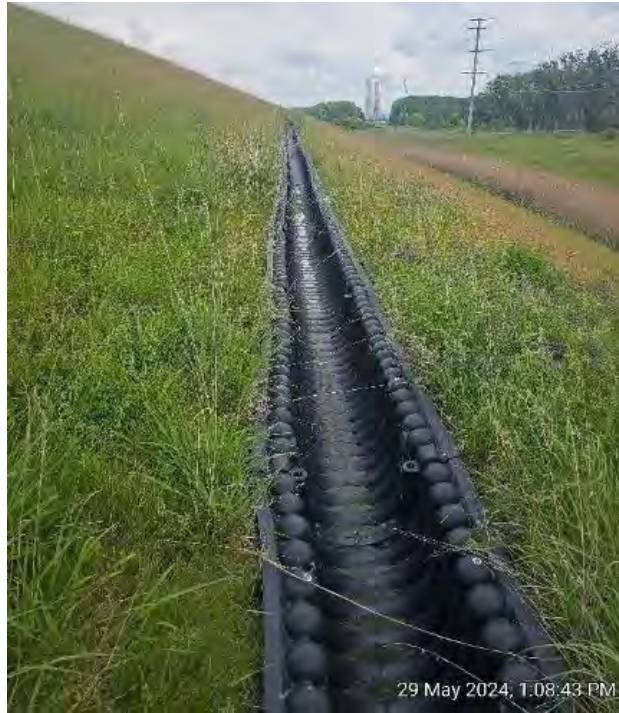
Photograph 42

Comments: Approximately half of a foot of riprap has eroded from below the SmartDitch outlet at Station 157+00.

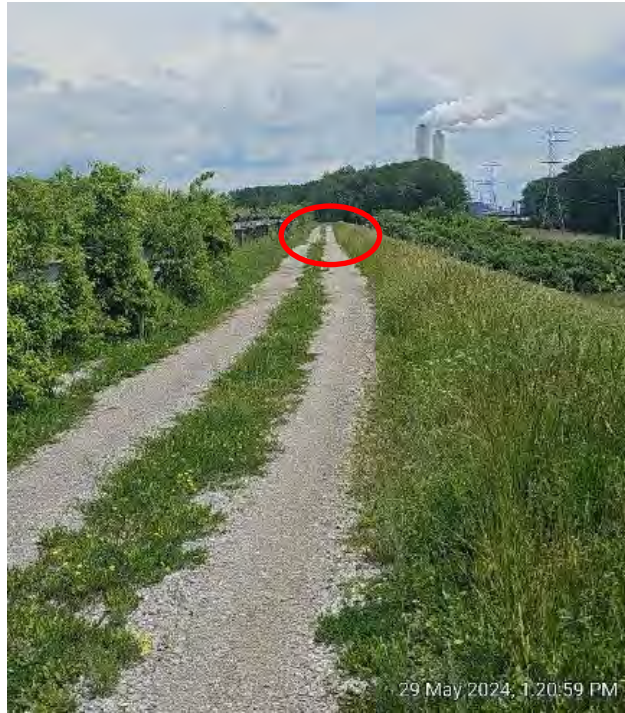
Photograph 44

Comments: East access road to the perimeter road atop the perimeter embankment was in good condition with no erosion rills observed.

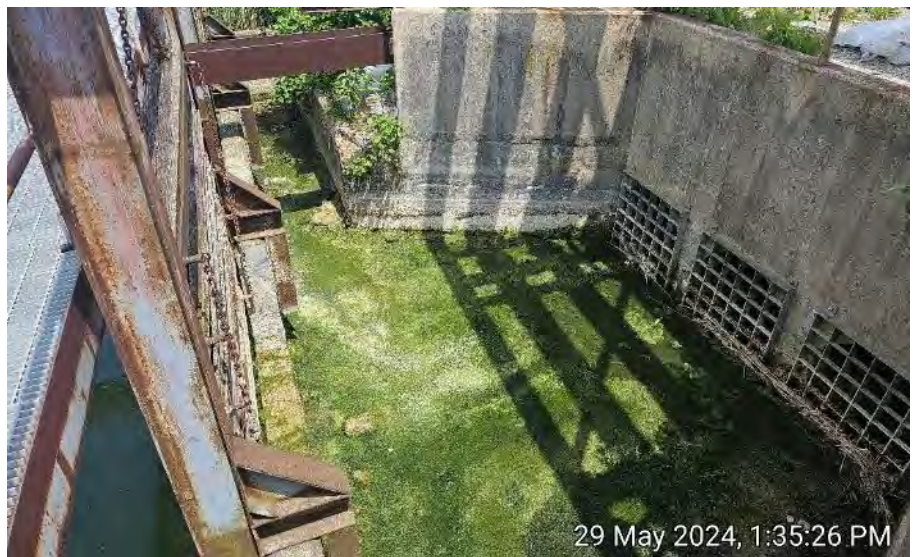
Comments: The gates and stop logs of the discharge structure were in satisfactory condition with no significant damage or obstructions observed. Sluicing operations at the Fly Ash Basin have stopped, so the water level within the Fly Ash Basin has decreased to approximately 607.7 feet at the time of inspection.
