2024 ANNUAL INSPECTION REPORT

RANGE ROAD LANDFILL

BELLE RIVER POWER PLANT

CHE8242V

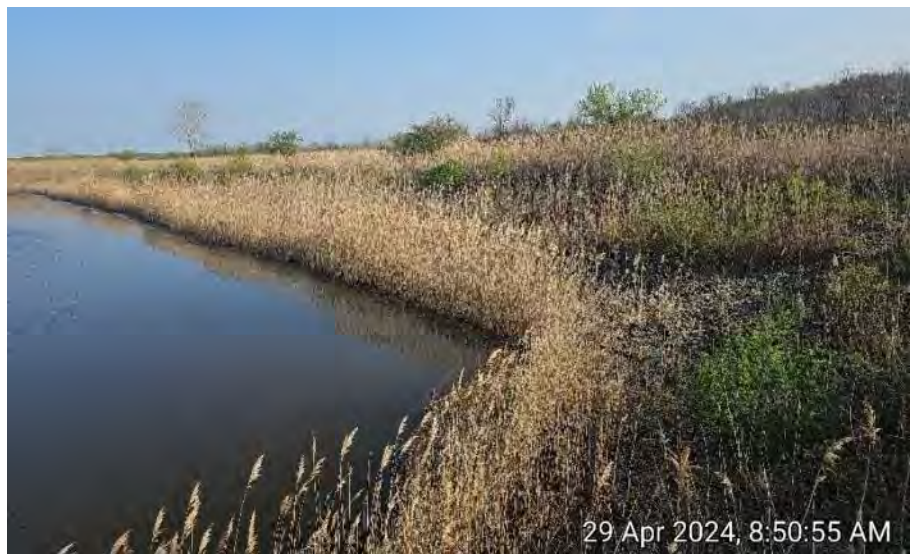
Comments: The SDB was in good condition. Some vegetation on side slopes. No visible slope erosion. The water quality within the SDB appeared to be appropriate for the NPDES permit.

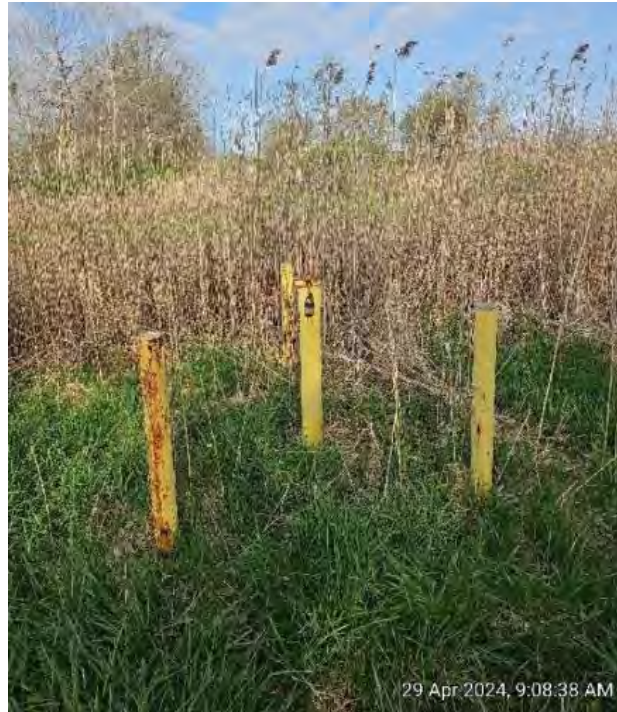
Photograph 10

Comments: Monitoring wells and piezometers around the perimeter road were in good condition (typical).

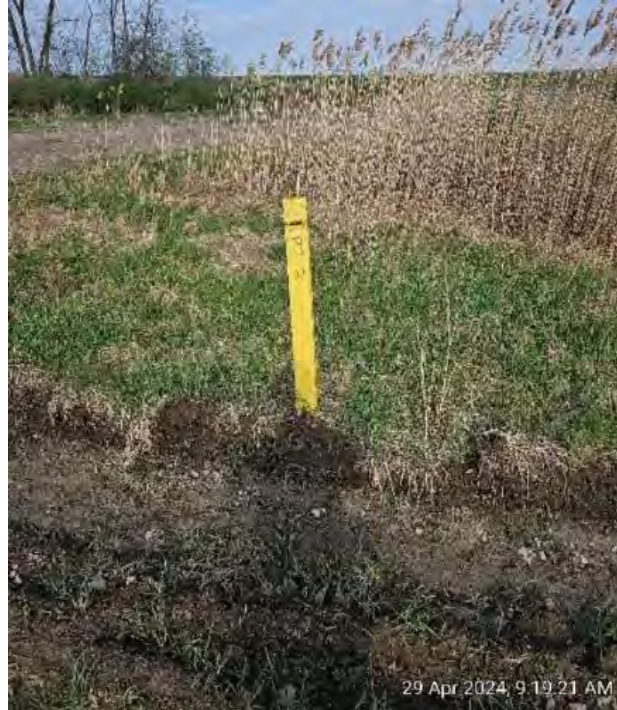
Photograph 14

Comments: Perimeter fence gates were locked and generally in good condition (gate on east side shown). Signs for DTE property and “No Trespassing” were observed at the gates. Piezometer 96-W-13 was locked and in good condition.

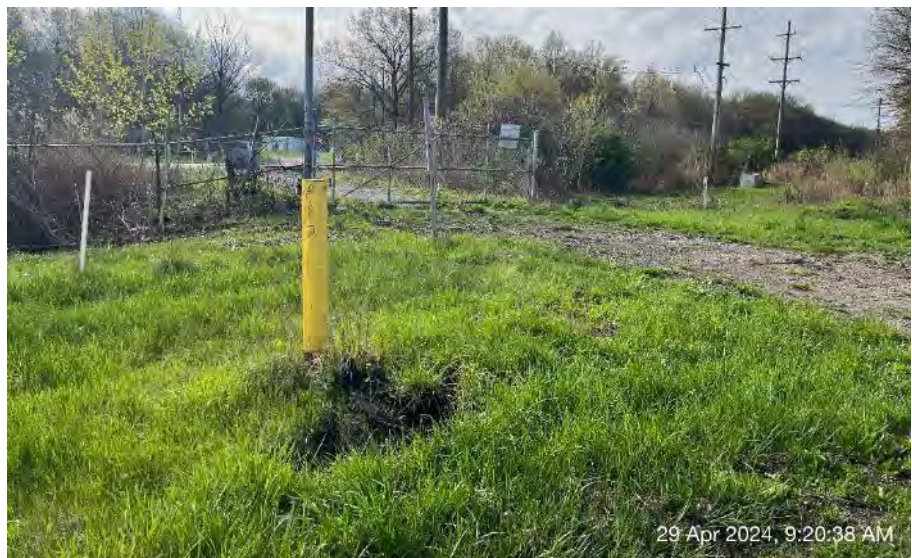
Comments: Perimeter road on the east side of the Landfill was in good condition. The perimeter fence in this location was tilting in towards the property.

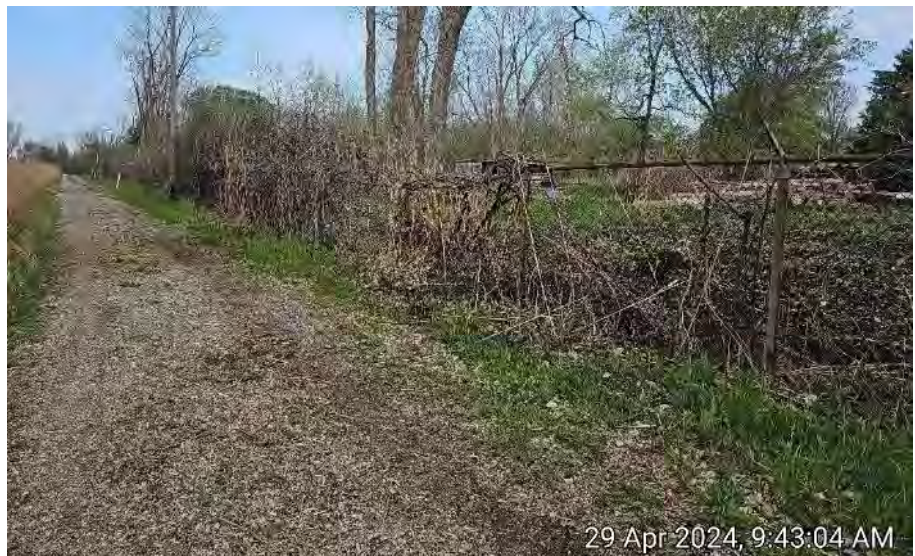
Comments: Landfill side slopes on north side Area B were covered in trees. MDEQ (now EGLE) approved leaving the trees in place along these slopes. No observations of slope instabilities (e.g., leaning or downed trees) were identified. Heavier vegetation observed within the perimeter ditch on the north side, but did not appear to affect flow.

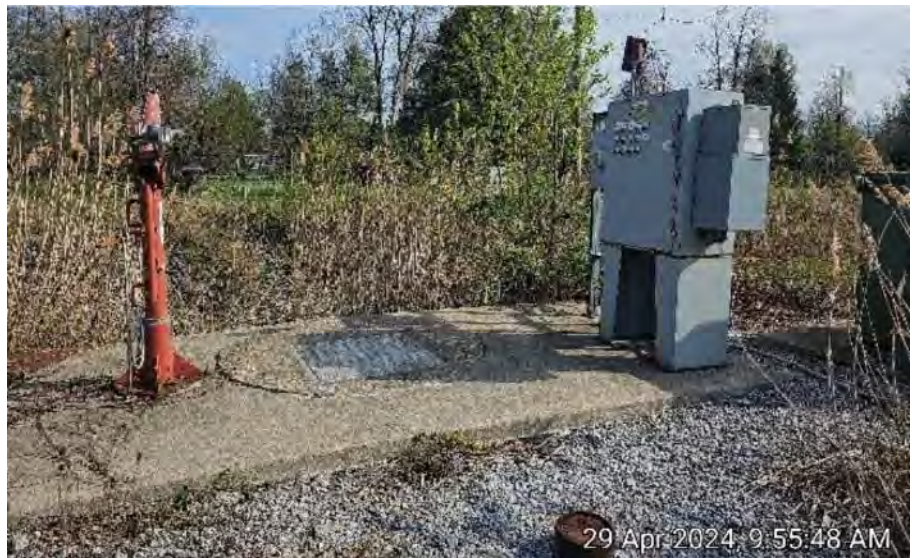
Comments: The sump, pump piping, and flow pipe entering the sump from the lower perimeter ditch at the northwest corner of the property were in good condition. Pumps and hands-on switches were checked by DTE personnel and appeared to be operating correctly.

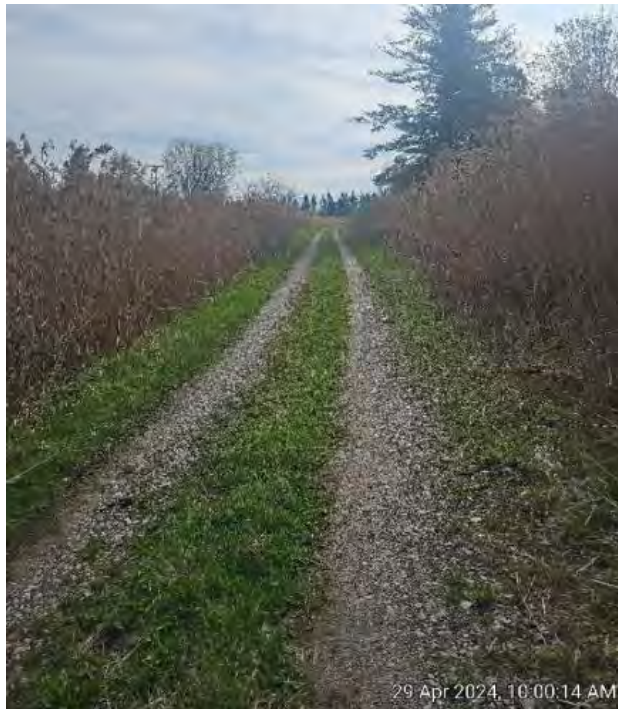
12. The perimeter road west of the manhole lift station was observed to have a wet spots that ponded in minor ruts at the bottom of the slope (Photograph #27). However, water was not observed to be flowing along the road at the time of the visual inspection.

3. Wet spots were observed on the perimeter road west of the manhole for the upper perimeter ditch of the lift station. Water was ponding within ruts at the bottom of the perimeter road slope.

Comments: Wet spots were observed on the perimeter road west of the manhole for the upper perimeter ditch of the lift station. Water was ponding in minor ruts at the bottom of the perimeter road slope. The water was not observed to be flowing along the road at the time of the visual inspection.

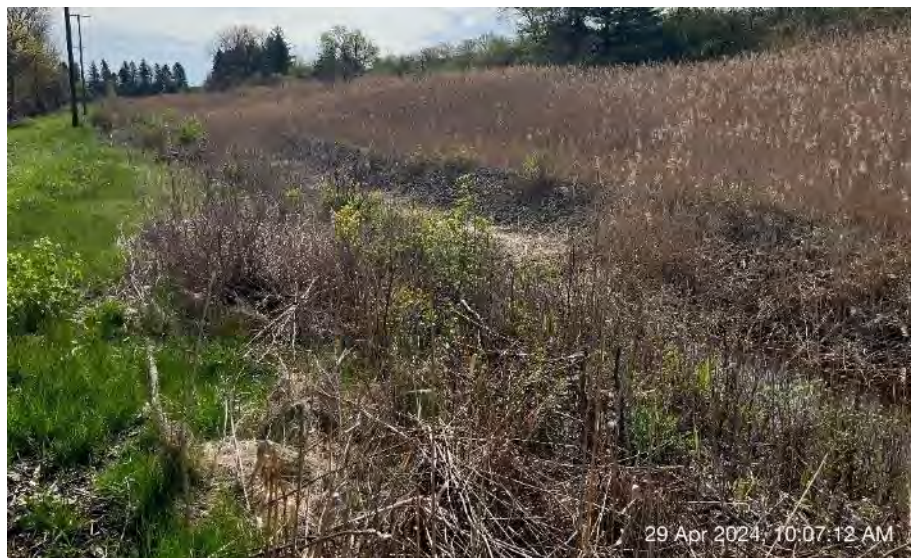
Comments: The perimeter ditches on the west side of the Landfill were generally clear of vegetation and had riprap on the side slopes.

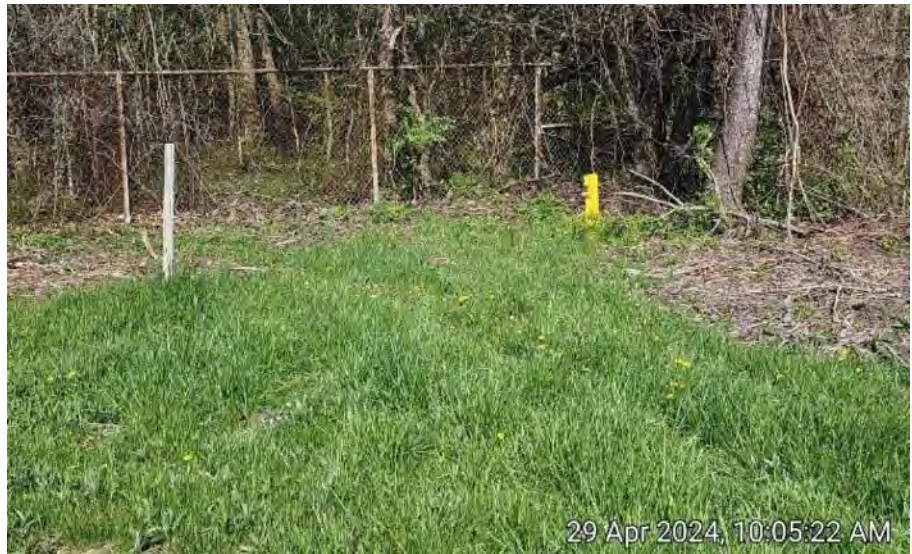
Comments: The slurry wall marker near the security gate on the west side of the property was damaged.

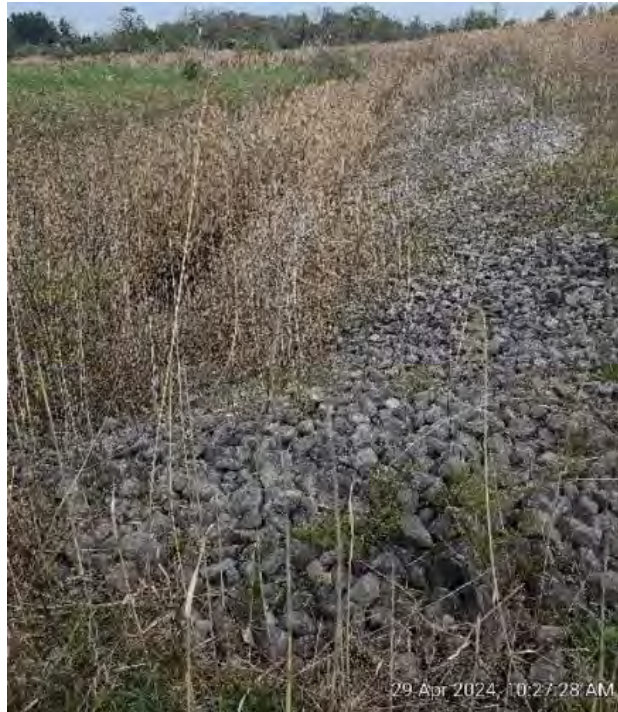
Photograph 34

Comments: The riprap-lined stormwater downchute at the southwest side of Area F1 had some vegetation growing within the riprap.

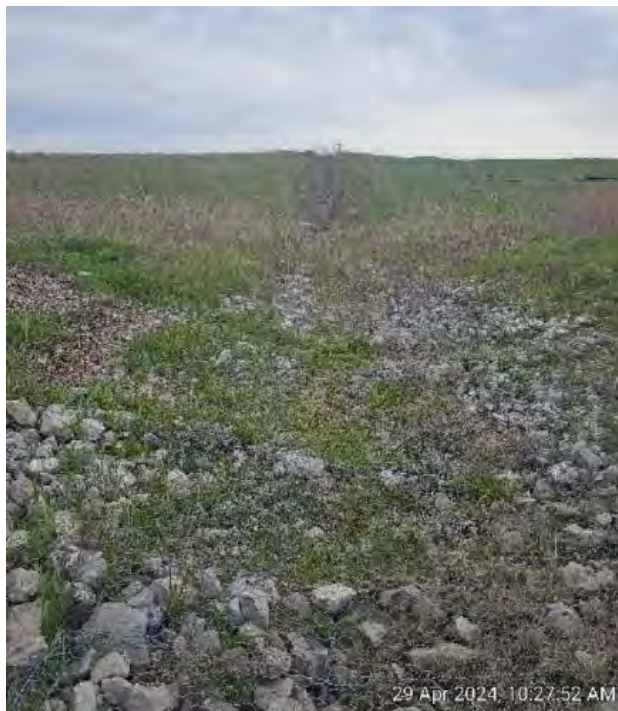
13. The riprap-lined stormwater downchute at the southwest side of Area F1 had some vegetation within the chute (Photograph #34) and some small woody vegetation at the top of the chute (Photograph #37). The mesh wiring was damaged near the bottom of the downchute where an erosion rill was observed within the riprap (Photograph #35).

Comments: Damage to the mesh wire of the stormwater downchute at the southwest side of Area F1 was observed. An erosion rill was observed below the mesh wire.

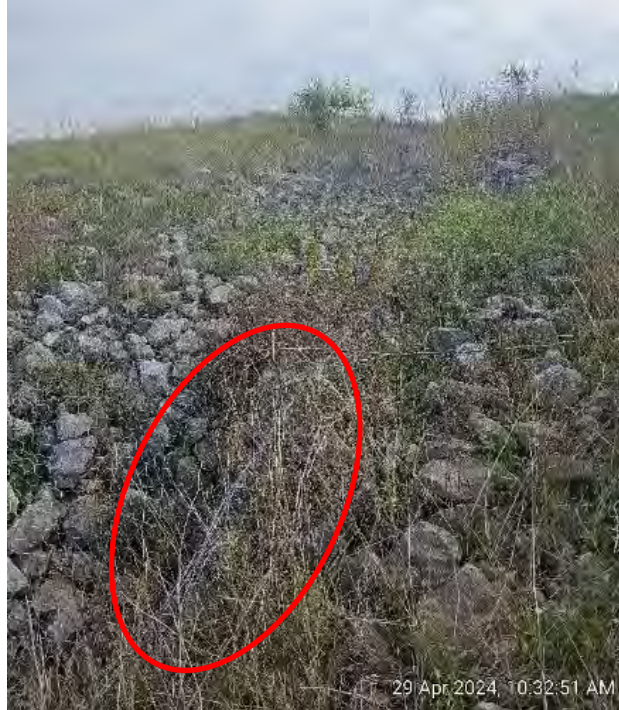
Photograph 36

Comments: The perimeter ditches on the west side of the Landfill had some vegetation. No erosion was observed in the riprap on the side slopes of the ditches. No obstructions were observed in the culverts.

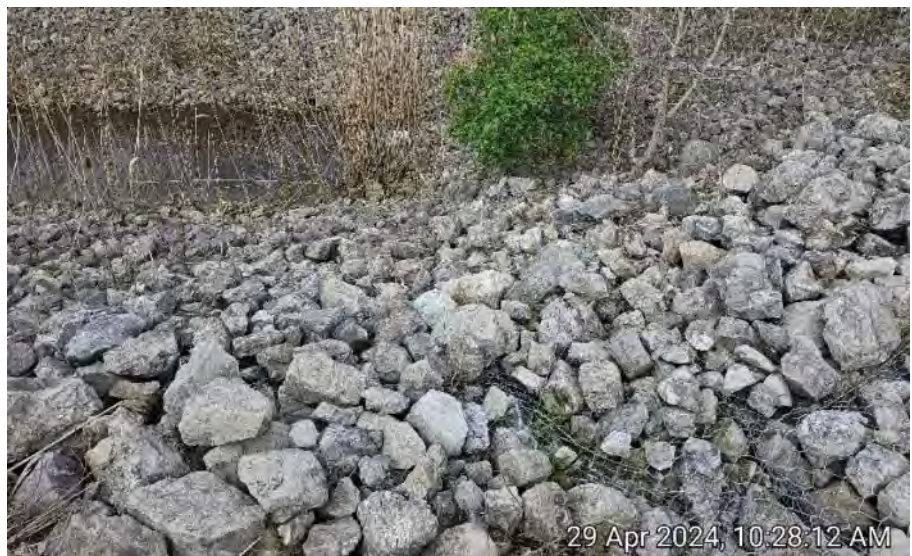
Comments: The riprap-lined stormwater downchute at the southwest side of Area F1 had some small, woody vegetation at the top of the chute. No erosion was observed in the riprap at the top of the downchute.

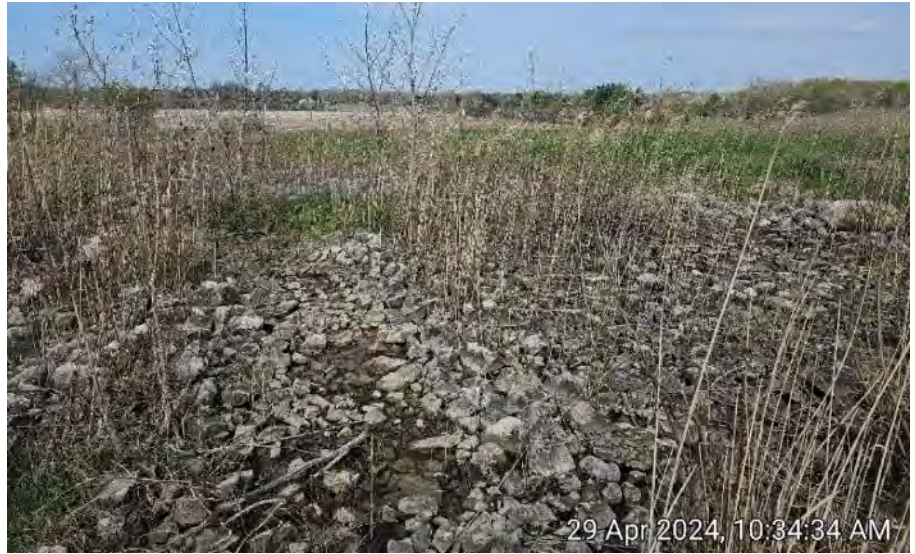
Photograph 38

Comments: The side slopes of the Area G2 Phase I were in good condition. The vegetation had become established and was well maintained.

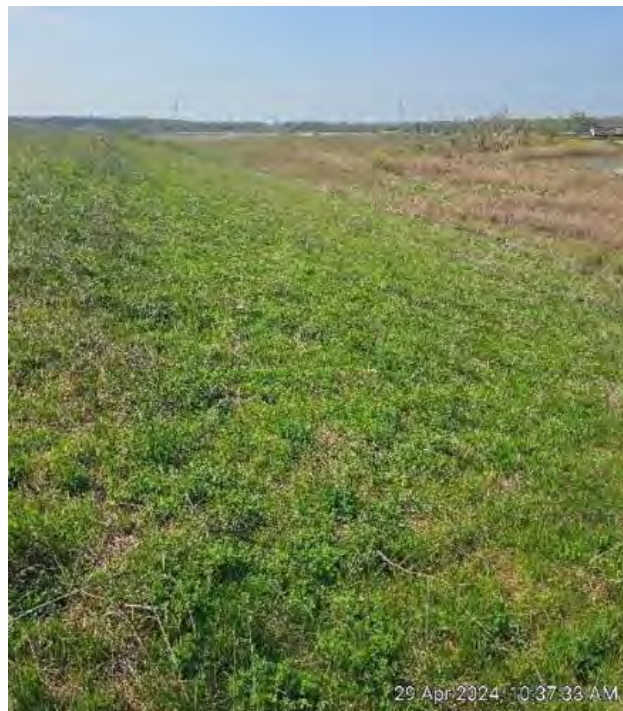
Comments: The top deck of the Areas F1, F2 and G2 Phase I was in good condition. The vegetation had become established and was well maintained. No low spots with water ponding were visible.

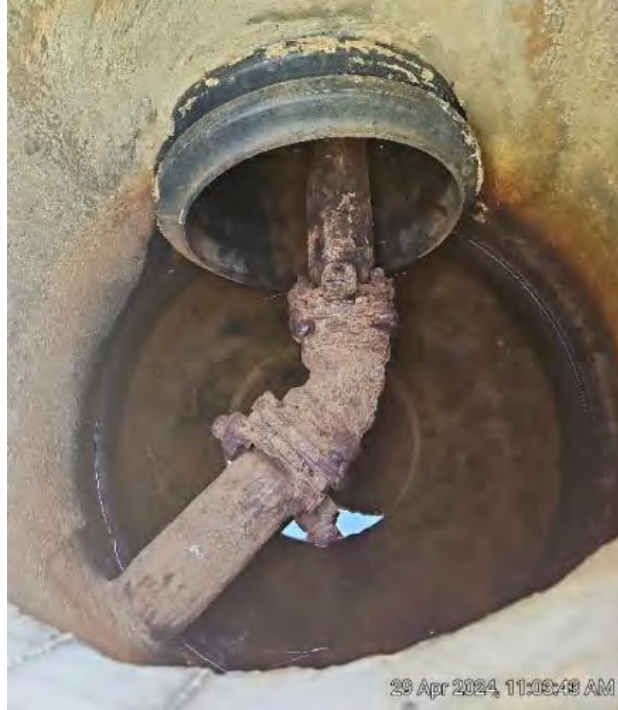
Photograph 42

Comments: Outlet pipe from the manhole into the upper perimeter ditch at the lift station at the northwest corner of the property. Little flow was observed during the inspection.

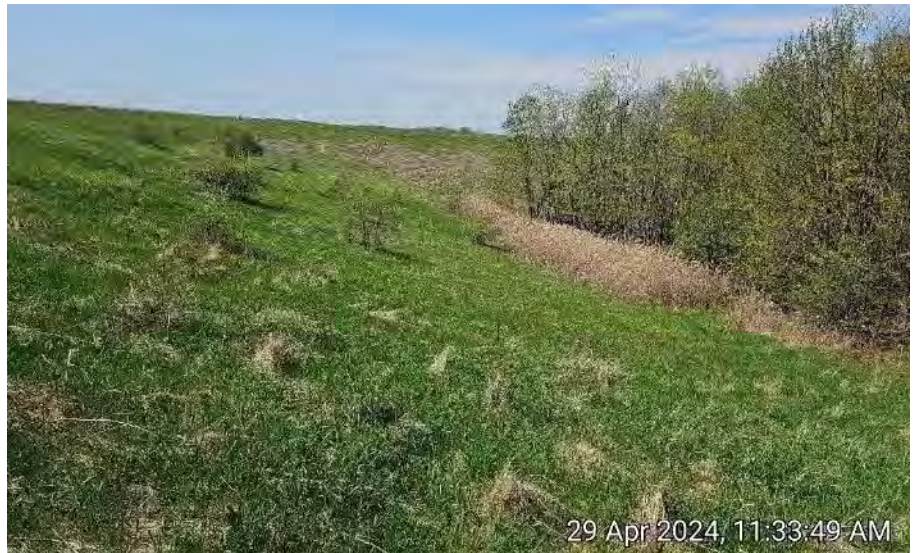
Photograph 44

Comments: Top deck of the Landfill was in good condition. Areas B and B1 shown in the photograph. Vegetation was generally well maintained. No low spots with water ponding were visible and downchute inlets were not obstructed.

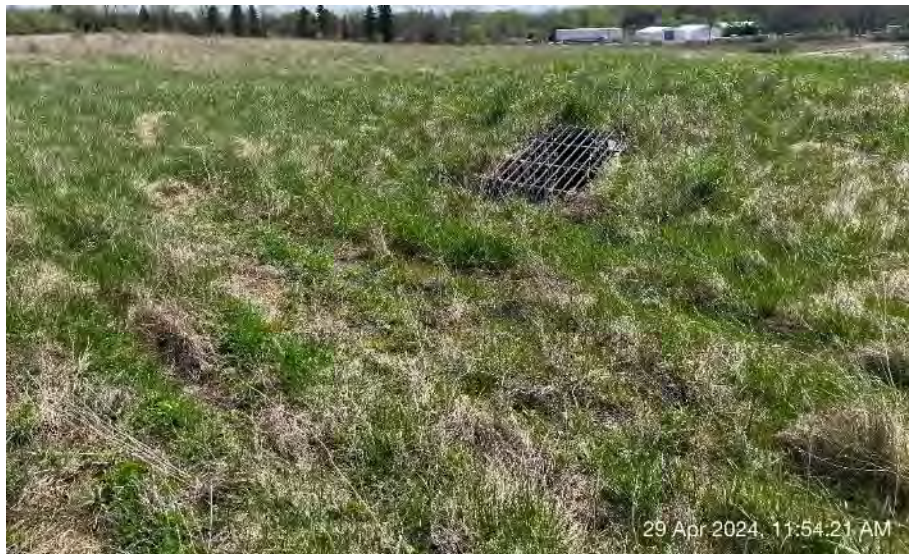
Comments: Top deck of the Landfill was in good condition. Areas B and D1 shown in the photograph. Vegetation was generally well maintained. No low spots with water ponding were visible.

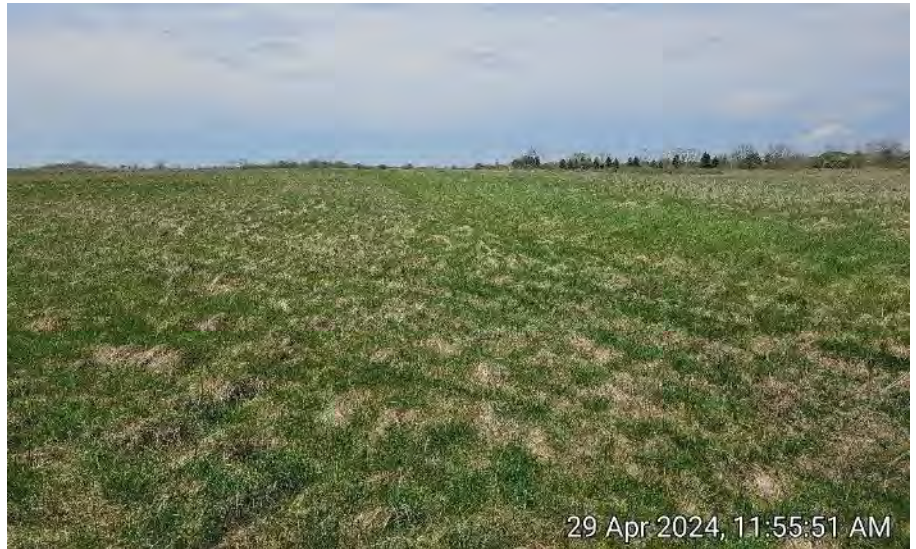
Photograph 46

Comments: The access road to the top deck in Areas D3 and D3/F3 was in good condition. The side slopes of Area D2 were vegetated, and no erosion was observed.

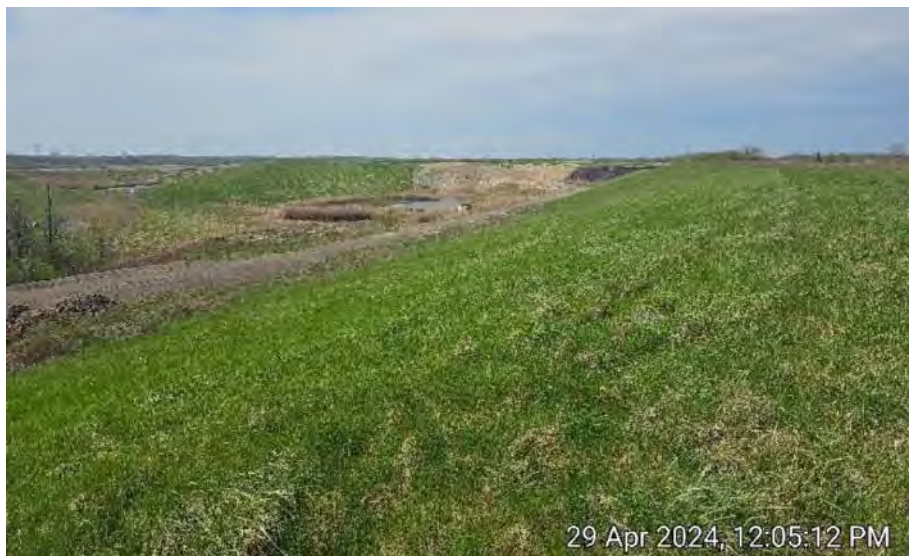
Comments: The internal detention pond by Area D3/F3 was in good condition. The side slopes of Areas D2 and D3 were vegetated, and no erosion was observed.

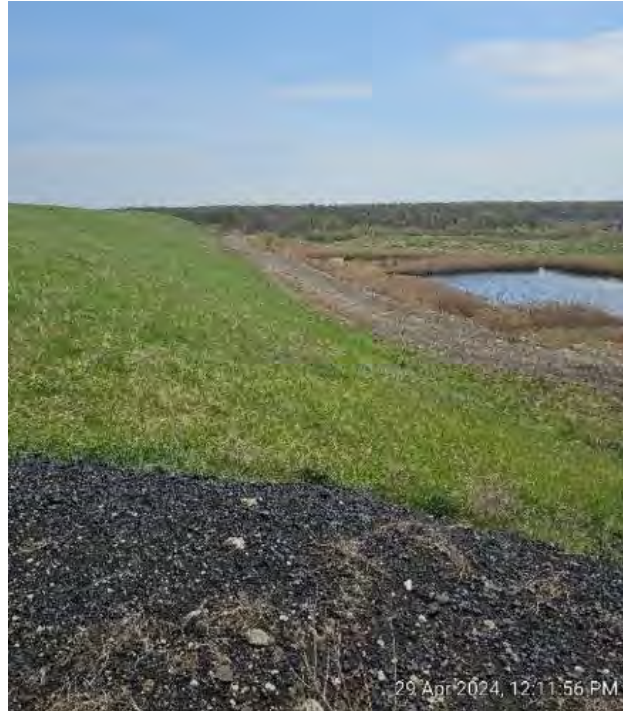
Photograph 48

Comments: The access road to the Area G2 Phase I was in good condition. Stormwater downchute along the access road was in good condition.

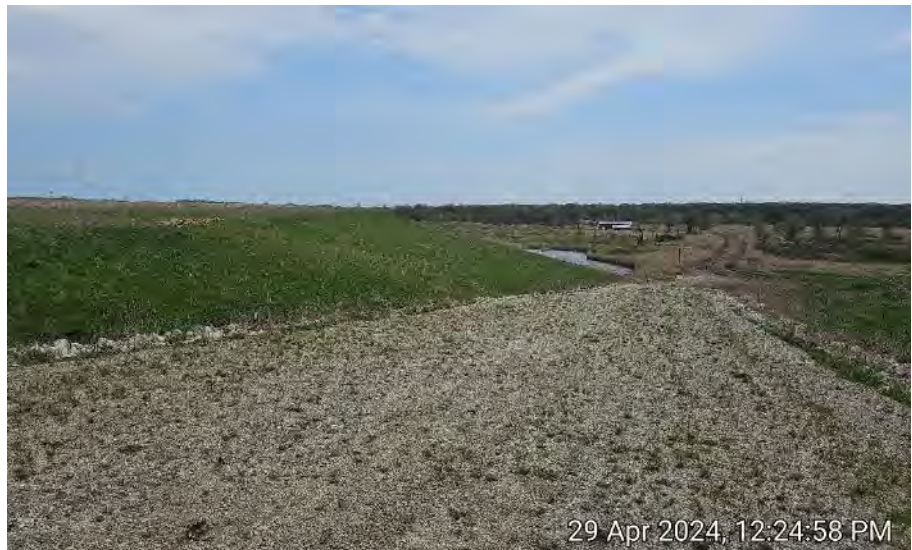
Comments: Top deck and side slopes of the Area G2 Phase I were in good condition. Vegetation was generally well maintained. No low spots with water ponding were visible.
