2024 ANNUAL INSPECTION REPORT SIBLEY QUARRY LANDFILL

TRENTON CHANNEL POWER PLANT

Trenton, Michigan

January 2025

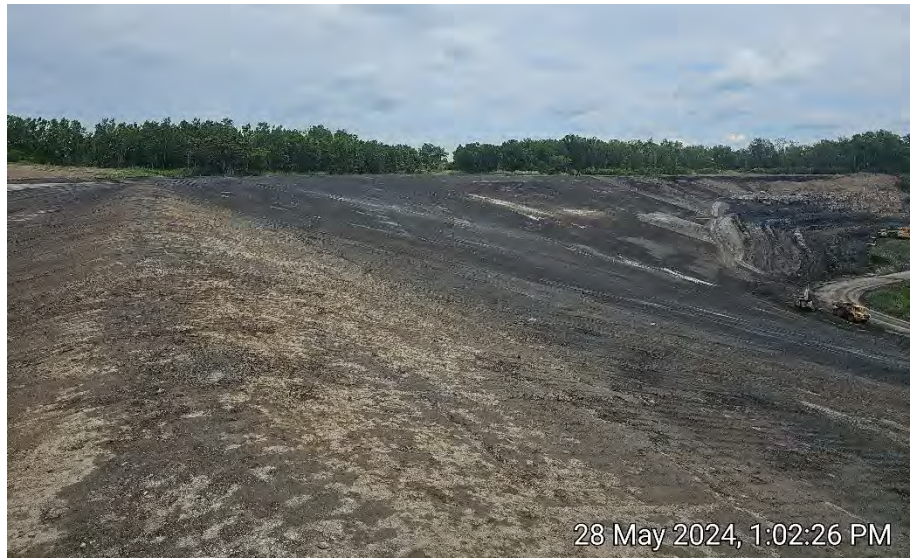
Comments: View of the northern CCR slopes after regrading to a 4H:1V slope. The excavated material was being hauled to the bottom of the quarry. There is a stormwater diversion berm at the top of the slopes (approximately 1 to 2 feet high) to reduce stormwater flow over the regraded slopes.

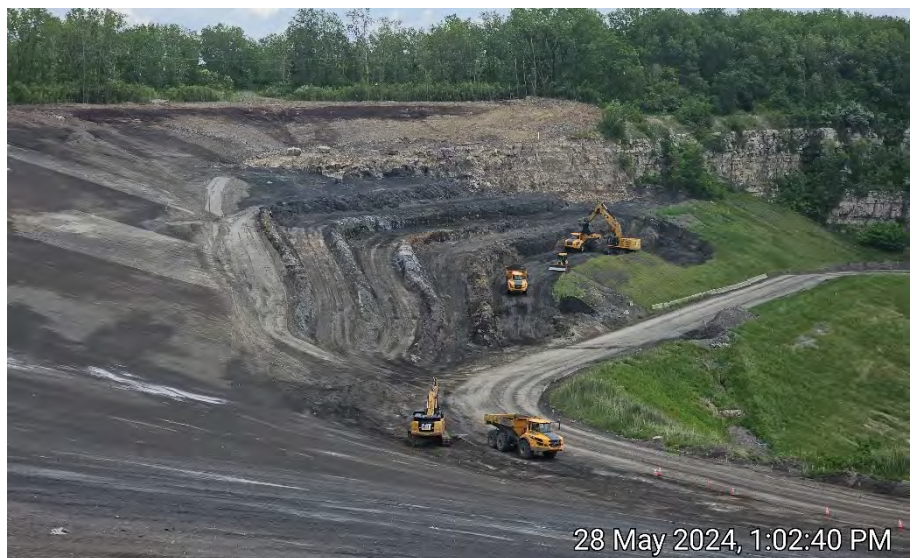
Photograph 2

Comments: Active excavation area on the northern CCR slopes. Equipment was loading and hauling CCR in line with generally accepted engineering practices. The equipment appeared to be operating safely and at speeds to minimize fugitive dust.

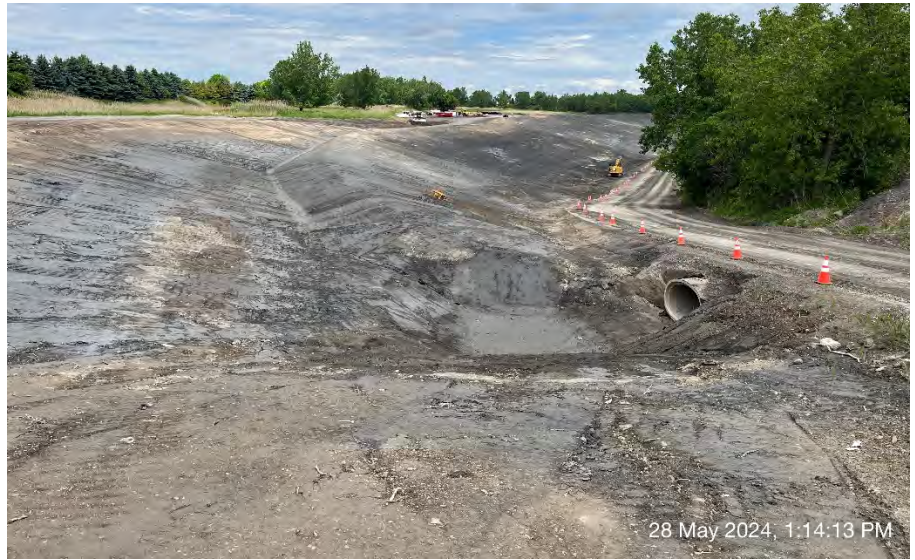
Comments: Diversion berm, stormwater collection point, and concrete culvert conveying stormwater from the top of the northern slopes to the bottom of the Landfill. The system is adjacent to the Switchback Two haul road. The culvert appeared to be in good condition and free of obstructions.

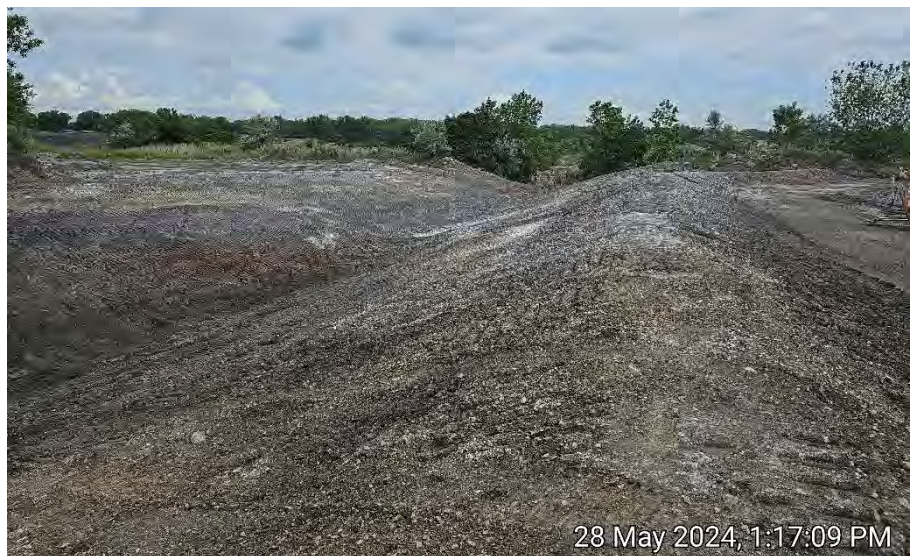
Photograph 4

Comments: Stormwater channel conveying stormwater from the culvert in Photograph #3 over the western sidewalls of the Landfill. The system is adjacent to the Switchback Two haul road. Side slopes and bottom of the ditch appeared to be in good condition with no erosion observed.

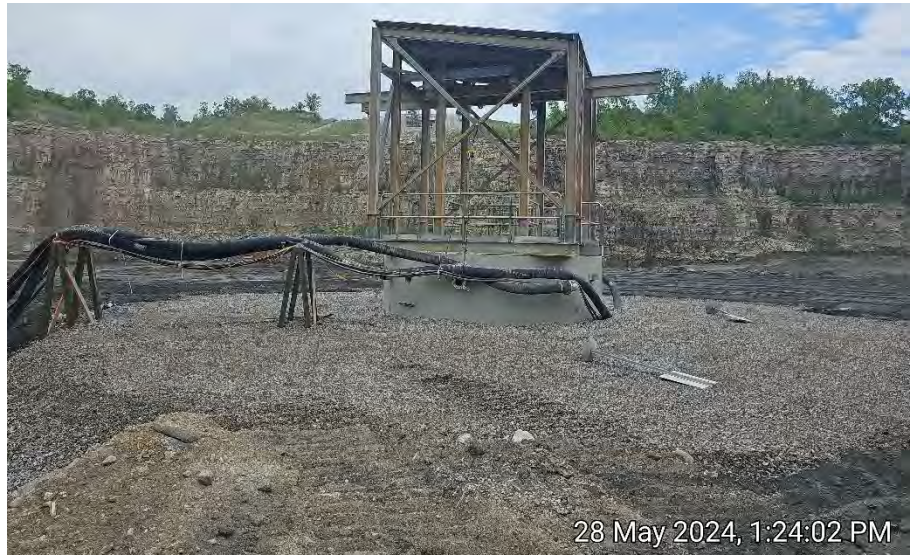
Comments: Chimney sump at the bottom of the quarry and drainage collection and filter layer surrounding the sump. The drainage collection and filter layer are also present below the CCR.

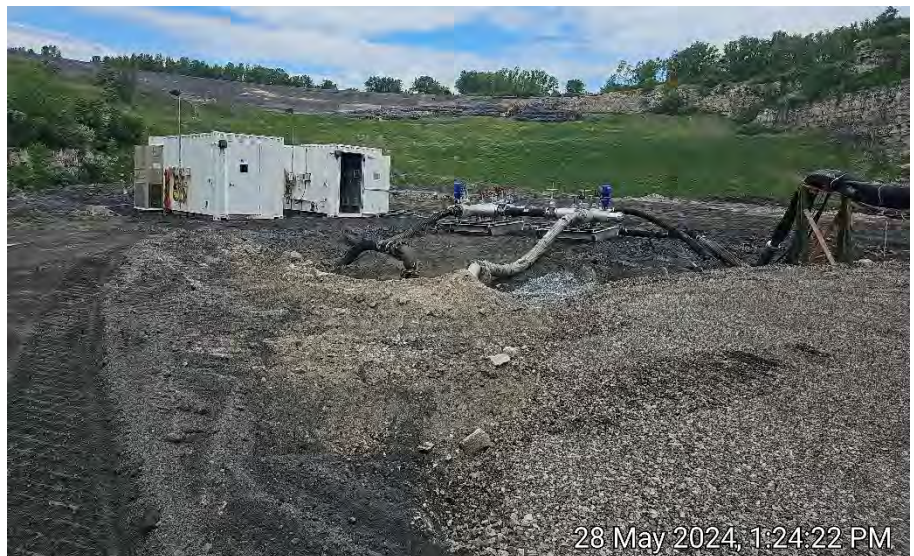
Photograph 6

Comments: Sump pumps installed at the bottom of the Landfill to convey water to the upper ponds. The two sump pumps were operating during the inspection.

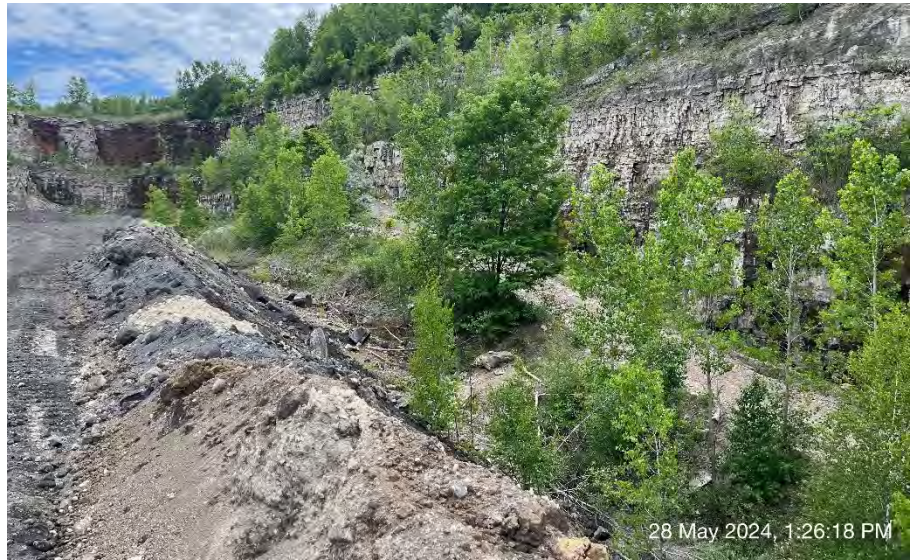
- 6) The side slopes of the CCR placed within the active filling area are relatively steep (approximately 1.5-horizontal-to-1-vertical, 1.5H:1V) (Photographs #7, #10, #11). However, no indications of slope instabilities (e.g., cracks) were observed during the inspection and this configuration is temporary during filling operations.

Comments: Western side slopes of the active CCR filling area at the bottom of the Landfill. The edge of the filling area is offset from the sidewall. The side slopes are relatively steep (~1.5H:1V) but did not show any indications of instabilities (e.g., cracks). Emergency road along south sidewall appeared to be in good condition.

- 1) DTE should continue monitoring the active CCR filling area near the side slopes for early signs of distress like cracks or subsidence and erosion rills to identify potential safety concerns early. This should continue to be implemented during active filling operations.

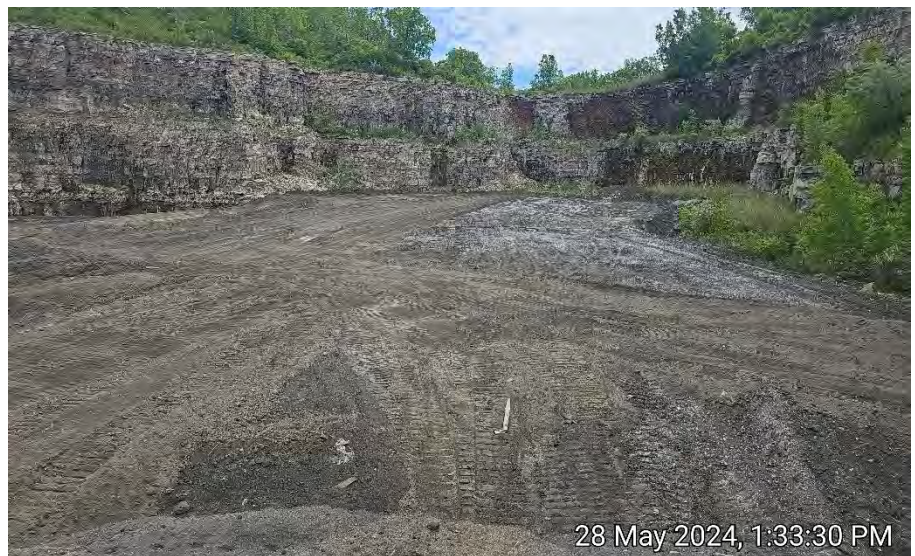
Photograph 8

- 7) Natural fractures in the bedrock sidewalls lead to groundwater inflow at multiple locations (Photographs #8, #9, #11); however, this inflow flows to the bottom of the Landfill where it is collected within the leachate collection layer and directed to the chimney sump.

Comments: Active CCR filling area at the bottom of the Landfill and the south sidewalls. Groundwater inflow from the sidewall was observed during the inspection. Placement of CCR appeared to be in line with generally accepted engineering practices.

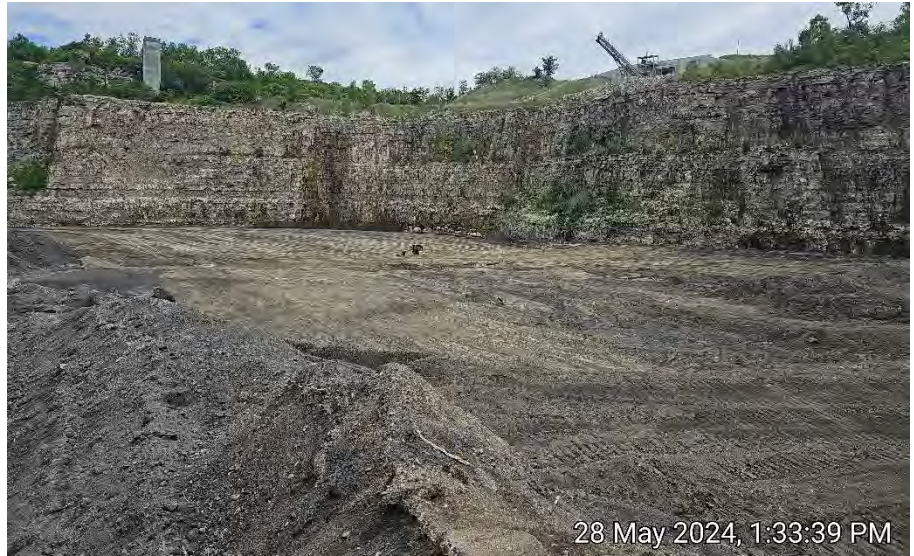
Comments: Active filling area at the bottom of the Landfill and east sidewall. Construction equipment was observed compacting the hauled material. Placement of CCR appeared to be in line with generally accepted engineering practices.

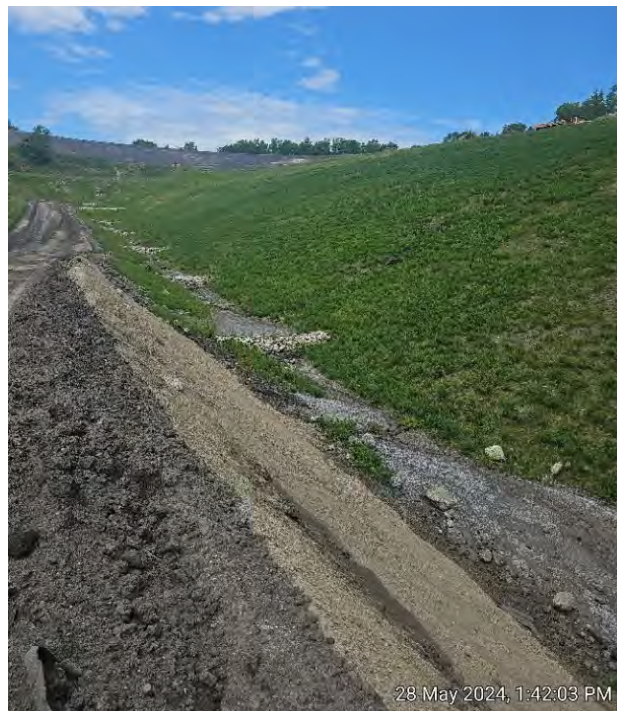
Photograph 10

- 4) Eroded sediments have collected behind the check dams in the stormwater channel at the bottom of the Switchback Two haul road (Photographs #10, #12). However, the functionality of the check dams to slow the flow of contact water and limit erosion at the toe of the Switchback Two haul road slopes did not appear to be impacted in the current condition.

- 2) Eroded sediments have accumulated behind the check dams in the stormwater channel at the bottom of the Switchback Two haul road. The check dams appear to be able to properly slow the stormwater flow velocity for the current conditions.

Comments: Side slopes of the Switchback Two haul road near the bottom of the Landfill. Stormwater channel and check dams at the bottom of the Switchback Two haul road leading to the bottom of the Landfill. Sediments were observed behind the check dams.

- 2) Some sediments behind the check dams in the stormwater channel at the bottom of the Switchback Two haul road should be removed. This will increase the hydraulic capacity within the stormwater channel. The sediments do not need to be completely removed because of the incised nature of the Landfill. This recommendation should be implemented within two years.

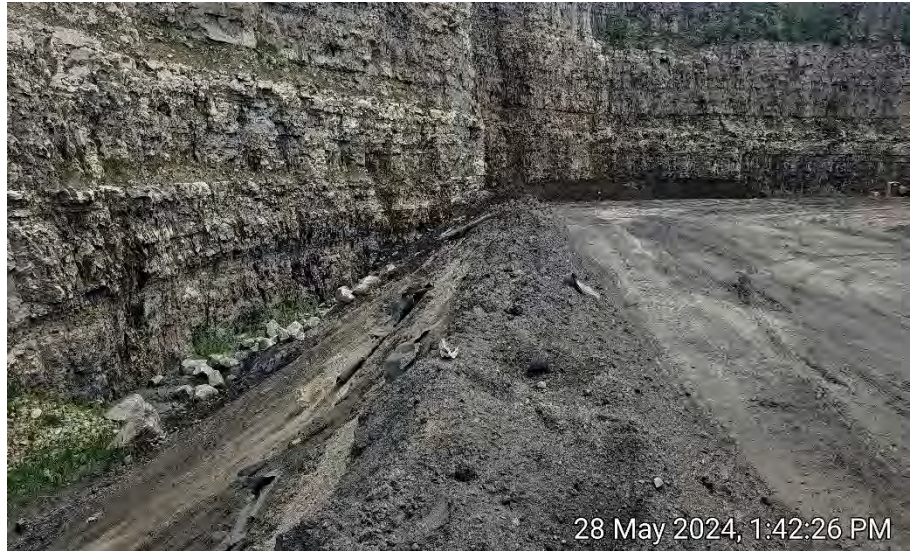
- 8) The natural fractures in the sidewalls pose a potential safety risk for rock falls. DTE has taken measures to address this safety concern by keeping a minimum of 20 feet between the sidewalls and the active filling operations (Photograph #11).

Comments: Eastern side slopes of the active CCR filling area at the bottom of the Landfill. The edge of the filling area is offset from the sidewall (note rock fall debris within buffer). The side slopes are relatively steep (~1.5H:1V) but did not show any indications of instabilities (e.g., cracks).

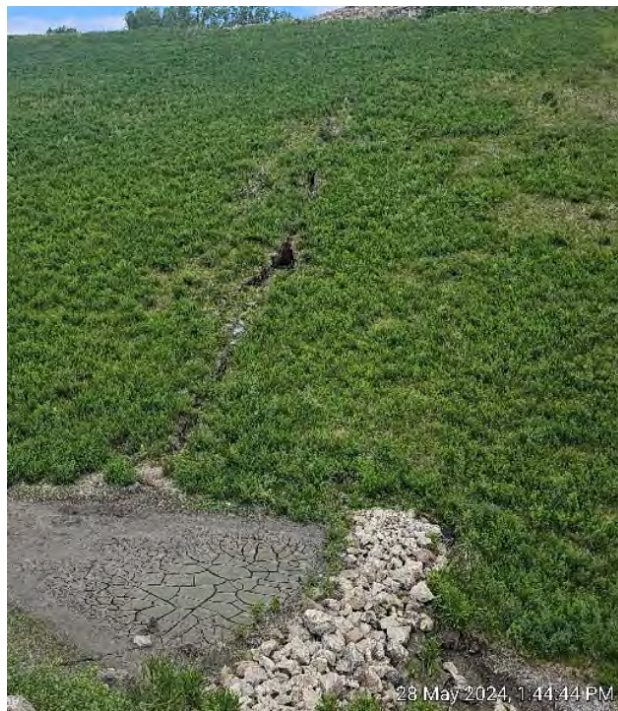
Photograph 12

- 5) One erosion rill was observed on the lower slope of the Switchback Two haul road (Photograph #12). Due to the incised nature of the Landfill, this feature does not represent an existing concern to the safety and operation of the Landfill.

- 3) One erosion rill was observed on the lower slope of the Switchback Two haul road. The rill had not significantly changed in size or geometry since the 2023 inspection. Although any eroded material will be contained within the Landfill footprint, continued erosion could begin to impact the stability of these slopes.

Comments: Erosion rill on the lower slope of the Switchback Two haul road. Eroded material was retained by the check dams within the stormwater channel adjacent to the road. The rill did not appear to have changed in size or geometry from previous inspections. Erosion features should continue to be monitored.

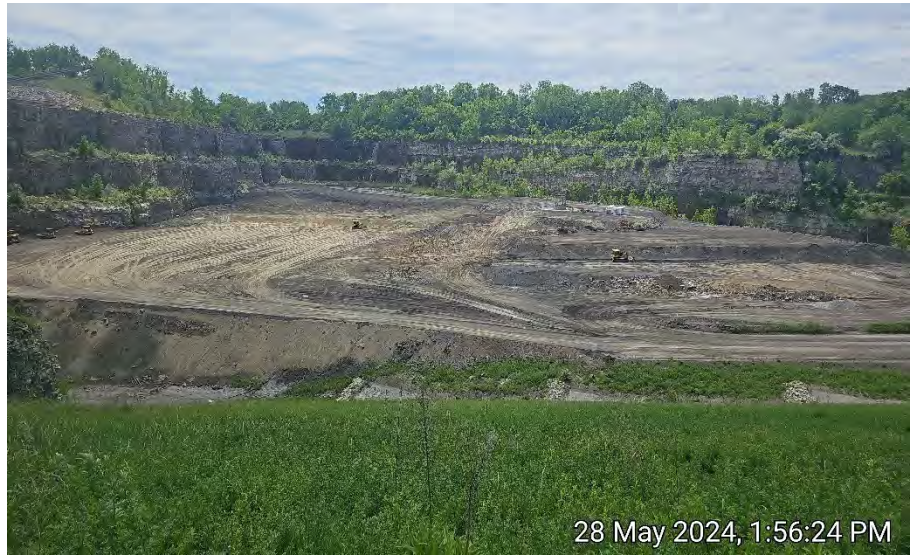
Comments: Overview of the landfill operations and active CCR filling areas. Construction operations appeared to be in line with generally accepted engineering practices. Fugitive dust was not observed during the inspection.

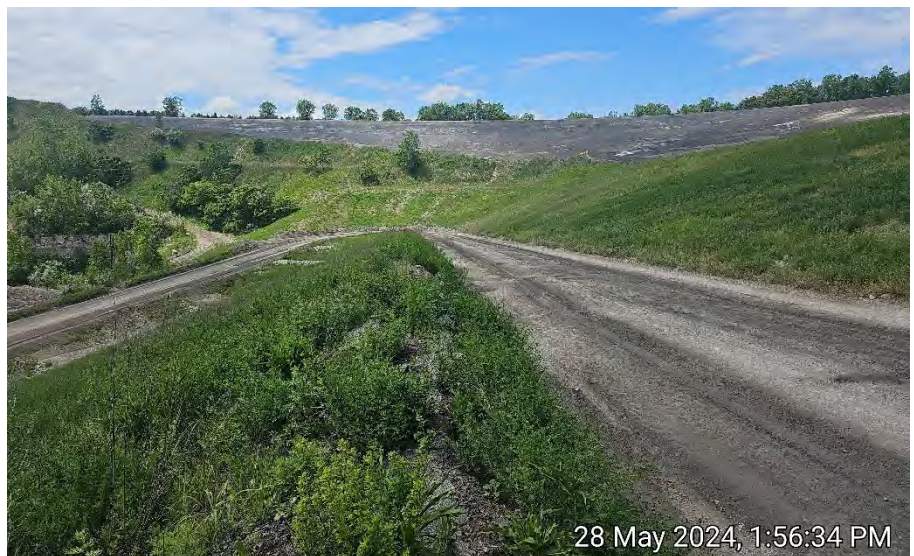
Photograph 14

Comments: Switchback Two haul road, sideslopes, and adjacent diversion berm. Haul road and diversion berm appeared to be in good condition.

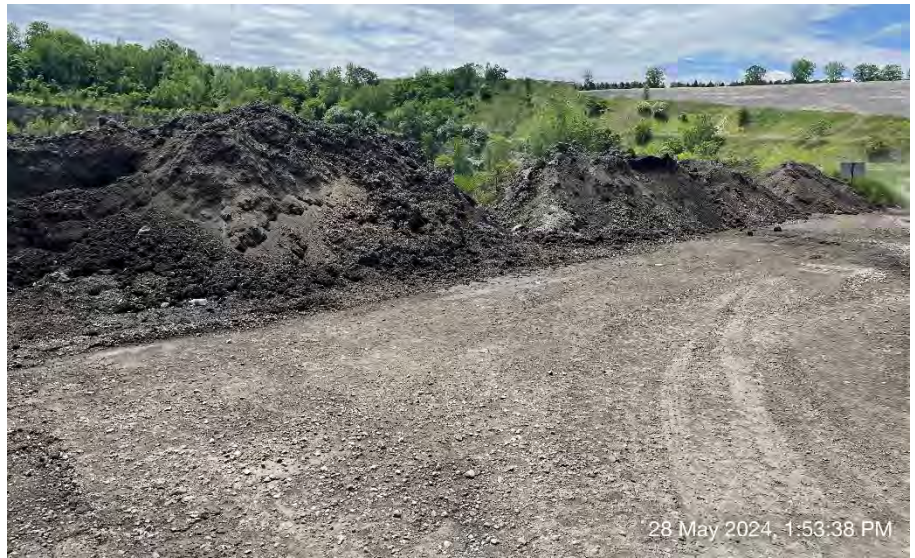
Comments: Diversion berm on Switchback Two haul road to mitigate stormwater flow over the bottom slopes. The diversion berm appeared to be in good condition.

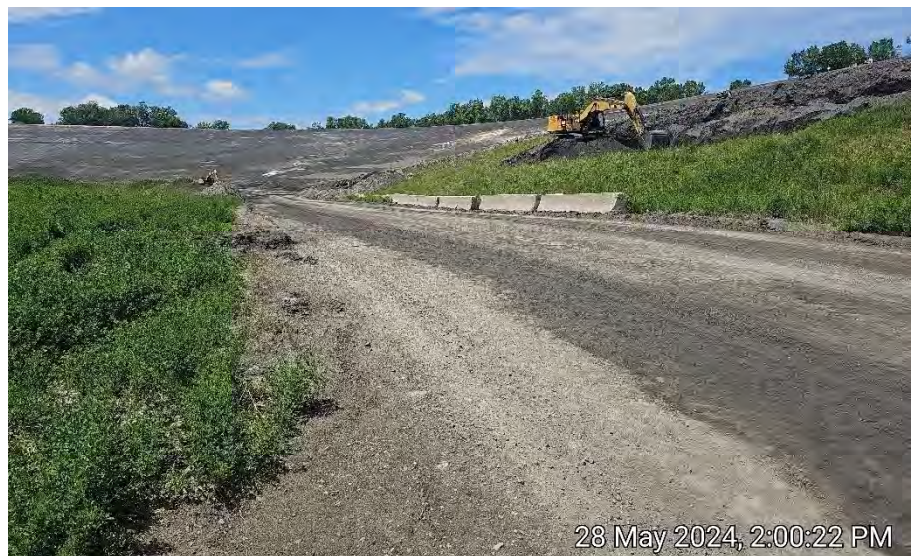
Photograph 16

Comments: Active excavation area on the northern CCR slopes. Excavated material was transported to the bottom of the Landfill. The equipment appeared to be operating safely and at speeds to minimize fugitive dust.

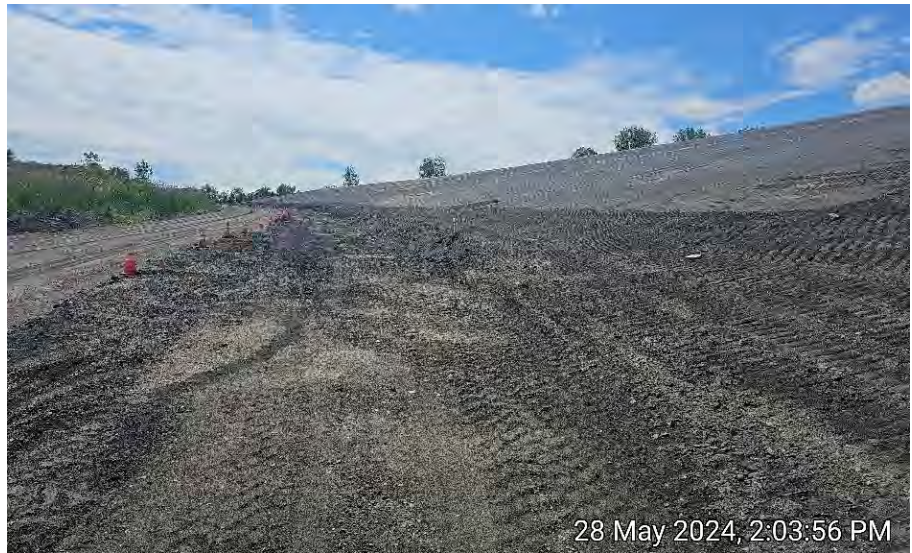
Comments: Toe of northern CCR slopes after regrading to a 4H:1V slope. Slopes appeared uniform with no signs of instability or erosion.

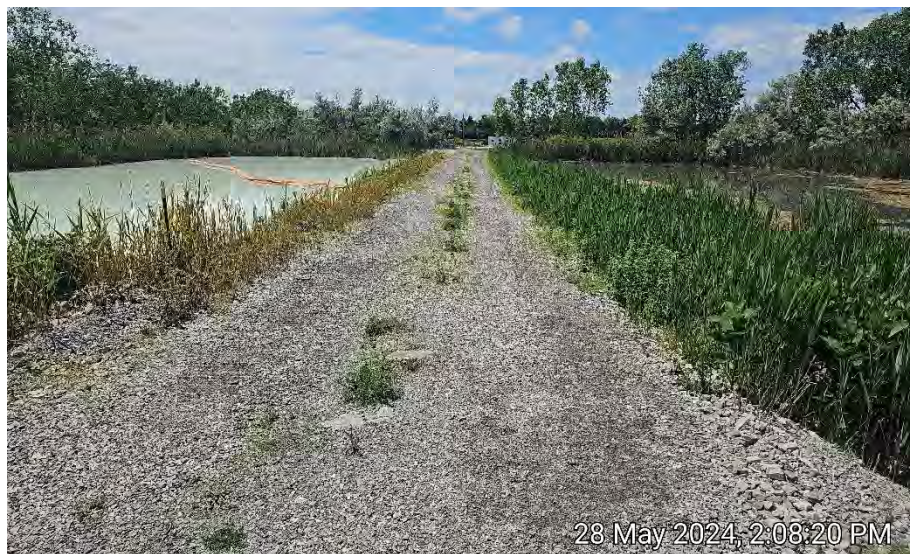
Photograph 18

Comments: Upper ponds during the inspection. North pond (right side of the photograph) is used as water supply for fugitive dust control. South pond (left side of the photograph) is used to treat water collected at the bottom of the Landfill.

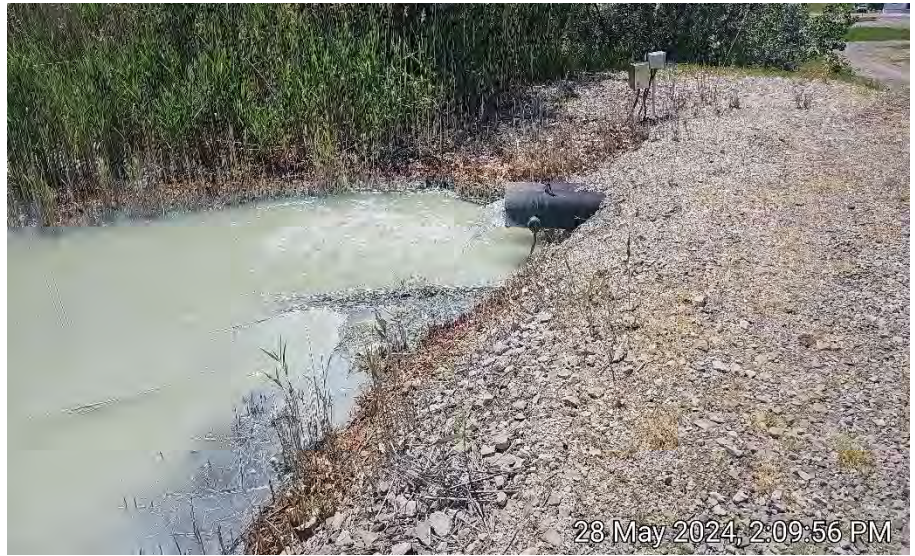
Comments: Discharge from chimney sump into the south upper pond. No erosion or instabilities along the upper ponds were observed.

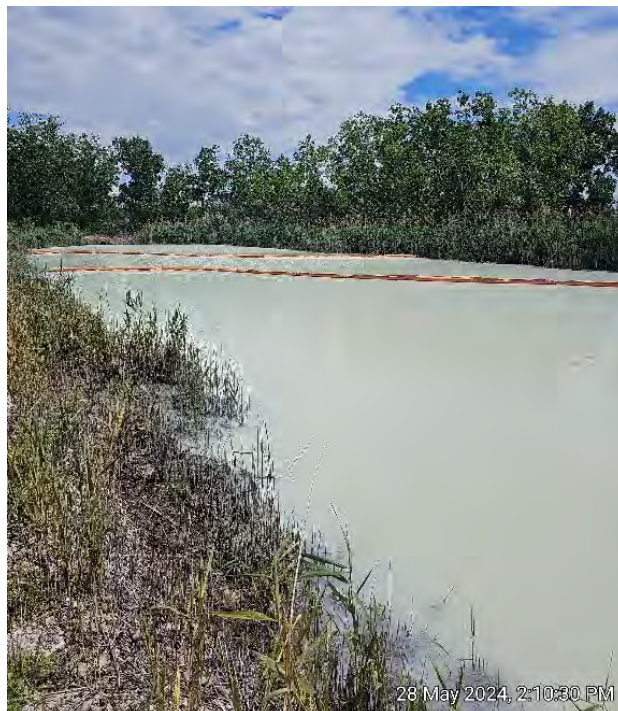
Photograph 20

Comments: South upper pond and silt curtains. No damage or obstructions were observed along the silt curtains.

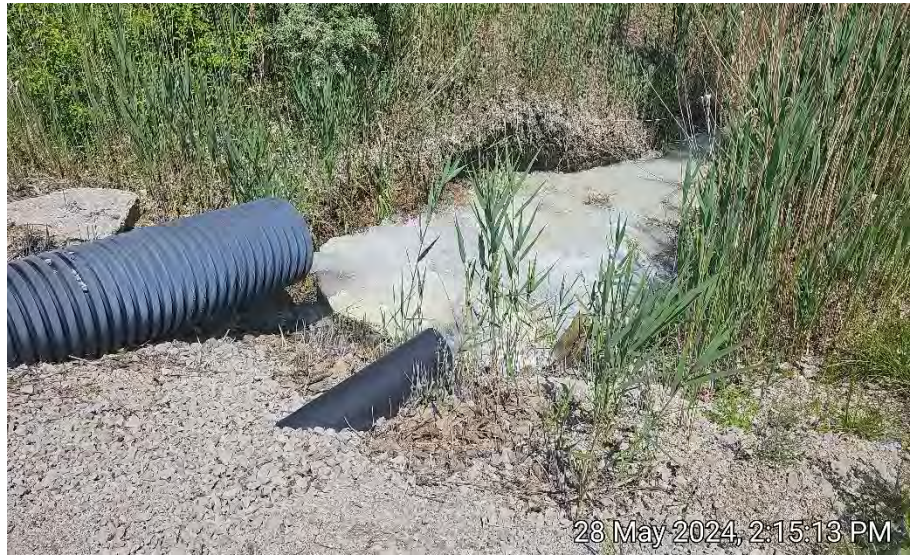
- 11) Some erosion was observed in the riprap and side slopes below the outfalls of the pipes from the upper ponds to the conveyance channel (Photograph #21) and from Settling Pond #4 to Settling Pond #3 (Photograph #25). However, no signs of slope instabilities (e.g., cracks) were observed in these locations.

- 5) Some erosion was observed in the riprap and side slopes below the outfalls of the pipes from the upper ponds to the conveyance channel and into Settling Pond #3. However, the erosion has not clearly increased since the 2023 inspection and no signs of slope instabilities (e.g., cracks) were observed along the embankments these pipes penetrate during the 2024 inspection.

Comments: Discharge from upper south pond into conveyance channel to the settling ponds. Some erosion was observed beneath the pipe and sides of the conveyance channel.

- 5) Additional riprap, gravel, and sand should be placed below the pipe outfalls from the upper ponds to the conveyance channel and from Settling Pond #4 to Settling Pond #3 to replace eroded material and maintain the stability of the embankments between these features. Because the erosion has not clearly progressed since the 2023 inspection and no signs of instabilities were observed, this recommendation should be implemented within five years.

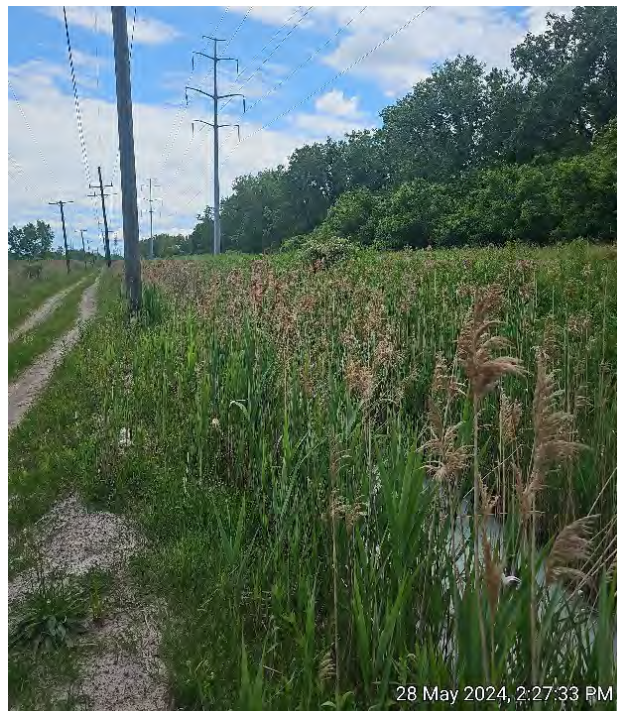
Photograph 22

- 12) Heavier vegetation was observed along the conveyance channel west of the settling ponds (Photograph #22) and within the settling ponds below the outfalls from the pipes into the ponds (Photographs #23, #25). However, no erosion was observed on the side slopes of the channel or pond and the vegetation did not appear to impact the flow of leachate.
- 13) A boundary ridge surrounds the area and prevents run-on for events up to and exceeding a 25-year, 24-hour storm in accordance with the Run-on Run-off Control Plan for the Landfill.
- 14) The ash conveyor system on the southeast edge of the quarry, constructed in 2022 (Photograph #28), has not been used between the 2023 and 2024 inspections.

- 4) Heavier vegetation was observed along the conveyance channel west of Settling Pond #4 and near the outfall from the pipes into the settling ponds. The current conditions did not appear to impact flow through the channel and settling ponds and no erosion of the side slopes were observed.

Comments: Conveyance channel west of the settling ponds. Heavy vegetation (phragmites) was observed on the sides of the channel, but did not appear to impact the conveyance of water to the settling ponds. No erosion or instabilities were observed along the side slopes of the conveyance channel.

- 4) Vegetation along the conveyance channel and within the settling ponds should be removed to maintain the hydraulic capacity of these features and prevent erosion. DTE mows vegetation around these and other features of the Landfill as part of routine maintenance. This recommendation should be implemented within two years.

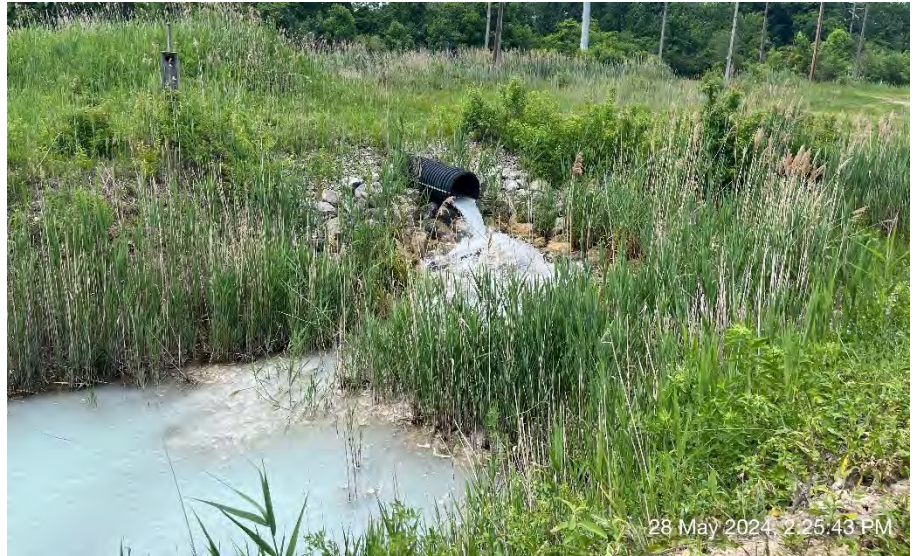
Comments: Discharge from conveyance channel into Settling Pond #4. Some vegetation was observed near the outlet but did not appear to impact the conveyance of water into the settling ponds. No erosion of the riprap below the outlet was observed.

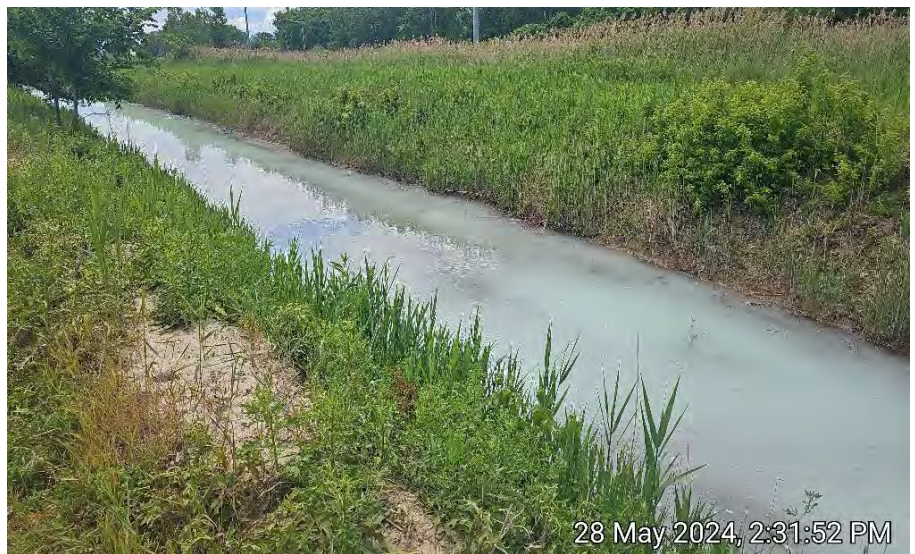
Photograph 24

Comments: Settling Pond #4. Side slopes of the pond appeared to be in good condition (i.e., no erosion, no instabilities, minimal vegetation).

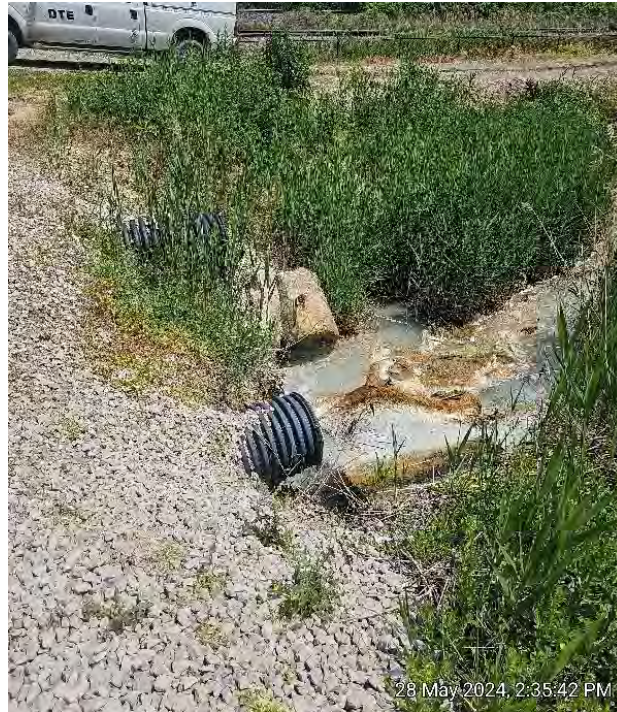
Comments: Culvert pipes between Settling Pond #4 and Settling Pond #3. No obstructions were observed in the culvert pipes. Some erosion and vegetation were observed beneath the outlets of the pipes. The vegetation did not appear to impact the conveyance of water. The area appears to have been filled in somewhat since the last annual inspection.

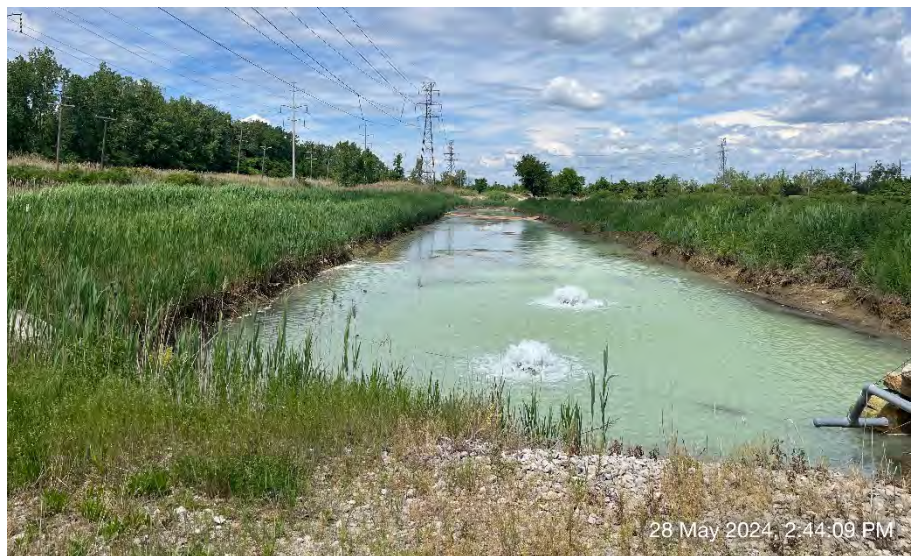
Photograph 26

Comments: Aerators in Settling Pond #3. Side slopes of the pond were observed to be in good condition (i.e., no erosion, no instabilities).

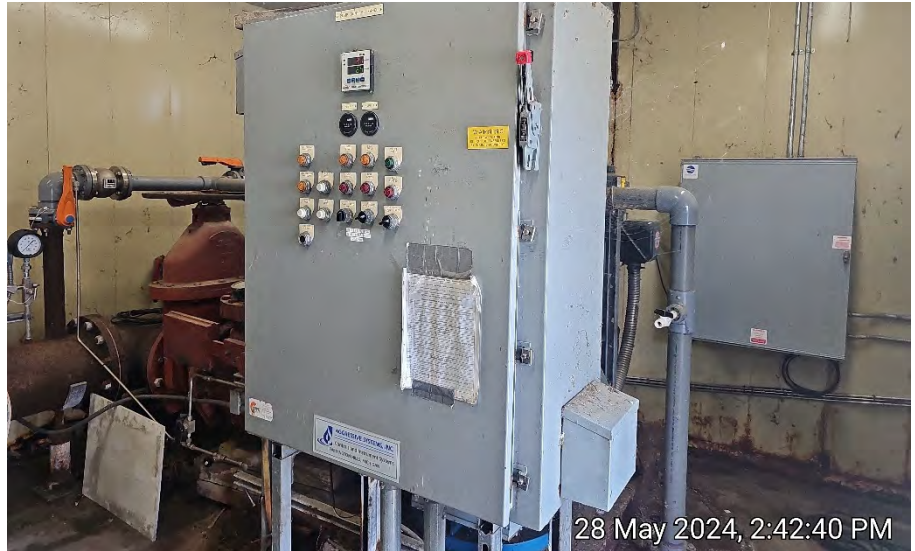
Comments: The instrument panel and pumps for the pump house at the south end of Settling Pond #4 were in good condition.

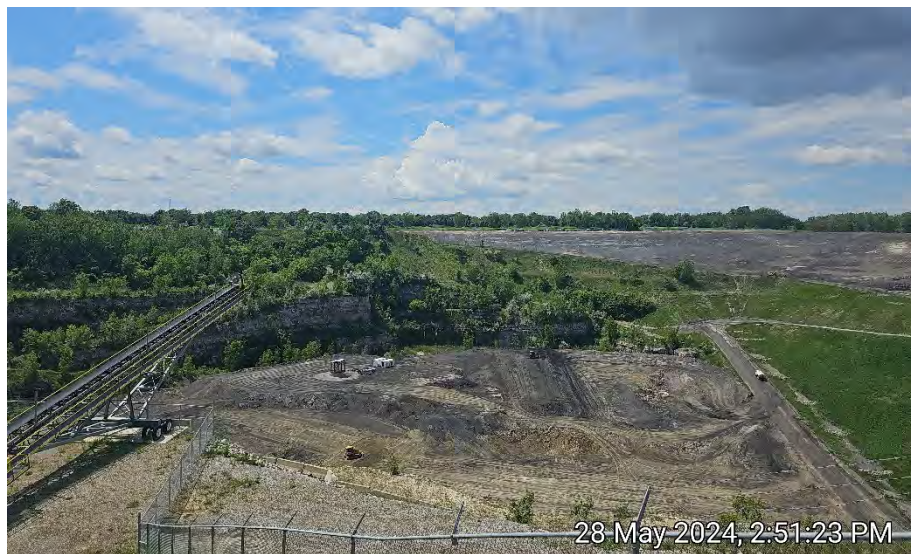
Photograph 28

Comments: Ash conveyor system at top of Landfill on the southeast side. The ash conveyor has not been used since the previous annual inspection.
