# **BOTTOM ASH IMPOUNDMENT ANNUAL INSPECTION REPORT**

**MONROE POWER PLANT  
3500 E FRONT STREET, MONROE, MICHIGAN 48161**

**DTE ELECTRIC COMPANY**

**CEC PROJECT 363-863**

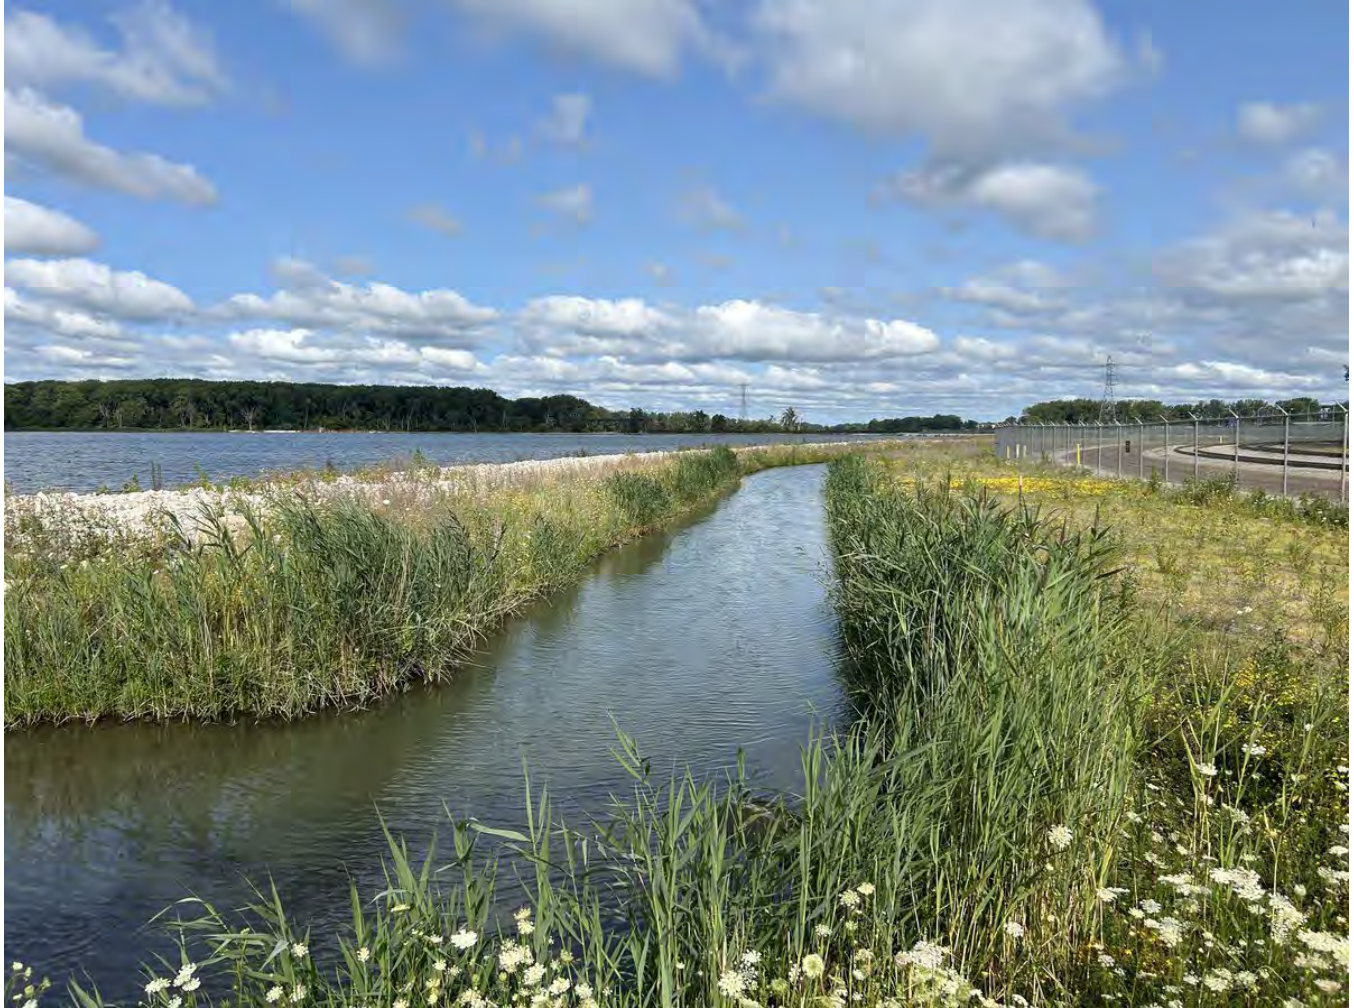
1

Looking west at process waste ditch with northern portion of BAI in background.

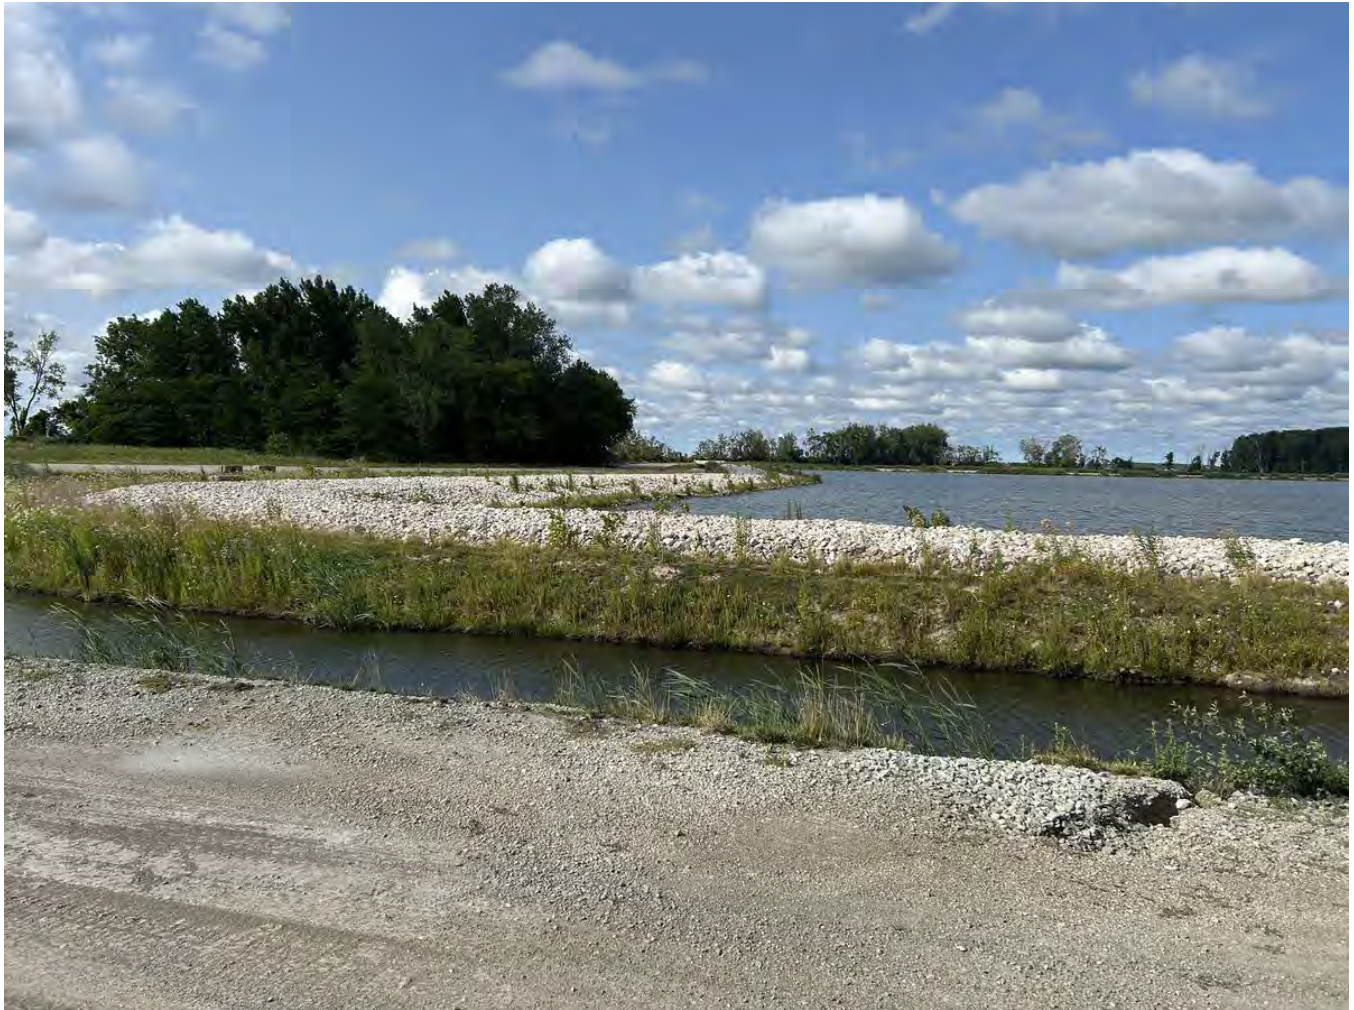
2

Looking south from west side of BAI at riprap lined berm separating process waste ditch (foreground) from BAI to right.

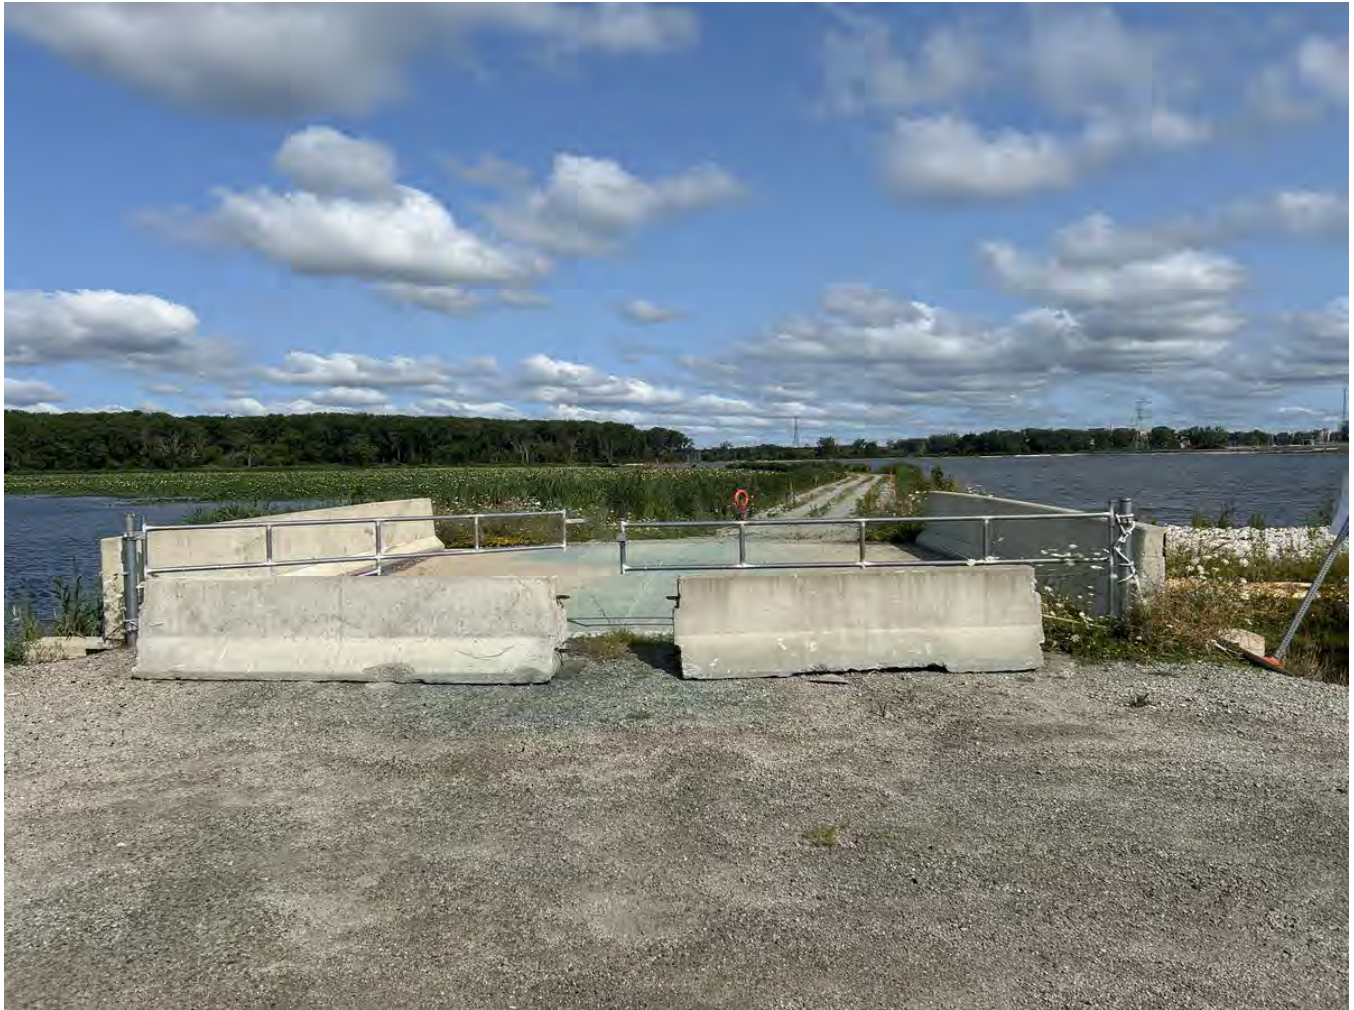
3

Looking west at separation berm from east end. Berm closed to vehicle traffic.

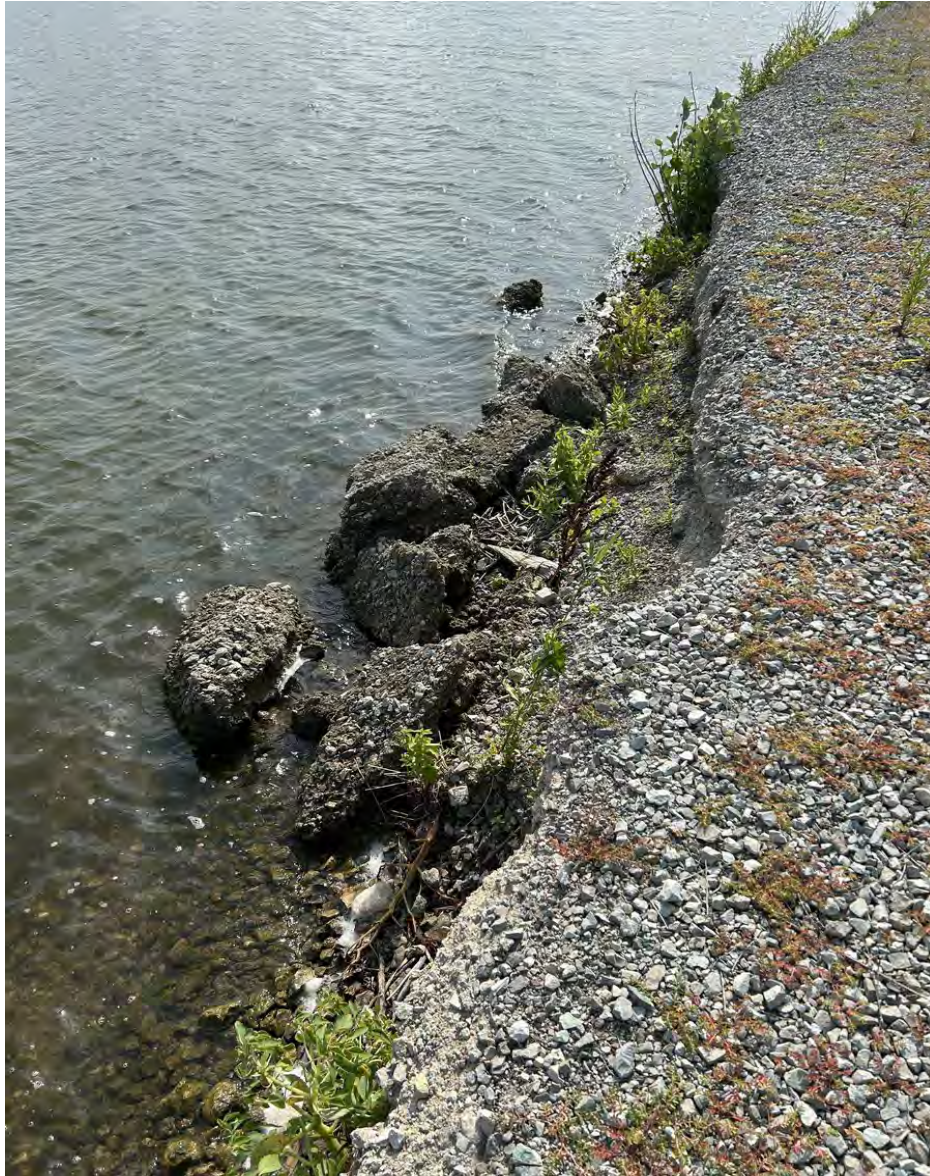
- A small leak in the otherwise inactive weir is noted, however not a major concern as the weir is a permitted outfall and flow quantity/quality is within compliance limits.
- Some minor/shallow sloughing/erosion is present along the north side of the separation berm, however this also is not a concern as there is little to no water level differential across the berm, no traffic is permitted on the berm, and the south pond is also DTE property.
- Lengthy vegetation and mature trees were noted along the slopes.

| Inspection Item | Yes | No | N/A or Comments |
|---|---|---|---|
| Slides, sloughs, scarps, bulges, or boils | <input checked="" type="checkbox"/> Yes | <input type="checkbox"/> No | <input type="checkbox"/> N/A / Comments: Minor/shallow sloughing on separation berm |

Typical minor/shallow erosion/sloughing on north face of separation berm.

- Repairing the northern face of the southern separation berm, however this is not an urgent need. The observed minor/shallow sloughing is not an immediate structural threat and there is little to no water level differential across the berm. Water depth adjacent to the berm is also shallow (2 to 4 feet). DTE should continue to monitor and prohibit vehicle traffic on the separation berm unless and until the berm is repaired.
- Regular maintenance of the vegetation on the inner and outer slopes of the impoundment.
- Continue to regularly monitor the weir for signs of structural weakness, in particular the area of the leak.

| <b>Recommended / Required Corrective Actions (and target completion date):</b><br>Regular maintenance of vegetation recommended. Separation berm slope should be repaired if vehicular traffic is planned to occur, otherwise not urgent. |

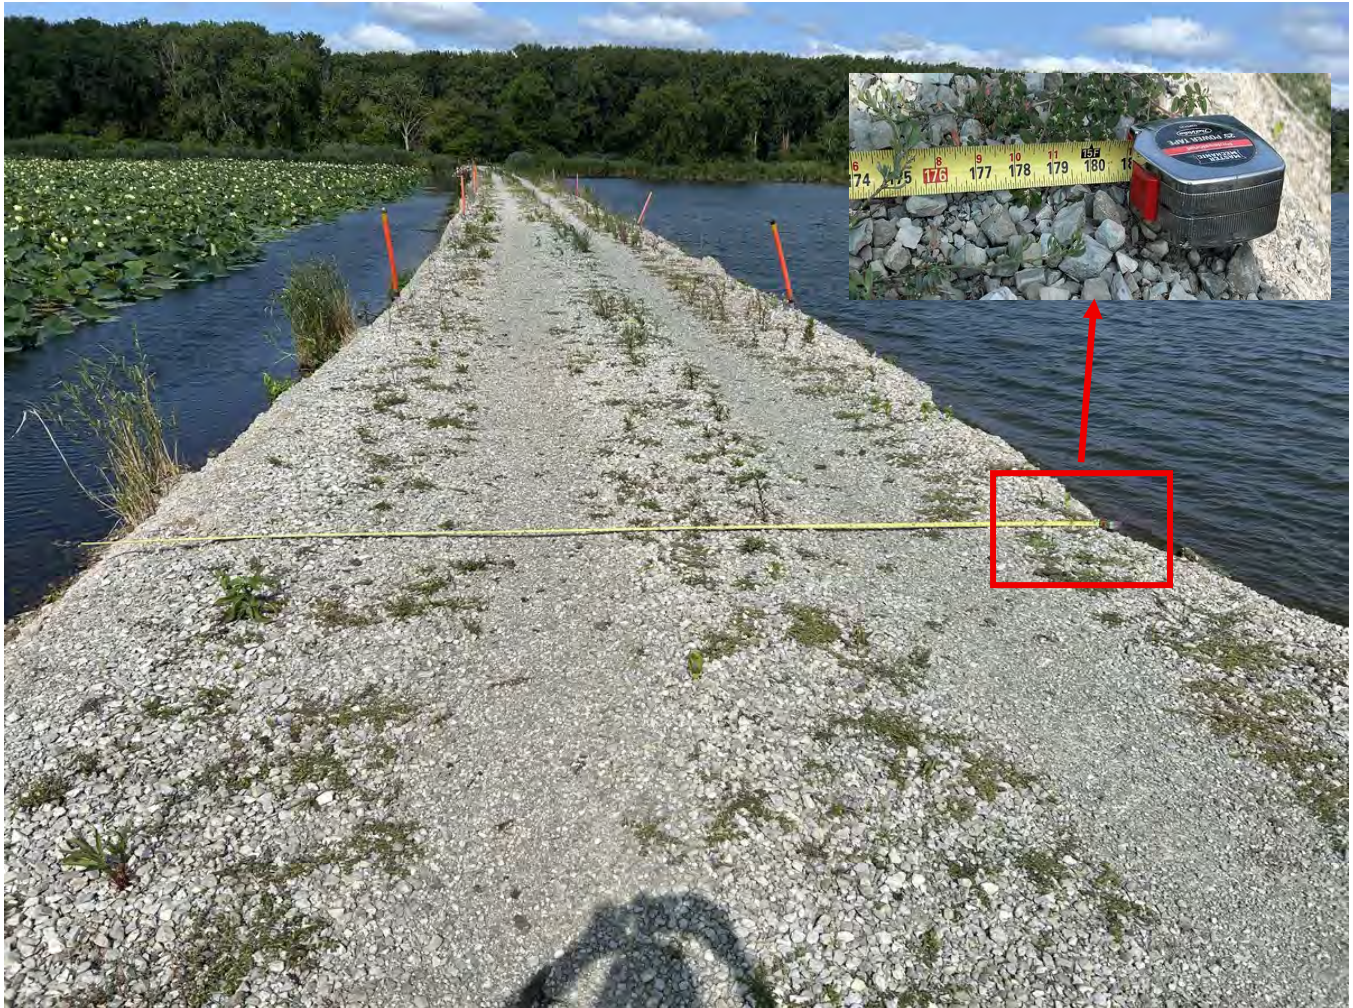
5

Typical narrowest crest width of separation berm.

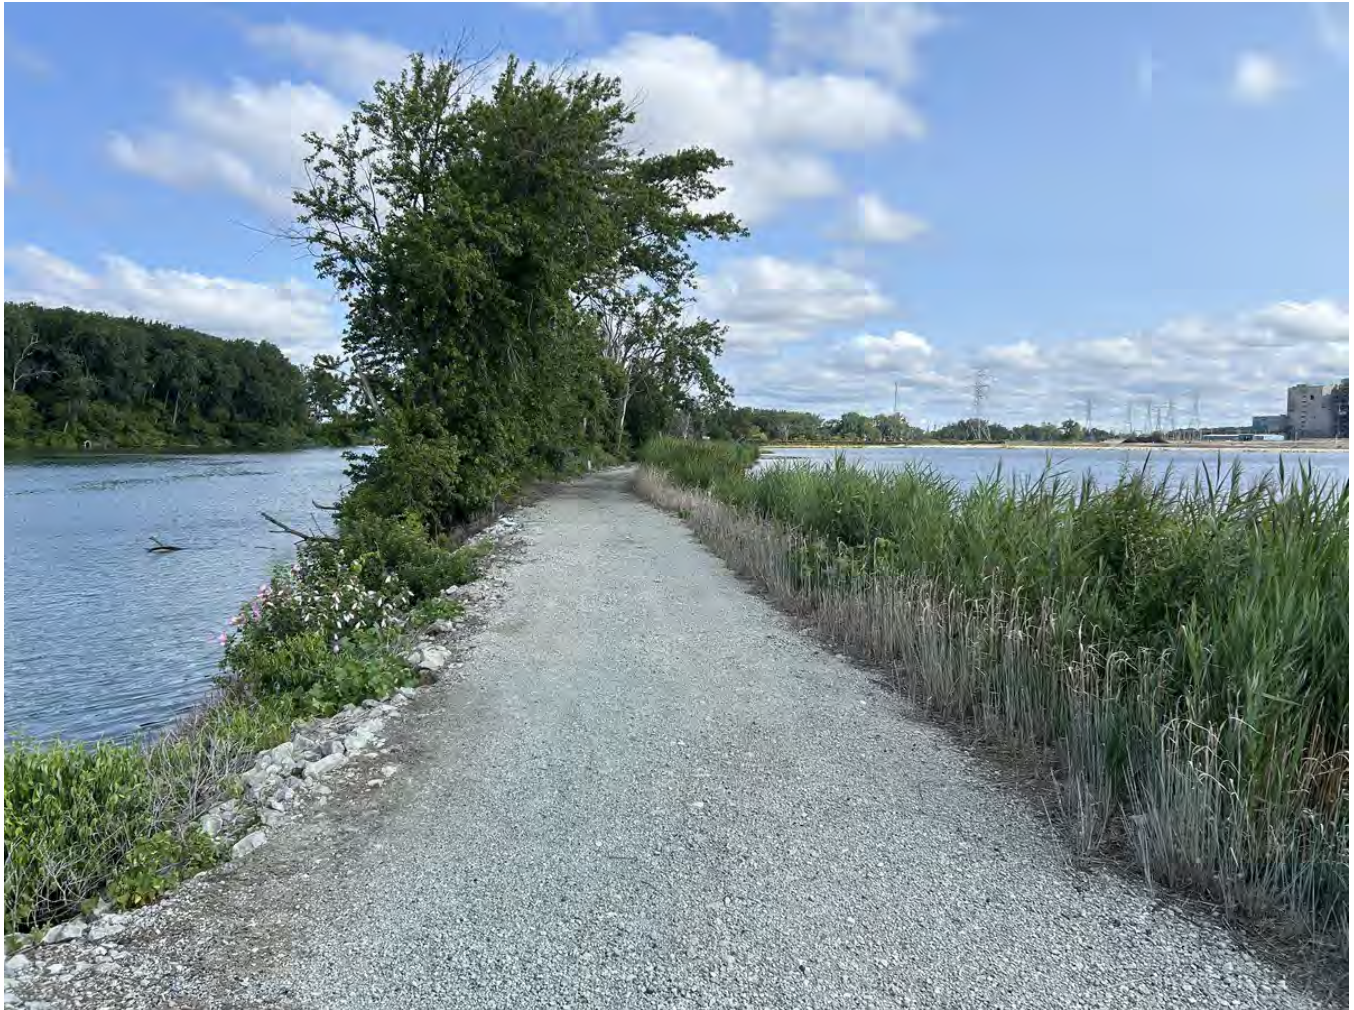
6

| Inspection Item | Yes | No | N/A or Comments |
|---|---|---|---|
| Animal burrows or excessive vegetation/trees | <input checked="" type="checkbox"/> Yes | <input type="checkbox"/> No | <input type="checkbox"/> N/A / Comments: Trees on western slope |

Looking north at west perimeter berm from southwest corner. Outfall canal to left, BAI to right. Mature woody vegetation on outboard slope. Lengthy vegetation on both outboard and inboard slopes.

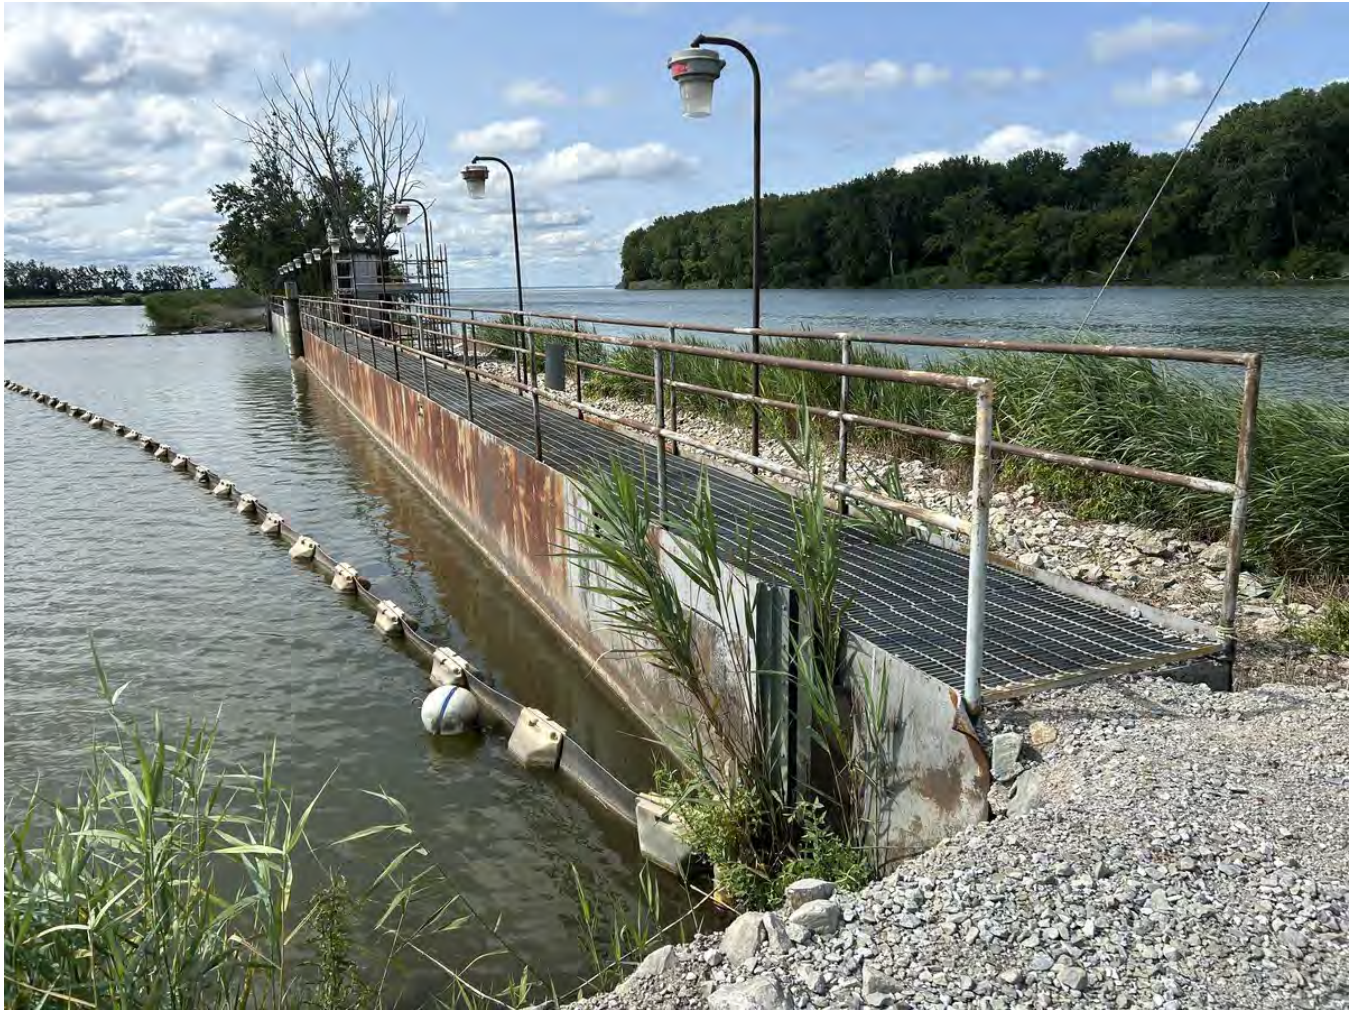
7

View of weir inboard side from north. Turbidity curtain, steel skimmer, and grated walkway with handrails all in fair condition.

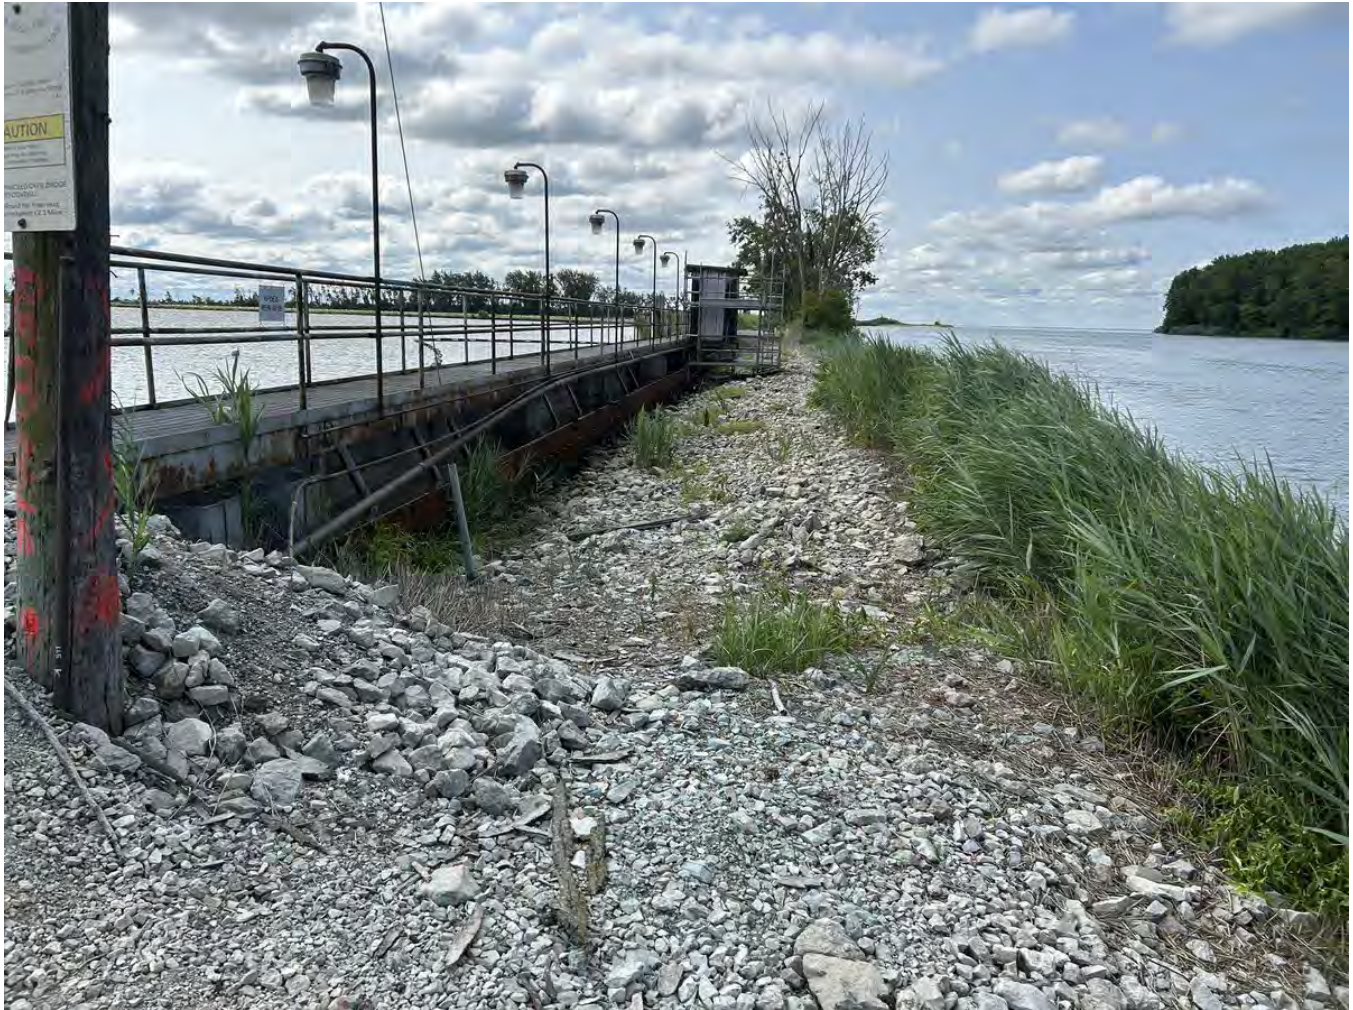
8

View of weir outboard side from north. Discharge channel armored with riprap and vegetation.

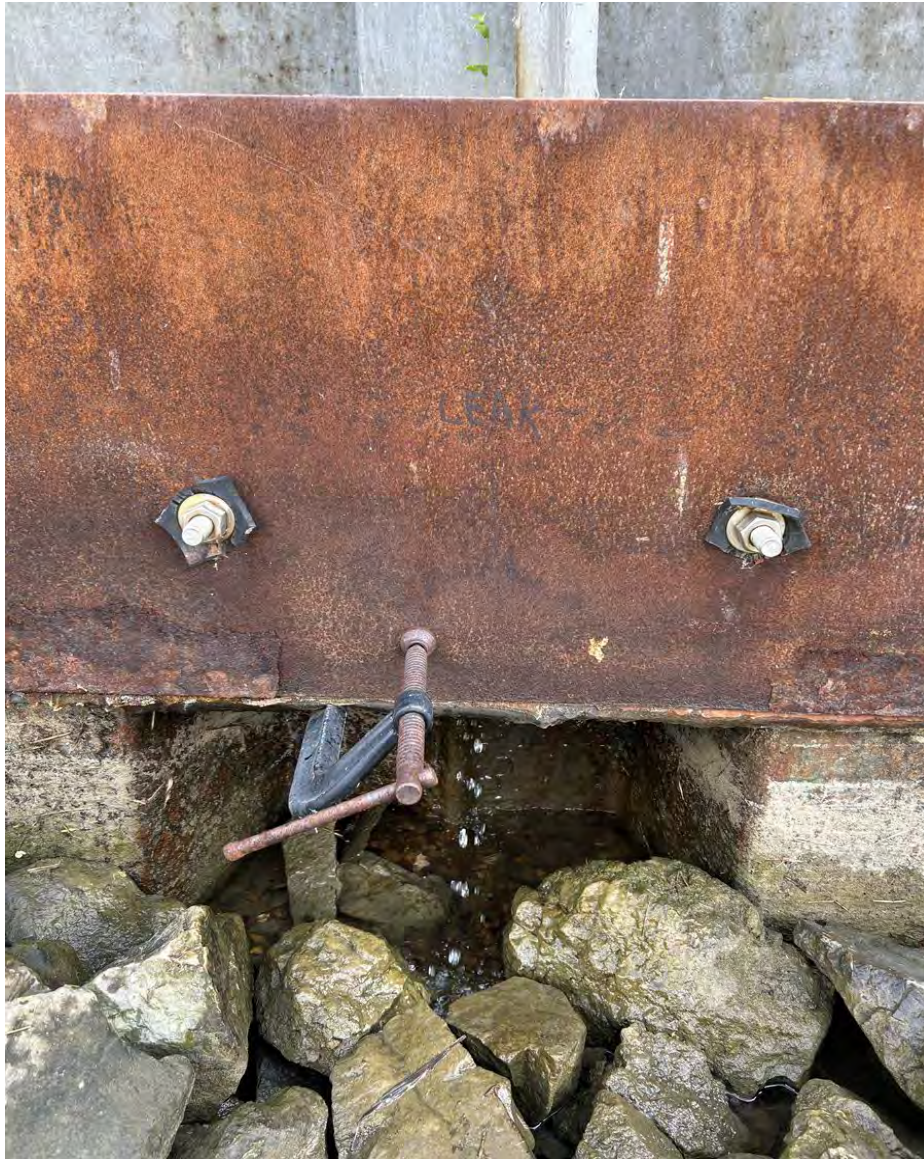
9

| Structure / Outlet ID | Condition Observed | Flow / Discoloration / Debris? | Comments / Actions |
|---|---|---|---|
| Weir (MP 001B) | Fair condition with some corrosion | No flow other than minor leak in one isolated location along ~200' long weir | DTE already taking action to address leak, however is not a major structural/safety concern |

Minor leak in weir.

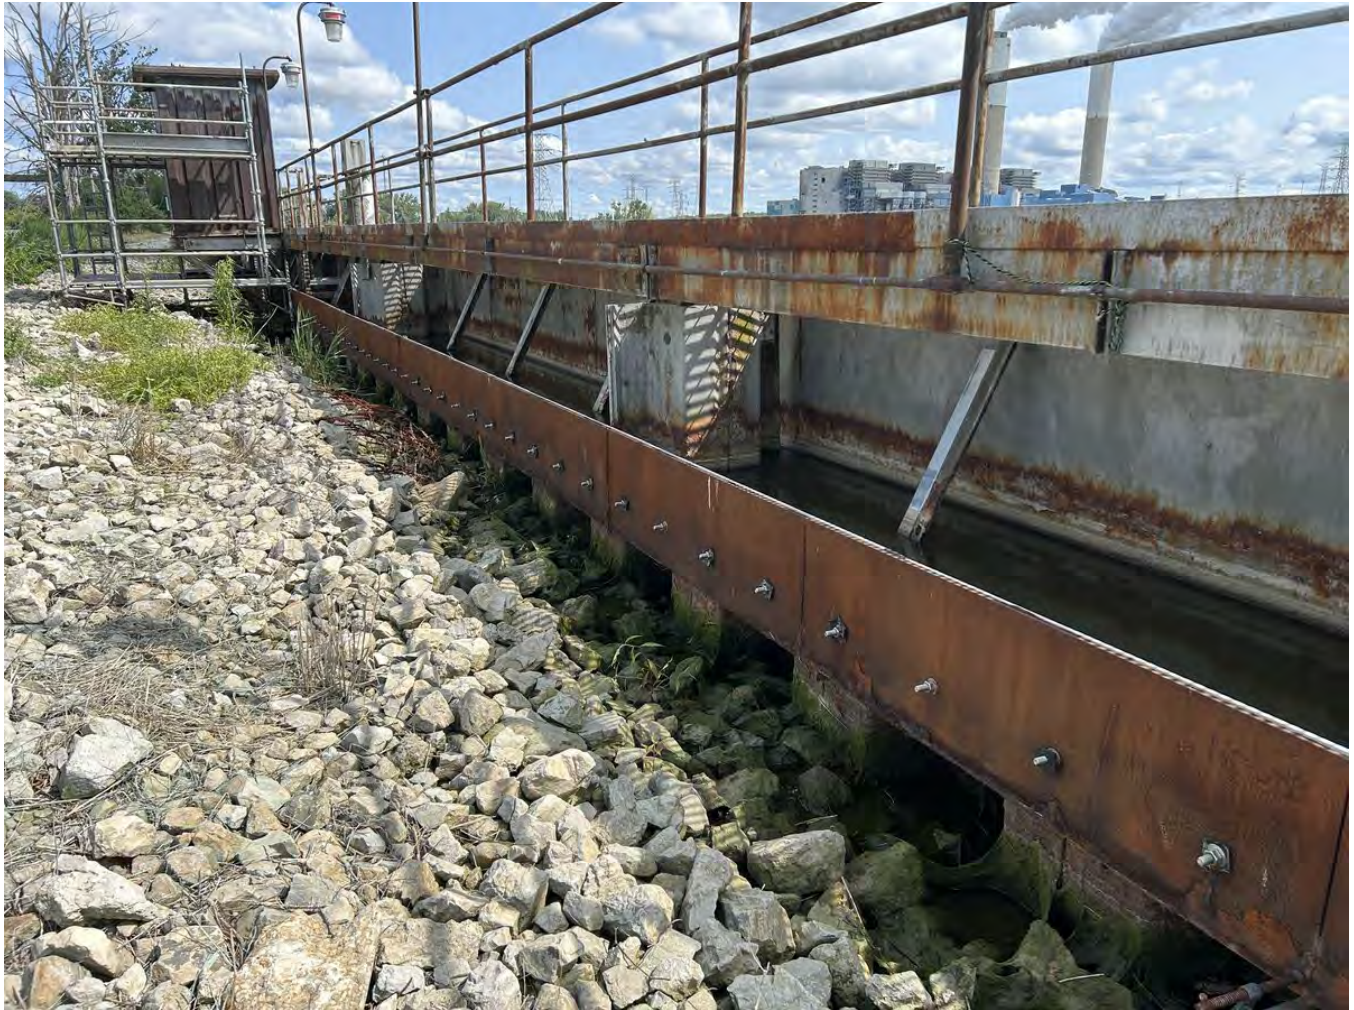
10

Typical view of outboard side of weir—no flow visible. Some corrosion present.

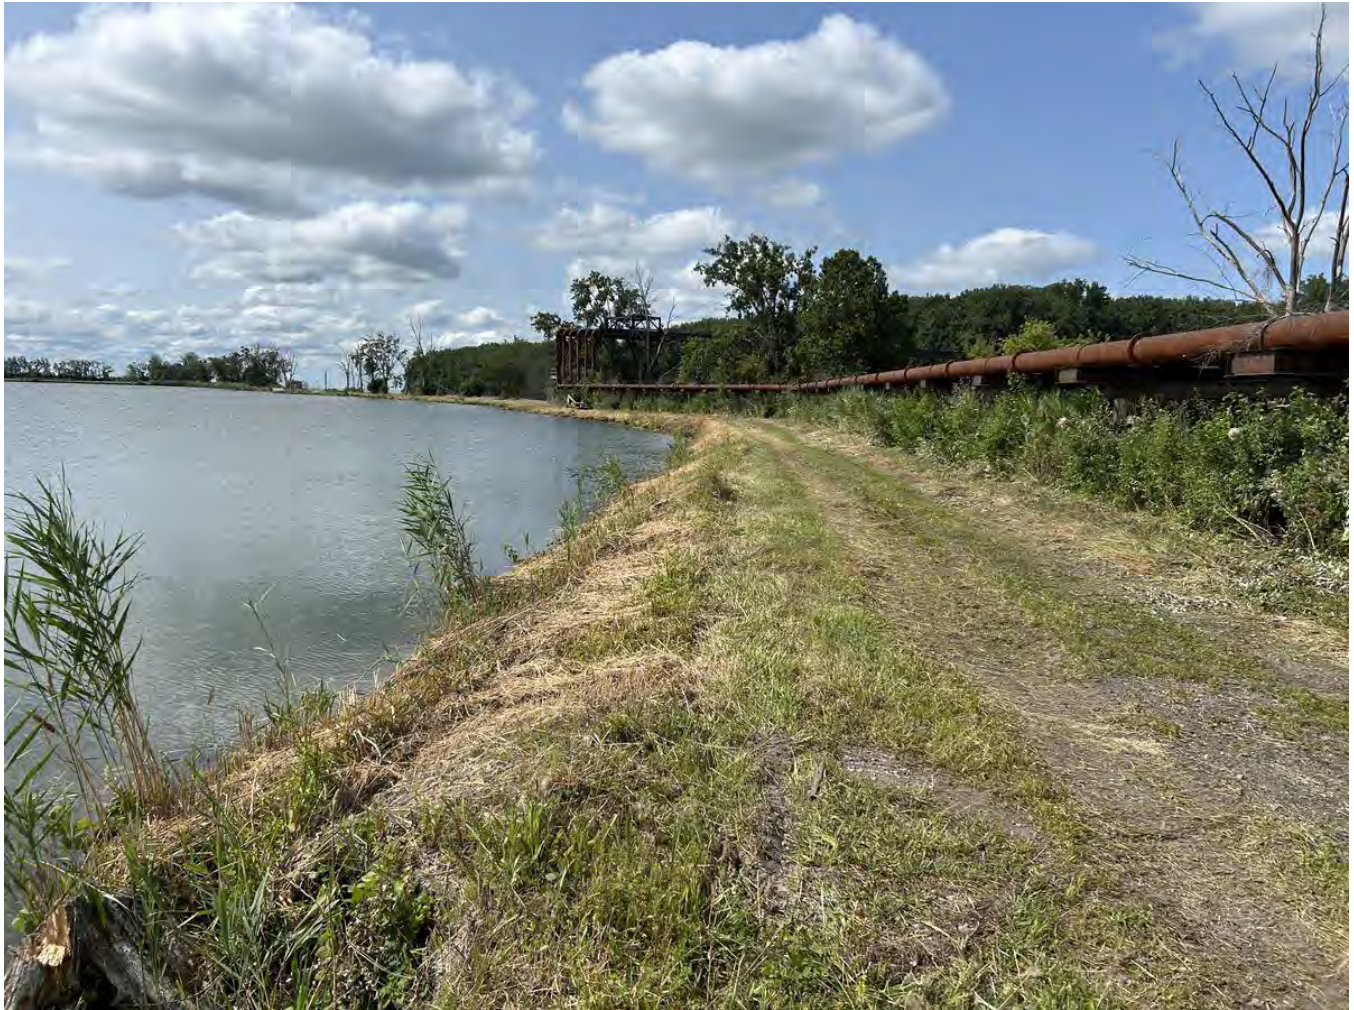
11

Looking south along inboard slope of perimeter berm from northwest corner of BAI. Vegetation recently mowed.

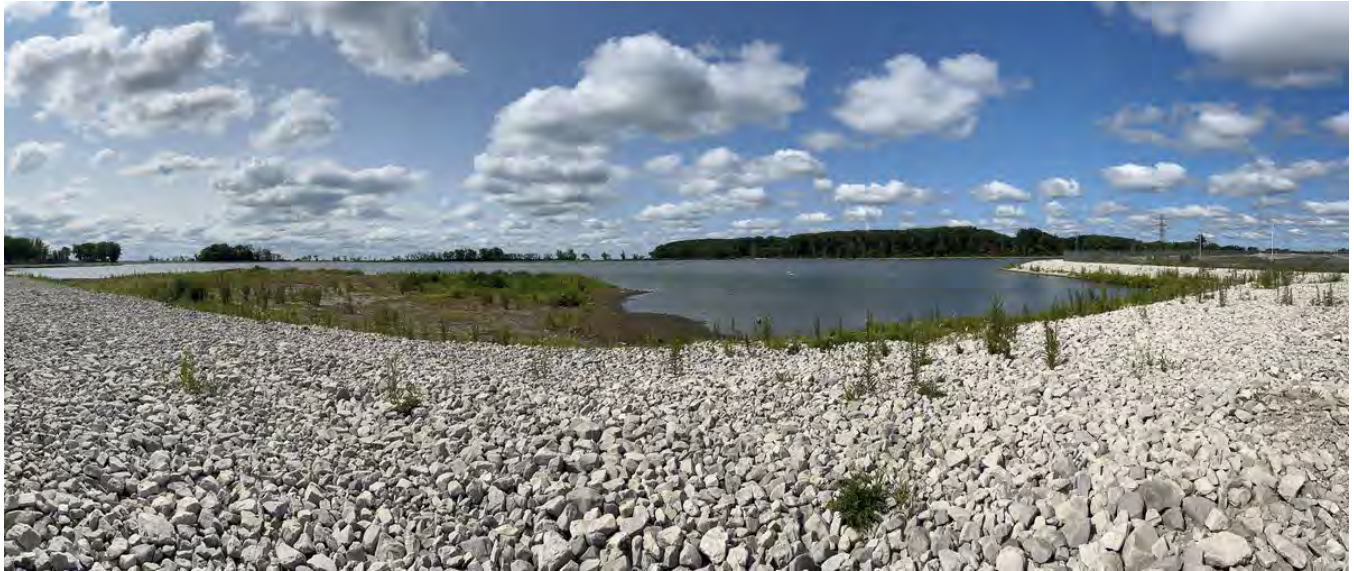
**Description:** Panoramic of north end of BAI, looking south.
