# **2025 ANNUAL INSPECTION REPORT**

## **VERTICAL EXTENSION LANDFILL**

**MONROE POWER PLANT**

January 2026

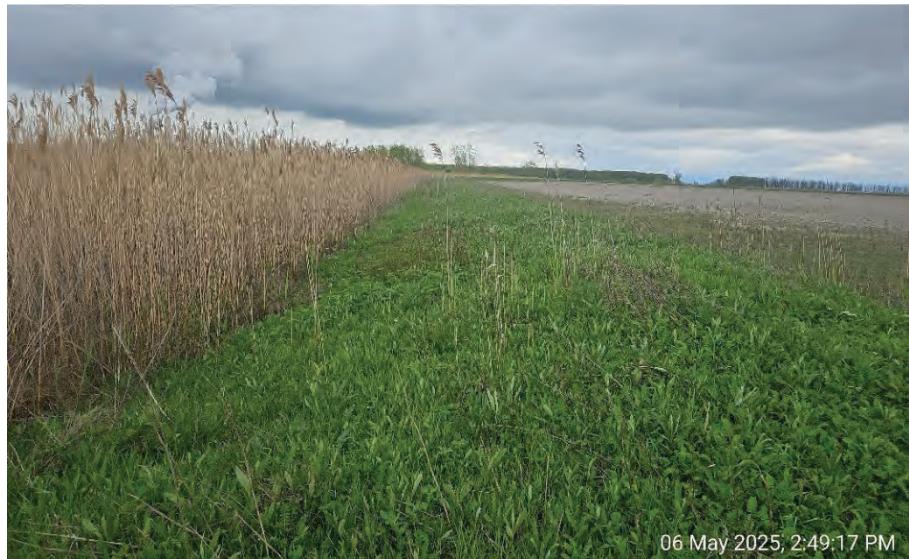
2. Dense vegetation was observed within the perimeter swales along the north (Photographs #1, #4, #7, #27, #28), east (Photograph #8), south (Photographs #9, #18, #19, #25), and west (Photograph #23) sides of the Landfill. The dense vegetation did not appear to affect the flow of stormwater.

3. The perimeter berms along the north (Photographs #1, #4, #27), east (Photograph #8), south (Photographs #9, #19, #25) and west (Photograph #23) sides of the Landfill had some vegetation but were overall in satisfactory condition. No apparent signs of slope instability or erosion along the perimeter berms were observed.

**Comments:** Some vegetation but no apparent signs of slope instability or erosion were observed on the perimeter berm along the north side of the Landfill. Dense vegetation was observed within the perimeter swale (R1) on the north side of the Landfill, but it did not appear to affect the flow of stormwater.

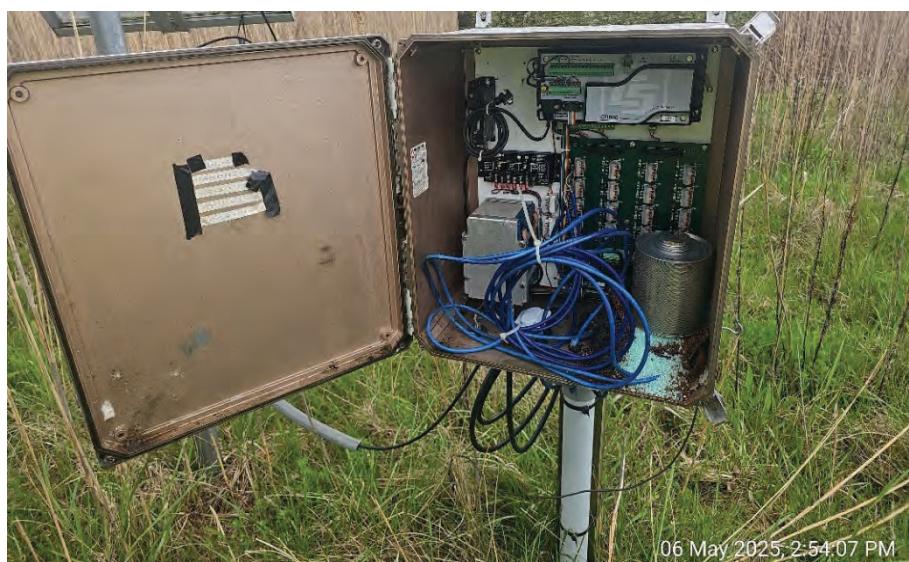
**Photograph 2**

8. The enclosures for the dataloggers (DL) showed signs of previous moisture intrusion and ants. The current conditions of the enclosures, desiccant canisters, and wiring were satisfactory (Photograph #2). The outside of the enclosures, solar panels, battery boxes, and antennae were in satisfactory condition (Photograph #15). Some vegetation was present around the DL locations, but it did not appear to obstruct the solar panels.

**Comments:** The instrument enclosures for the dataloggers (DL) showed signs of previous moisture intrusion and ants. Previous desiccant canisters had corroded within the enclosures and were removed. Current conditions of the enclosures, new desiccant canisters, and wiring were satisfactory. (DL-3 shown)

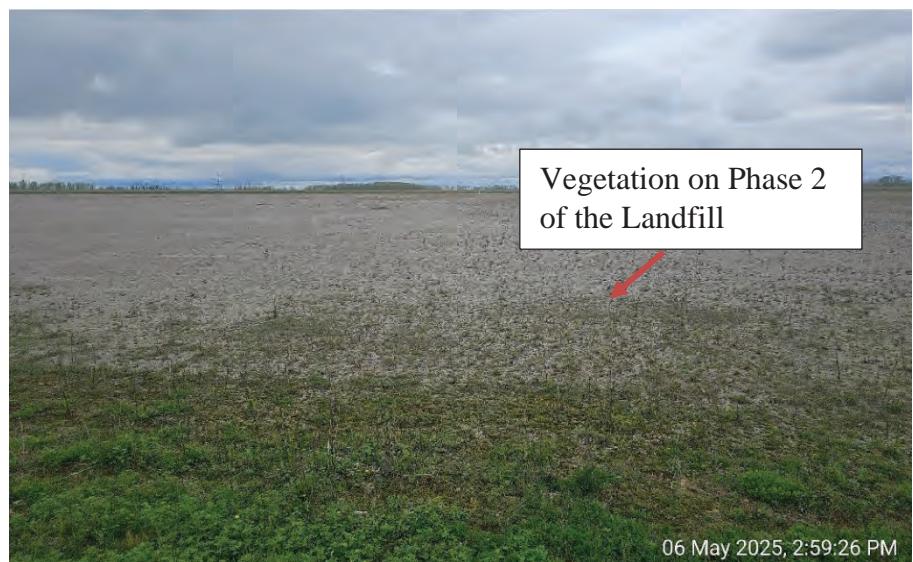
7. The pore pressure relief layer constructed for Phase 2 of the Landfill was in good condition with minimal vegetation (Photographs #3, #14).

**Comments:** The pore pressure relief layer constructed for Phase 2 of the Landfill was in good condition with minimal vegetation.

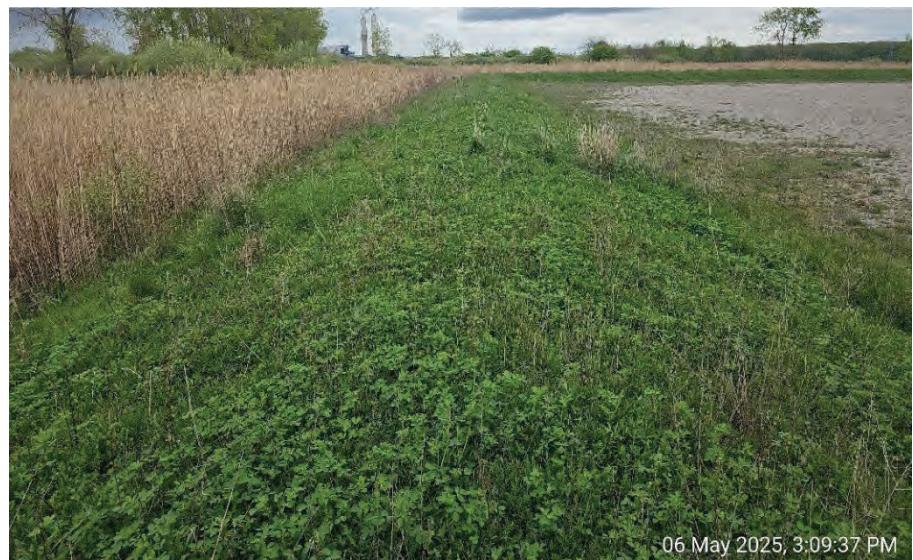
**Photograph 4**

**Comments:** Some vegetation but no apparent signs of slope instability or erosion were observed on the perimeter berm along the northeast side of the Landfill. Dense vegetation was observed within the perimeter swale (R2) on the northeast side of the Landfill, but it did not appear to obstruct the flow of stormwater.

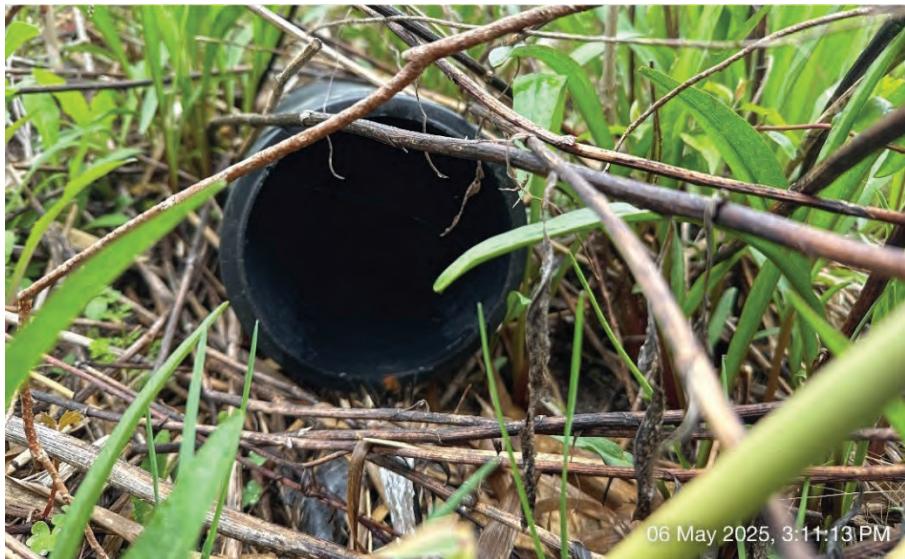
- Some flow was observed from pipes on the northeast and southeast sides of the Landfill below Phase 2 (Photographs #5, #12, #13, #16) likely due to precipitation prior to and during the inspection.

**Comments:** Some flow was observed from one of the pressure relief pipes on the northeast side of the Landfill during the inspection. The flow was directed into perimeter swale R2 and the outlet had no obstructions, sediments, or vegetation.

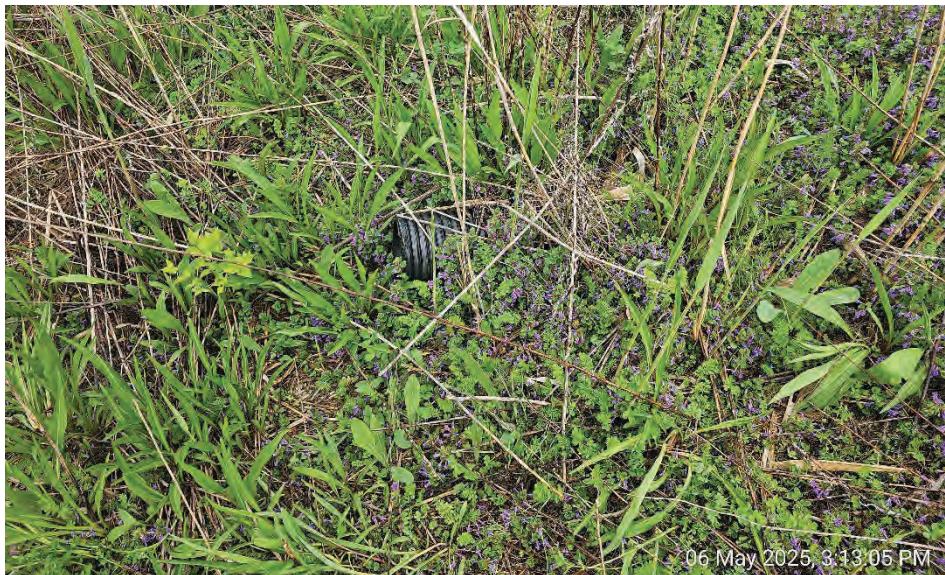
**Photograph 6**

**Comments:** The dense vegetation within the perimeter swales obscured the outlets of the pressure relief pipes on all sides of the Landfill. However, the vegetation did not appear to impede the conveyance of any water into the perimeter swales. (typical)

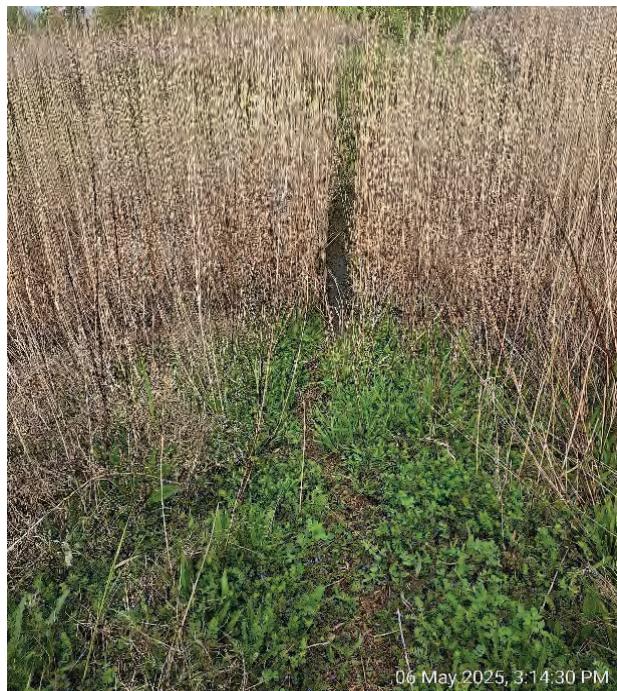
4. Water was observed in the perimeter swales around the Landfill (R1 through R4), but minimal flow was observed during the inspection (R1 in Photograph #28, R2 in Photograph #7, R3 and R4 in Photograph #18). The water level in the north, east, southeast, southwest, and west perimeter swales (R1, R2, and R3) was lower than the pore pressure relief pipe outlets and top of the culverts. In the south perimeter swale, R4, the water level partially submerged some of the pore pressure relief pipe outlets (Photograph #17).

**Comments:** Dense vegetation was observed within the perimeter swales (R2) on the northeast and east sides of the Landfill. Water was observed within the swales, but minimal flow was observed during the inspection.

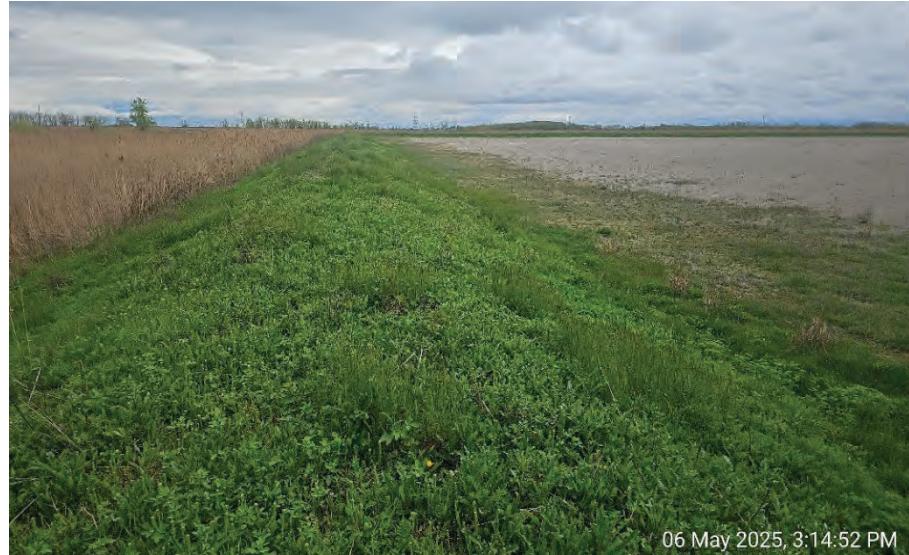
**Photograph 8**

**Comments:** Some vegetation but no apparent signs of slope instability or erosion were observed on the perimeter berm along the east side of the Landfill. Dense vegetation was observed within the perimeter swale (R2) on the east side of the Landfill, but it did not appear to obstruct the flow of stormwater.

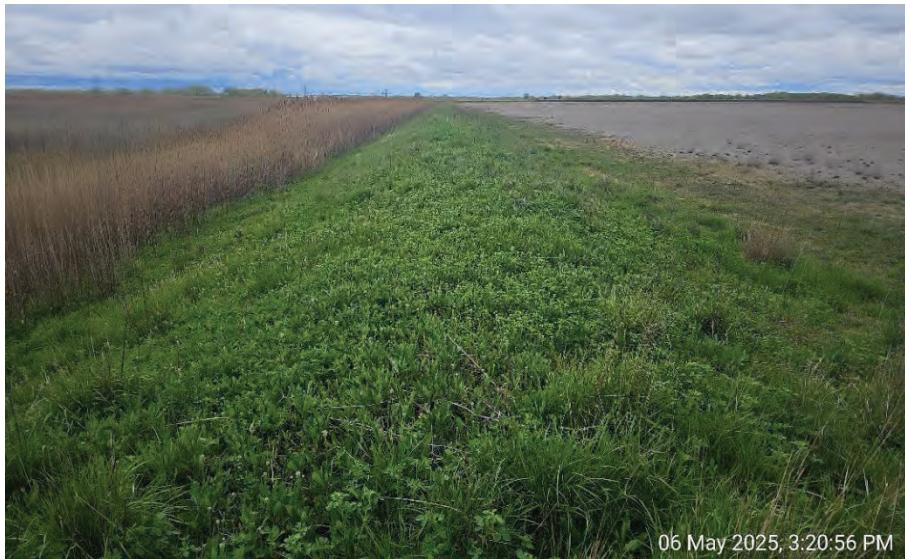
**Comments:** Some vegetation but no apparent signs of slope instability or erosion were observed on the perimeter berm along the southeast side of the Landfill. Dense vegetation was observed within the perimeter swale (R4) on the southeast side of the Landfill, but it did not appear to obstruct the flow of stormwater.

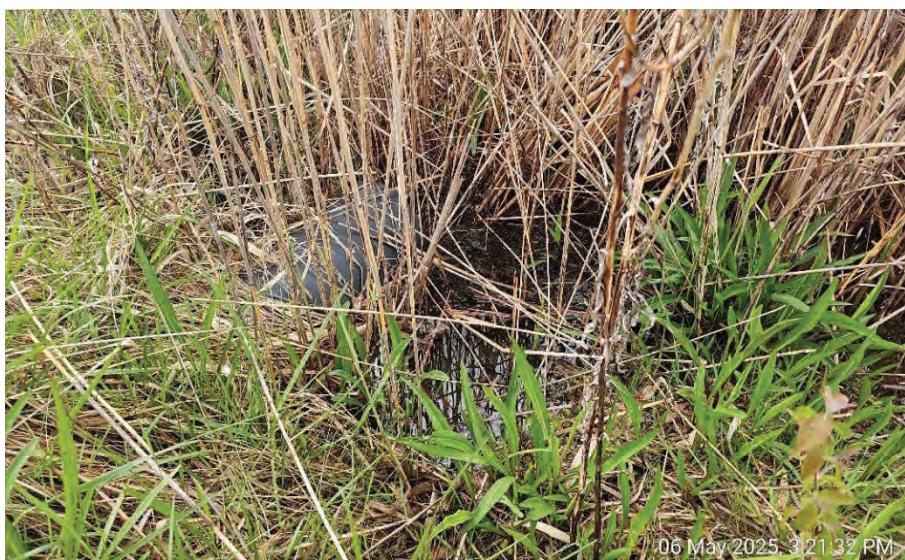
**Photograph 10**

**Comments:** The culvert inlet at the southeast corner of the Landfill was in good condition. Dense vegetation was observed within the perimeter swales adjacent to the culvert; however, the vegetation did not appear to impact the ability of the culvert to convey water. Flow was observed during the inspection.

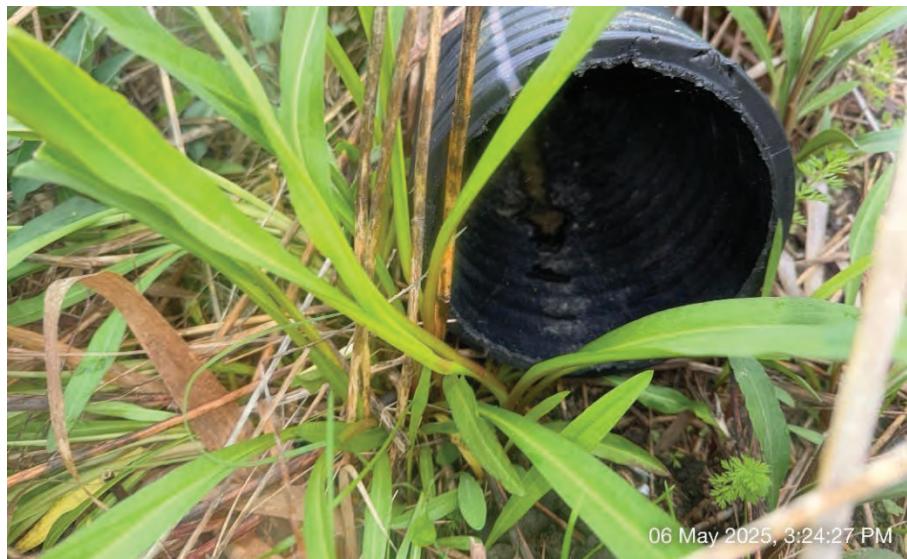
**Comments:** The pressure relief pipes that were observed during the inspection had no obstructions and generally no sediments or vegetation (pipe on the southeast side of the Landfill shown) (typical).

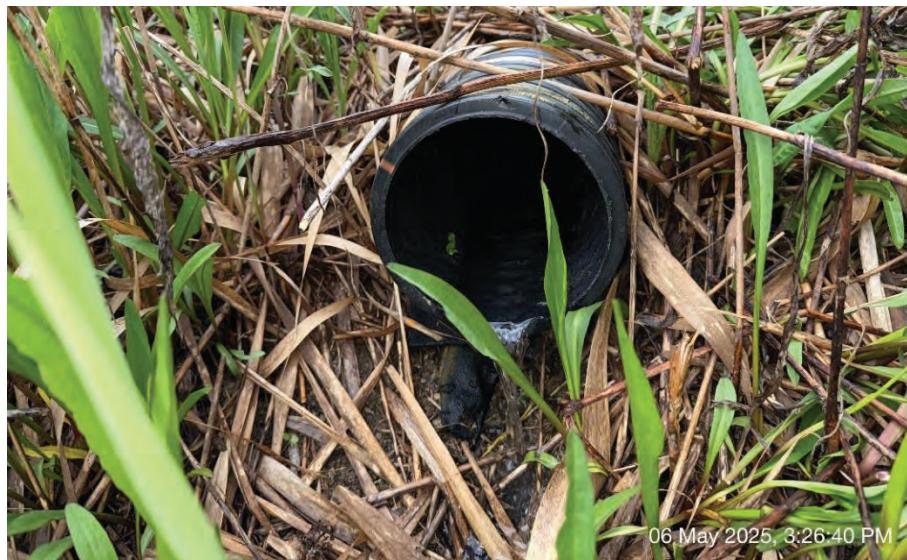
#### Photograph 12

**Comments:** Some flow was observed from one of the pressure relief pipes on the southeast side of the Landfill during the inspection. This flow was directed into perimeter swale R4 and the outlet had no obstructions, sediments, or vegetation.

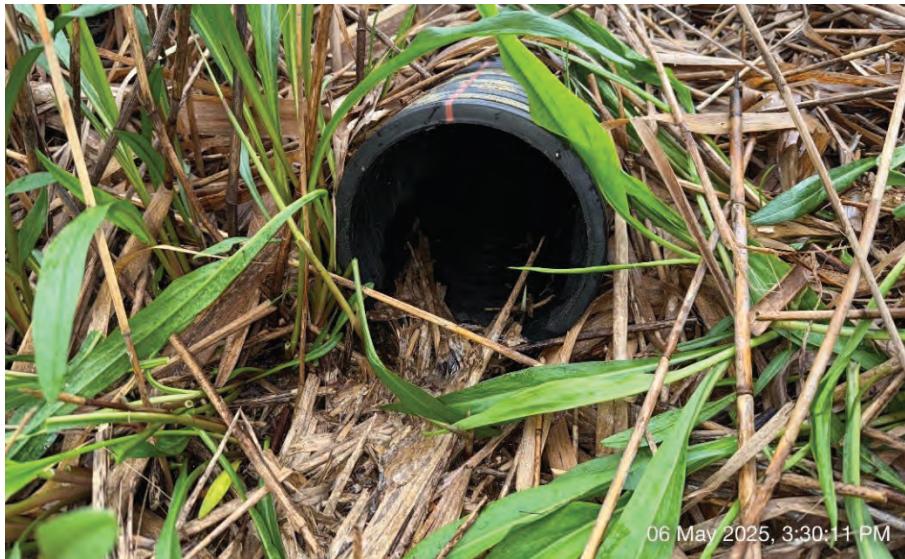
**Comments:** Minimal flow was observed from one of the pressure relief pipes on the southeast side of the Landfill during the inspection. Some vegetation was observed at the outlet of the pipe, but it did not appear to obstruct the flow into perimeter swale R4.

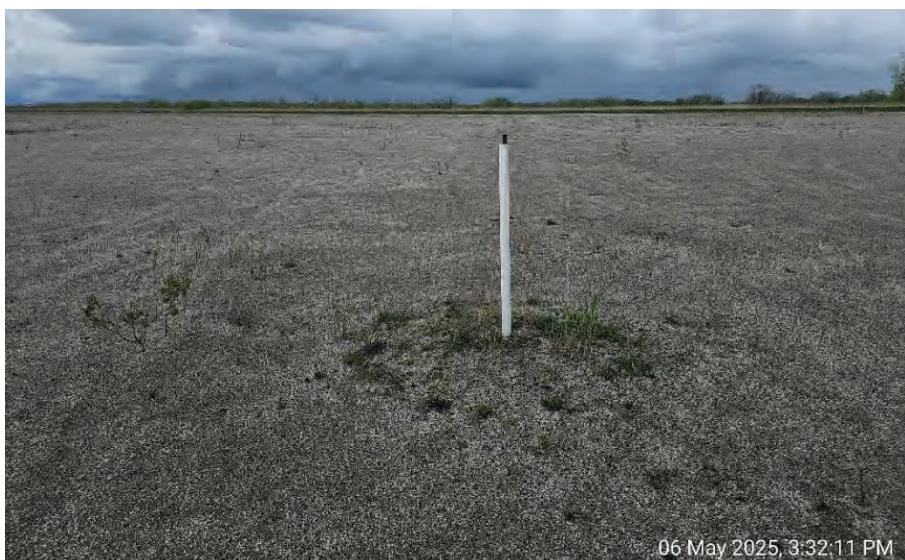
**Photograph 14**

**Comments:** Many of the settlement plates installed in Phase 2 of the Landfill appeared to be in good condition. The pore pressure relief layer constructed for Phase 2 of the Landfill was in good condition.

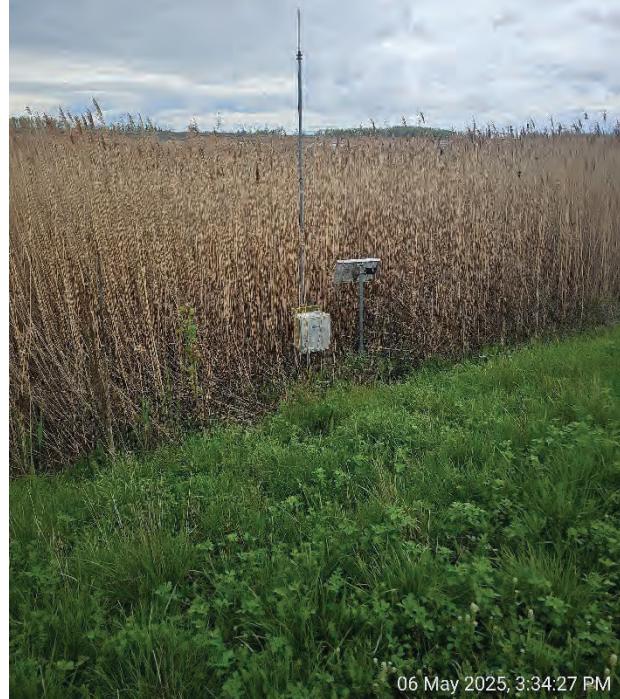
**Comments:** The DL locations had some vegetation around them, but it did not appear to obstruct the solar panels. The exterior of the enclosures, solar panels, battery boxes, and antennae appeared to be in satisfactory condition (DL-2 shown).

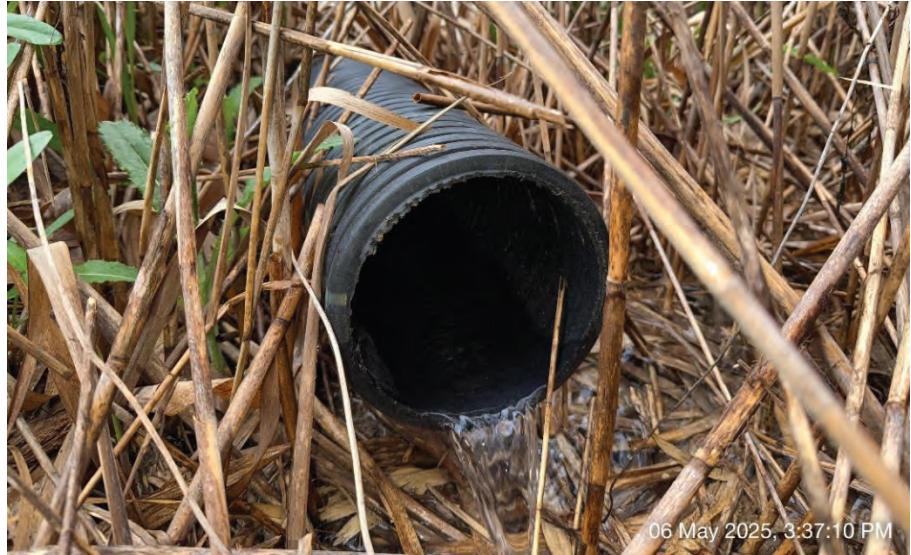
**Photograph 16**

**Comments:** Some flow was observed from one of the pressure relief pipes on the south side of the Landfill during the inspection. This flow was directed into perimeter swale R4 and the outlet had no obstructions, sediments, or vegetation.

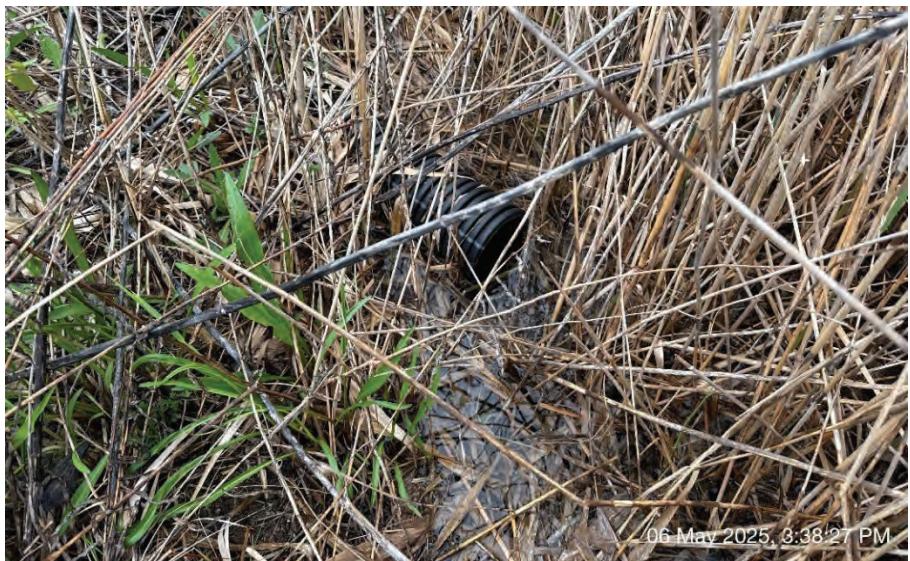
**Comments:** Some of the pressure relief pipes on the south side of the Landfill were partially submerged by the water within the perimeter swale R4.

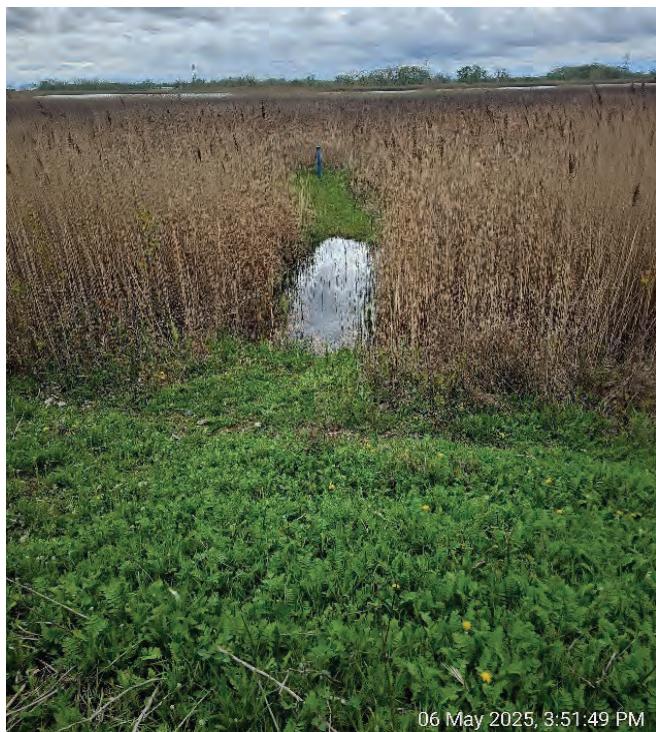
**Photograph 18**

**Comments:** Dense vegetation was observed within the perimeter swale on the southeast and south sides of the Landfill (R4 and R3). Water was observed within the swales, but minimal flow was observed during the inspection.

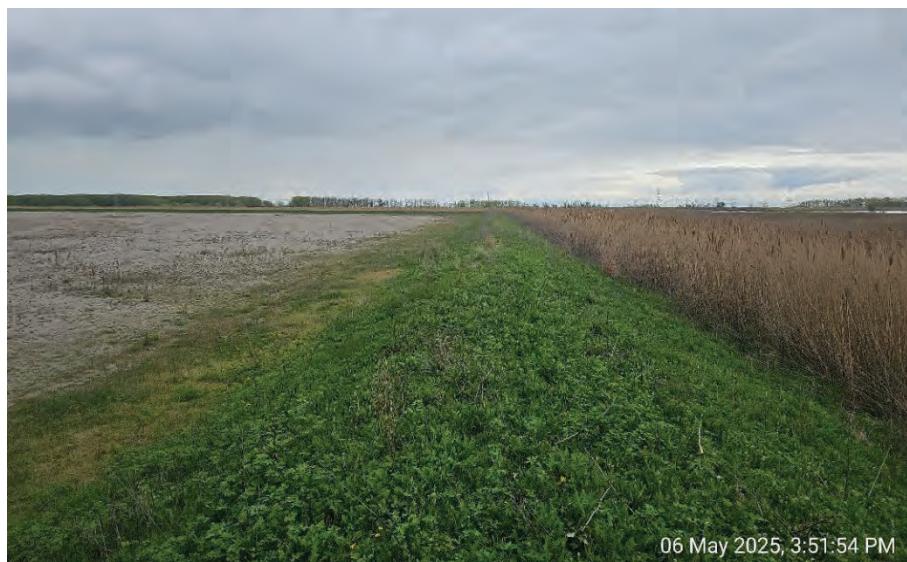
**Comments:** Some vegetation but no apparent signs of slope instability or erosion were observed on the perimeter berm along the south side of the Landfill. Dense vegetation was observed within the perimeter swale (R3) on the south side of the Landfill, but it did not appear to obstruct the flow of stormwater.

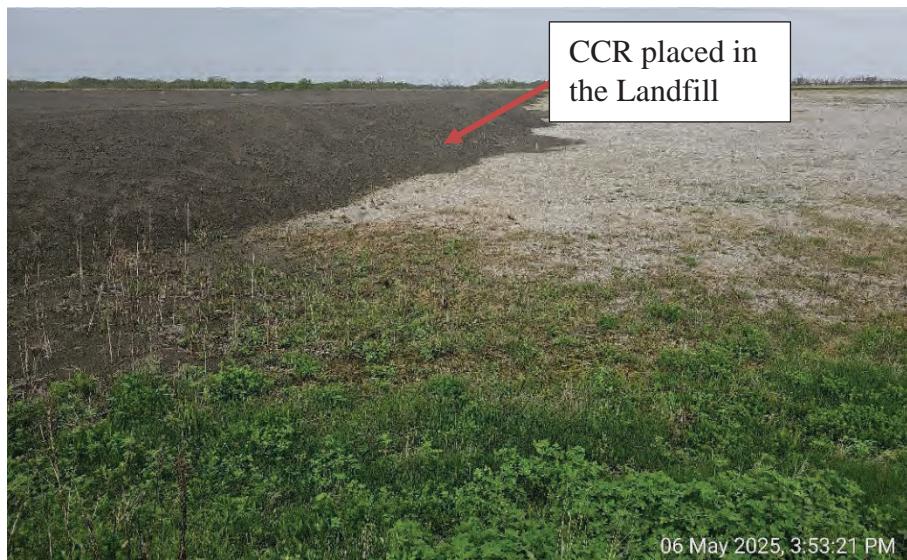
#### Photograph 20

**Comments:** The CCR placed in the Landfill appears to have been placed and stacked in accordance with generally accepted engineering practices. No CCR placement has occurred since the last inspection.

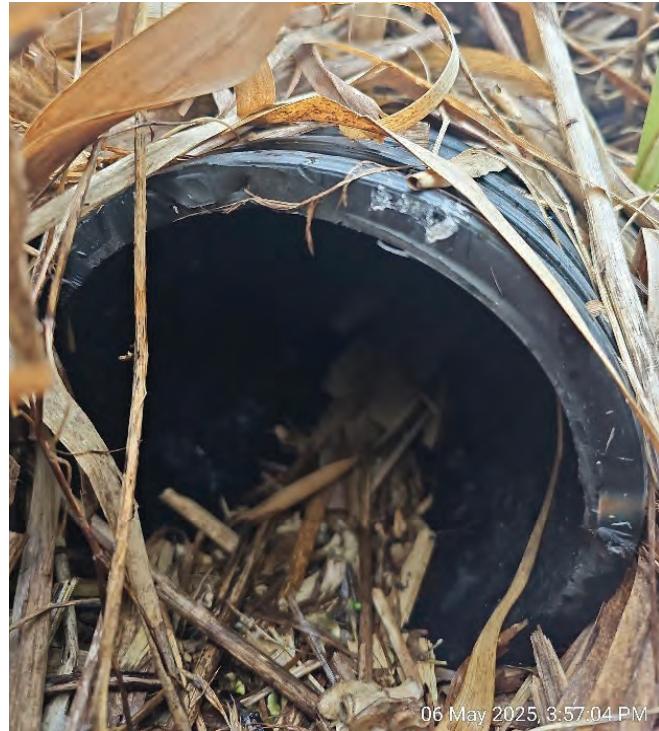
**Comments:** Some vegetation was observed at the outlets of some of the pore pressure relief pipes located on the south side of the Landfill. However, the vegetation did not appear to obstruct any flow from the pipes into perimeter swale R3.

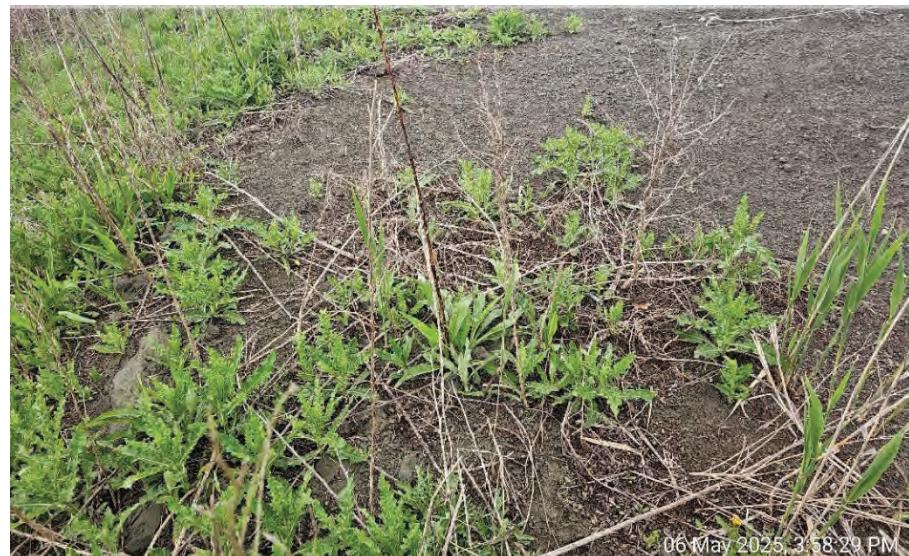
#### Photograph 22

11. CCR has eroded onto the crest of the perimeter berm at one location on the southwest side of the Landfill (Photograph #22). During this annual inspection, no observable increase in the extent of eroded CCR was observed compared to the 2024 inspection.

1. CCR near the southwest corner of the Landfill has eroded onto the crest of the perimeter berm. It appears that this CCR material has not migrated to the perimeter swale. This condition was documented during the 2024 annual inspection. The extent of the eroded CCR has not increased based on visual observations during the 2025 annual inspection. In August 2025, DTE removed the CCR material from the crest of the perimeter berm and regraded the CCR surface in the southwest corner of Phase 1 of the Landfill (Photograph #33) to address this condition.

**Comments:** CCR has eroded onto the crest of the perimeter berm at one location on the southwest side of the Landfill. It does not appear the CCR has eroded into perimeter swale R3. The extent of the eroded CCR did not appear to have changed since the previous inspection.

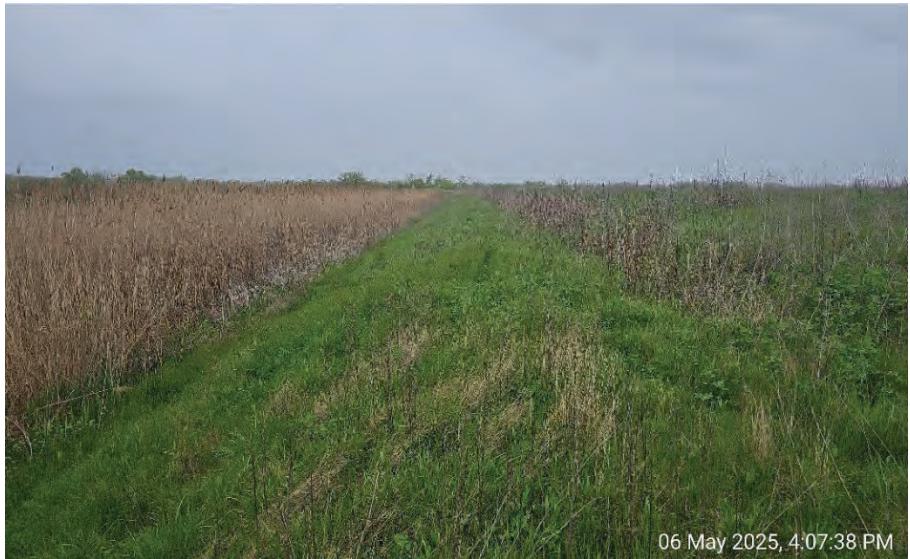
**Comments:** Some vegetation but no apparent signs of slope instability or erosion were observed on the perimeter berm along the west side of the Landfill. Dense vegetation was observed within the perimeter swale (R1) on the west side of the Landfill, but it did not appear to obstruct the flow of stormwater.

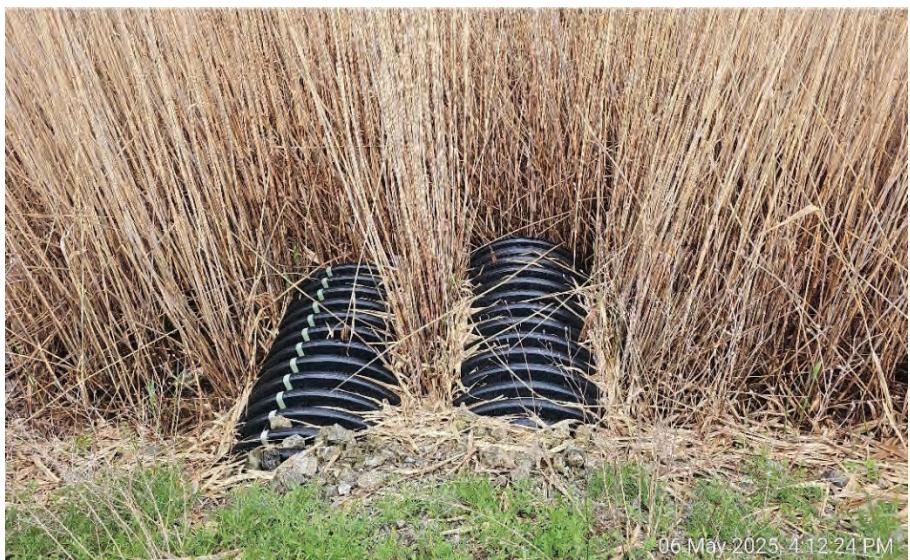
**Photograph 24**

**Comments:** The two culverts at the southwest corner of the Landfill were in good condition. Dense vegetation was observed at the discharge point of these culverts into the Fly Ash Basin, but the vegetation did not appear to obstruct flow.

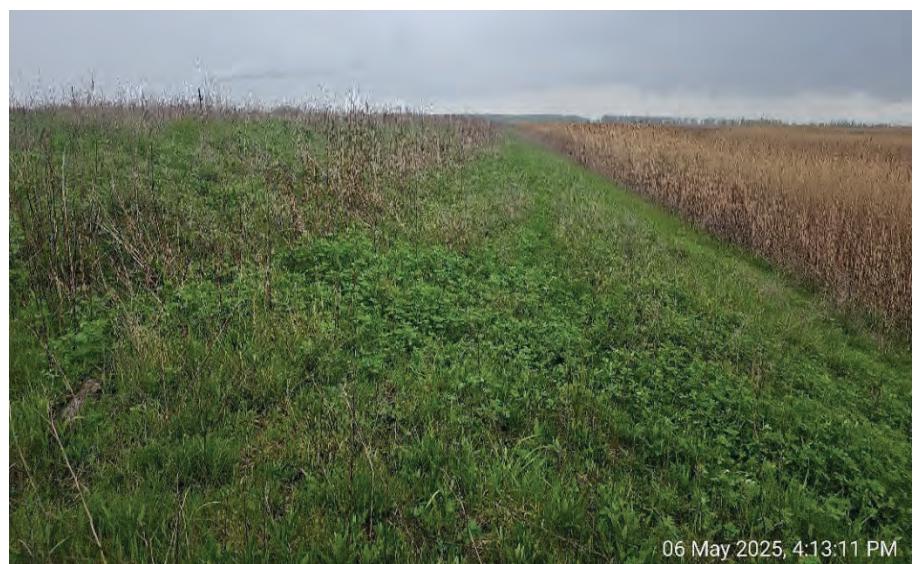
**Comments:** Some vegetation but no apparent signs of slope instability or erosion were observed on the perimeter berm along the southwest side of the Landfill. Dense vegetation was observed within the perimeter swale (R3) on the southwest side of the Landfill, but it did not appear to obstruct the flow of stormwater.

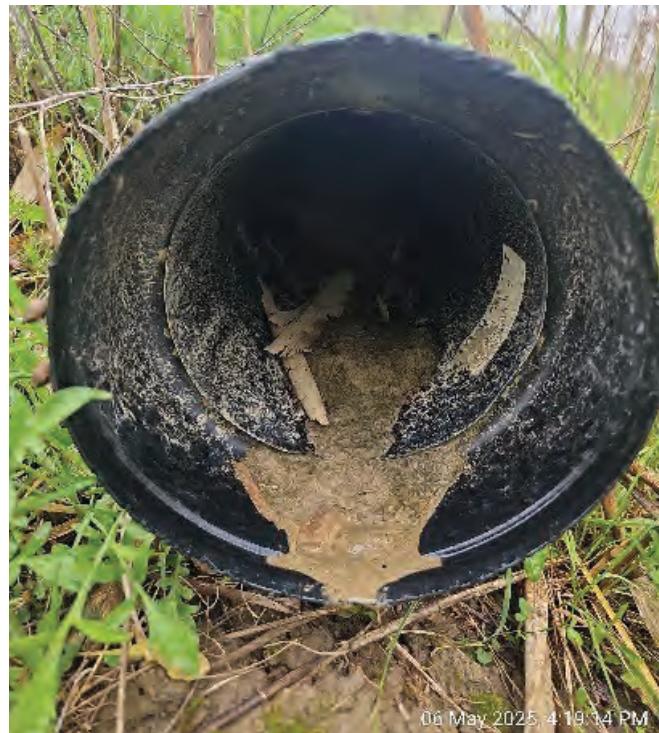
**Photograph 26**

**Comments:** Some sediments were observed within one pore pressure relief pipe outlet on the west side of Landfill, but it did not appear to obstruct flow into perimeter swale R1. Minimal flow was observed from this pipe.

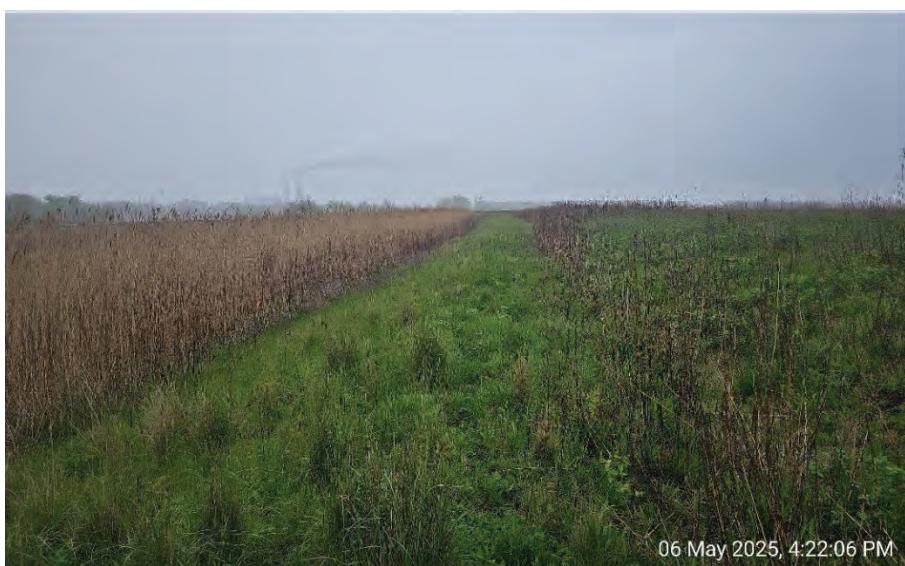
**Comments:** Some vegetation but no apparent signs of slope instability or erosion were observed on the perimeter berm along the northwest side of the Landfill. Dense vegetation was observed within the perimeter swale (R1) on the northwest side of the Landfill, but it did not appear to obstruct the flow of stormwater.

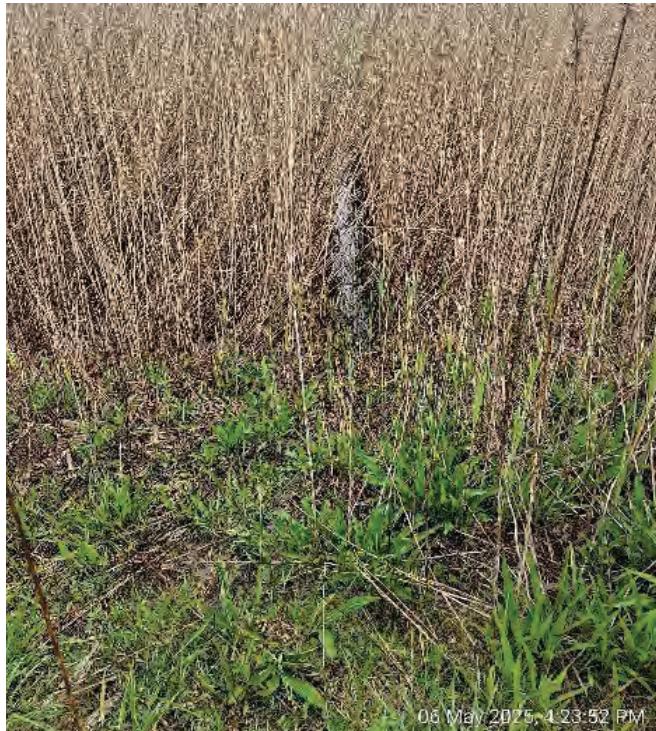
**Photograph 28**

**Comments:** Dense vegetation was observed within the perimeter swale (R1) on the northwest side of the Landfill. Water was observed within the swale, but minimal flow was observed during the inspection.

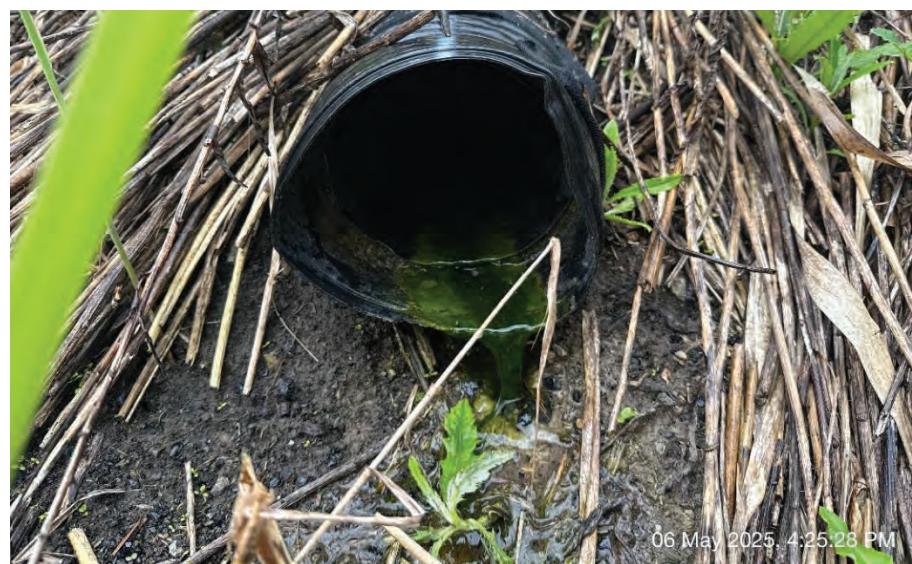
- Two pipes on the northwest side of the Landfill below Phase 1 had minimal flow during the inspection (Photograph #29). The pipes in this location have historically had minimal flow due to active filling in Phase 1 above these pipes. Algae were also observed along the outlets of these pipes.

**Comments:** Minimal flow and some algae were observed at two pressure relief pipes on the northwest side of the Landfill during the inspection. These pipes are located below Phase 1 of the Landfill. Some vegetation was observed at the outlets of the pipes, but it did not appear to obstruct the flow into perimeter swale R1.

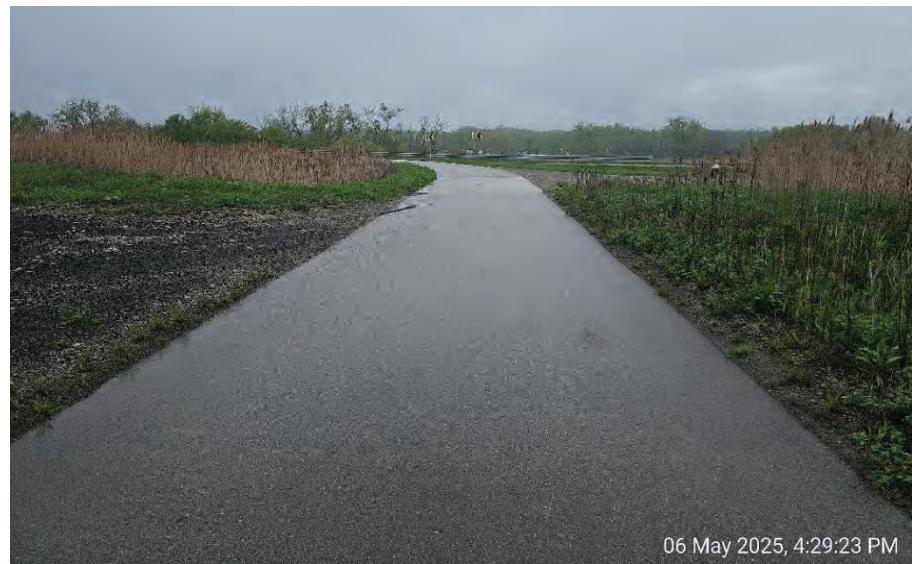
**Photograph 30**

**Comments:** The paved access road near the northwest corner of the Landfill was in good condition.

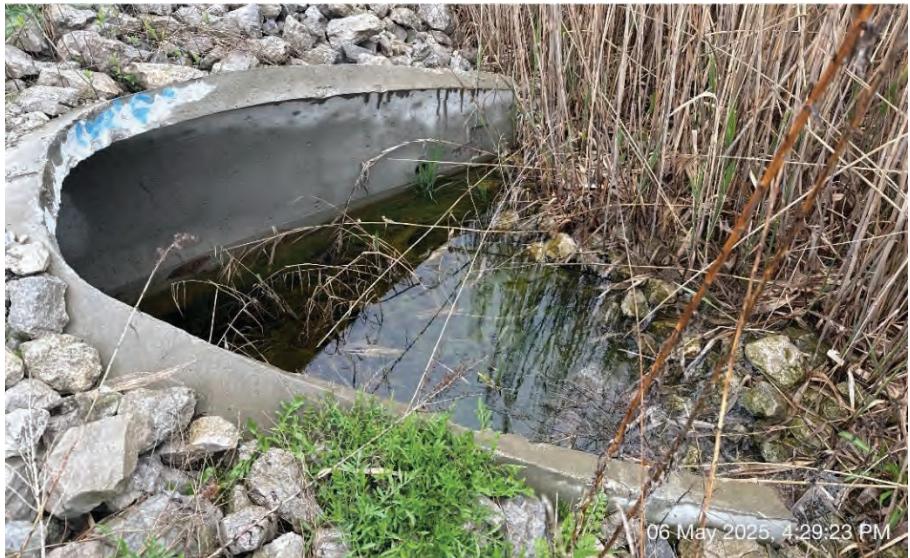
**Comments:** The reinforced concrete culvert beneath the paved access road and riprap around the culvert were generally in good condition. Some vegetation was observed in the riprap. Dense vegetation was observed within perimeter swale R1 by the culvert. Water was observed within the swale, but minimal flow through the culvert was observed during the inspection.

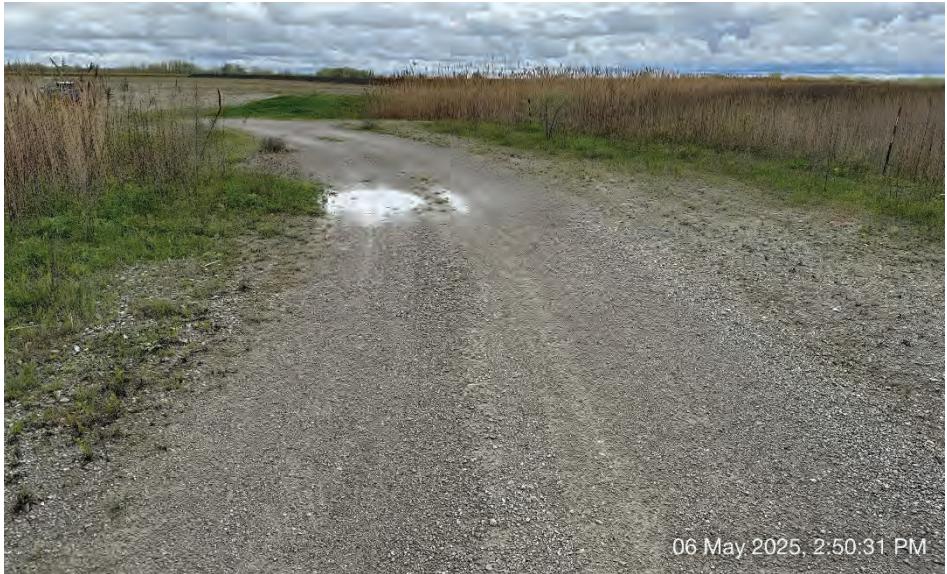
**Photograph 32**

1. The paved and aggregate access roads on the north side of the Landfill were in good condition with no observed ruts or erosion (Photographs #30, #32). One low spot was observed on the aggregate access road (Photograph #32).

**Comments:** The aggregate access road on the north side of the Landfill was in satisfactory condition. There was one low spot with water from precipitation before and during the inspection, but no ruts or erosion were observed.
