**DTE Electric Company**

## **2025 ANNUAL INSPECTION REPORT FLY ASH BASIN**

**MONROE POWER PLANT**

January 2026

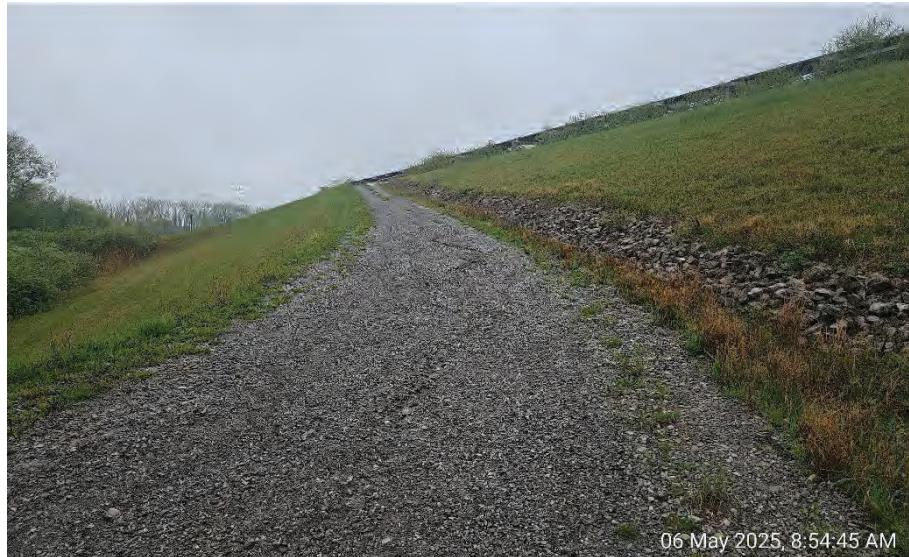
**Photograph 2**

2. No structural damage was observed in the concrete, discharge pipes, or gates of the discharge structure and no obstructions were observed in the gates and discharge pipes (Photographs #2, #3, #4). The stop logs were in poor condition and in the raised position (Photograph #3); the stop log gates are no longer used. The slope between the discharge structure and the discharge canal had no apparent indicators of slope movements (e.g., sinkholes, cracks) (Photograph #5). The outfall structures and culverts to the discharge canal were in satisfactory condition with no obstructions observed (Photograph #6). A remote-operated vehicle was used to inspect and record the interiors of the discharge pipes shortly after the annual visual inspection (June 23, 2025). No cracks, joint separation, or excessive buildup of sediments (or blockages) were observed in the recordings of the discharge pipes.

**Comments:** No structural damage was observed in the concrete or discharge pipes. No obstructions were observed in the discharge pipes. Sluicing operations at the Fly Ash Basin have stopped, but some water was flowing over the discharge structure and into the pipes during the inspection due to precipitation prior to and during the inspection.

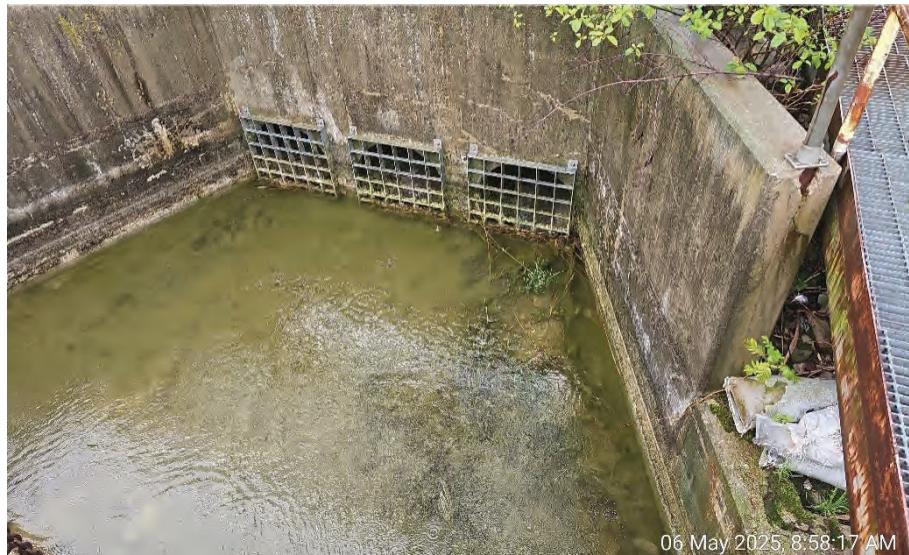
**Comments:** The gates of the discharge structure were in satisfactory condition with no significant damage or obstructions observed. The stop logs were in poor condition and in the raised position.

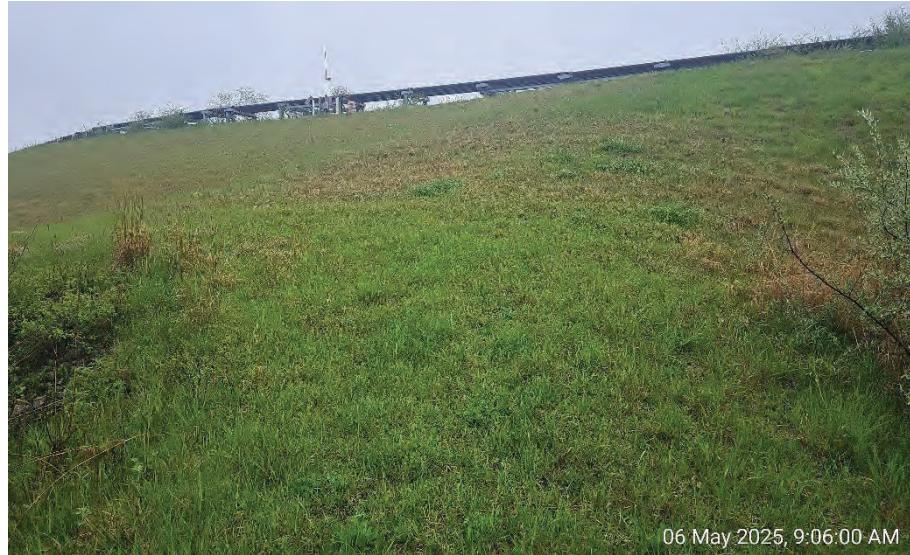
**Photograph 6**

**Comments:** Some outflow from the discharge box structures was observed during the inspection because of precipitation prior to and during the inspection. The outfall structures and culverts to the discharge canal were in satisfactory condition with no obstructions observed. The outflow is typically minimal because sluicing operations have stopped at the Fly Ash Basin.

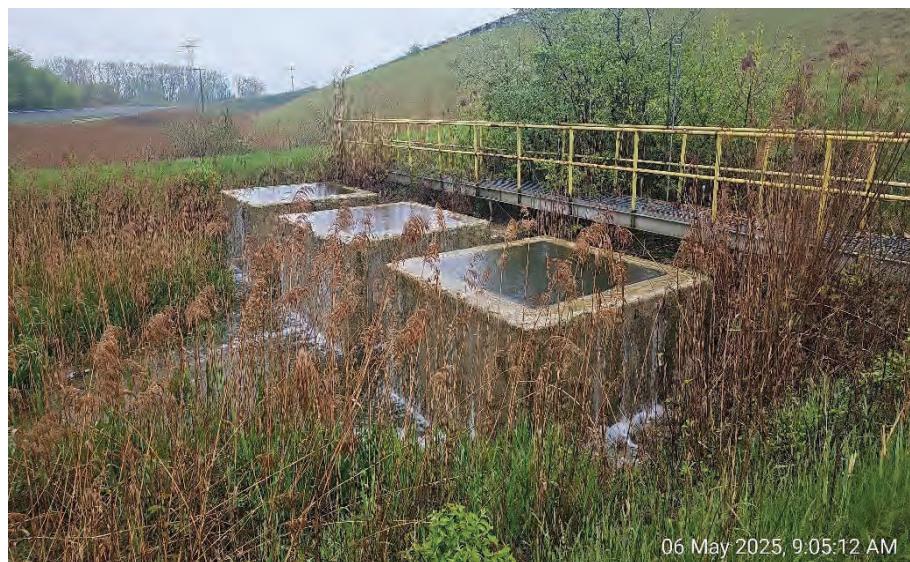
**Comments:** The weir outlet for the discharge canal was in satisfactory condition. Flow was observed during the inspection because of precipitation prior to and during the inspection. The weir typically has minimal discharge because sluicing operations have stopped at the Fly Ash Basin.

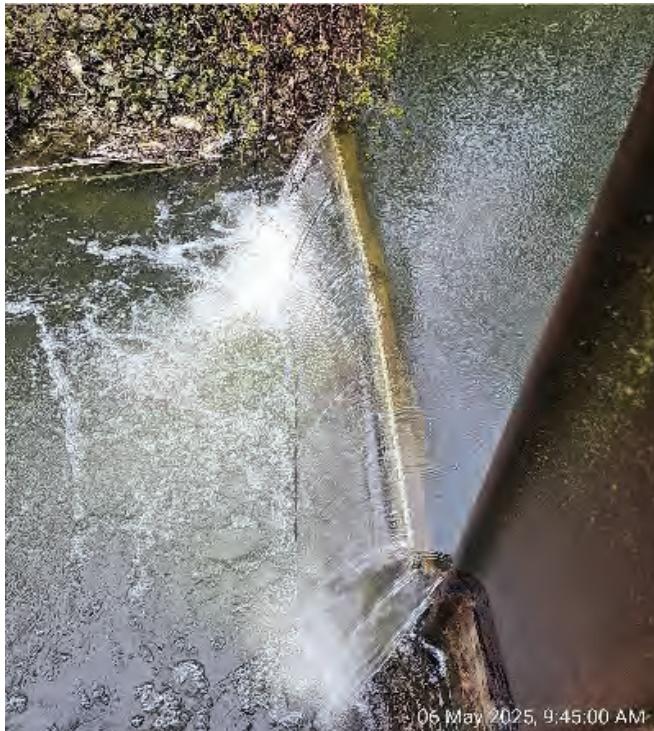
**Photograph 8**

4. The discharge canal leading into Plum Creek and the silt curtain and weir at the end of the canal were in satisfactory condition (Photographs #7, #8). Significant vegetation was observed growing in the discharge canal. Some water was observed flowing over the weir outlet during the inspection due to precipitation prior to and during the inspection. Sluicing operations to the Fly Ash Basin have stopped, so flow through the discharge canal is normally minimal.

**Comments:** The silt curtain upstream of the weir and the discharge canal was in satisfactory condition. Significant vegetation was observed within the canal. Sluicing operations have stopped at the Fly Ash Basin, so there is minimal flow within the canal that did not appear to be impeded by the vegetation.

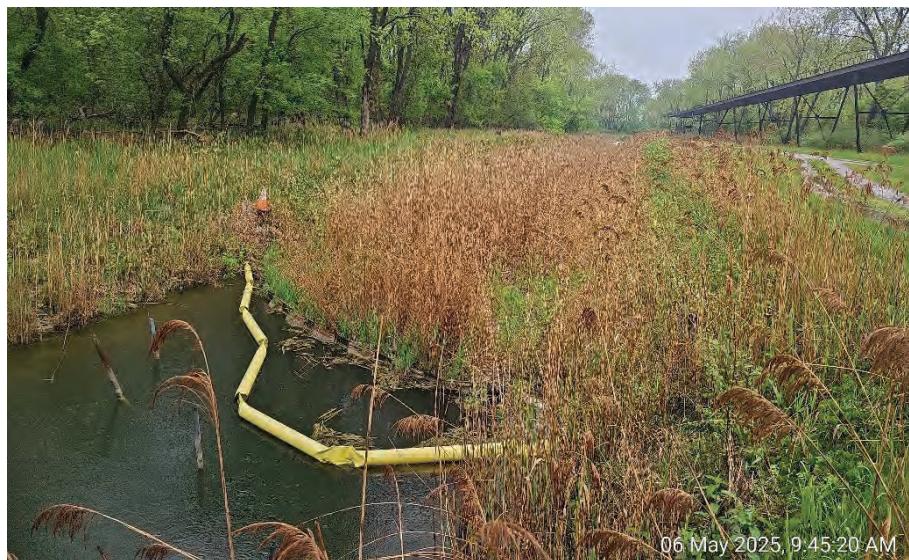
**Comments:** Perimeter road atop the perimeter embankment was generally in good condition with no erosion or rutting and minimal low spots observed (typical conditions shown).

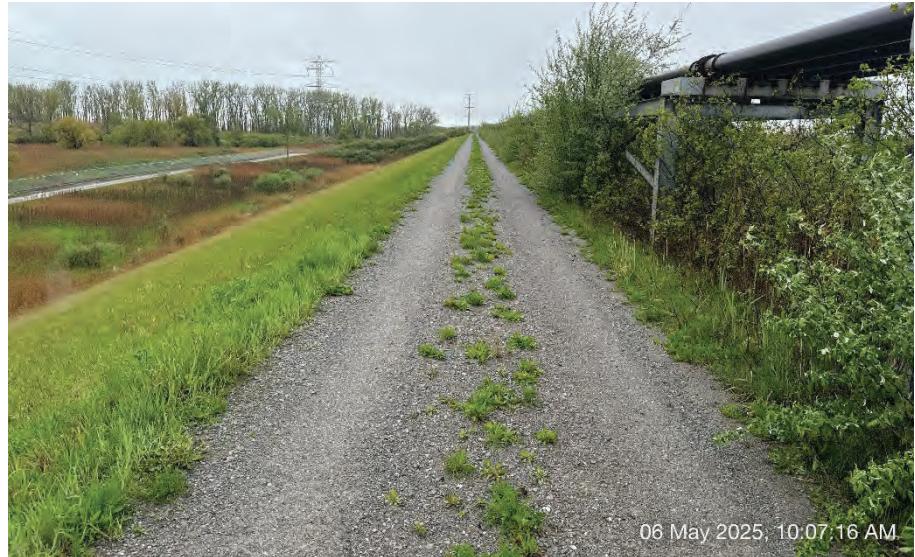
**Photograph 10**

**Comments:** Exterior slopes of the perimeter embankment on the east side (Stations 160+50 to 179+00) were in good condition. No indicators of slope instabilities (e.g., cracks) or erosion were observed. Vegetation was well maintained.

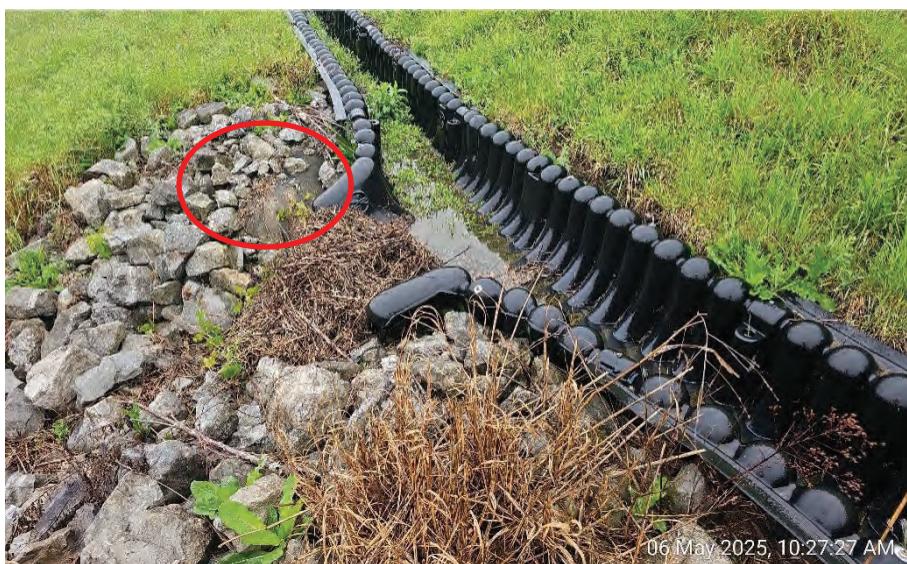
Approximately 1 foot of riprap has eroded from below the SmartDitch outlet at Station 151+00. The outlet has been distorted due to settlements, which has also exposed the geotextile upslope of the SmartDitch.

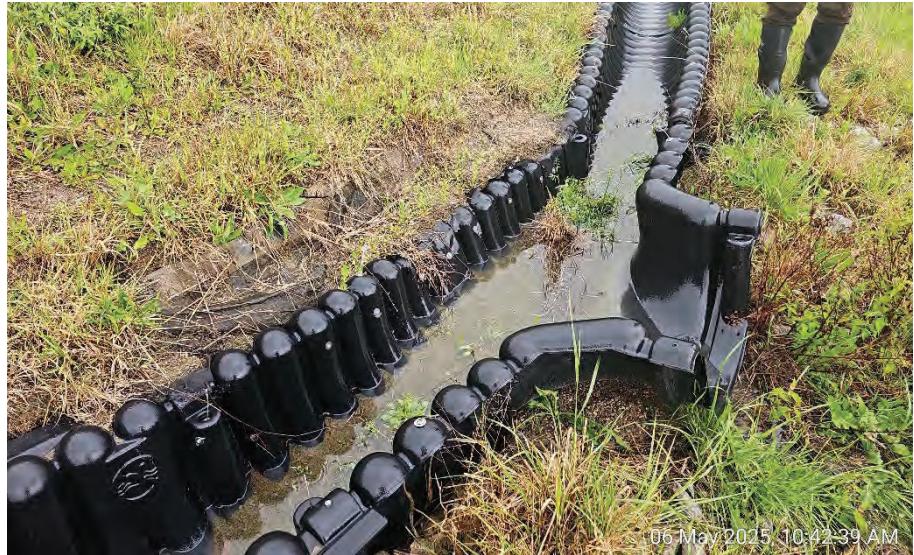
**Photograph 16**

**Comments:** Exterior slopes of the perimeter embankment on the east side (Stations 149+00 to 160+50) were in good condition. No indicators of slope instabilities (e.g., cracks) or erosion were observed. Vegetation was well maintained. The SmartDitch was in fair condition: some cut vegetation, erosion around the edges, and settlement.

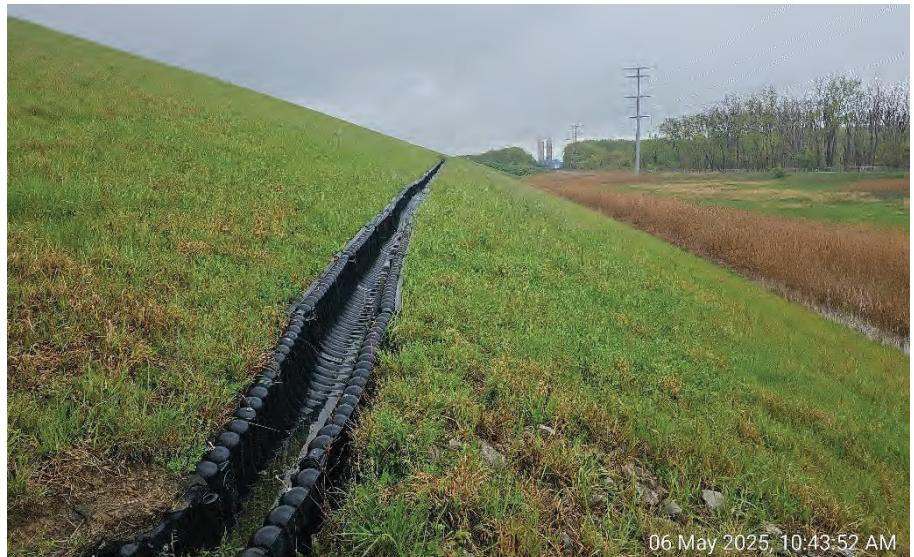
**Comments:** The covered high-density polyethylene (HDPE) drainpipes connecting sections of the SmartDitch were generally in good condition. Minimal erosion was observed in the aggregate for the vehicle crossing. (typical conditions shown). Many of the drainpipes had minimal sediments and cut vegetation near the outlets.

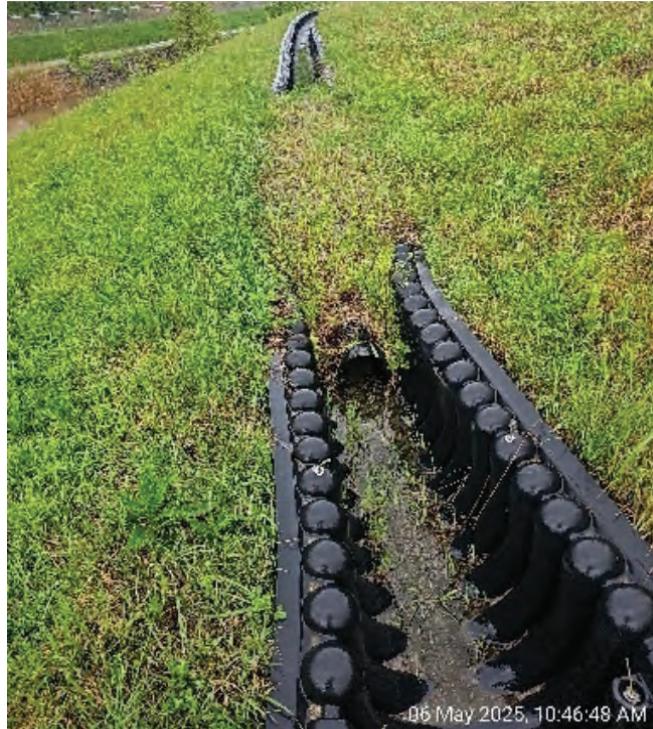
**Photograph 18**

**Comments:** The covered HDPE drainpipes connecting sections of the SmartDitch near Stations 149+00 (shown in picture), 30+00, and 22+50 had some sediments or cut vegetation within the pipes. However, the sediments and cut vegetation were not observed to impede conveyance of stormwater through the pipes.

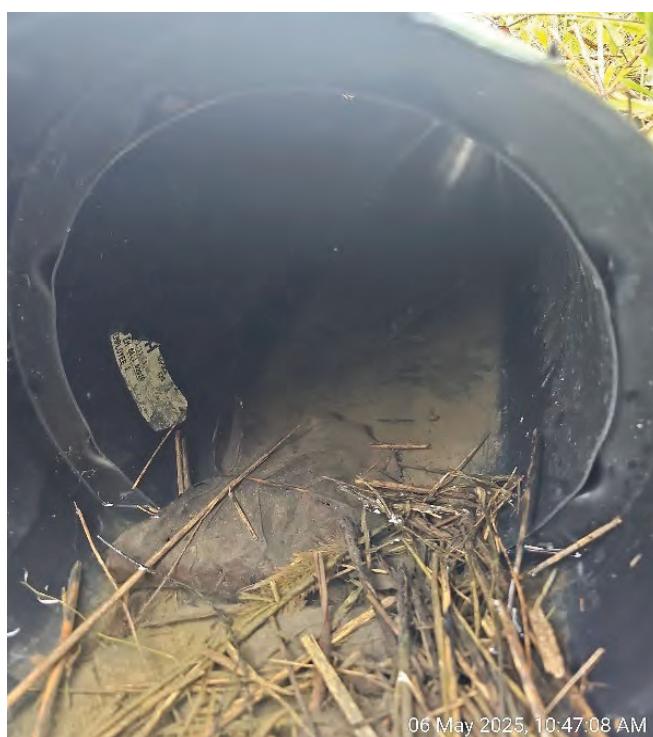
**Comments:** Exterior slopes of the perimeter embankment on the southeast side (Stations 143+50 to 149+00) were in good condition. No indicators of slope instabilities (e.g., cracks) or erosion were observed. Vegetation was well maintained. The SmartDitch was in fair condition: some cut vegetation, erosion around the edges, and settlement.

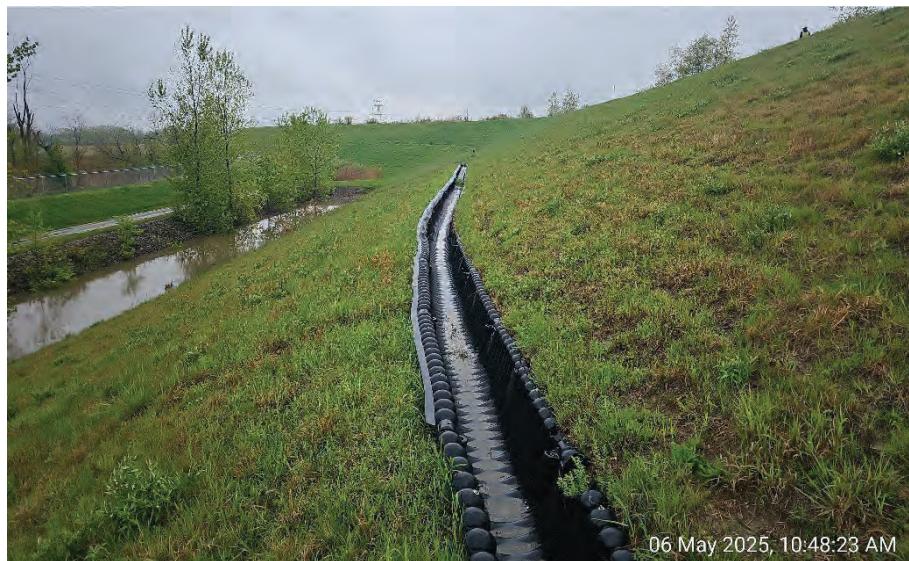
**Photograph 20**

**Comments:** More than 1 foot of riprap has eroded from below the SmartDitch outlet at Station 145+50. The outlet has been distorted due to settlements. The geotextile below the outlet of the SmartDitch has been exposed.

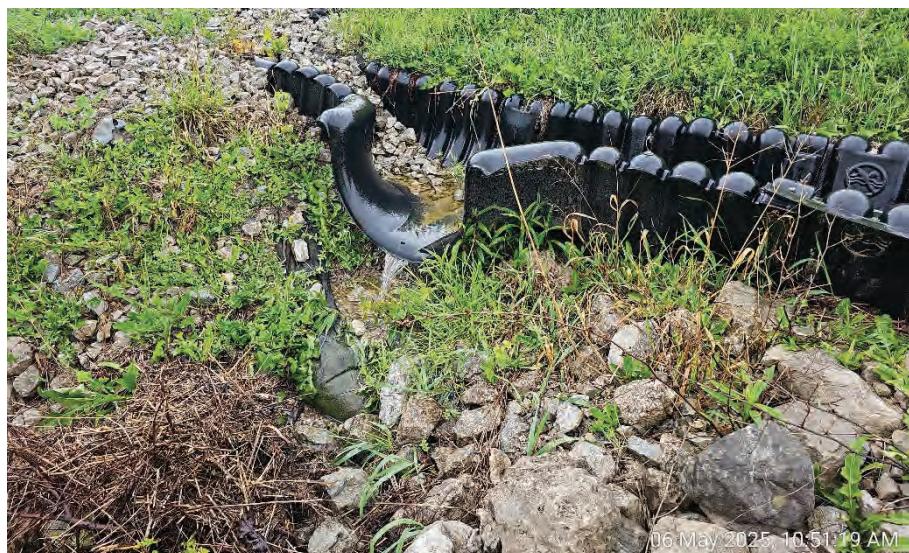
**Comments:** The aggregate covering the HDPE drainpipe along the southeast corner has eroded and exposed the geotextile.

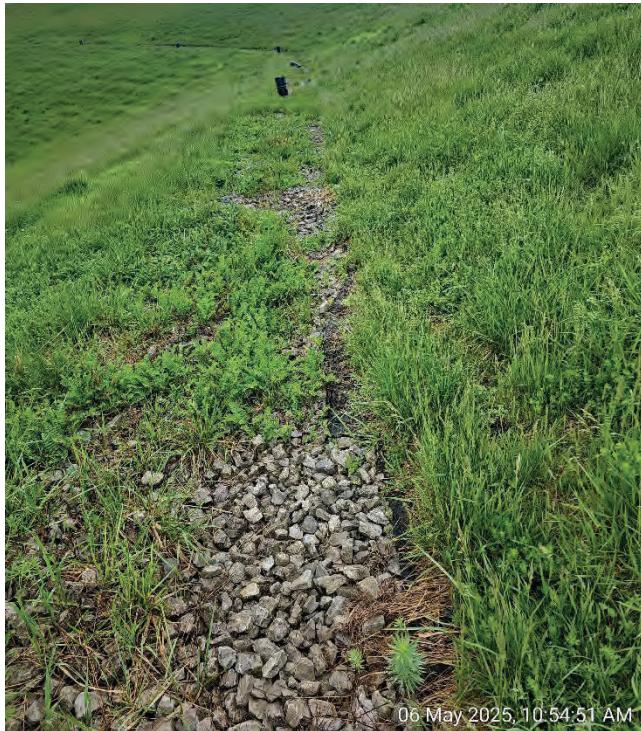
**Photograph 22**

- f. One of the observation ports covering the HDPE slotted pipes along the southeast corner was damaged and separated from the HDPE pipe (Photograph #22).

**Comments:** One of the observation ports for the HDPE drainpipe covered by the aggregate along the southeast corner was damaged and separated from the drainpipe.

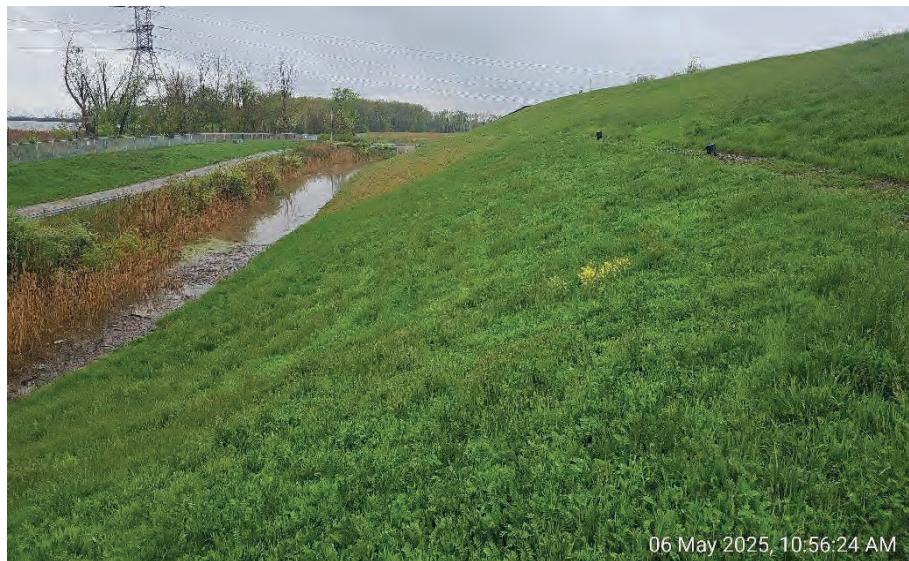
**Comments:** Denser vegetation including some woody vegetation was observed within the riprap downchute at Station 139+50. Some erosion was also observed in the riprap. However, the vegetation and erosion did not appear to impede the ability of the downchute to convey stormwater to the perimeter channel.

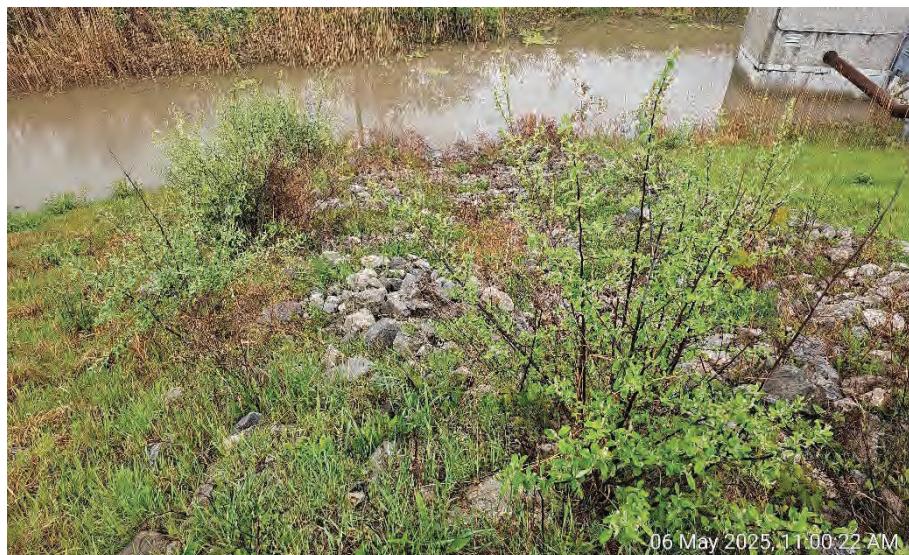
**Comments:** More than 1 foot of riprap has eroded from below the SmartDitch outlet at Station 145+50. The outlet has been distorted due to settlements. Significant cut vegetation was observed within the outlet but did not appear to impede conveyance of stormwater flow into the riprap.

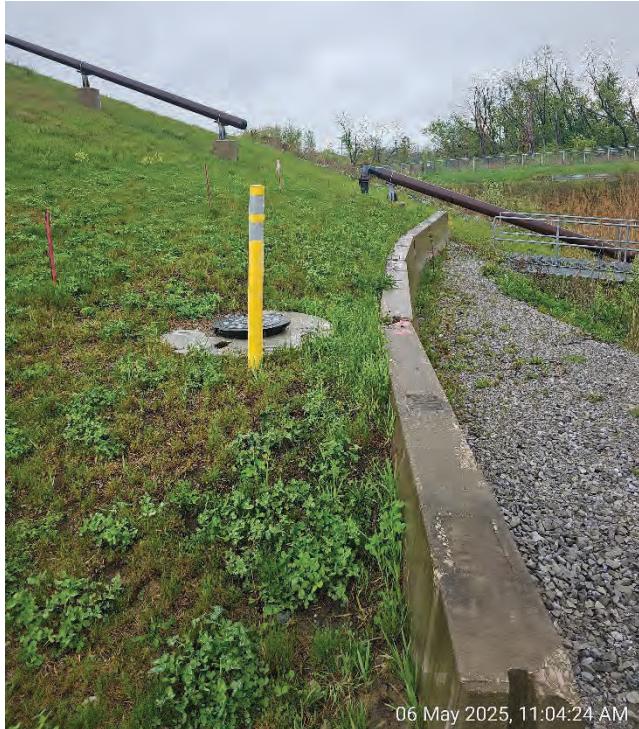
**Photograph 28**

**Comments:** Exterior slopes of the perimeter embankment on the southeast side (Stations 112+00 to 139+50) were in good condition. No indicators of slope instabilities (e.g., cracks) or erosion were observed. Vegetation was well maintained.

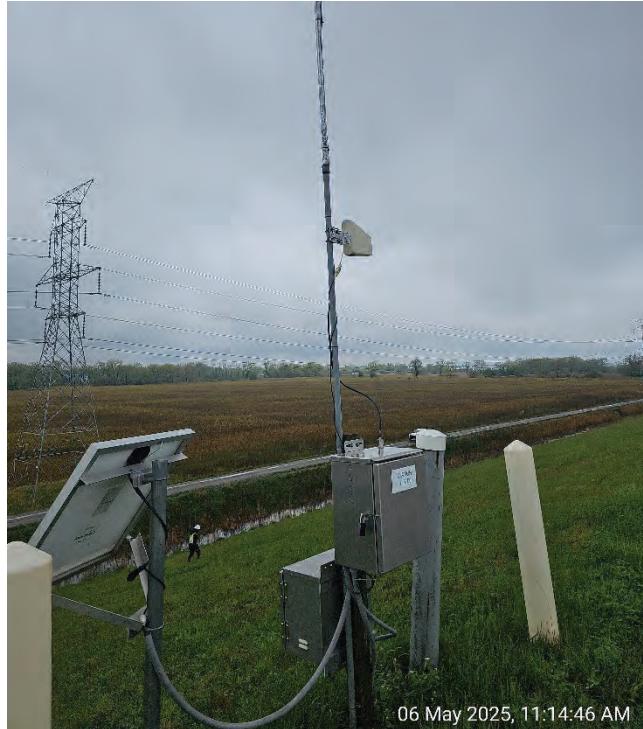
**Photograph 30**

(Photograph #29). The seals of the equipment boxes are damaged, but the inside of the monitoring equipment boxes including the wiring and data acquisition device were in satisfactory condition (Photograph #30).

**Comments:** The interiors of the instrumentation monitoring equipment including the equipment boxes and wiring were in satisfactory condition (typical conditions shown). The desiccant canisters were replaced within the past year. The seals of the equipment boxes have some damage.

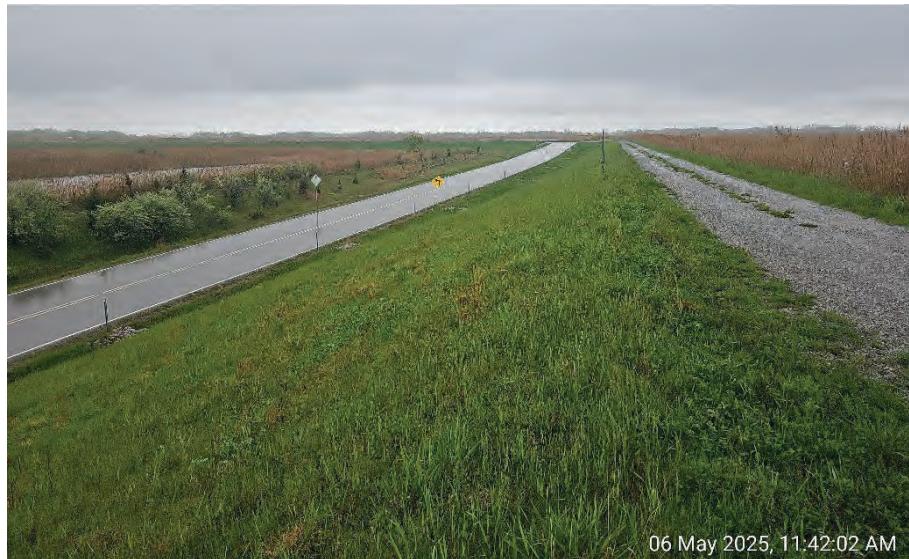
**Photograph 34**

**Comments:** Exterior slopes of the perimeter embankment on the southwest side (Stations 88+50 to 104+50) were in good condition. No indicators of slope instabilities (e.g., cracks) or erosion were observed. Vegetation was well maintained. The asphalt access road was in good condition with no cracks observed.

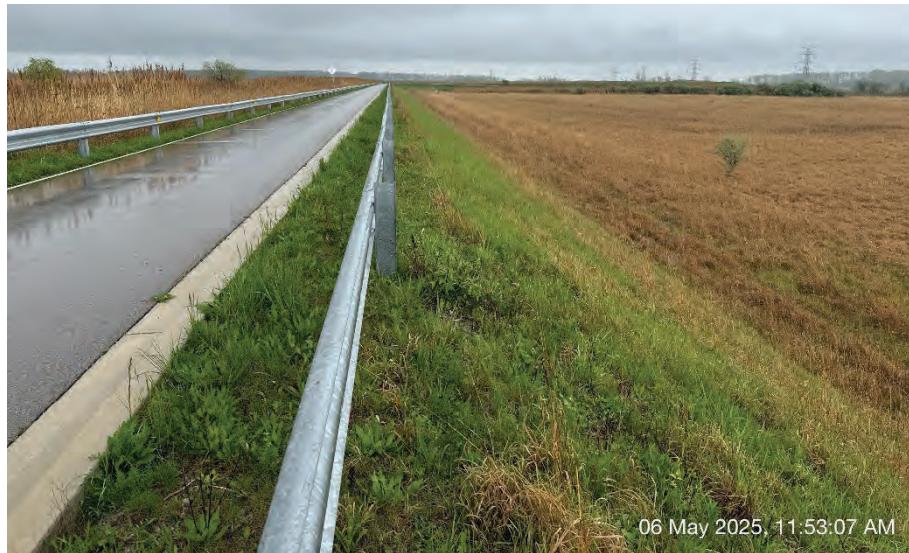
**Comments:** Exterior slopes of the perimeter embankment on the west side (Stations 68+50 to 88+50) were generally in good condition. No indicators of slope instabilities (e.g., cracks) or erosion were observed. Vegetation was well maintained. The SmartDitch was in fair condition: some cut vegetation, erosion around the edges, and settlement.

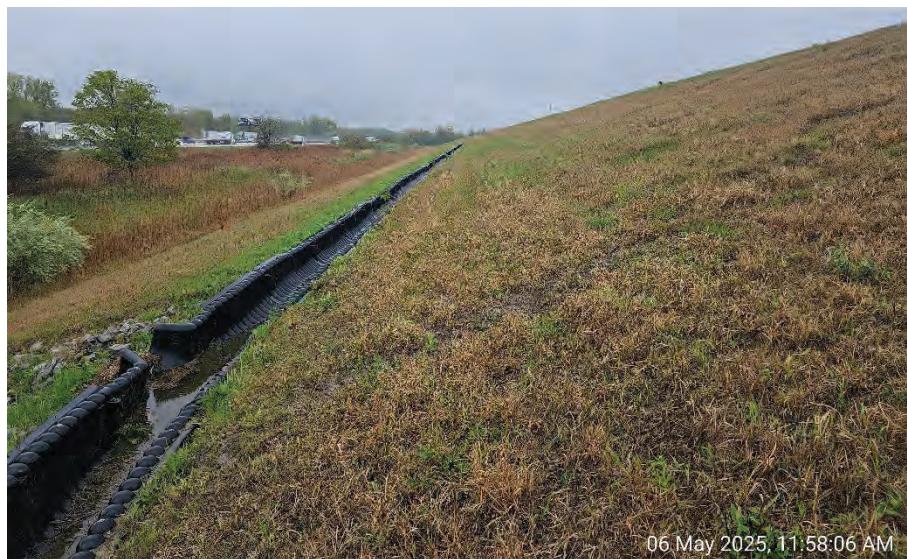
**Comments:**  
Approximately 0.5 feet of riprap has eroded from below the SmartDitch outlet at Station 88+00. The outlet has been distorted due to settlements. Significant cut vegetation was observed within the outlet but did not appear to impede conveyance of stormwater flow into the riprap.

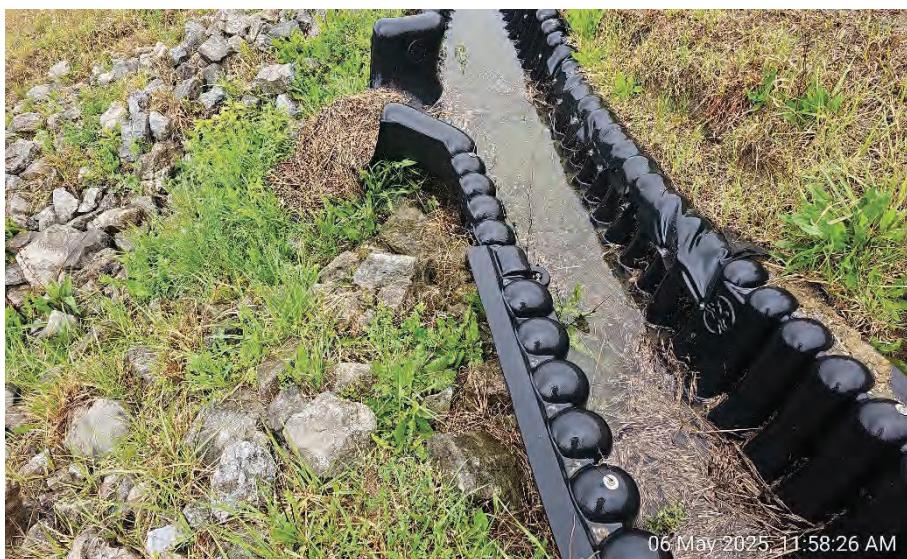
- c. The geotextile has been exposed at the toe of the exterior slopes of the perimeter embankment on the west side; however, no tears were observed in the geotextile (Photograph #37).

**Comments:** The geotextile has been exposed at the exterior toe of the perimeter embankment on the west side. No tears were observed in the geotextile.

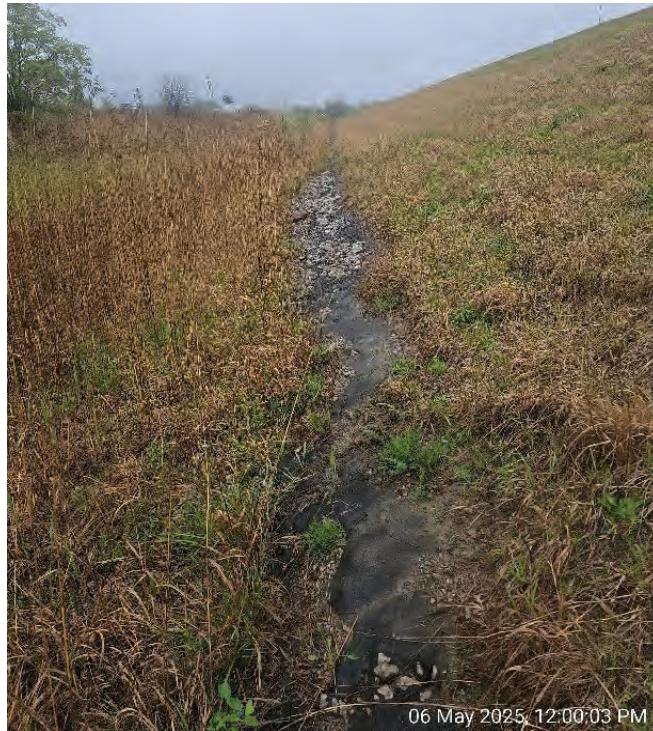
**Photograph 38**

- g. Portions of the SmartDitch on the west side of the perimeter embankment were damaged by a fire in March 2023. Some embankment materials have eroded into the SmartDitch near Station 86+00 (Photograph #38). However, the damage did not appear to affect the overall functionality of the SmartDitch.

**Comments:** Portions of the SmartDitch on the west side of the perimeter embankment were damaged by a fire in March 2023. Some embankment materials have eroded into the SmartDitch near Station 86+00. However, the damage did not appear to affect the overall functionality of the SmartDitch.

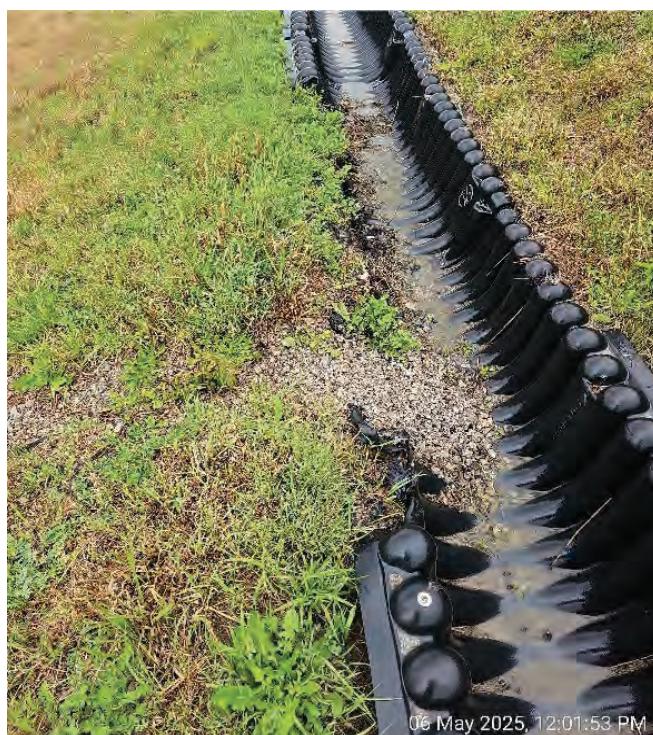
**Comments:** Previous sand-bentonite repairs to the perimeter embankment near Station 83+00 were still in satisfactory condition. There were some bare areas near this location that may have been caused by the fire in March 2023.

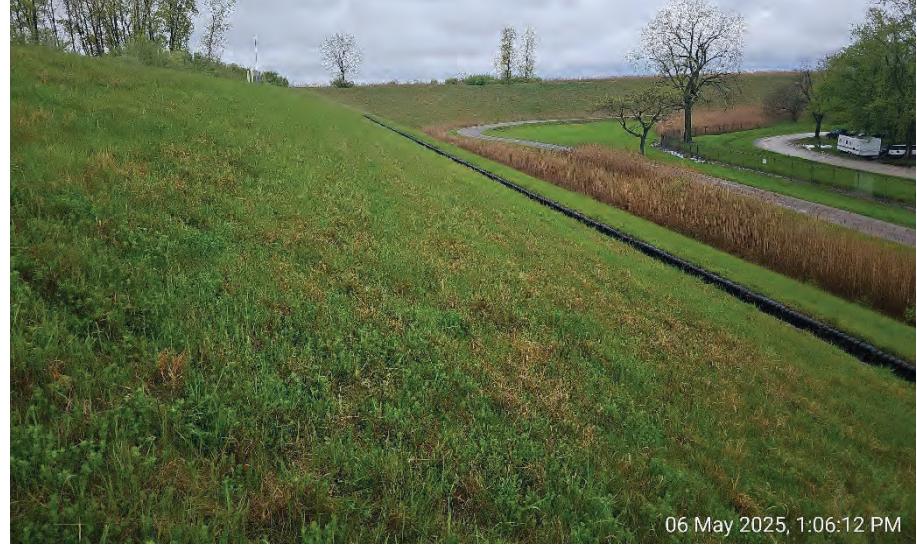
<b>Photograph 57</b>

<b>Date:</b> 5/6/2025	
<b>Direction:</b> Southwest	
<b>Comments:</b> Exterior slopes of the perimeter embankment on the north side (Stations 31+50 to 35+50) were in good condition. No indicators of slope instabilities (e.g., cracks) or erosion were observed. Vegetation was well maintained. The SmartDitch was in fair condition: some cut vegetation, erosion around the edges, and settlement.	
<b>Photograph 58</b>

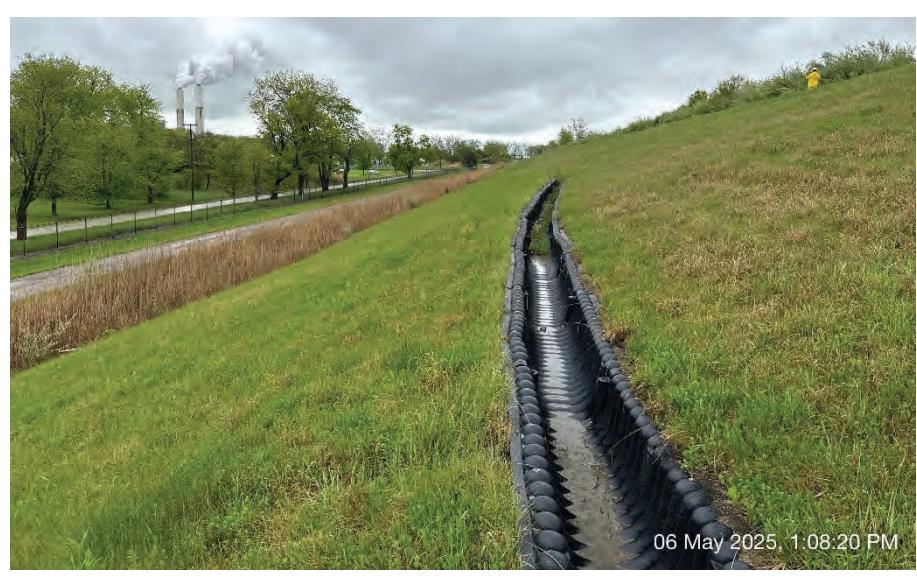
<b>Date:</b> 5/6/2025	
<b>Direction:</b> East	
<b>Comments:</b> Exterior slopes of the perimeter embankment on the northeast side (Stations 14+00 to 31+50) were in good condition. No indicators of slope instabilities (e.g., cracks) or erosion were observed. Vegetation was well maintained. The SmartDitch was in fair condition: some cut vegetation, erosion around the edges, and settlement.
