2025 ANNUAL INSPECTION REPORT RANGE ROAD LANDFILL

BELLE RIVER POWER PLANT

China Township, Michigan

January 2026

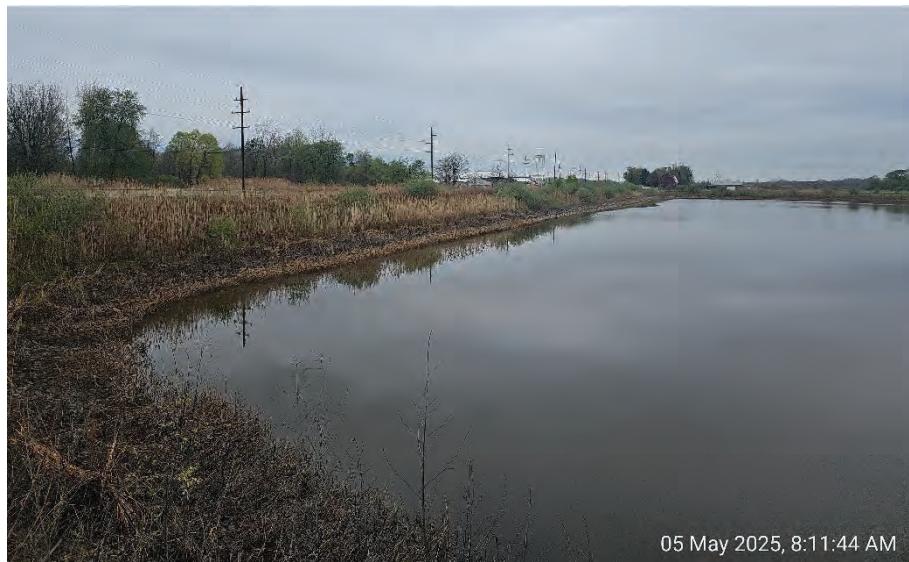
Comments: The south side slopes of the Stormwater Detention Basin (SDB) were in good condition. Some vegetation but no erosion was observed on the side slopes. The water quality within the SDB appeared to be appropriate for the NPDES permit.

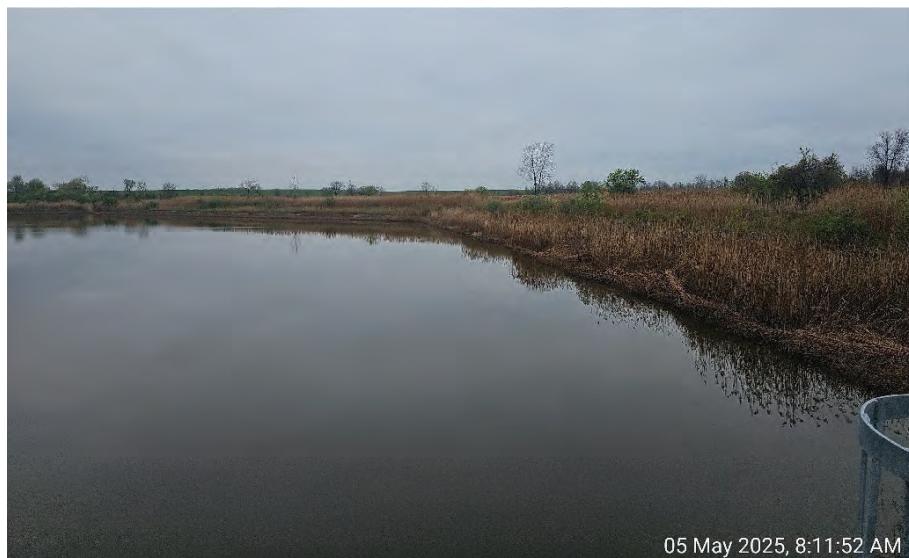
Photograph 2

Comments: The north side slopes of the SDB were in good condition. Some vegetation but no erosion was observed on the side slopes. The water quality within the SDB appeared to be appropriate for the NPDES permit.

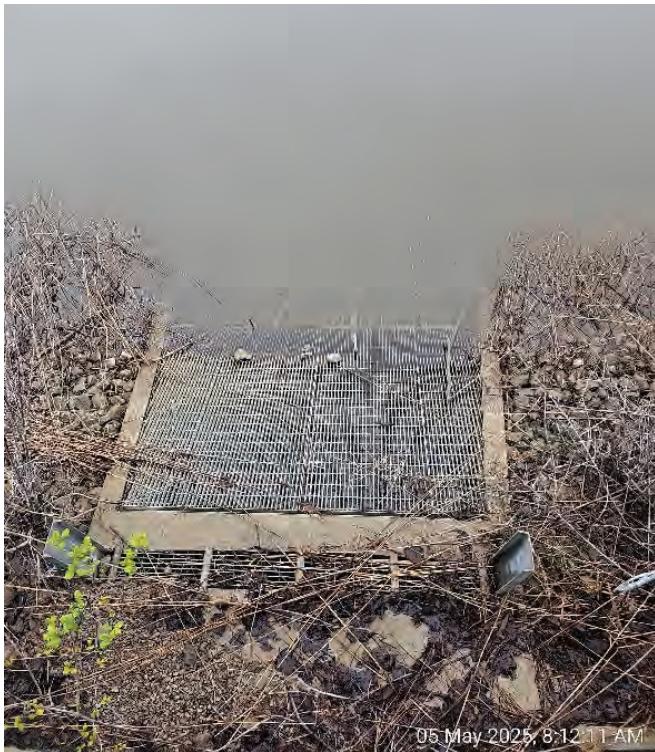
1. The SDB was in good condition. The side slopes of the SDB had some vegetation, particularly on the north side, but no signs of erosion (Photographs #1, #2). The trash rack for the SDB outlet was in good condition and mostly clear of vegetation that could impede water flow (Photograph #3). The water quality within the SDB appeared to be appropriate for the NPDES permit (Photographs #1, #2, #3). The maintenance program includes the regular removal of vegetation from both the trash rack and the side slopes of the SDB.

Comments: The trash rack for the outlet of the SDB was mostly clear of vegetation and in good condition.

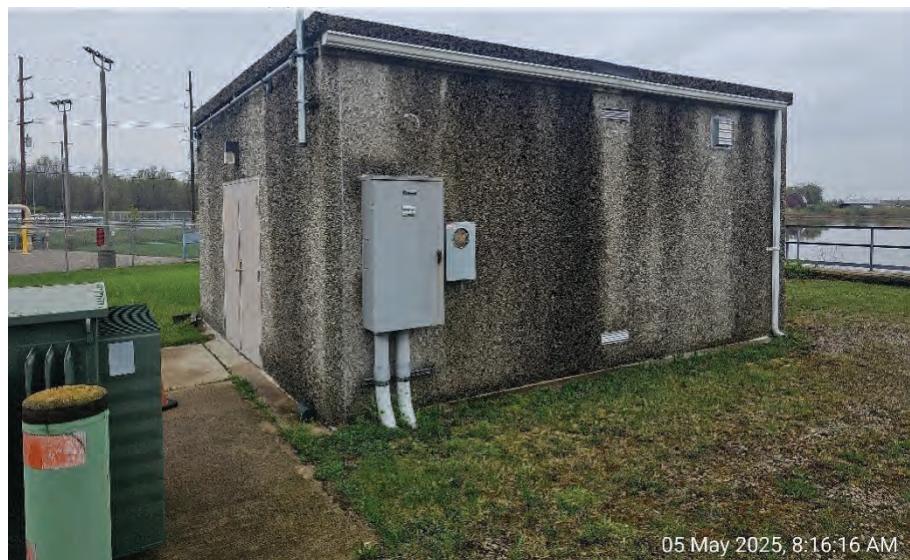
Photograph 4

Comments: The pump house for the SDB was not accessed during the inspection. However, pumps were operational according to DTE personnel.

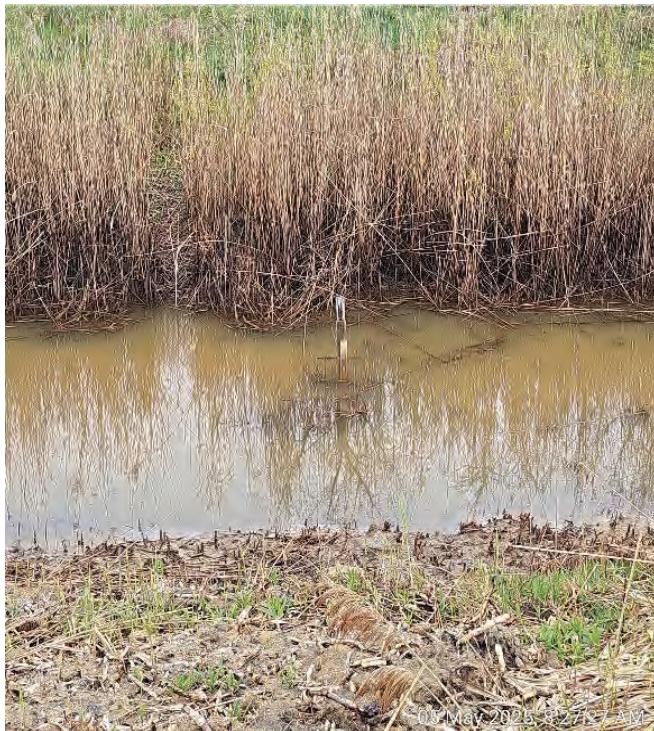
Comments: The staff gauges located within the east perimeter ditch were generally in satisfactory condition (typical) (staff gauge-07 shown).

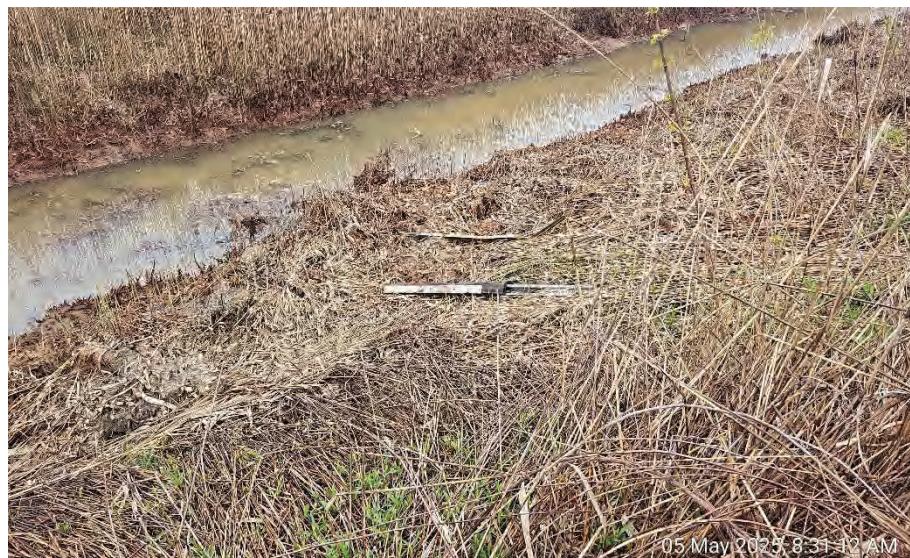
Photograph 10

6. All staff gauges within the perimeter ditch were located, and most were in satisfactory condition (Photographs #9, #13, #17, #18). Staff Gauge-06 on the east side of the Landfill had been damaged and was lying on the side slope of the perimeter ditch (Photograph #10). Vegetation within the perimeter ditch limited the visibility of some of the staff gauges along the northwest side of the Landfill (Photograph #32). DTE personnel have placed markers along the perimeter road to indicate the locations of the staff gauges; however, some of these markers have been damaged.

Comments: Staff gauge-06, located on the east side of the Landfill, was damaged and lying on the side slope of the perimeter ditch. This staff gauge was repaired by DTE following the inspection.

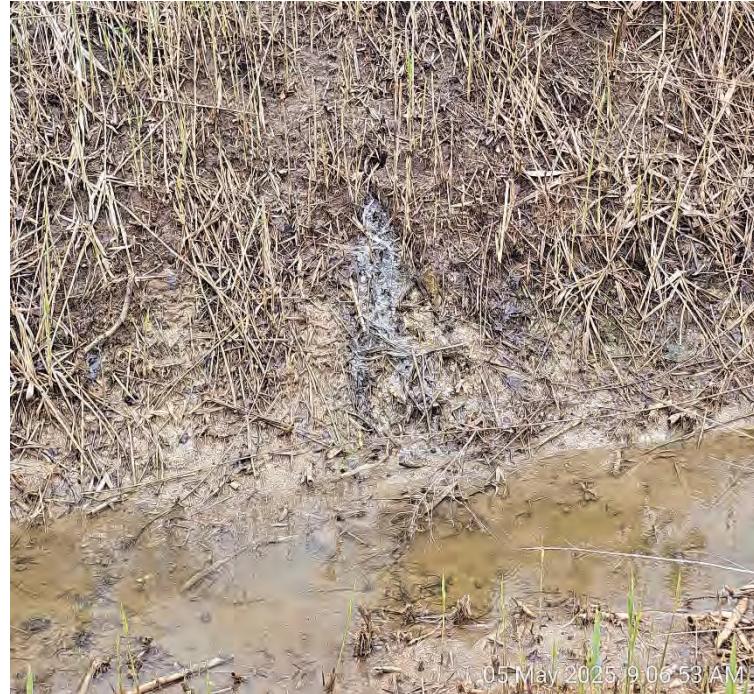
Photograph 20

10. Some seepage was observed at the toe of the slopes on the north side of the Landfill in Area B (Photograph #20). There were no indications of slope instability near this seepage.

Comments: Some seepage was observed at the toe of the slopes on the north side of the Landfill.

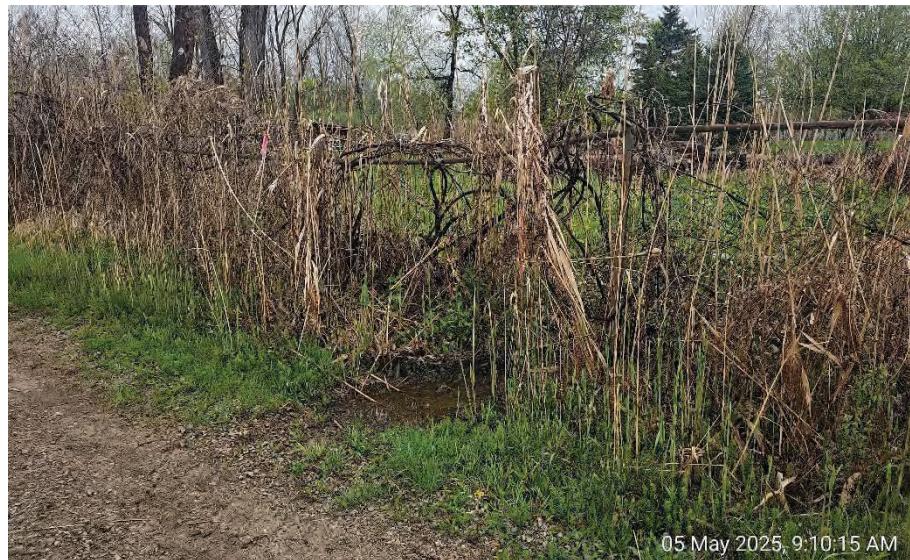
7. The security fences and gates were locked and generally in good condition (Photographs #12, #36). The perimeter fence was damaged in a few locations along the north side

Comments: The perimeter fence was damaged at one location along the north perimeter road. The top rail was bent, and the link mesh was broken.

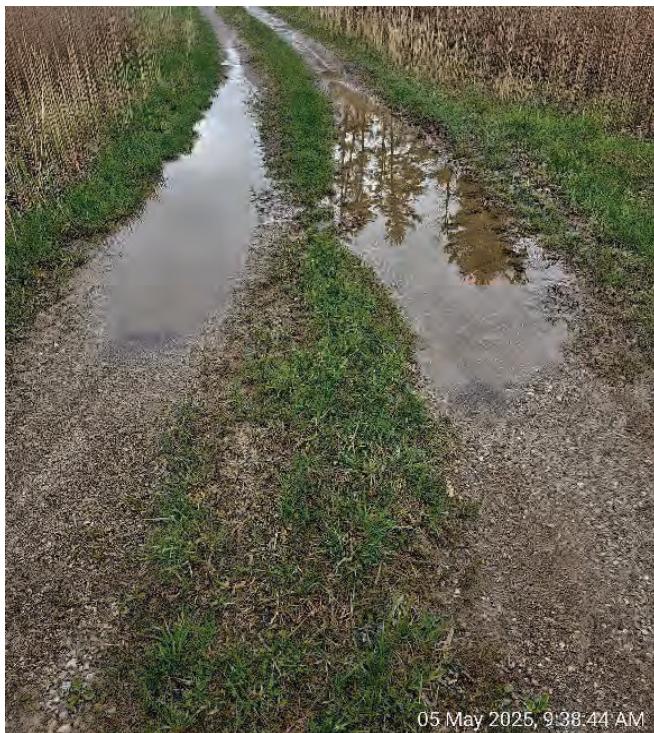
Comments: Low spots and puddles were observed along the perimeter road at the northwest corner of the site between the upper and lower perimeter ditches.

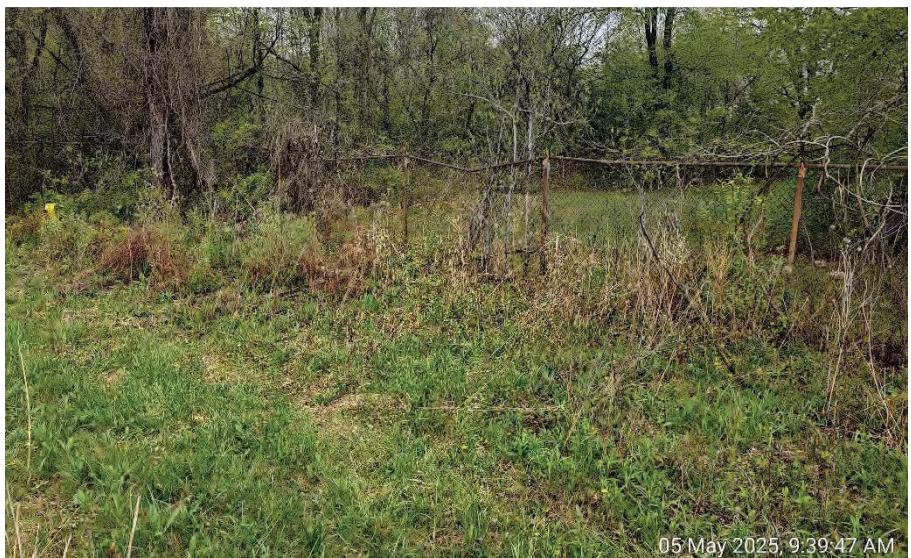
Comments: The perimeter fence was damaged at one location along the northwest corner of the site. The top rail was bent.

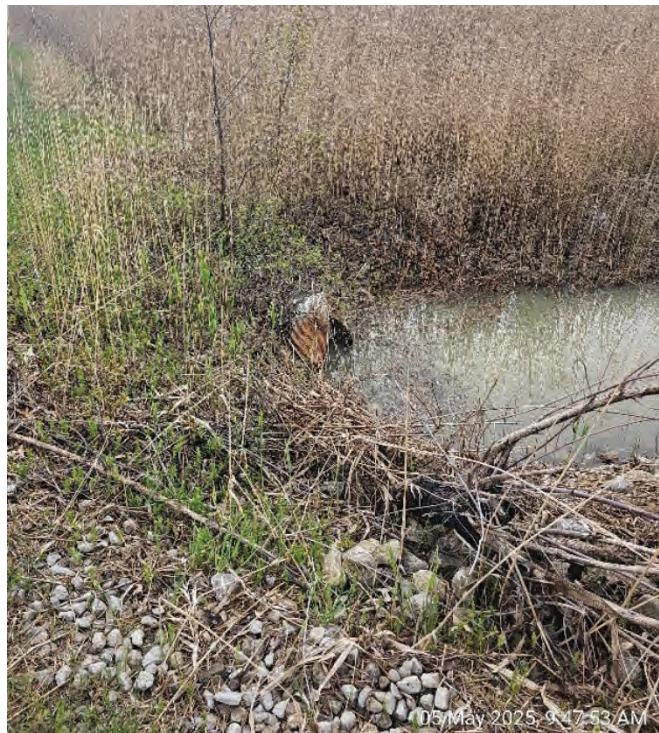
Photograph 30

- viii. The various culverts and discharge pipes within the perimeter ditch system were generally in good condition and not obstructed (Photographs #13, #14, #23, #24, #35). Damage was observed in one corrugated metal culvert at the northwest corner of the Landfill; however, flow through the culvert did not appear to be obstructed (Photograph #30).

Comments: The corrugated metal culvert inlet to the lower perimeter ditch at the lift station was damaged. However, flow through the culvert did not appear to be obstructed.

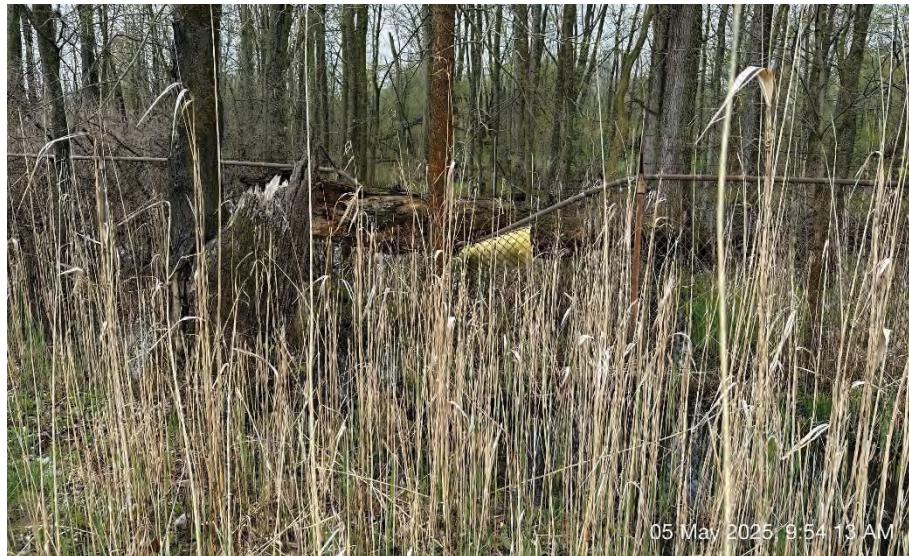
Comments: The perimeter fence was damaged at one location along the west side of the site. The top rail was bent from a tree branch falling on the fence.

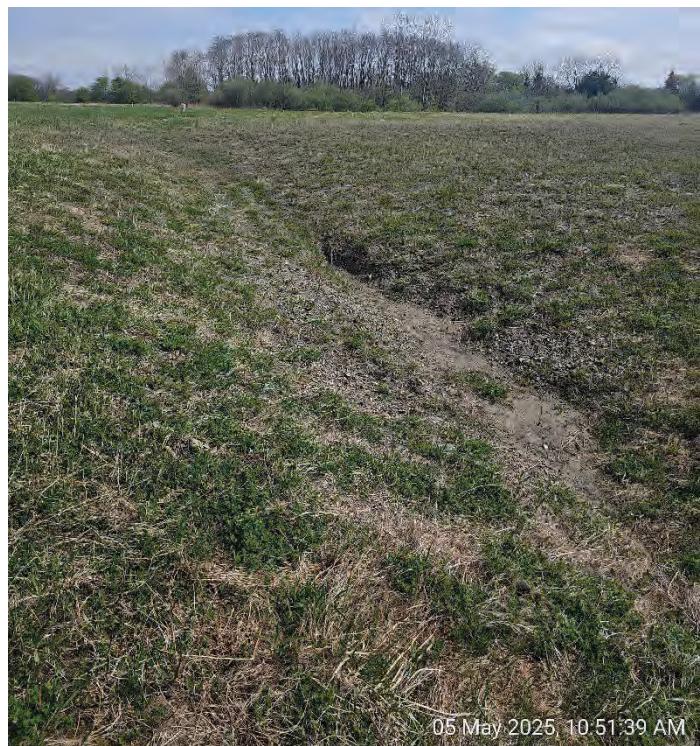
13. A small erosion gully was observed along the top deck where Areas B, B1, and C join (Photograph #41). No water was flowing within the gully during the inspection.

Comments: A small erosion gully was observed along the top deck where Areas B, B1, and C join.

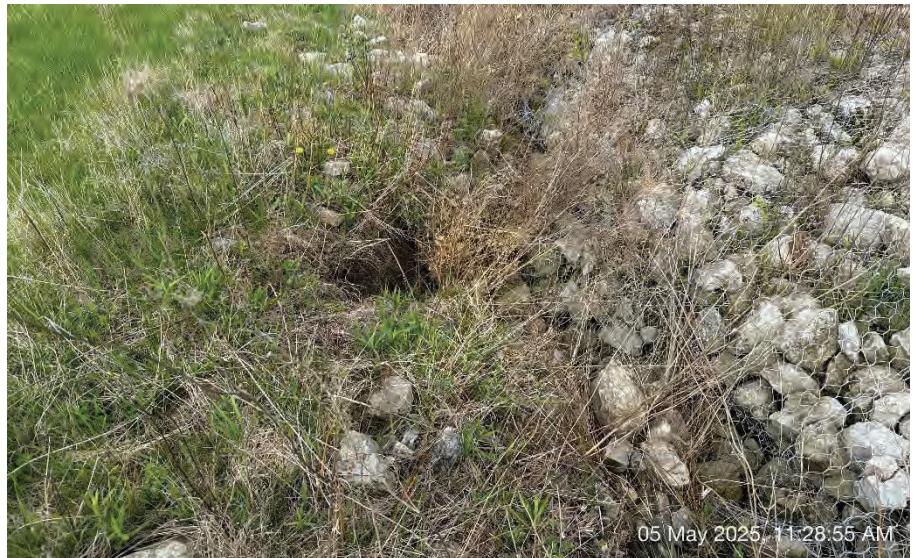
14. The stormwater downchute at the southwest corner of Area F1 has had the riprap along the left side (facing downslope) eroded, resulting in damage to the mesh wiring around the riprap (Photograph #47). It appears finer soil particles have been transported from the mid-slope to the bottom of the downchute (Photograph #49). The erosion at the downchute appears to have progressed slightly over the last year. The riprap at the top of the stormwater downchute was in satisfactory condition with some vegetation but no erosion observed (Photograph #46).

Comments: The riprap on the left side of the stormwater downchute (facing downslope) at the southwest corner of Area F1 had eroded and the wire mesh has been distorted.
