DTE Electric Company

2025 ANNUAL INSPECTION REPORT

SIBLEY QUARRY LANDFILL

Trenton, Michigan

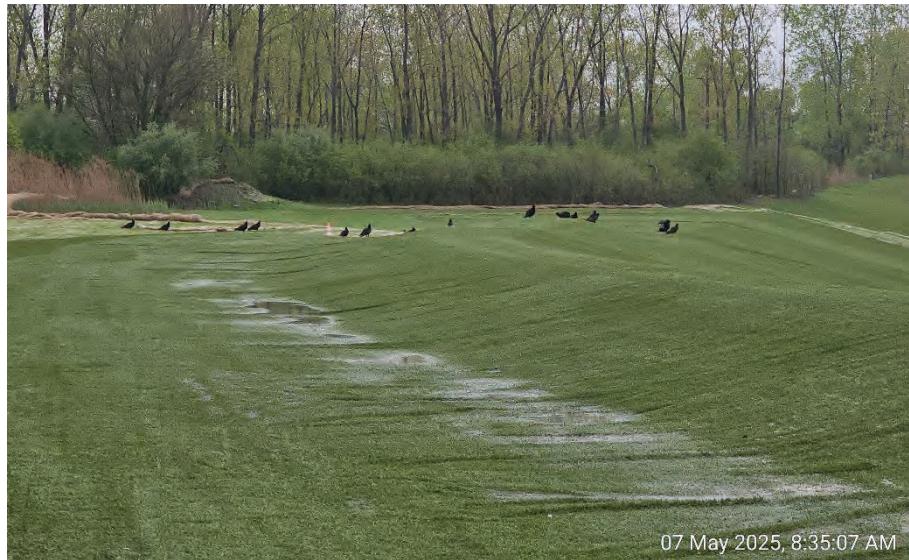
- b. A ClosureTurf® cover system has been installed along the northern slopes extending from the top of Switchback Two to the east quarry sidewalls (Photographs #2, #3, #8, #29). The ClosureTurf system was in good condition with minimal wrinkles and infill erosion. Some material had eroded onto the ClosureTurf system at a location near the east quarry sidewalls where vegetation was still being established (Photograph #2). Some rocks from the east quarry sidewalls had also eroded onto the ClosureTurf system at this location.

Comments: A ClosureTurf® final cover system has been installed on the northern slopes. The ClosureTurf system was in good condition. The diversion berm at the top of the slope (approximately 1 to 2 feet high) was observed to prevent surface flow over the slopes and convey stormwater to the bottom of the Landfill.

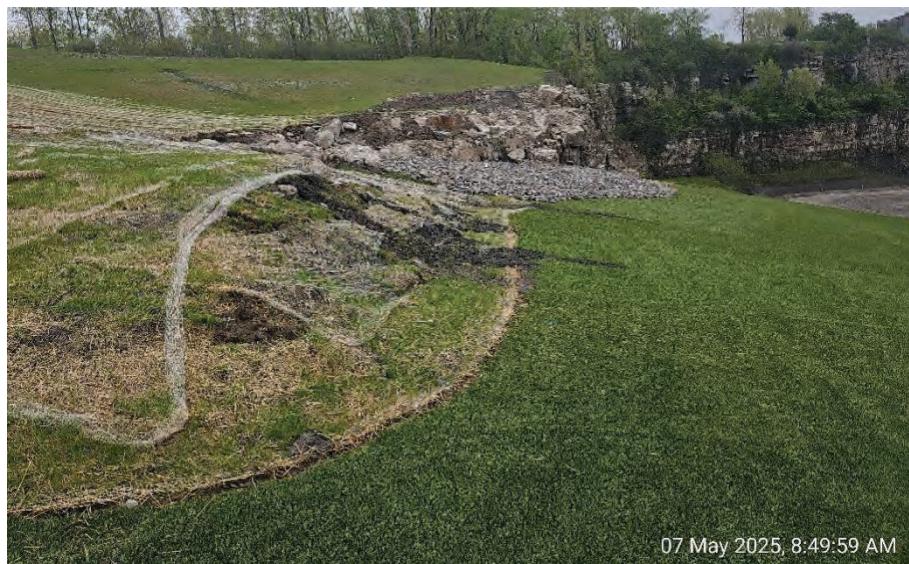
Photograph 2

Comments: Some erosion was observed on a section of the northern slopes not covered with the ClosureTurf system. The eroded material was deposited on top of the ClosureTurf system. Vegetation is being established at this section. Some rocks from the quarry sidewalls had also eroded onto the ClosureTurf system.

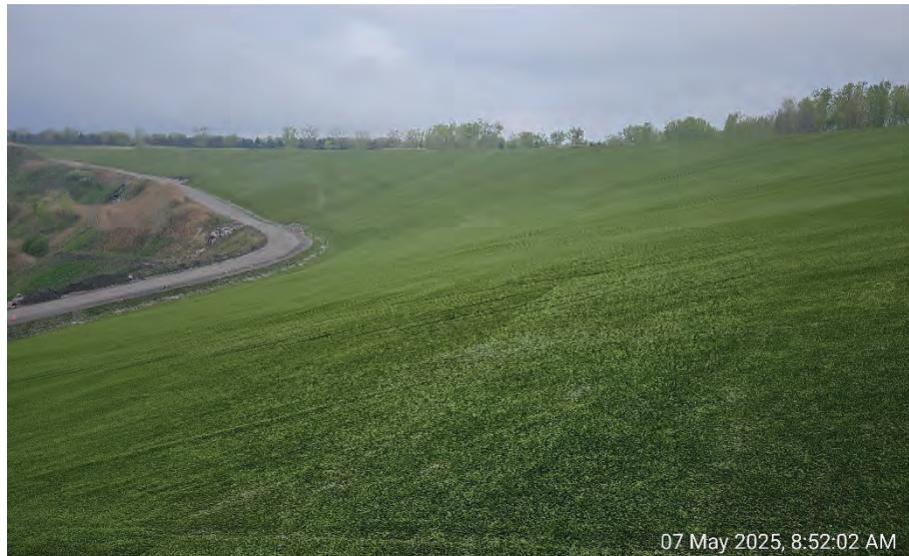
Comments: The northern slopes have been regraded to a 4H:1V slope and covered with a ClosureTurf system. The slopes were uniform and the ClosureTurf system was in good condition with minimal wrinkles and infill erosion.

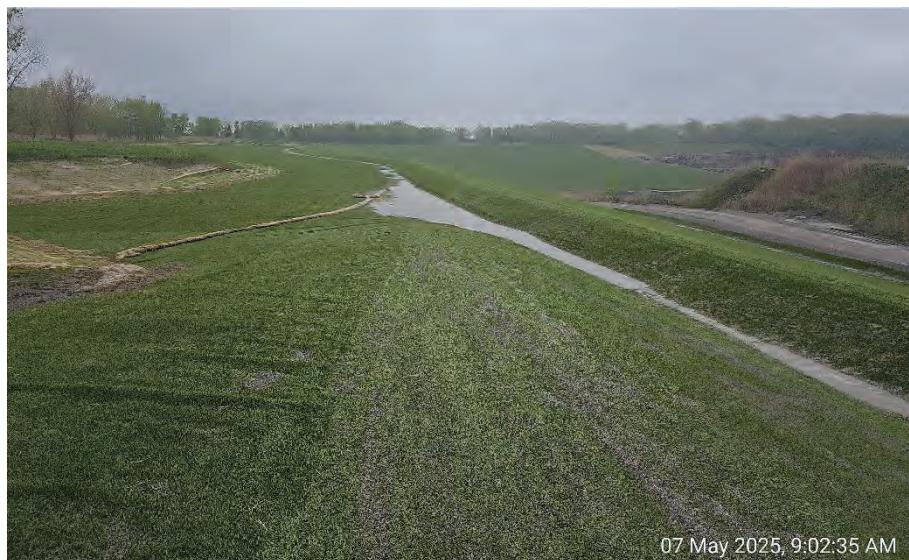
Photograph 4

Comments: The diversion berm at the top of the northern slopes was observed to prevent surface flow over the slopes and convey stormwater to the bottom of the Landfill.

HydroBinder® was used along the diversion berm to prevent erosion of infill. Water was present because of rainfall prior to the inspection.

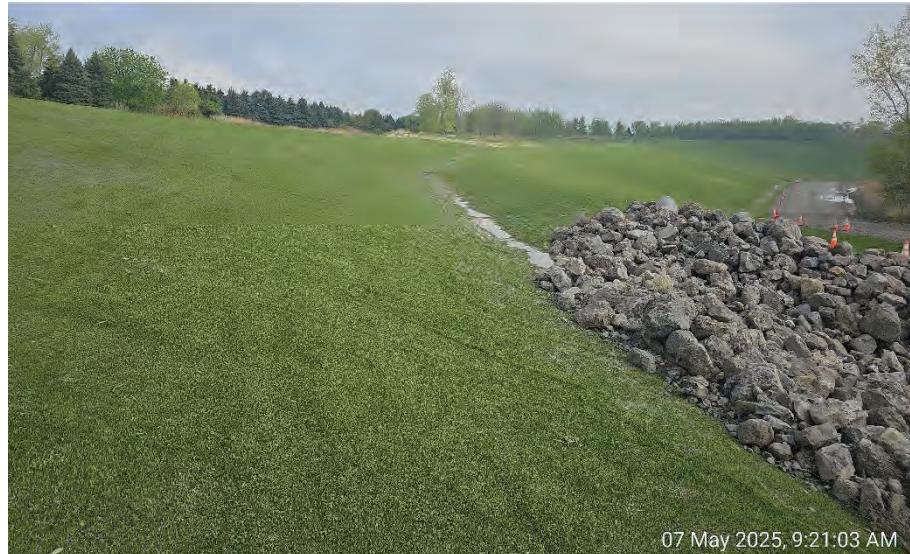
Comments: The diversion berm at the top of the northern slopes were in good condition. The diversion berm was observed to prevent surface flow over the slopes and convey stormwater to the bottom of the Landfill.

Stormwater was observed flowing along the berm and into the riprap during the inspection.

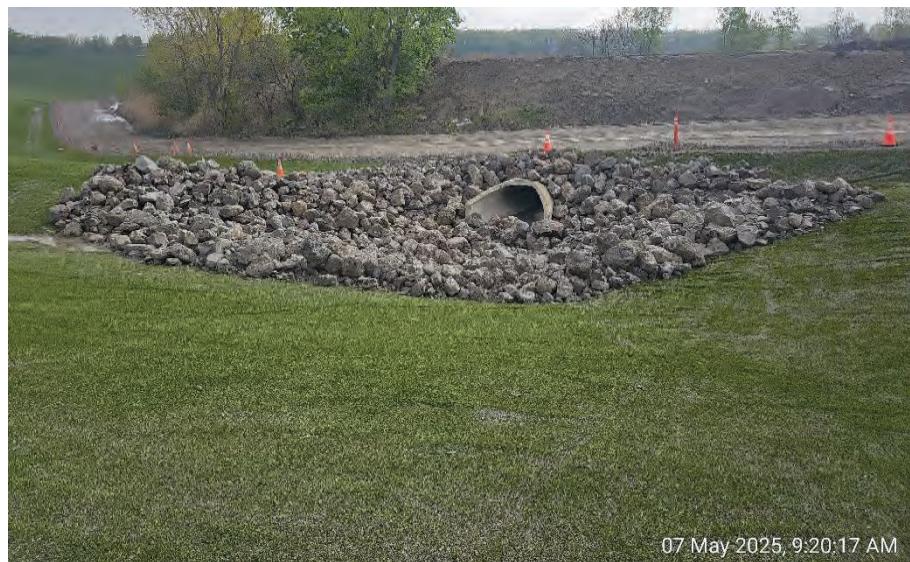
Photograph 6

Comments: The riprap-lined channel and concrete culvert under Switchback Two were in good condition and free of obstructions. The channel and culvert convey stormwater to the bottom of the Landfill.

Stormwater was observed flowing through the channel and culvert during the inspection.

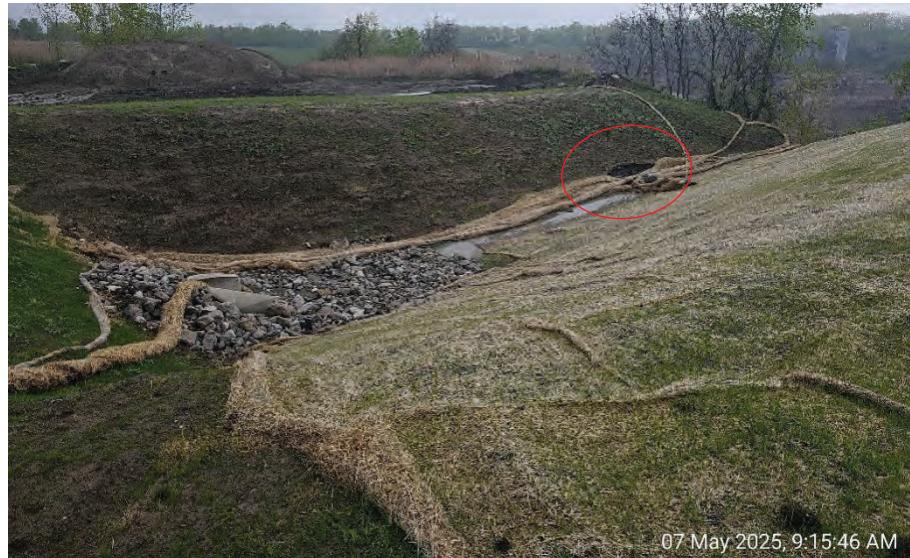
- d. Additional modifications have been made to the riprap-lined channel and concrete culvert under Switchback Two (Photographs #6, #7) that convey stormwater from the diversion berm at the top of the northern slopes over the west quarry sidewalls to the bottom of the Landfill. The riprap-lined channel and concrete culvert were in good condition and had no obstructions. Stormwater was observed flowing through the channel and culvert during the inspection. Some erosion was observed on the side of the channel at one location where vegetation was being established (Photograph #7).

Comments: The riprap-lined channel conveying stormwater from the top of the northern slopes over the west sidewalls to the bottom of the Landfill was in good condition.

Stormwater was observed flowing through the channel during the inspection. Some erosion was observed on the side of the channel. Vegetation is being established at this location.

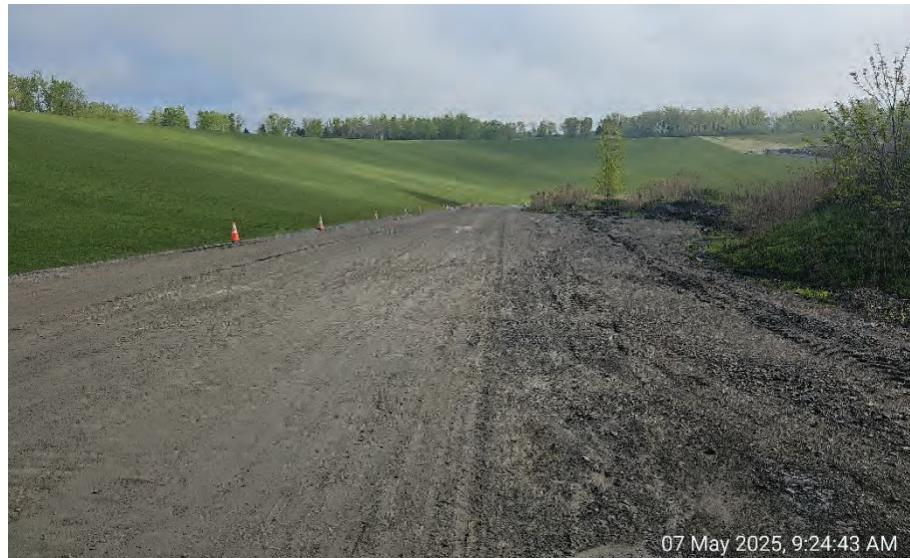
Photograph 8

Comments: Switchback Two was in good condition with no low spots or rutting observed. No fugitive dust was observed during the inspection.

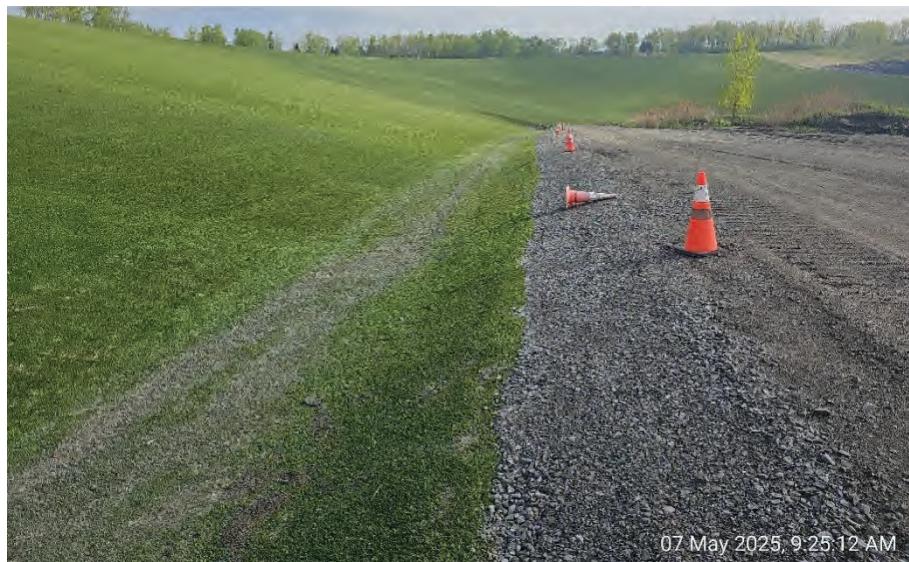
Comments: The stormwater channel along Switchback Two was in good condition. HydroBinder® was used within the channel to prevent erosion of infill. No erosion was observed along the adjacent Switchback Two haul road.

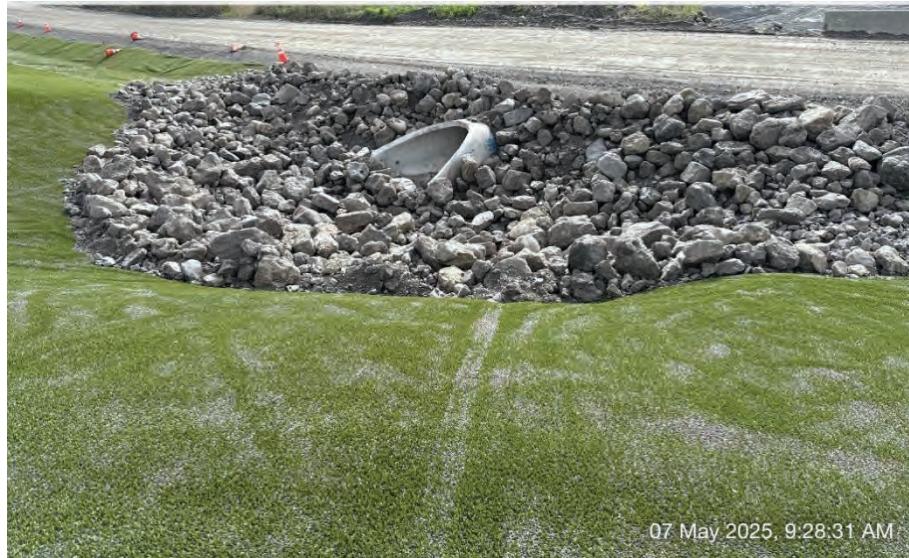
Photograph 10

Comments: The riprap-lined portions of the stormwater channel and concrete culverts under Switchback Two were in good condition and free of obstructions (typical). No erosion was observed within the riprap or along Switchback Two.

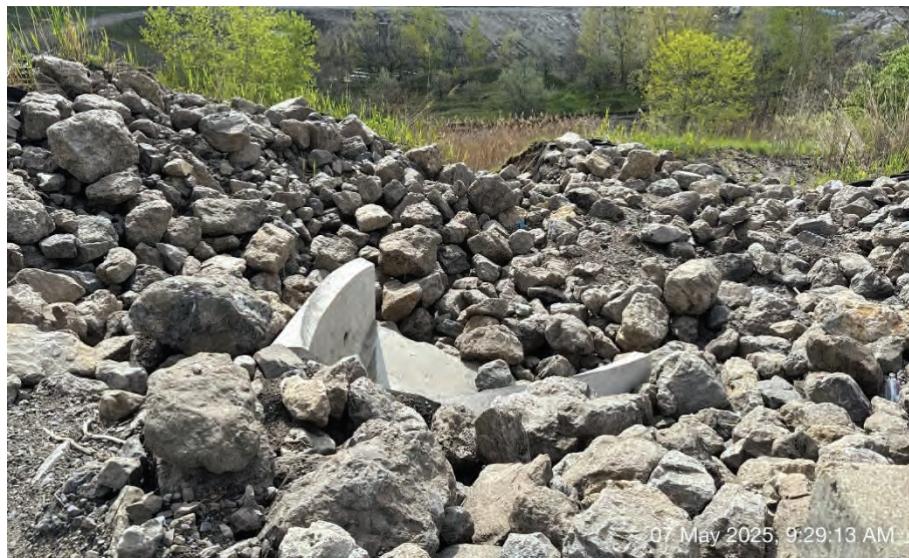
- e. Concrete culverts under Switchback Two and riprap-lined sections (Photographs #10, #11) have been installed at three locations within the stormwater channel along Switchback Two. The riprap and concrete culverts were in good condition. However, erosion gullies were observed on the slopes at the outfalls of the concrete

Comments: The outlets of the riprap-lined channels and concrete culverts were generally in good condition with some erosion in the riprap (typical). However, erosion was observed on the slope where the stormwater discharges over the sidewall to the bottom of the Landfill.

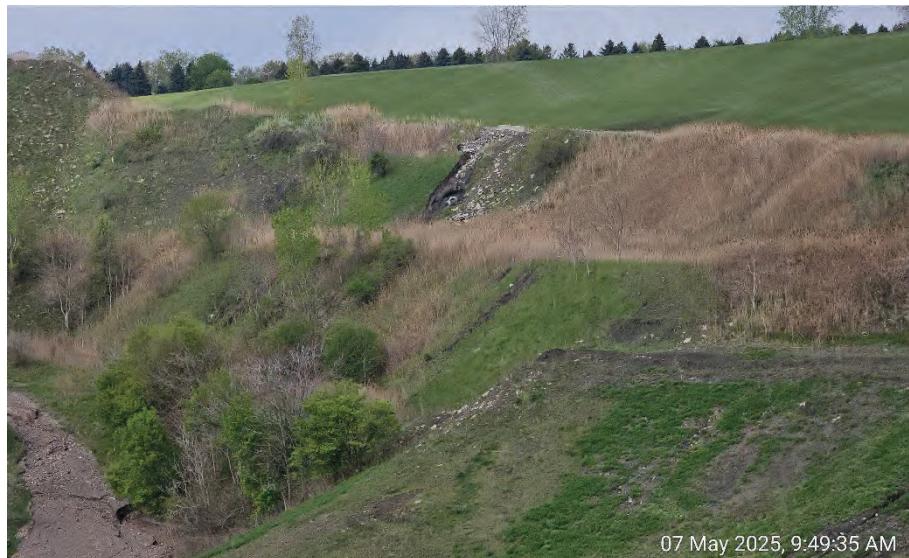
Photograph 12

- 1) Erosion gullies were observed on the slopes at the outfalls of the concrete culverts for the stormwater channel along Switchback Two. No signs of slope instability, such as cracks, settlements, or changes in moisture on Switchback Two were observed during the inspection. Future erosion could affect the stability of Switchback Two which would affect operations and pose a potential safety concern to drivers hauling along Switchback Two and personnel working within the active CCR filling area below Switchback Two.

Comments: Erosion gullies were observed on the slopes at the outfalls of the concrete culverts for the stormwater channel along Switchback Two. The eroded material is being transported to the bottom of the Landfill.

- 1) DTE should continue to monitor the outfalls of the concrete culverts and surrounding riprap along Switchback Two to assess whether expansion of the existing erosion gullies or the formation of new erosion features is occurring. Switchback Two should also be monitored in these areas for cracking or other signs of slope instability. This should be continued during active filling operations.

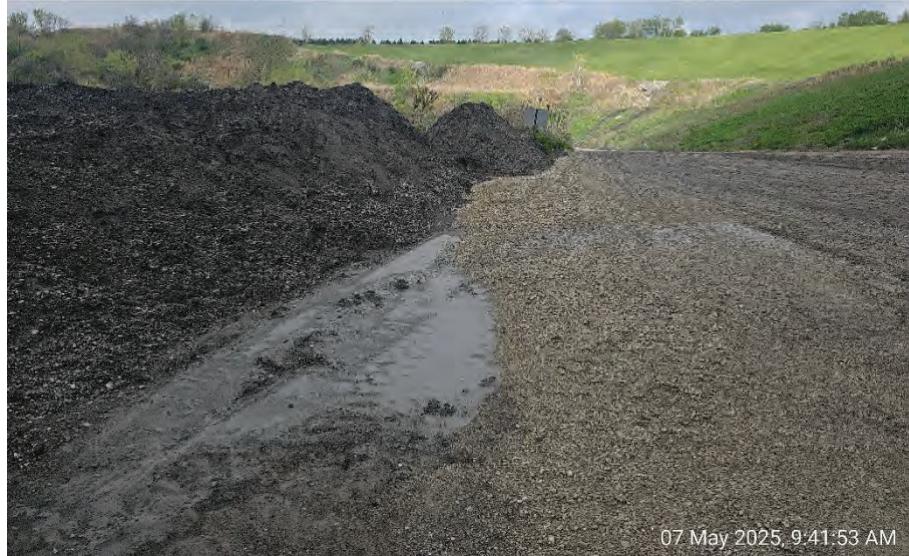
Comments: The diversion berm along the bottom of Switchback Two to mitigate stormwater flow over the bottom slopes was in good condition.

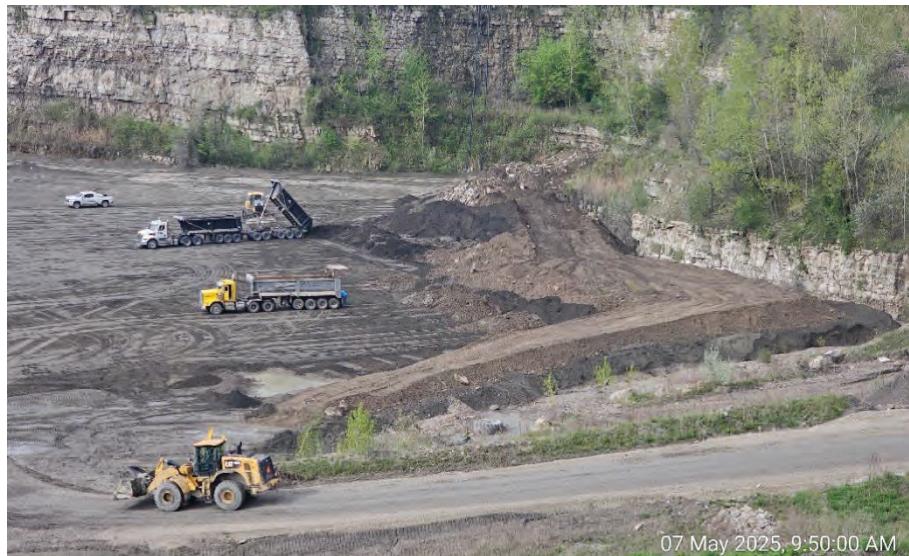
Photograph 14

Comments: Overview of the Landfill operations and active CCR filling areas. CCR material was transported to the bottom of the Landfill, dumped, stacked, then spread and compacted. The equipment appeared to be operating safely and at speeds to minimize fugitive dust.

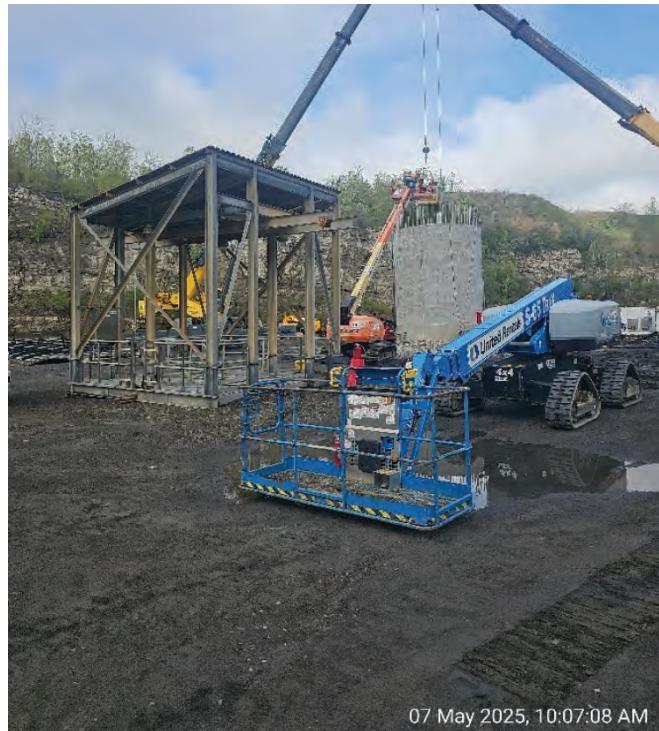
Comments: The chimney sump at the bottom of the Landfill was being raised at the time of the visual inspection. The sump and surrounding filter layer were in good condition. Pumping was not occurring during the inspection while the pumps were undergoing maintenance.

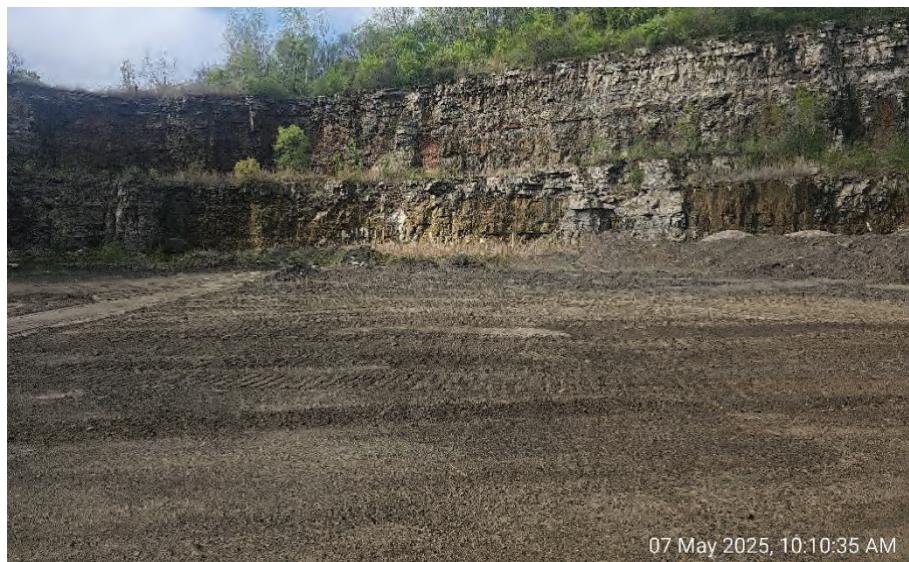
Photograph 16

- 5) The natural fractures within the quarry sidewalls present a potential safety hazard related to rock falls. DTE had implemented a safety buffer to maintain a minimum distance of 20 feet from the sidewalls (Photograph #16). However, active CCR filling is now adjacent to the quarry sidewalls as the elevation of the CCR has increased (Photographs #17, #18).

Comments: Active CCR filling area at the bottom of the Landfill and south sidewall of the Landfill. Groundwater inflow from the sidewall was observed during the inspection. Placement of CCR appeared to be in line with generally accepted engineering practices.

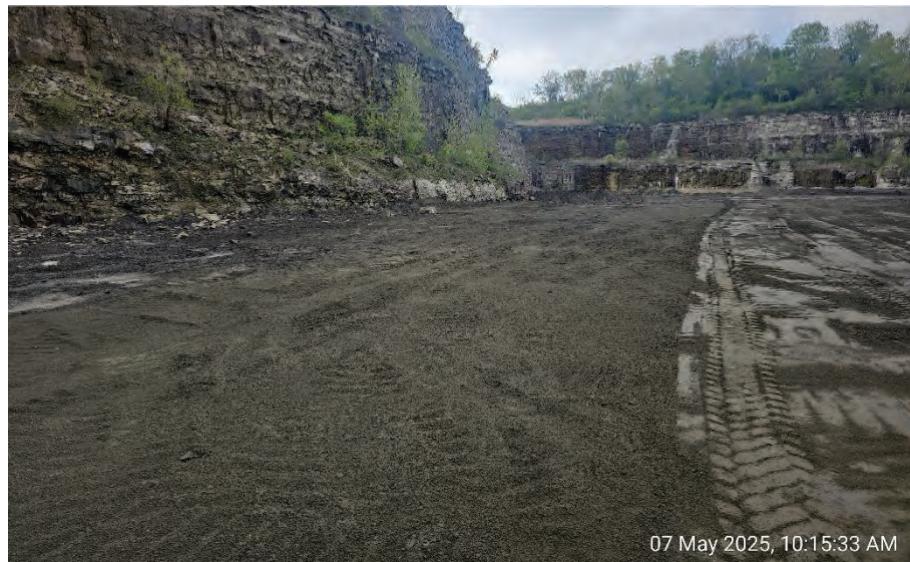
Comments: Active CCR filling area at the bottom of the Landfill and east and south quarry sidewalls. Groundwater inflow from the sidewalls was observed during the inspection. Placement of CCR appeared to be in line with generally accepted engineering practices. The CCR is now placed adjacent to the quarry sidewalls.

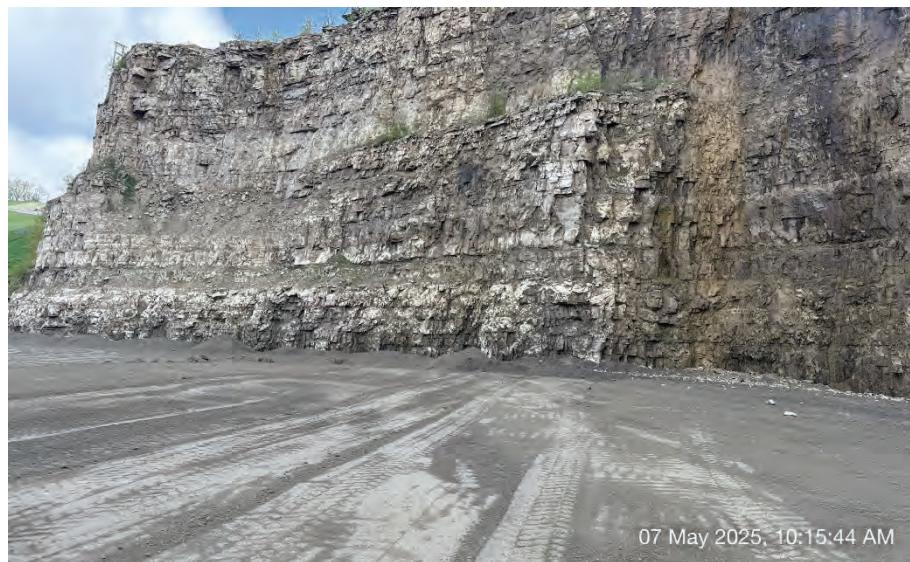
Photograph 18

Comments: Active CCR filling area at the bottom of the Landfill and north quarry sidewalls. Groundwater inflow from the sidewalls was observed during the inspection. Placement of CCR appeared to be in line with generally accepted engineering practices. The CCR is now placed adjacent to the quarry sidewalls.

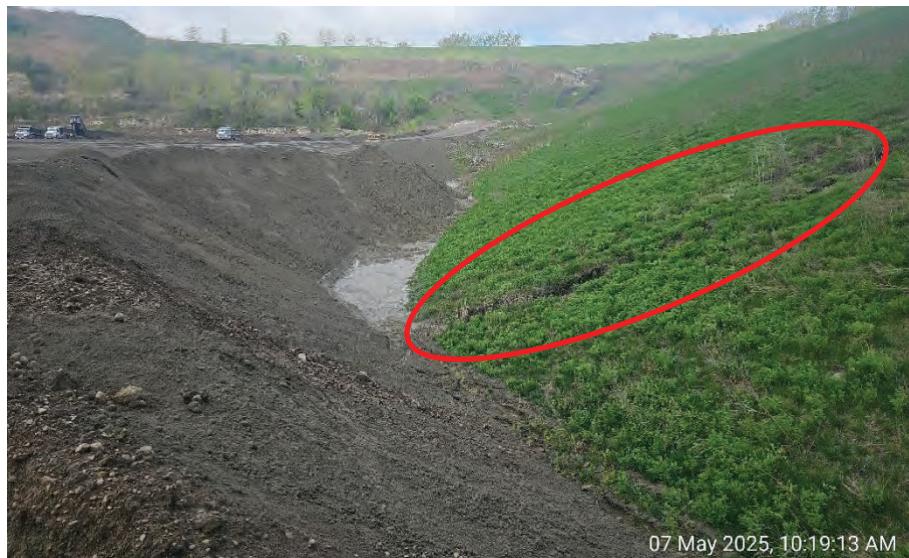
- 7) One erosion rill was observed on the lower slope of Switchback Two (Photograph #19). Due to the incised nature of the Landfill, this feature does not represent an existing concern to the safety and operation of the Landfill. The size of the erosion rill had not significantly increased since the 2024 annual inspection. The lower slope of Switchback Two otherwise was in satisfactory condition (e.g., vegetation well maintained, no indicators of slope instability).

- 4) The erosion rill observed on the lower slope of Switchback Two, which was also observed during previous inspections, has not significantly changed in size or geometry since the 2024 annual inspection. All eroded material will be contained within the landfill footprint; however, continued erosion could begin to affect the stability of the northern slopes.

Comments: An erosion rill was observed on the lower slope of the Switchback Two haul road. The lower slope of Switchback Two was generally in satisfactory condition. Vegetation was well maintained and no indicators of slope instability were observed.

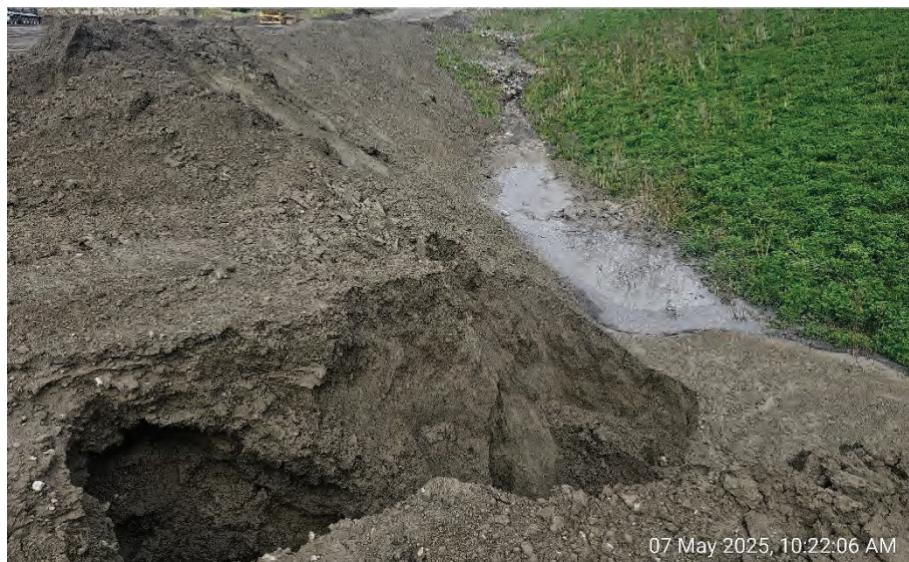
Photograph 20

- 6) The side slopes of the CCR placed within the active filling area are relatively steep (approximately 1.5H:1V). An erosion gully was observed on the north side slope of the stacked CCR at the bottom of the Landfill (Photograph #20). The eroded CCR was contained within the Landfill footprint. However, this condition represents a potential safety concern if equipment operators get too close to the side slopes of the active filling area.

- 2) The side slopes of the CCR placed within the active filling area are relatively steep, and an erosion gully was observed along the north side slopes. Although the eroded material is contained within the Landfill footprint, erosion of the side slopes may pose a safety concern for the operation of construction equipment working in the active filling area near the side slopes.

Comments: An erosion gully was observed on the north side slope of the stacked CCR at the bottom of the Landfill. The stormwater channel and check dams at the bottom of Switchback Two leading to the bottom of the Landfill were filled with sediments from erosion of the lower slope and edges of stacked CCR.

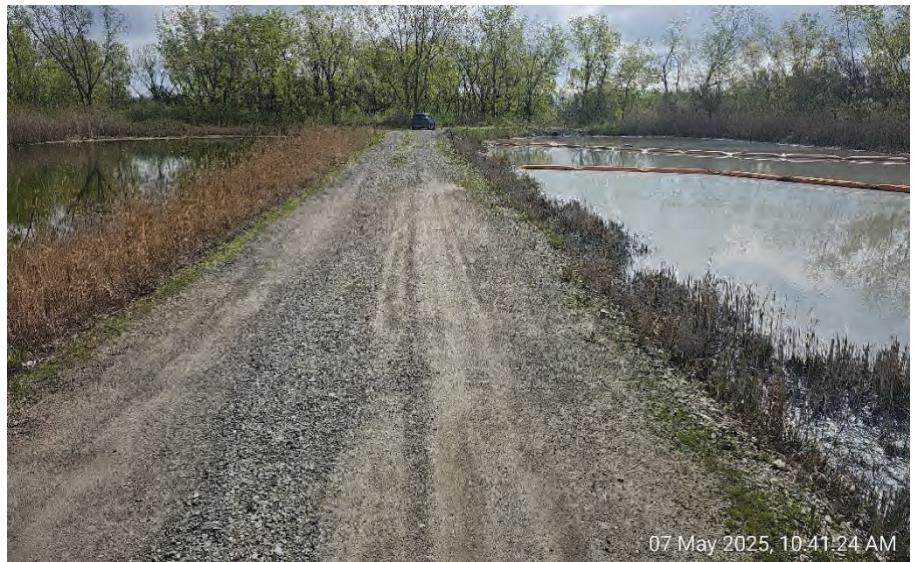
Comments: The upper ponds were in good condition with some vegetation and no erosion observed. The north pond (left side) is used as water supply while the south pond (right side) is used to treat water collected at and pumped from the bottom of the Landfill. The silt curtains in the south pond were in satisfactory condition.

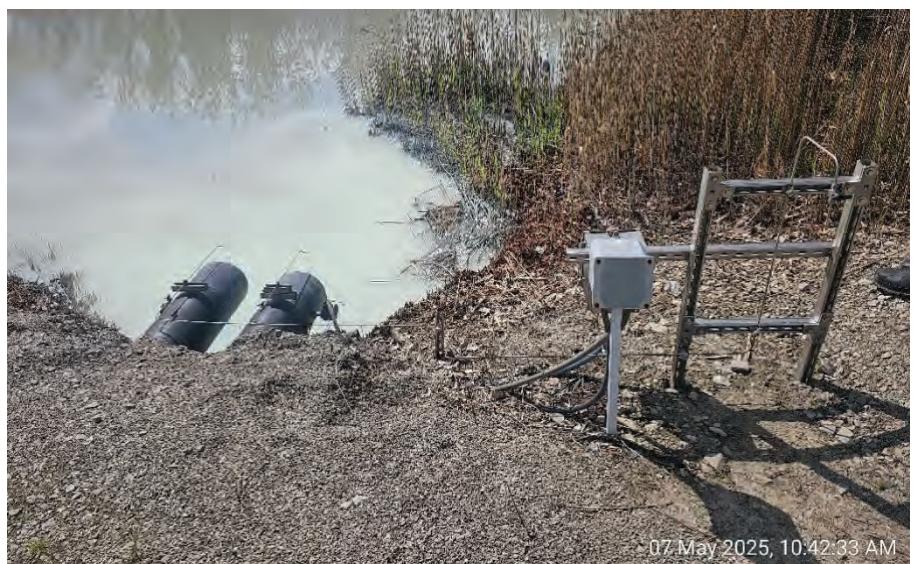
Photograph 22

Comments: The discharge pipes from the chimney sump at the bottom of the Landfill into the south upper pond were in good condition. No erosion or indicators of slope instability were observed along the upper ponds. Pumping from the chimney sump was not occurring during the inspection.

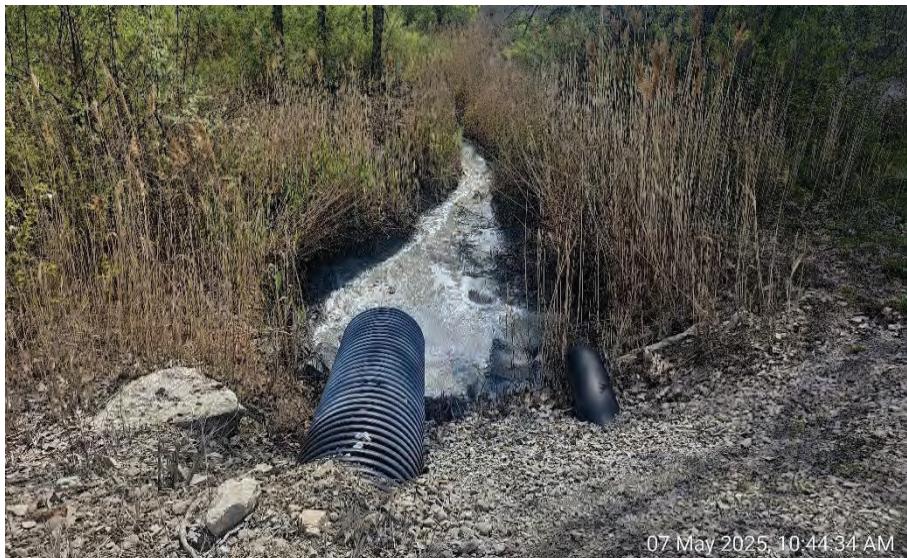
Comments: The discharge from the south upper pond into the conveyance channel was in satisfactory condition. Some erosion was observed on the sides of the conveyance channel. However, minimal erosion was observed below the discharge. No indicators of instability were observed on the embankment between the south upper pond and conveyance channel.

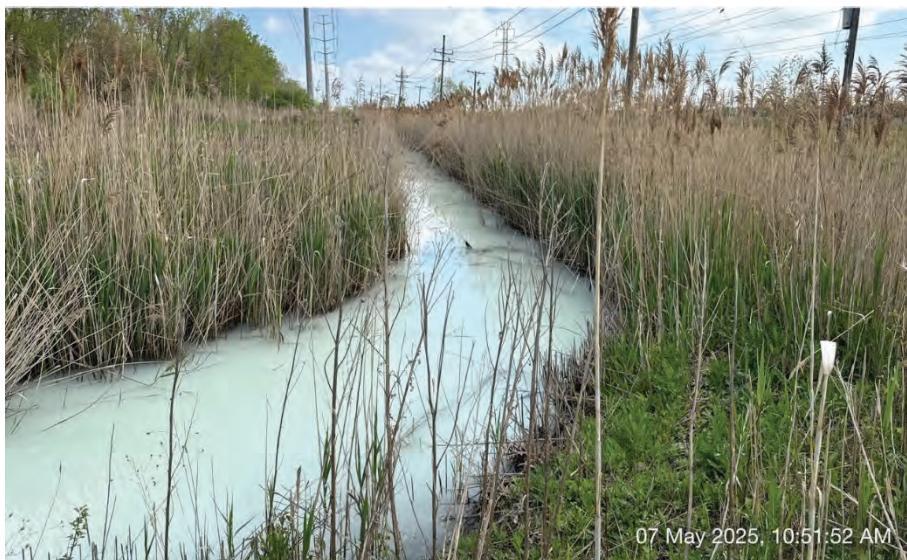
Photograph 24

Comments: The conveyance channel west of the settling ponds was in satisfactory condition. Vegetation (phragmites) was observed on the sides of the channel but did not appear to impact the conveyance of water to the settling ponds. No erosion or indicators of instability were observed along the side slopes of the conveyance channel.

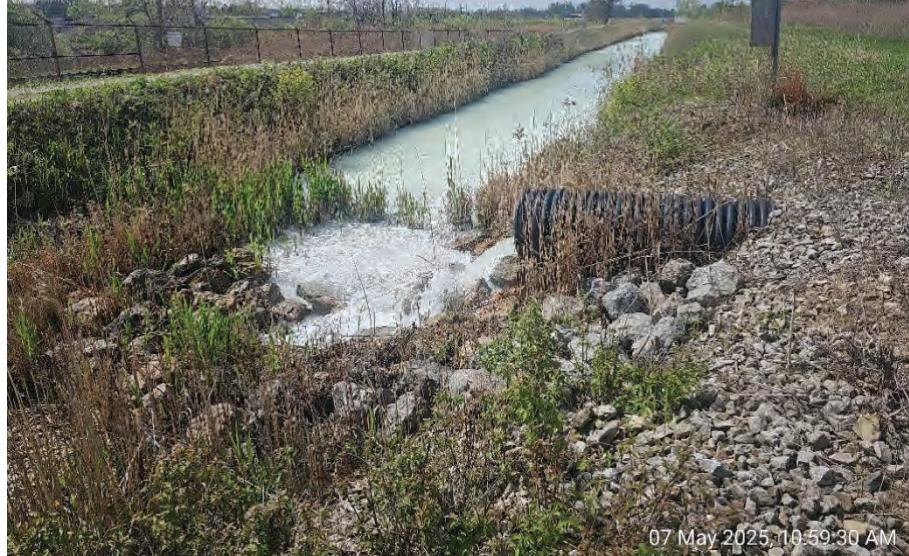
Comments: The discharge from the conveyance channel into Settling Pond #4 and Settling Pond #4 were in good condition. Some vegetation was noted near the outlet, but it did not appear to affect water flow into the settling ponds. No erosion of the riprap below the outlet was observed.

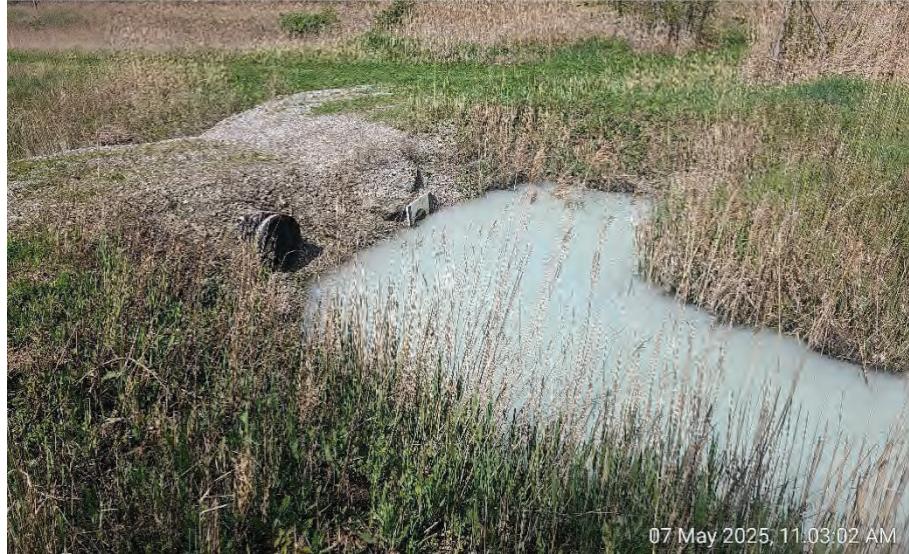
Photograph 26

Comments: The culverts between Settling Pond #4 and Settling Pond #3 were in good condition. No obstructions were observed at the inlets. Some vegetation and erosion were observed beneath the outlets of the pipes into Settling Pond #3.

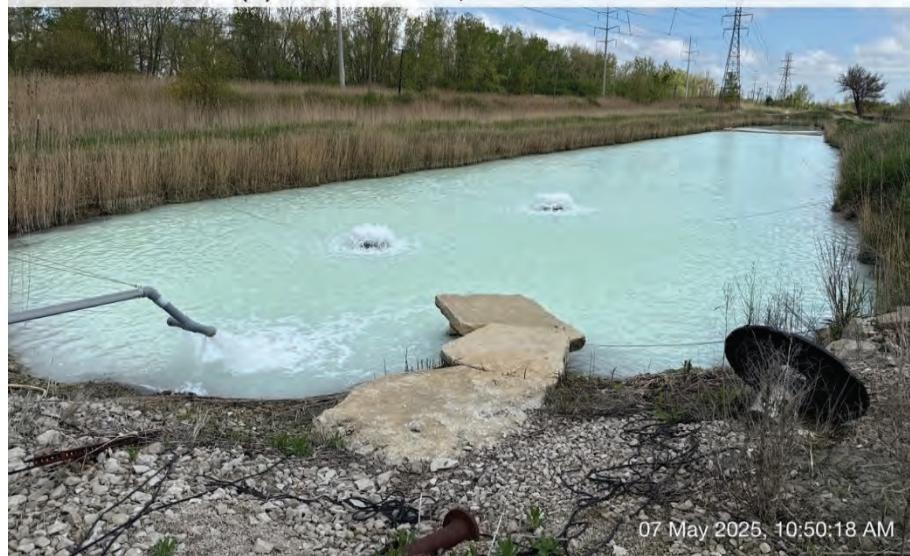
Comments: The aerators in Settling Pond #3 were operational and in good condition. Settling Pond #3 was overall in good condition. The side slopes of the pond had no observed erosion or indicators of slope instability. The silt curtains were in satisfactory condition.

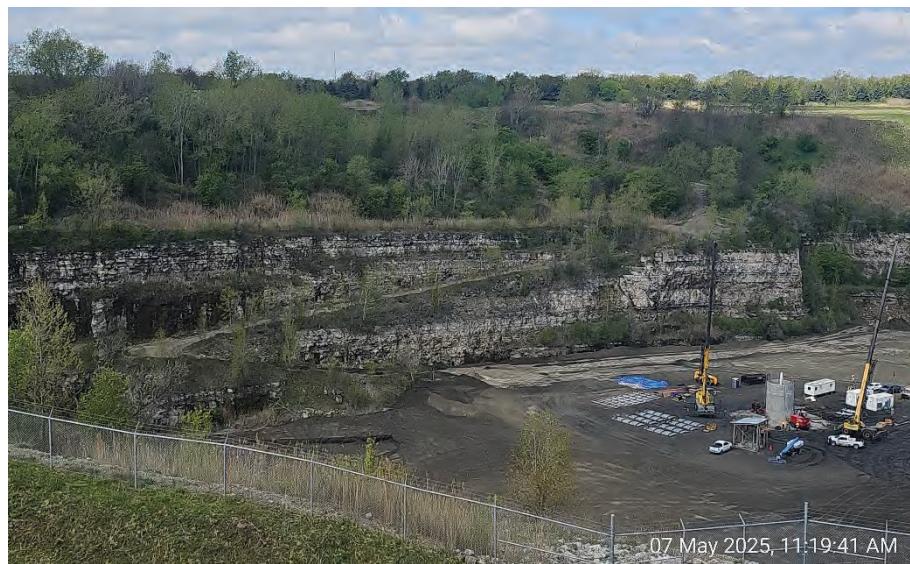
Photograph 28

Comments: The emergency haul roads on the east quarry sidewalls appeared to be in satisfactory condition but are not in use during the active filling operations.

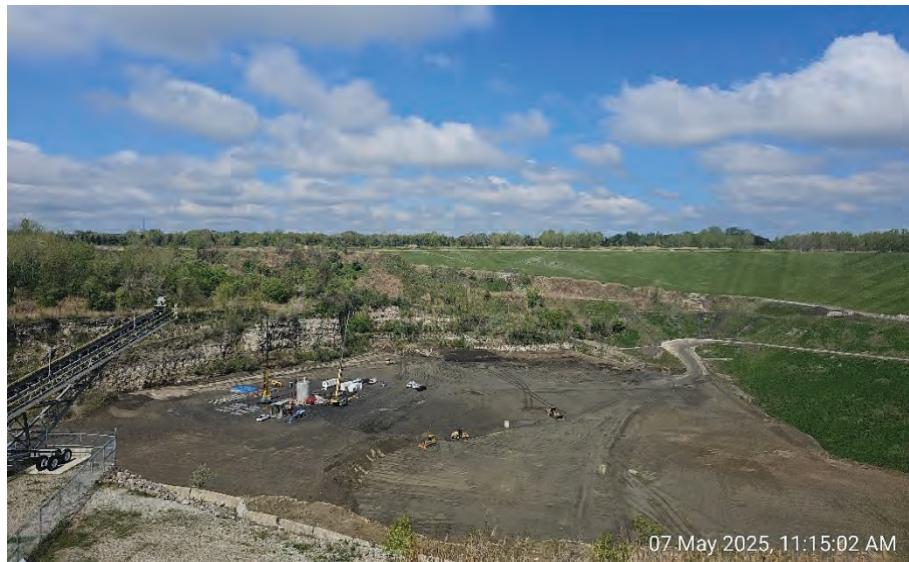
Comments: The ash conveyor system at the top of Landfill on the southeast side was in good condition. The ash conveyor has not been used since the previous annual inspection.
