# **DTE Energy Monroe Power Plant**

## **Inactive Bottom Ash Impoundment CCR Rule Compliance Project**

### **Annual Inspection Report - 2017**

Project Number: 60516675

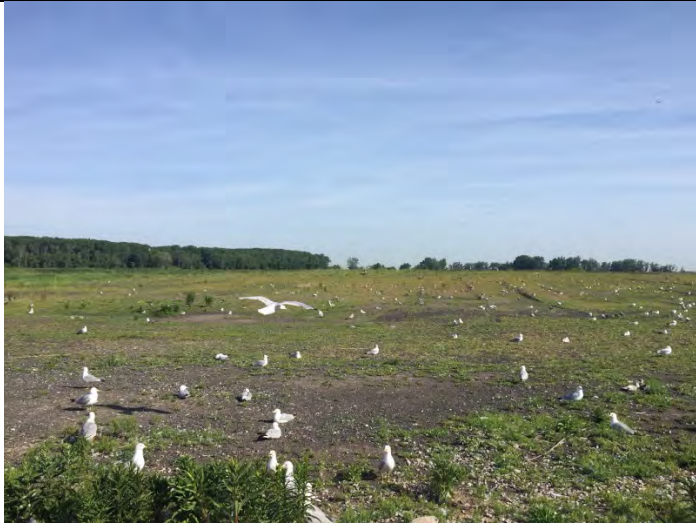
**Photo 1: Looking South from access road**

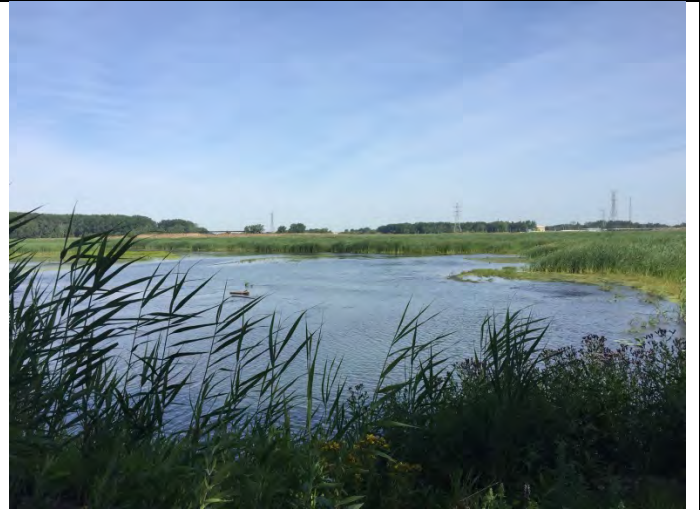
**Photo 2: Looking west from east access road at sluiced ash area**

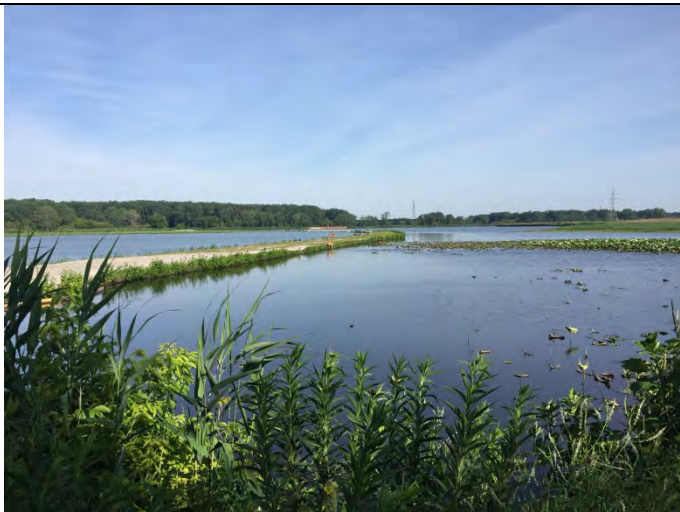
**Photo 3: Looking west from east access road at south separation berm**

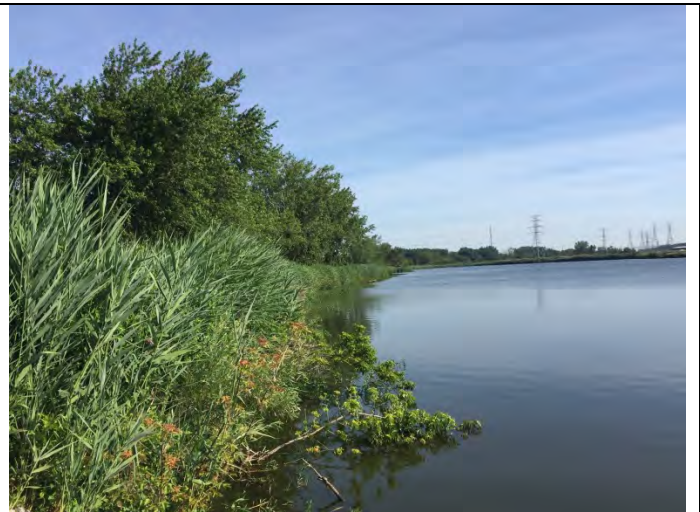
**Photo 4: Looking north along west access road north of separation berm**

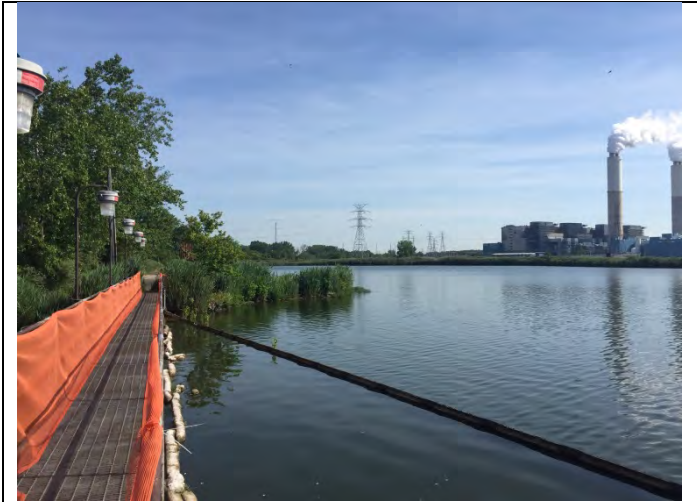
**Photo 6: Looking north from spillway walkway**

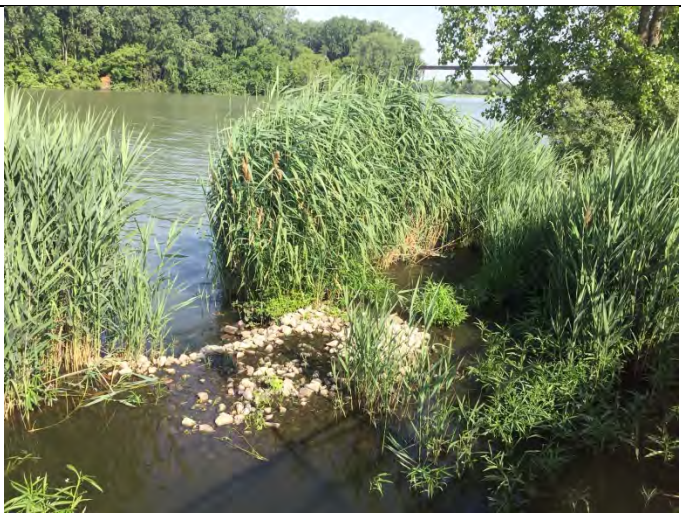
- The downslope sides of the Impoundment are heavily vegetated and a thorough inspection of the entire surface area of the impoundment is not practical.
- The downstream side of the spillway is heavily vegetated and flow through the spillway is redirected preferentially due to this vegetation. Flow through the spillway is not impeded due to the vegetation at this time.

**Photo 5: Looking west at discharge from spillway into canal**
