2015 ANNUAL INSPECTION REPORT SIBLEY QUARRY LANDFILL

Trenton, Michigan

**Subject: 2015 Annual Inspection Report
Sibley Quarry Landfill Annual Inspection**

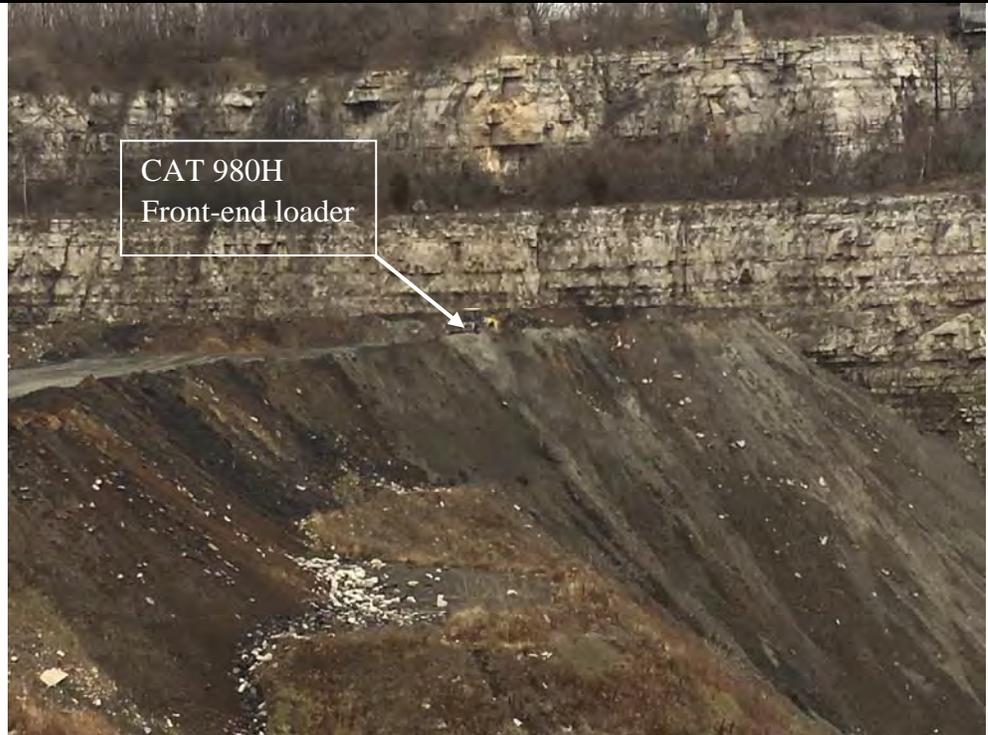
Photograph 1

Comments: Front-end loader is at the top of CCR slope pushing recently brought CCR down the slope (facing east).

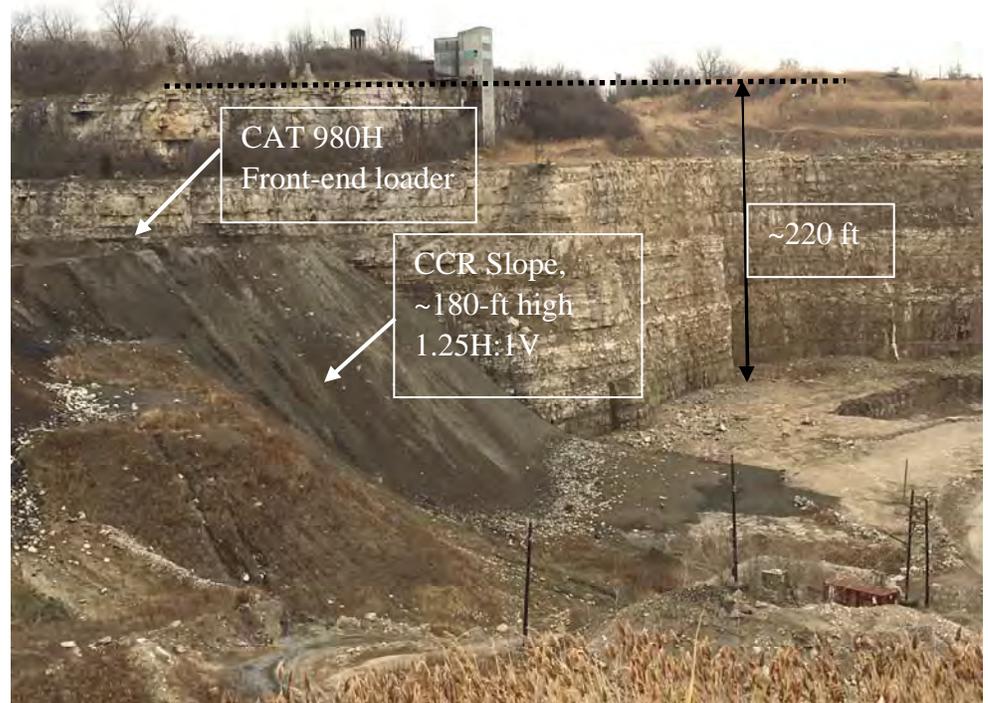
Photograph 2

Comments: CCR slope at the far east end of the quarry.

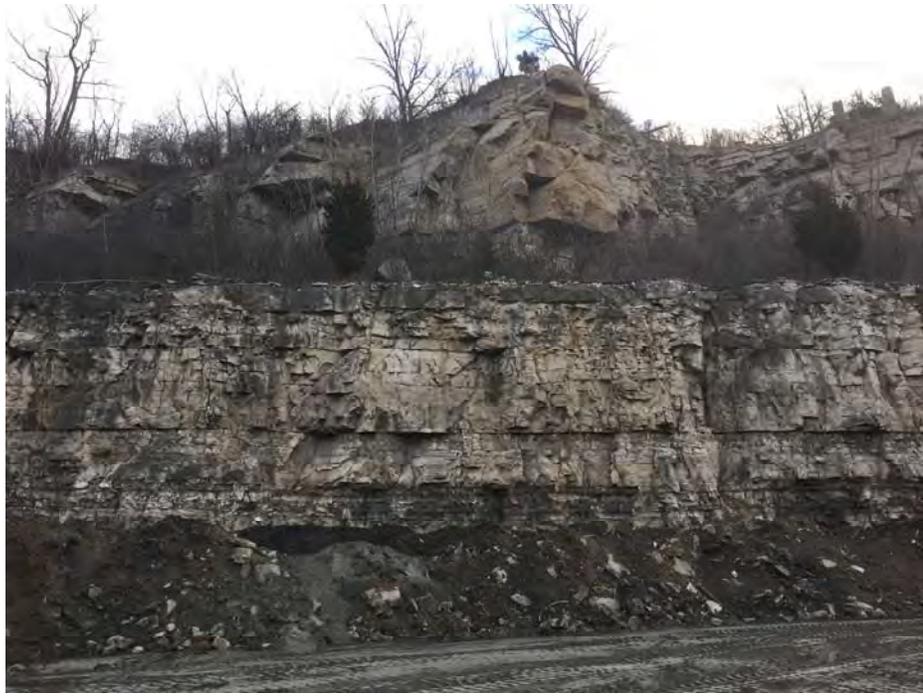
Photograph 3

Comments: Quarry
side walls in the
general area where
front-end loader is
operating (facing east).

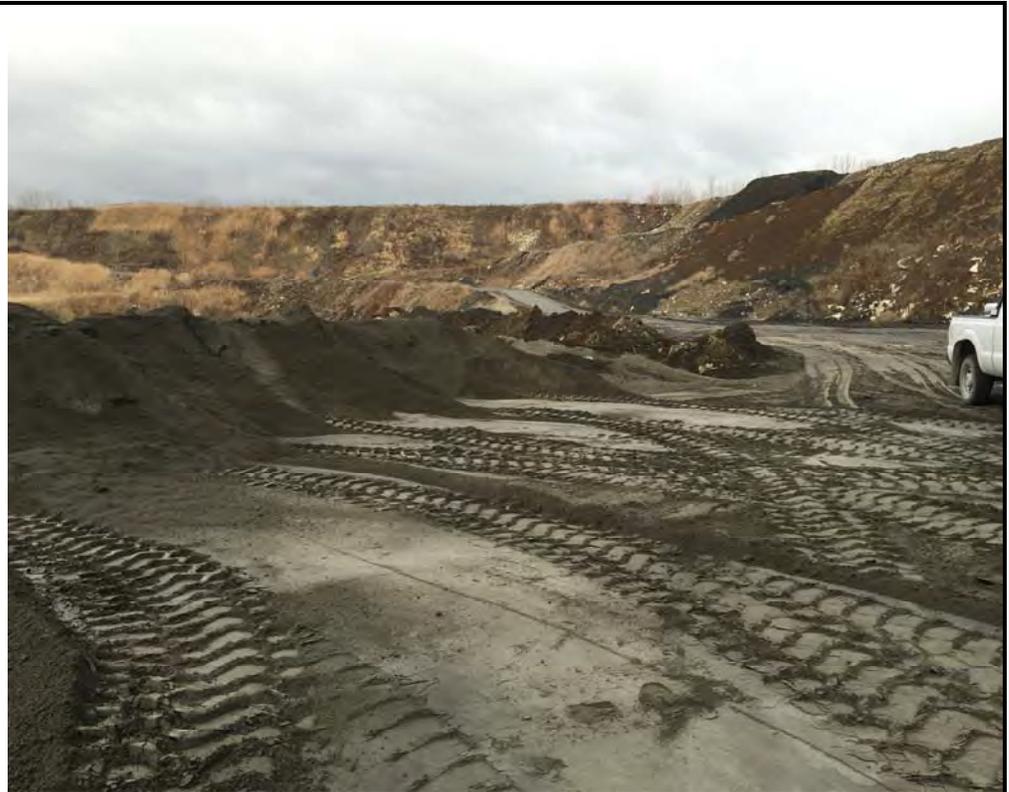
Photograph 4

Comments: Piles of
CCR recently brought
to the site (facing
west).

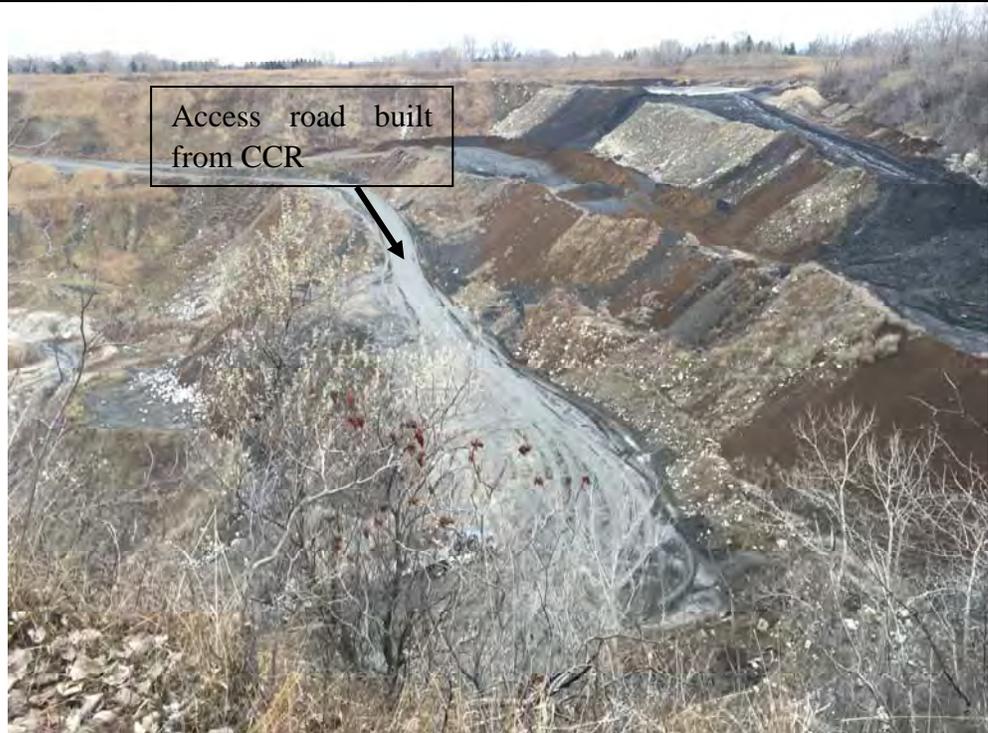
Photograph 5

Comments: General
view of the active
filling area (facing
west).

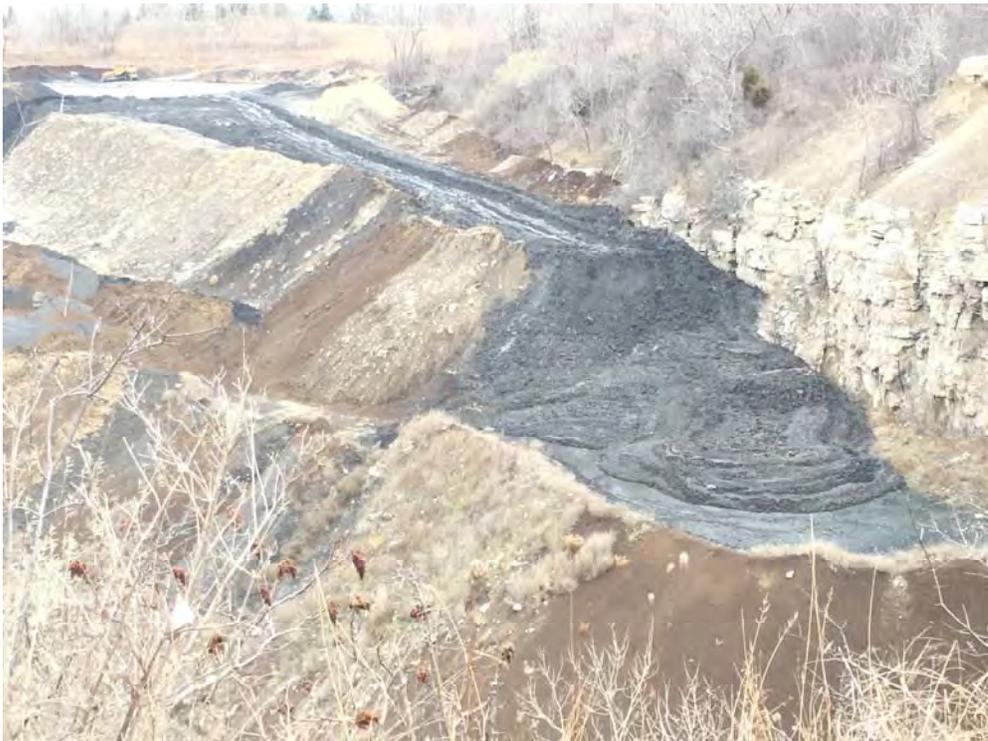
Photograph 6

Comments: CCR
from ash basin
cleaning placed at the
upper tier of the
landfill (facing west).

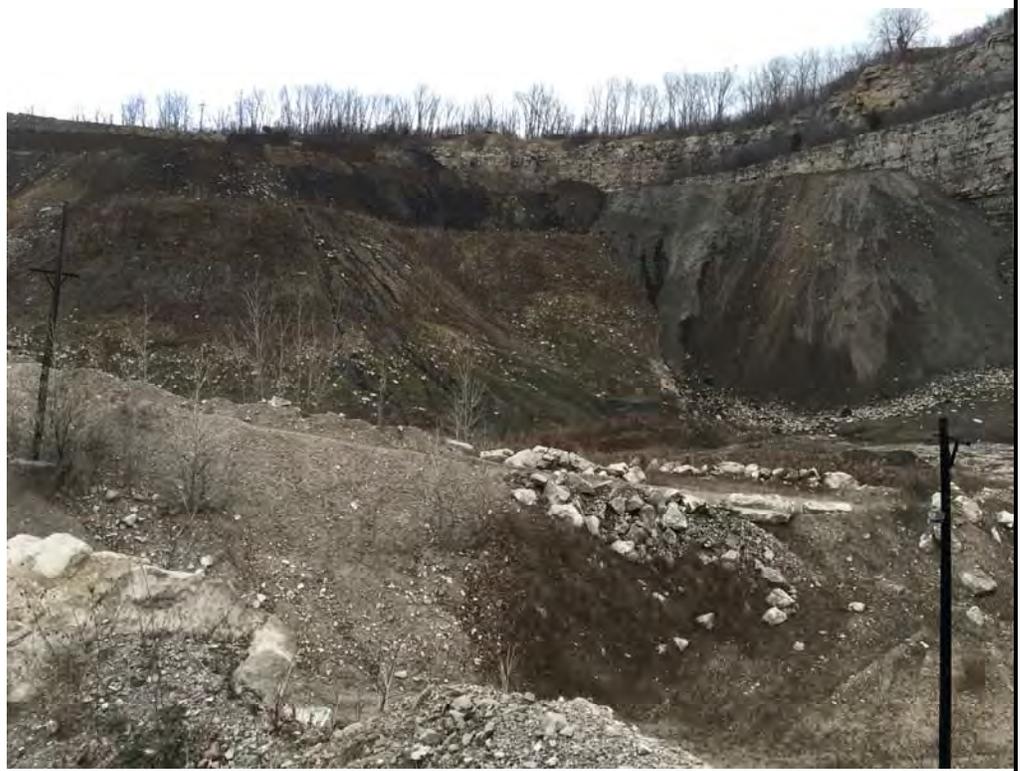
Photograph 7

Comments: Active
filling area from the
bottom of the quarry
(facing northeast).

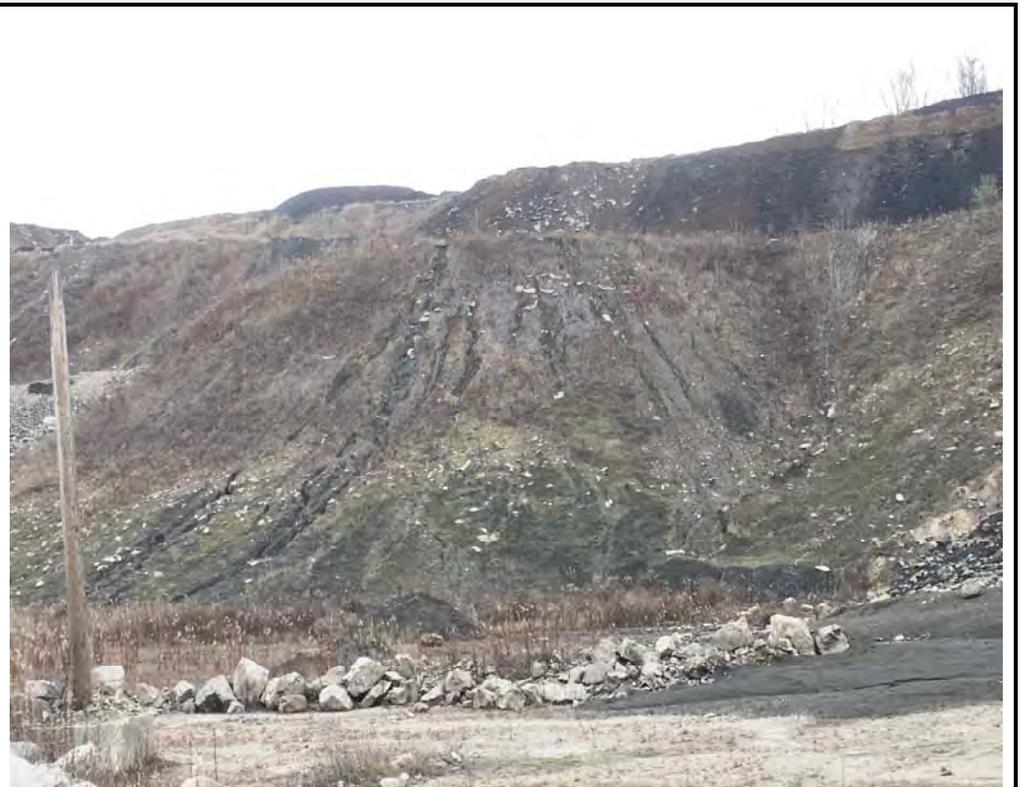
Photograph 8

- 8) Based on topographic information, the Landfill does not appear to have direct run-on from the adjacent areas.
- 9) Erosion gullies on the CCR slopes (see Photograph 8) were observed. These gullies do not have to be maintained due to the incised nature of the Landfill.

Gully erosion was observed on the active face of the CCR disposal area. Measurements were not taken for safety reasons.

Comments: Gully
erosion on the active
filling area (facing
northeast).

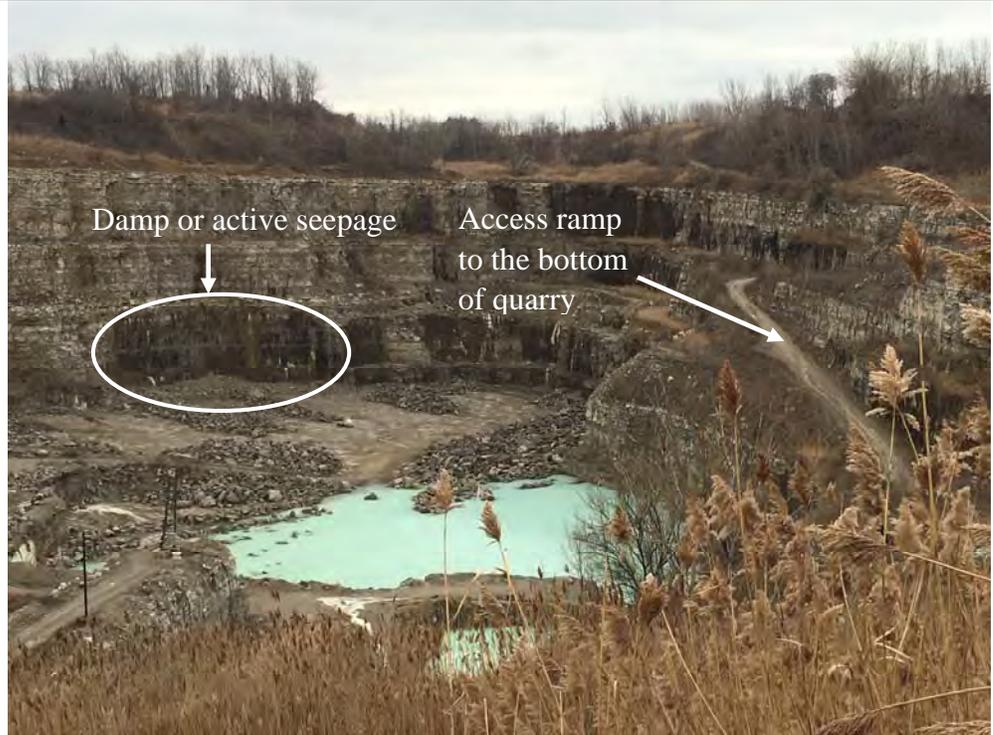
Photograph 9

Comments: View from the quarry, facing south. Areas on the side walls that appear to be darker are damp or there is active groundwater seepage.

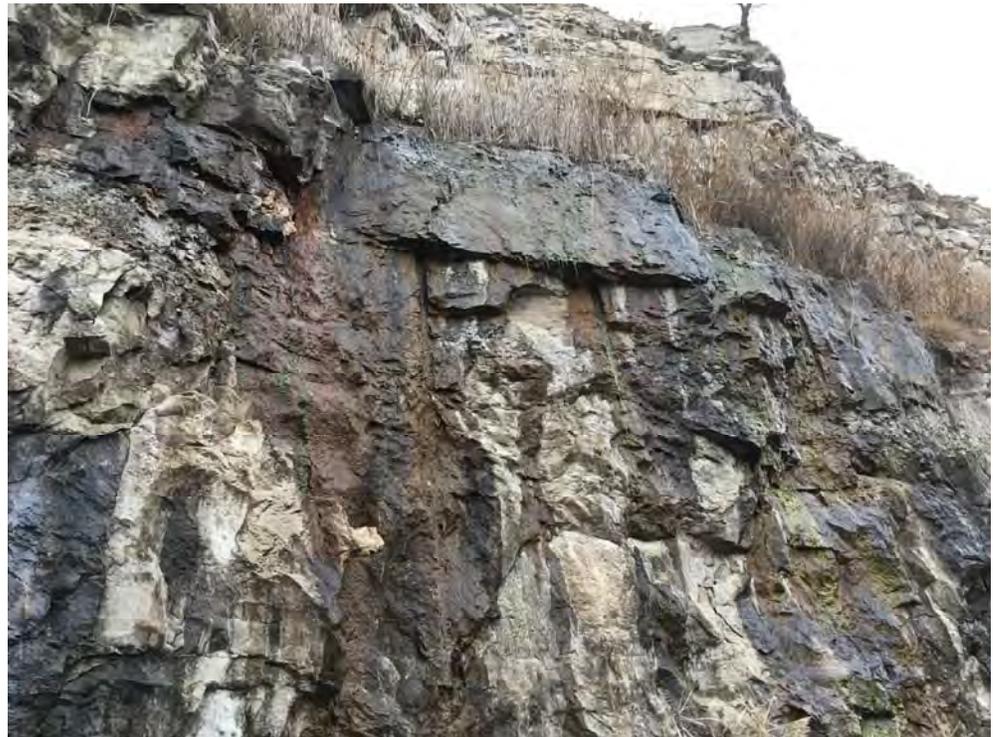
Photograph 10

- 5) The quarry bedrock side walls are fractured.
- 6) Portions of the exposed quarry side walls appeared to be damp or have active groundwater flow from a seam or bedrock layer interface (see Photographs 10, 11, 15 and 16).

7. Are there wet areas that indicate seepage through the side walls? Yes No
If 'Yes', describe (size, location, etc.) _____
Multiple areas on the quarry sidewalls show damp conditions or
groundwater flow. See Photographs 10 and 11

Comments: Side walls along the access ramp. Groundwater was observed to be seeping from sections of the side wall; some parts were observed to be damp.

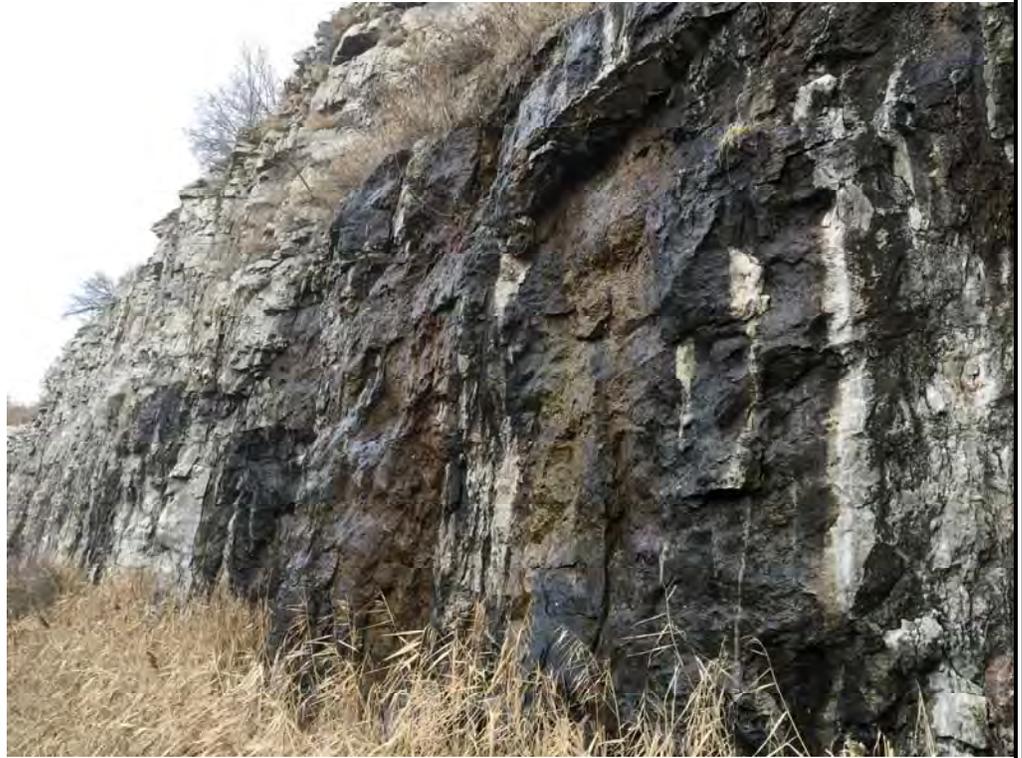
Photograph 11

Comments: Side walls along the access ramp. Groundwater was observed to be seeping from sections of the side wall; some parts were observed to be damp.

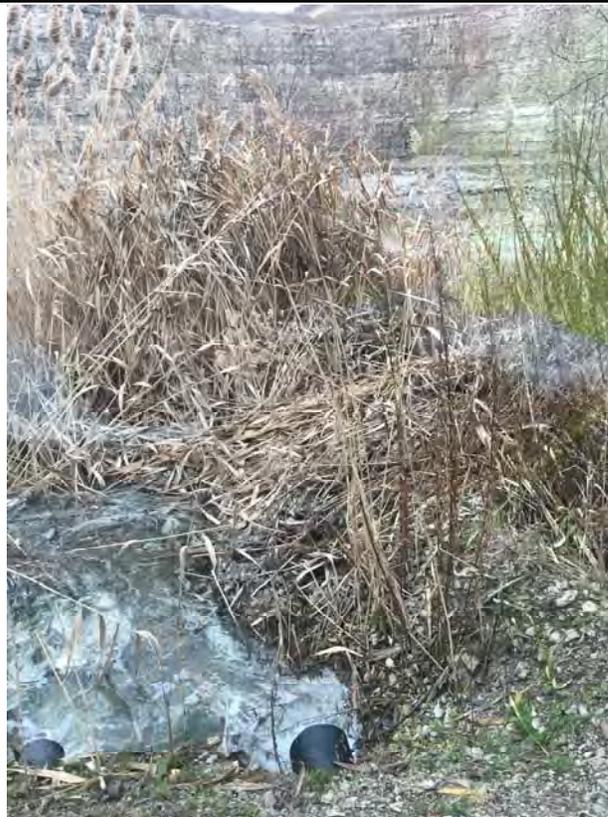
Photograph 12

Comments:
Groundwater seepage from southeast sidewall is conveyed under the quarry access road via below grade culverts.

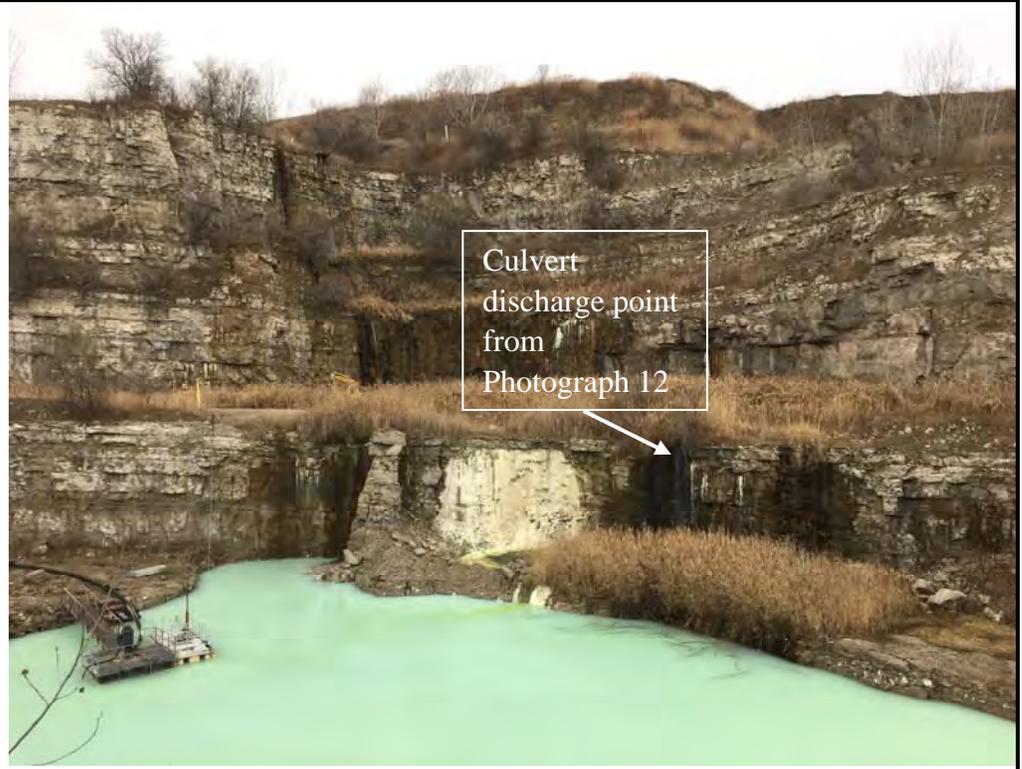
Photograph 13

Comments: View of the sump and pump (facing north).

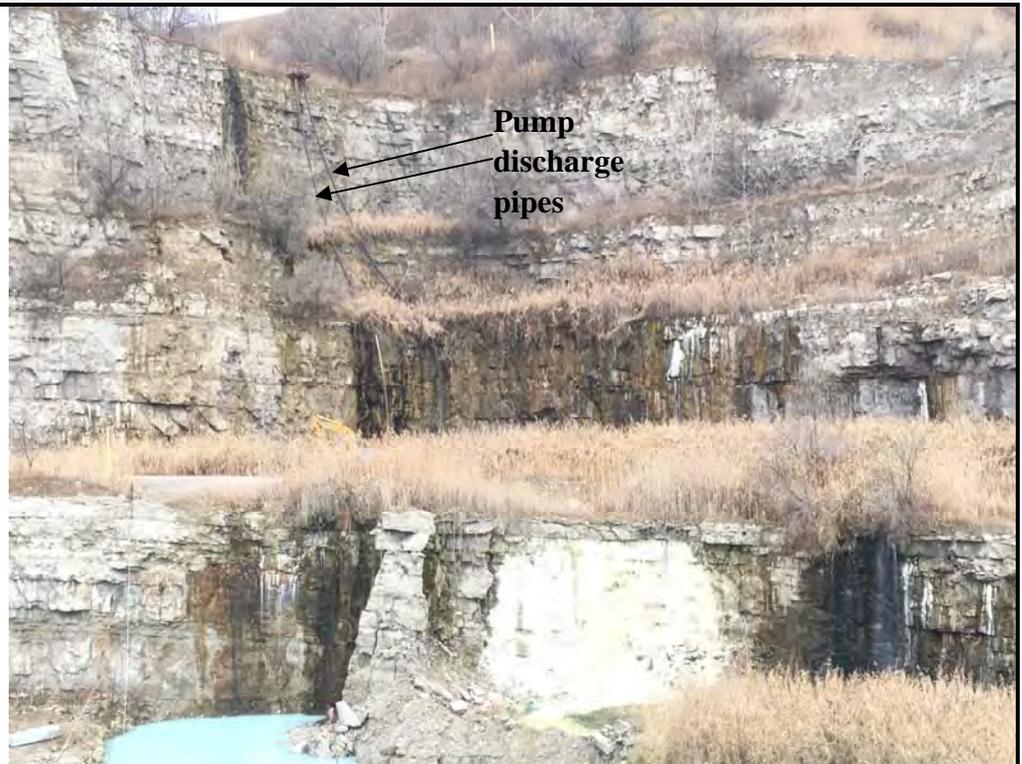
Photograph 14

Comments: Water from the sump is pumped to upper ponds with two 8-in diameter pipes.

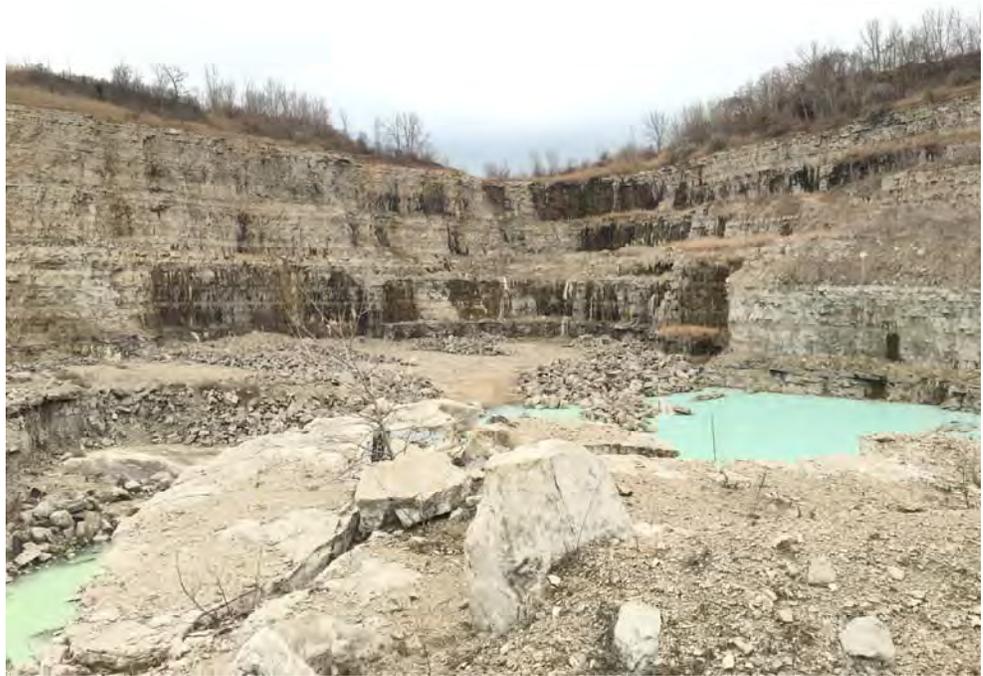
Photograph 15

Comments: View of
the side walls (facing
south). Areas on the
side walls that appear
to be darker are damp
or there is active
seepage.

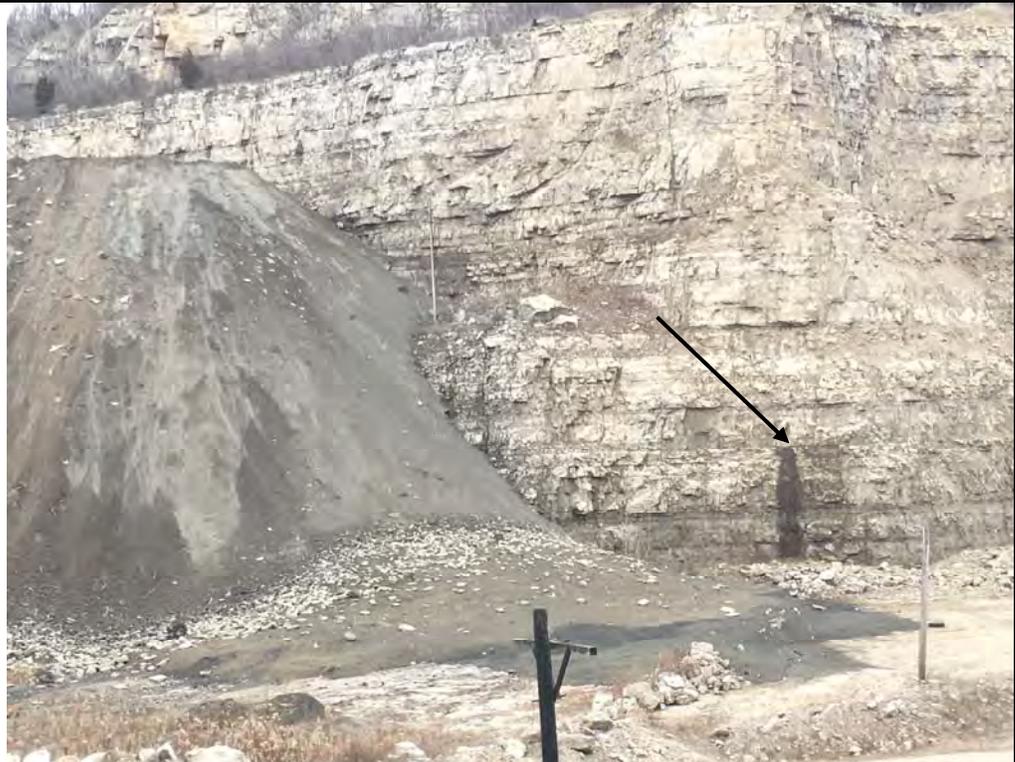
Photograph 16

Comments: The
arrow points out the
part of the side wall
that appears to be
damp (facing east).

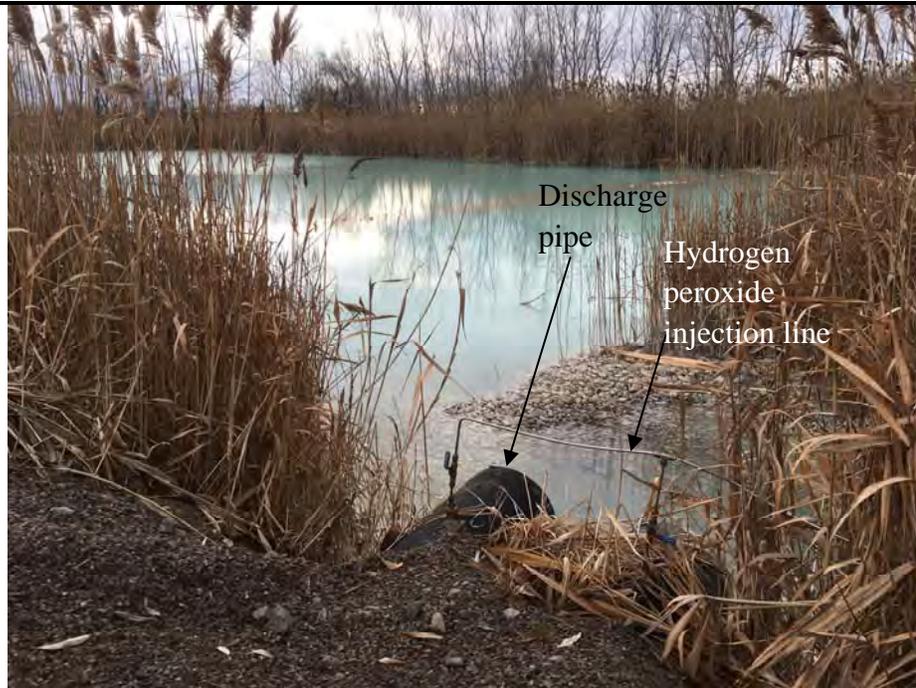
Photograph 17

Comments: Upper ponds where the water from quarry sump is treated with hydrogen peroxide (facing east).

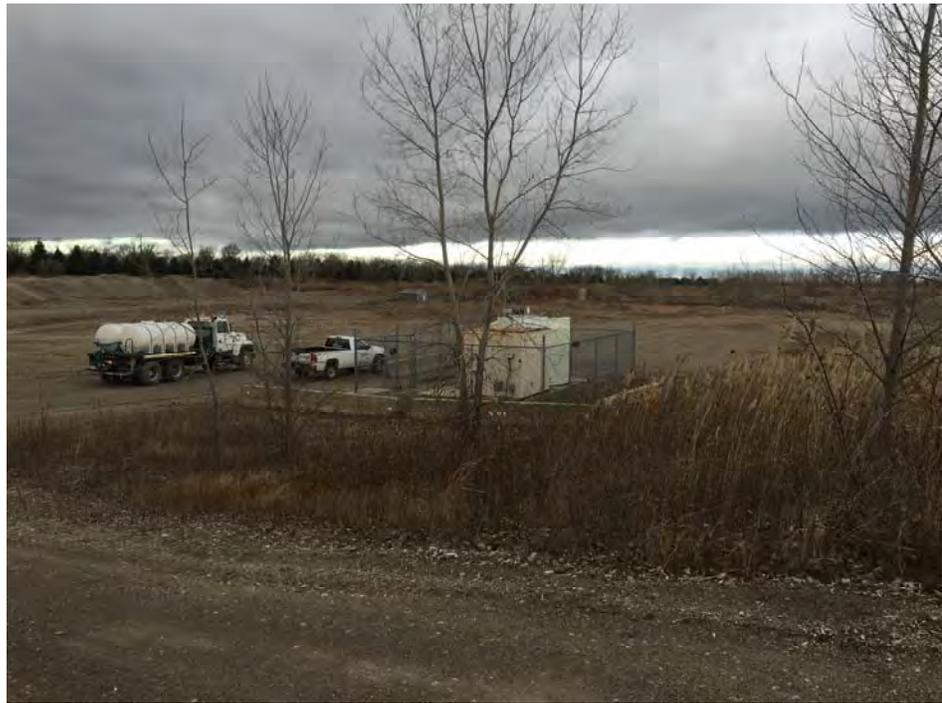
Photograph 18

Comments: Hydrogen peroxide tank (facing north).

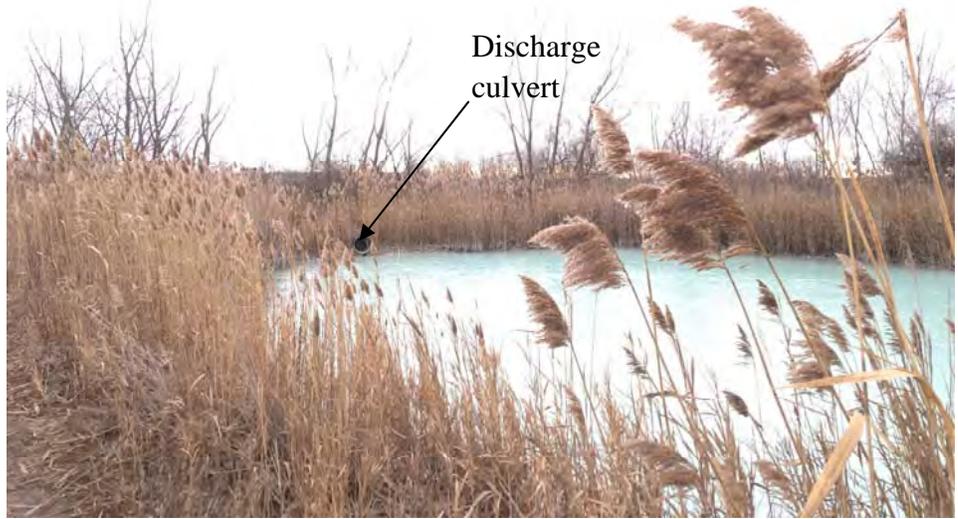
Photograph 19

Comments: Water
from the upper ponds
discharge into the
conveyance channel
through a culvert.

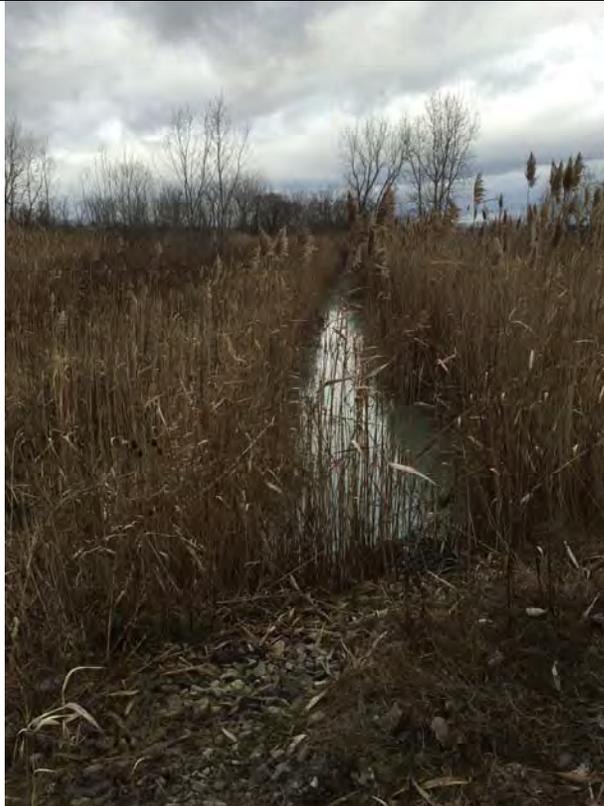
Photograph 20

Comments:
Conveyance channel
(facing west).

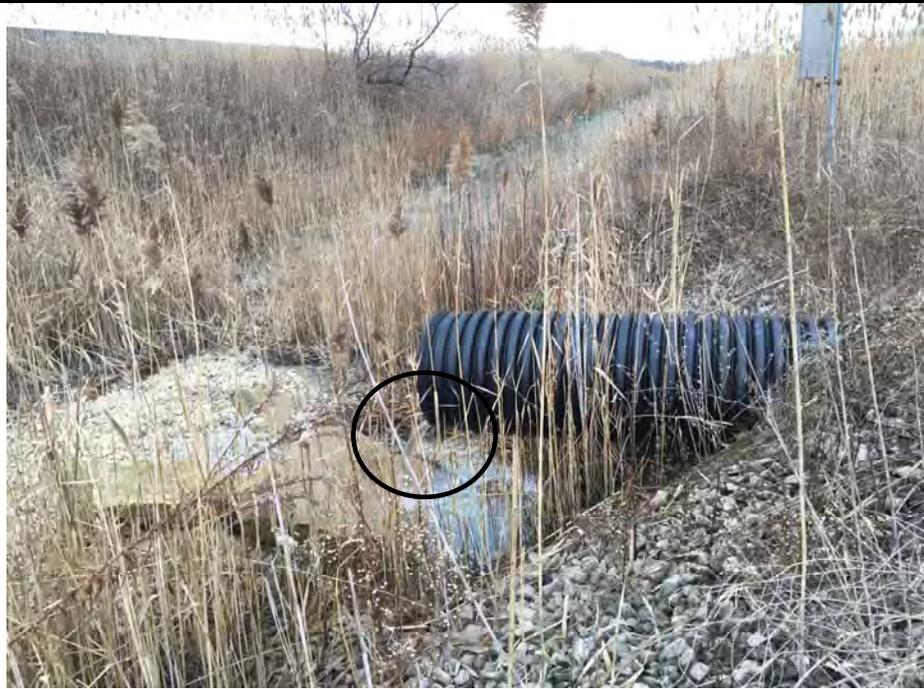
- 10) The Quarry sump, sump pump, upper ponds, conveyance channel and settling ponds appeared to be in good condition. Water discharging from the conveyance channel to settling Pond #4 appeared to be clear (see Photograph 21).
- 11) No fugitive dust complaints were observed in the Landfill Operating Record.

Comments: Culvert
connecting
conveyance channel to
Settling Pond #4
(facing south).
Discharge water
appeared to be clear.

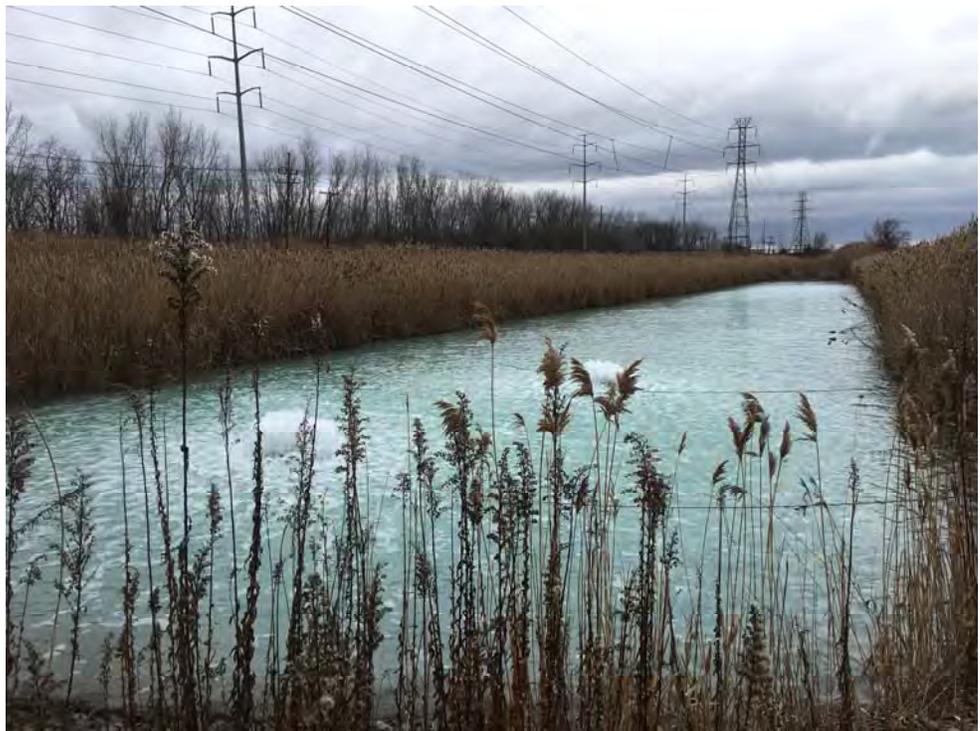
Photograph 22

Comments: View from
the downstream end of
Settling Pond #3 near
the NPDES discharge
pump house.
