2023 ANNUAL INSPECTION REPORT
RANGE ROAD LANDFILL
ASH DISPOSAL FACILITY

BELLE RIVER POWER PLANT

China Township, Michigan

January 2024

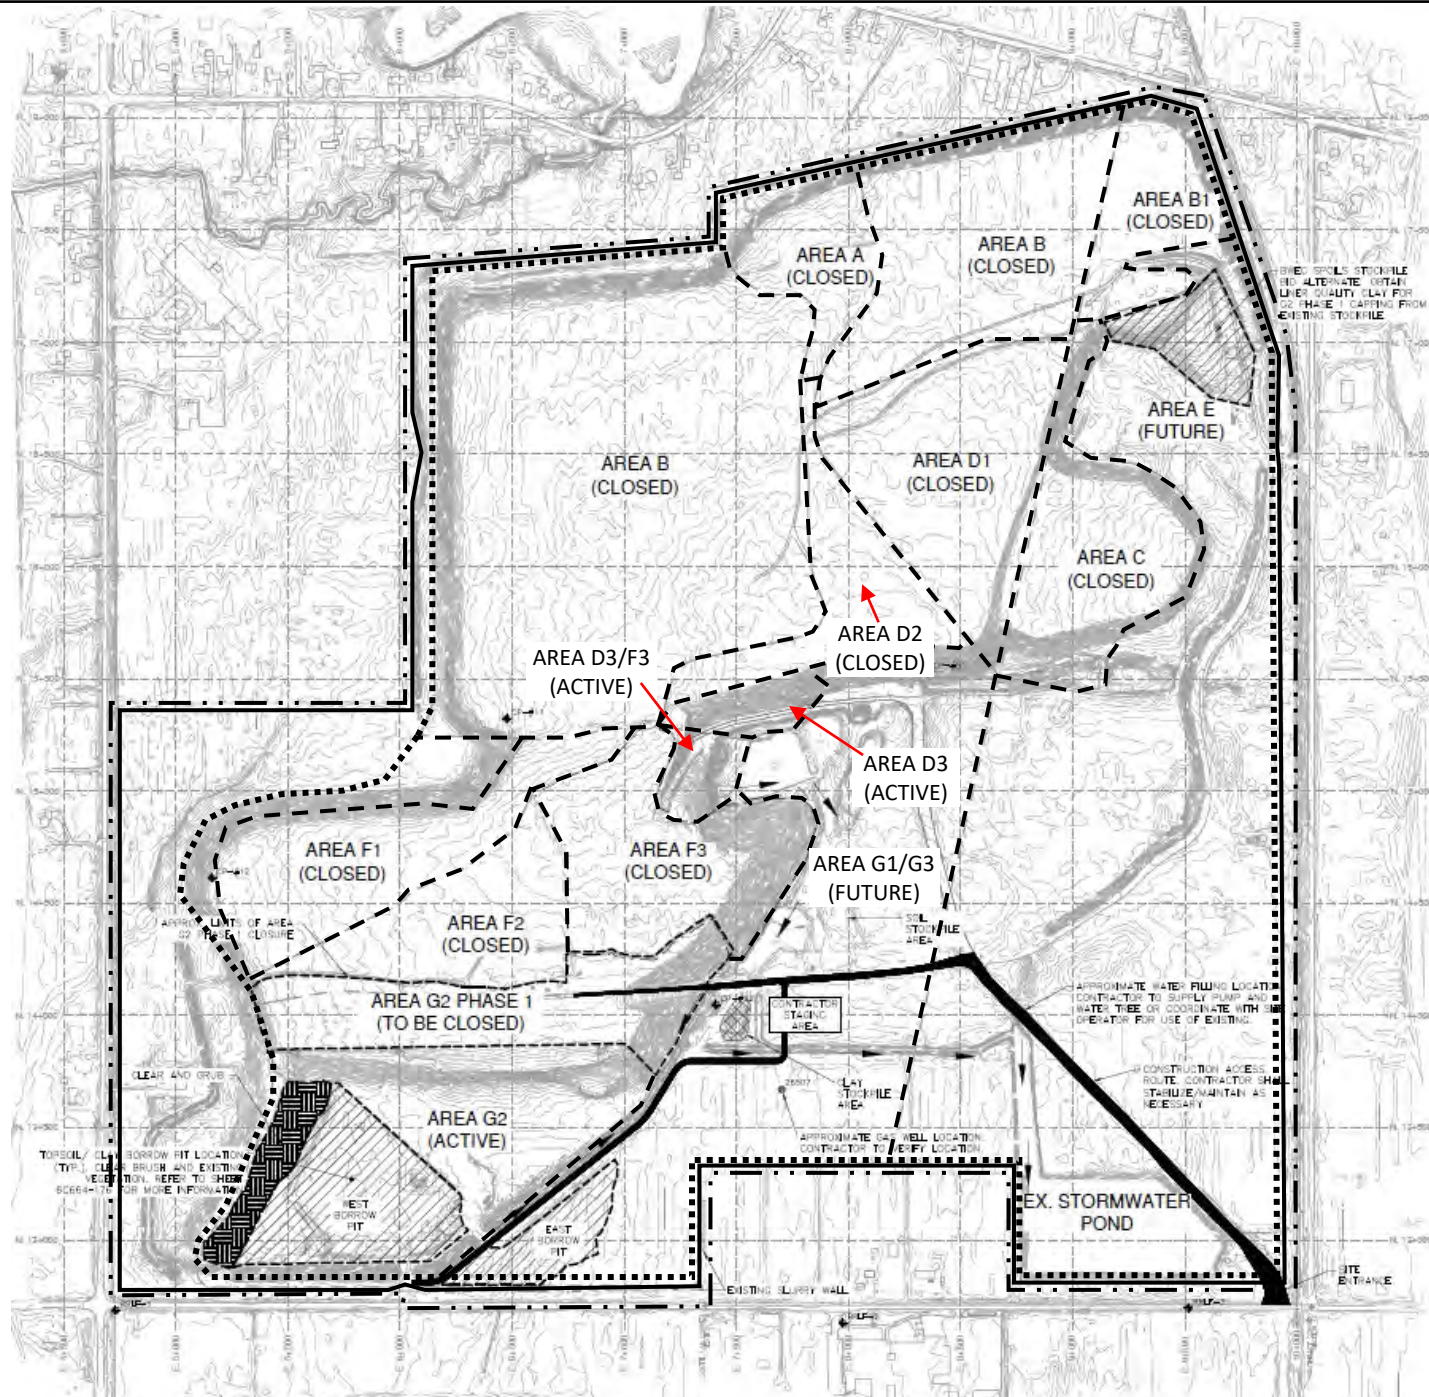
FIGURE
1

Currently, nine work areas are certified as closed and three areas are active. Areas D3, G2, and F3/D3 are active as identified in Figure 1. For construction purposes, Area G2 has been subdivided into three phases. Plans for Area G2 Phases I, II, and III have been approved by EGLE for waste placement. Area G2 Phase I fill was completed, capped, and certified by NTH and approved by EGLE. Area E was not included in a current waste filling sequence overall site plan (Draft September 26, 2017) and may not be needed depending on actual future volumes of CCR received by the Landfill. However, Area E is still identified in the current operating license (No. 9603), dated May 15, 2020.

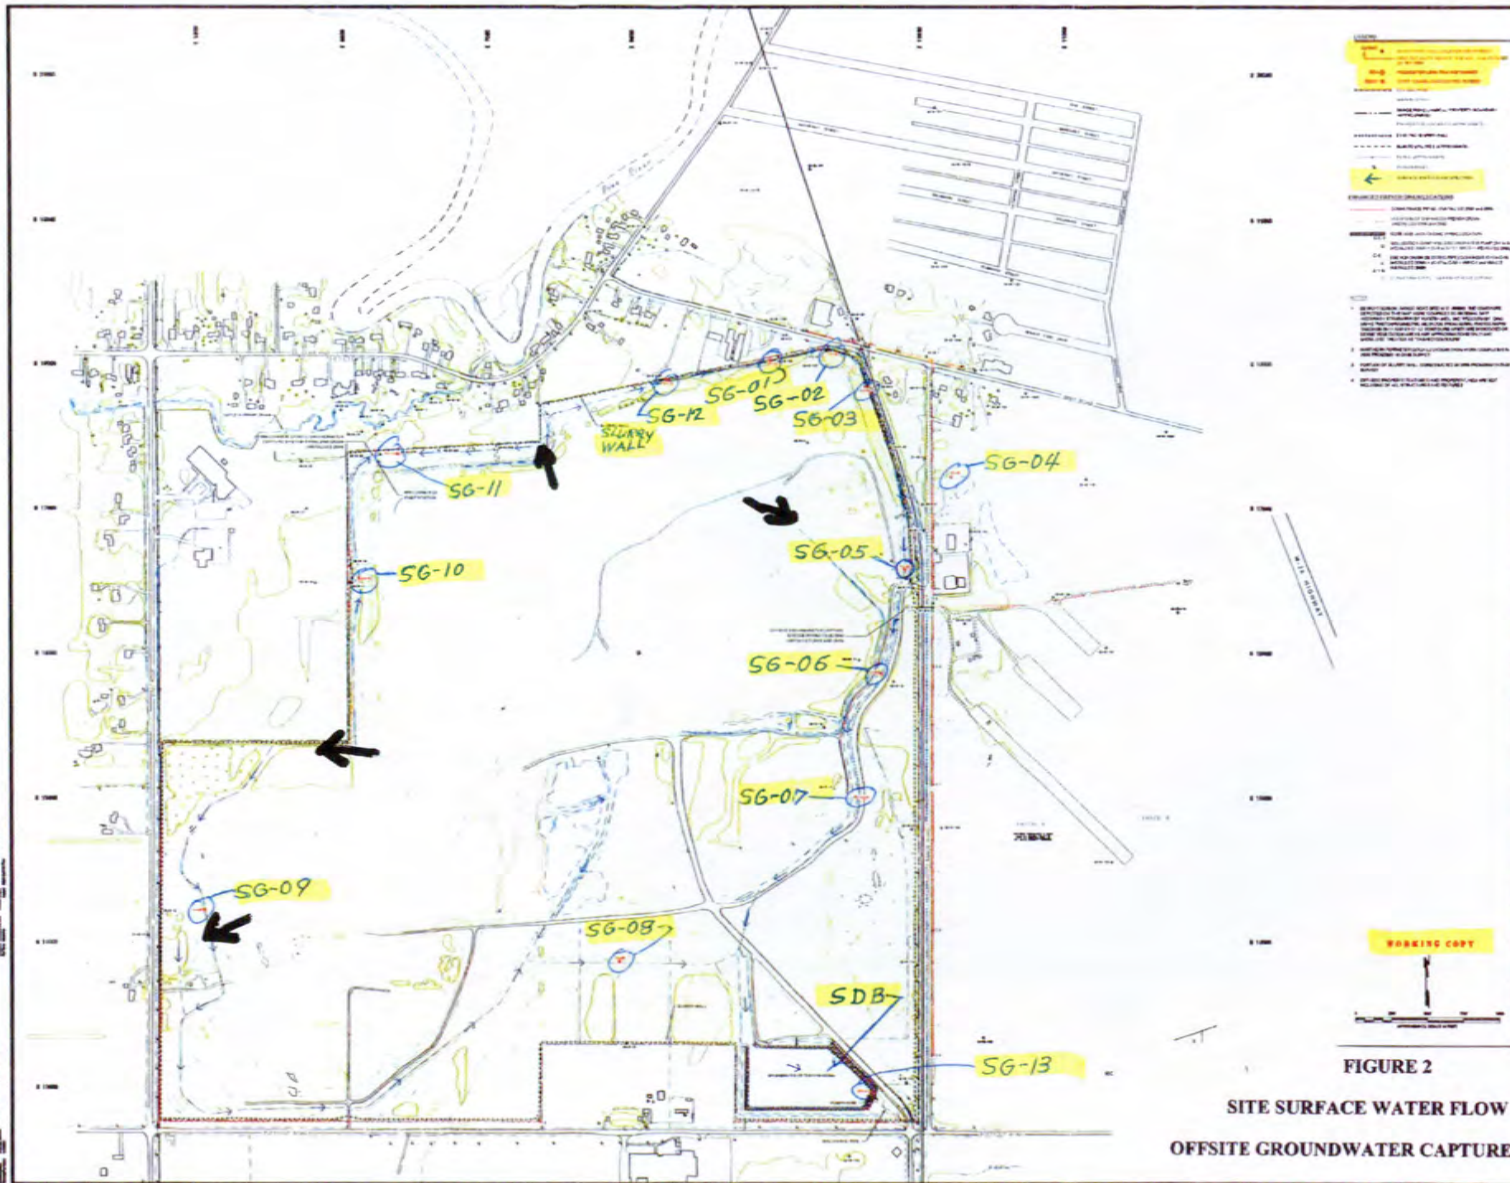
FIGURE 2
SITE SURFACE WATER FLOW AND
OFFSITE GROUNDWATER CAPTURE SYSTEMS

approximately 10 to 15 ft deep, surrounds the entire Landfill along the property perimeter. The perimeter ditch surrounds the entire Landfill and drains to the SDB (Figure 2).

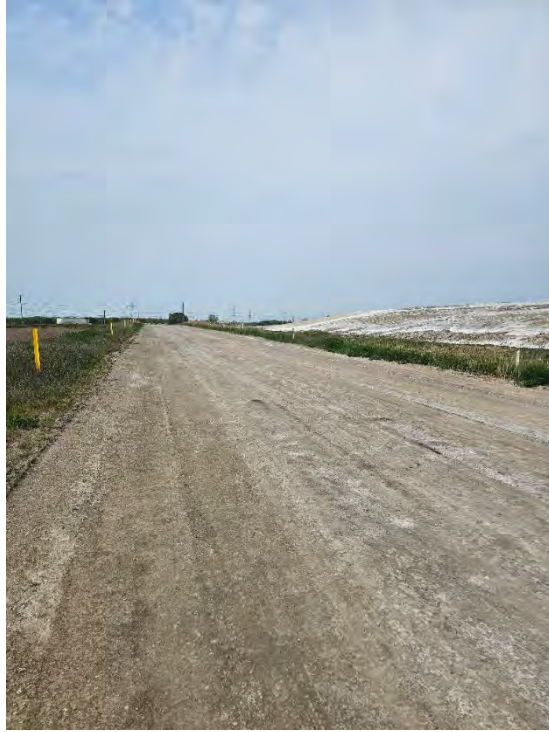
Comments: The perimeter road/access road to the south side of Area G2 was in good condition.
