DTE Electric Company
One Energy Plaza
Detroit, Michigan 48226

**2023 ANNUAL
INSPECTION REPORT
FLY ASH BASIN**

MONROE POWER PLANT

January 2024

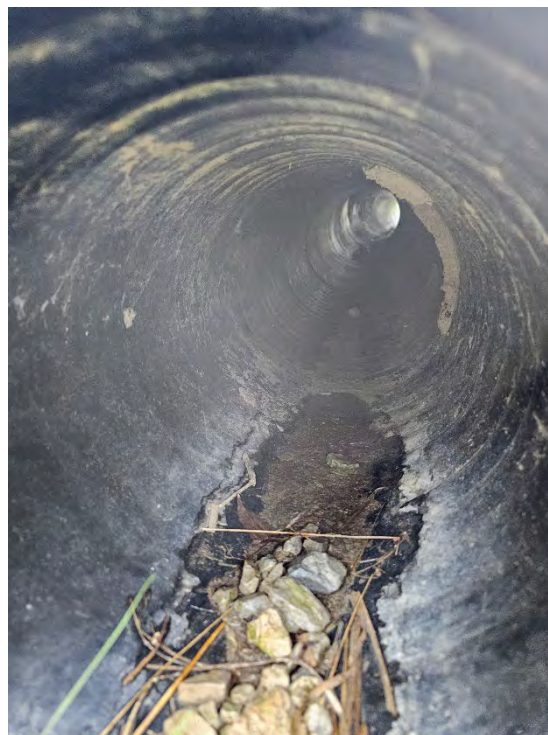
Comments: The covered high density polyethylene (HDPE) drain pipes connecting portions of the SmartDitches were observed to have minimal sediments and vegetation and were overall in good condition (typical conditions shown).

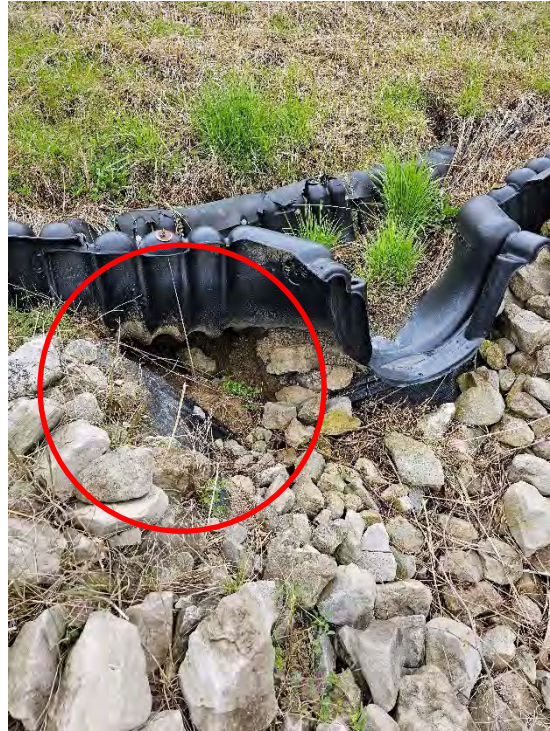
Comments: Over one foot of riprap appeared to have eroded from below the SmartDitch outlet into the riprap downchute at approximate Station 32+00. The geotextile fabric was exposed and torn below the SmartDitch outlet (circled).

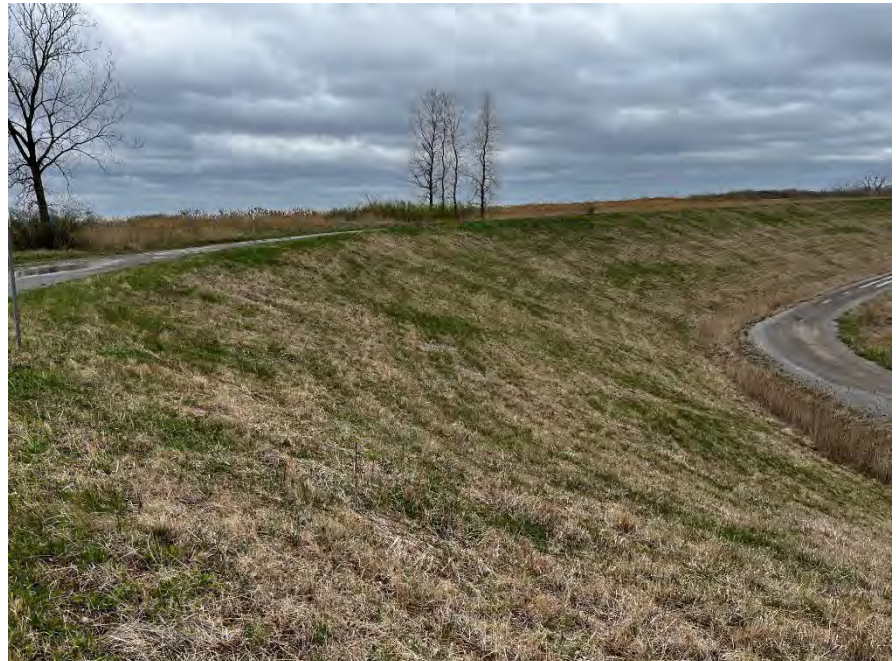
Photograph 20

1. The exterior slopes of the embankment were generally observed to be in satisfactory condition (Photographs #1, #17, #20, #22, #38, #42, #45). The slopes were covered in grass and appeared to be well-maintained. Specific observations related to the exterior slopes of the embankment included the following.

Comments: Exterior slopes of the perimeter embankment were in satisfactory condition (north embankment near Station 36+00 shown).

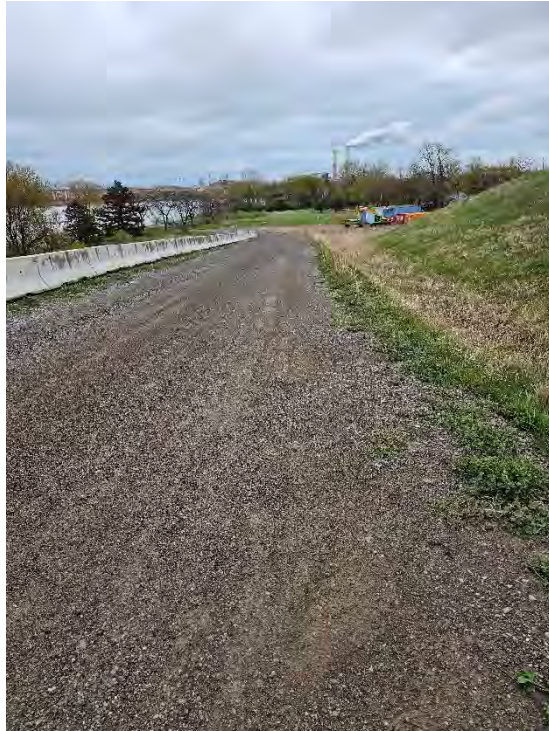
Comments: Access roads to the perimeter road atop the perimeter berm were in good condition with no erosion rills (north access road near Station 56+00 shown).

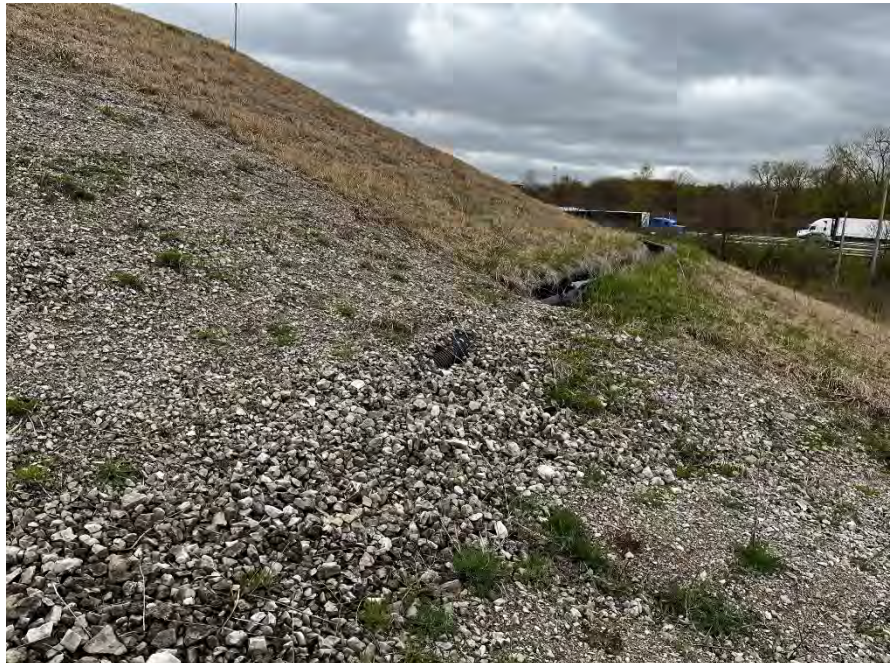
Comments: Gravel placed on the perimeter embankment slopes at approximate Station 67+00 appeared to have raveled from the upper portion of the slope to the lower portion of the slope. Portions of the slotted high-density polyethylene pipe were exposed as a result.

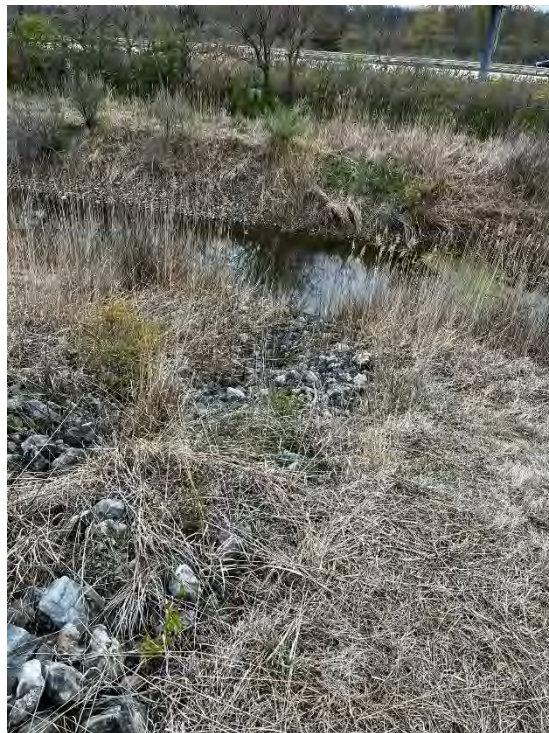
Comments: Some vegetation observed in the riprap downchute near Station 70+00. No adverse conditions were identified that appeared to affect the functionality of the riprap downchutes to convey stormwater.

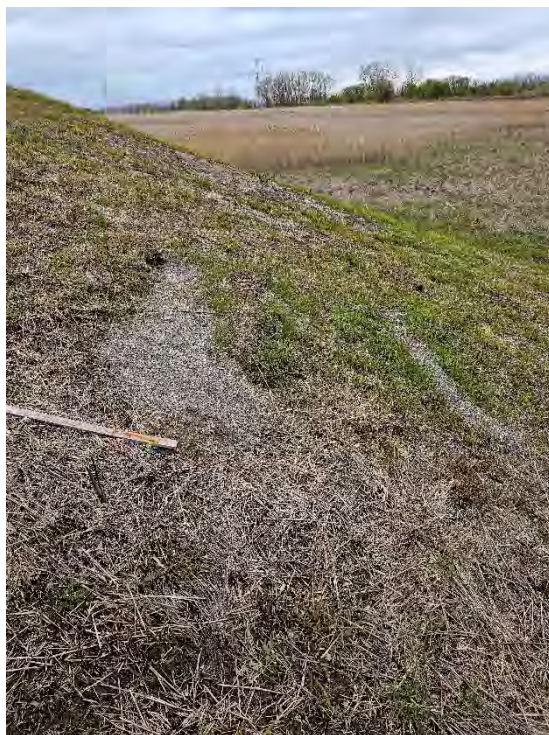
- e. Bentonite and sand repairs made to a gouge in the perimeter embankment slope from construction equipment near approximate Station 88+00 were in satisfactory condition (Photograph #34) and no indications of additional movement were observed during the visual inspection.

Comments: Bentonite and sand repair made to gouge near approximate Station 88+00 was in satisfactory condition. No indications of additional movement were observed.

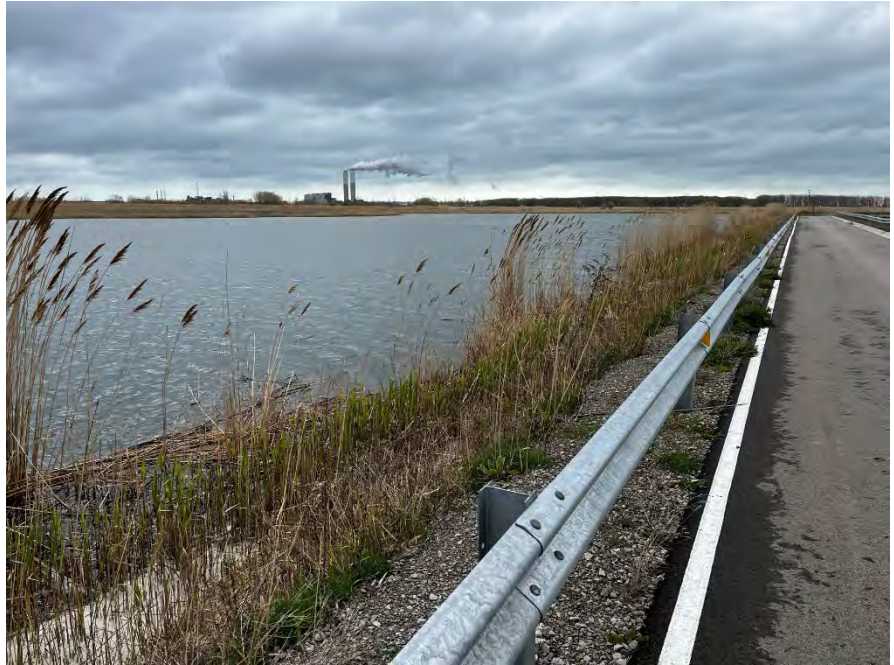
8. No adverse conditions were identified within the perimeter of the embankment and on the interior slopes (Photograph #35).
9. Sluice lines 5 (northern side of Ash Basin) (Photograph #54) and 1, 3, and 6 (southern side of Ash Basin) (Photograph #37) were inspected and observed to be in good condition. The outlets of the sluice lines were near open water, and no breaks or leaks were observed in the sluice lines along the embankment. Lines 1 and 5 (Photographs #37, #54) were actively sluicing ash into the Ash Basin at the time of the inspection.

Comments: No adverse conditions were identified within the perimeter of the embankment and on the interior slopes. The asphalt road on the crest of the embankment for access to the Vertical Extension Landfill was in good condition.

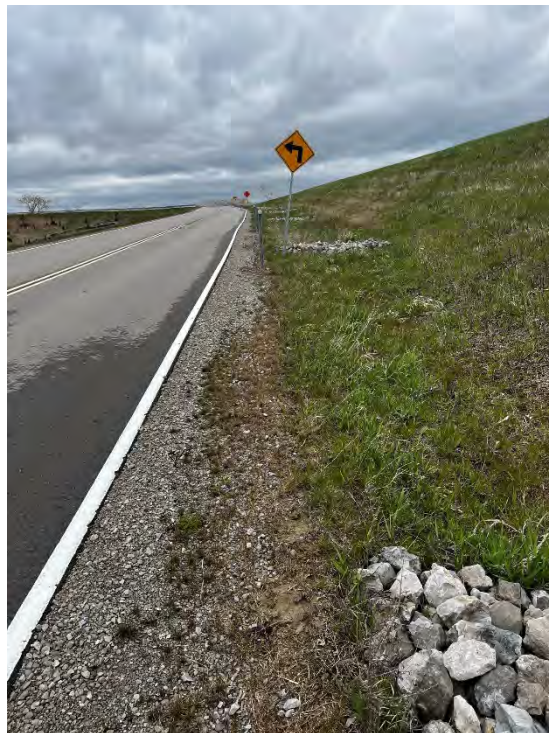
Photograph 36

the asphalt road construction, stormwater features were added at the toe of the embankment slope between approximate Stations 105+00 and 110+00 (Photograph #36). The associated stormwater features appeared to be in good condition.

Comments: The asphalt road for access to the Vertical Extension Landfill was in good condition. Associated stormwater features added at the toe of the embankment slope between approximate Stations 105+00 and 110+00 were in good condition.

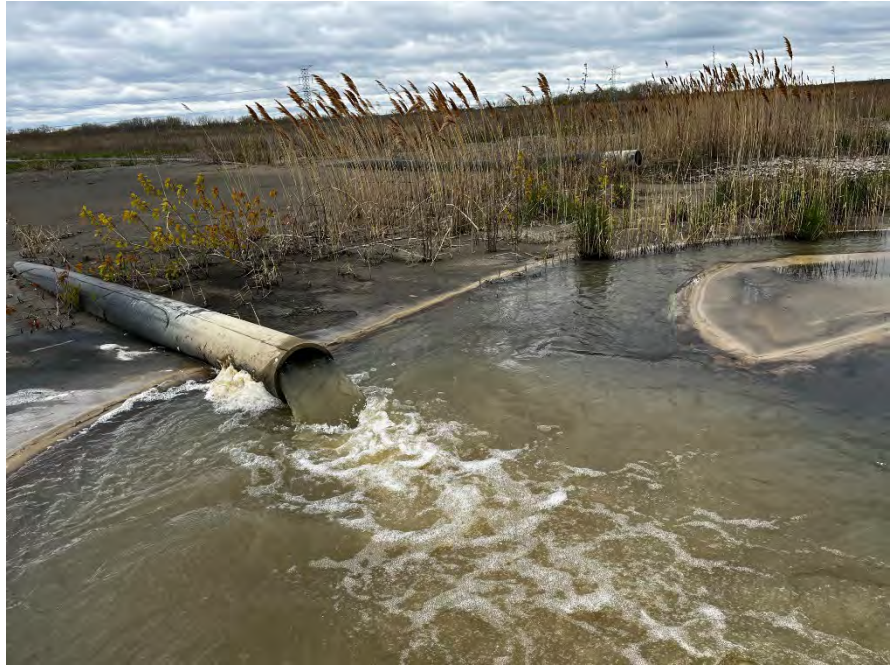
Comments: Sluice lines 1, 3, and 6 on the south side of the Ash Basin were in good condition. The outlets were near open water, and no breaks or leaks were observed in the lines along the embankment. Line 1 was actively sluicing ash into the Ash Basin during the inspection.

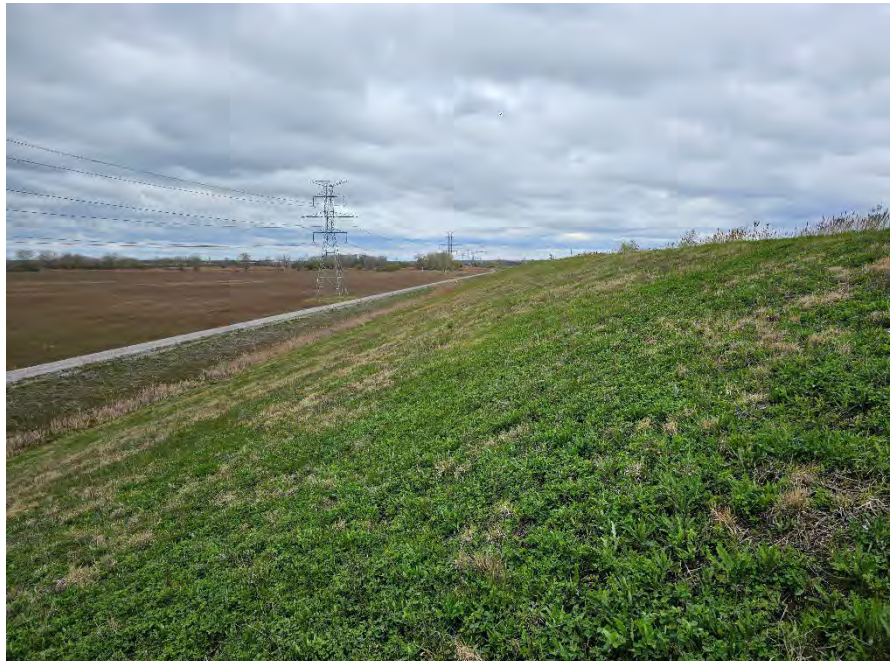
Photograph 38

Comments: Exterior slopes of the perimeter embankment were in satisfactory condition (southeast embankment near Station 135+00 shown).

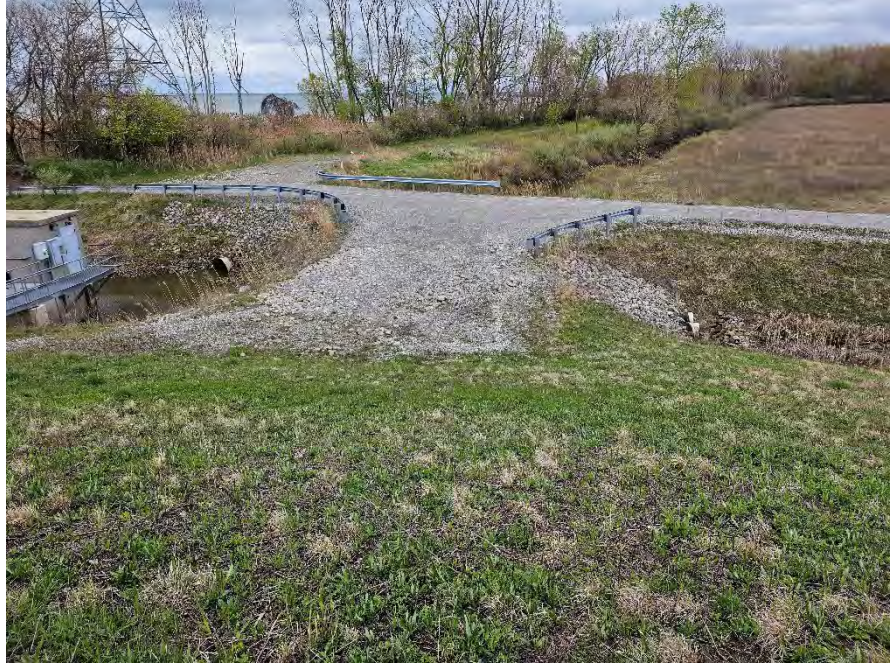
11. The pump house and access road on the southeast corner of the Ash Basin were inspected and observed to be in good condition (Photograph #39). No obstructions were observed in the culverts below the access road to the pump house (Photograph #40)

Comments: The pump house and access road on the southeast corner of the Ash Basin were in good condition. The perimeter swales on the east and south sides of the Ash Basin had some water that was observed flowing towards the pump house. The swales were in satisfactory condition.

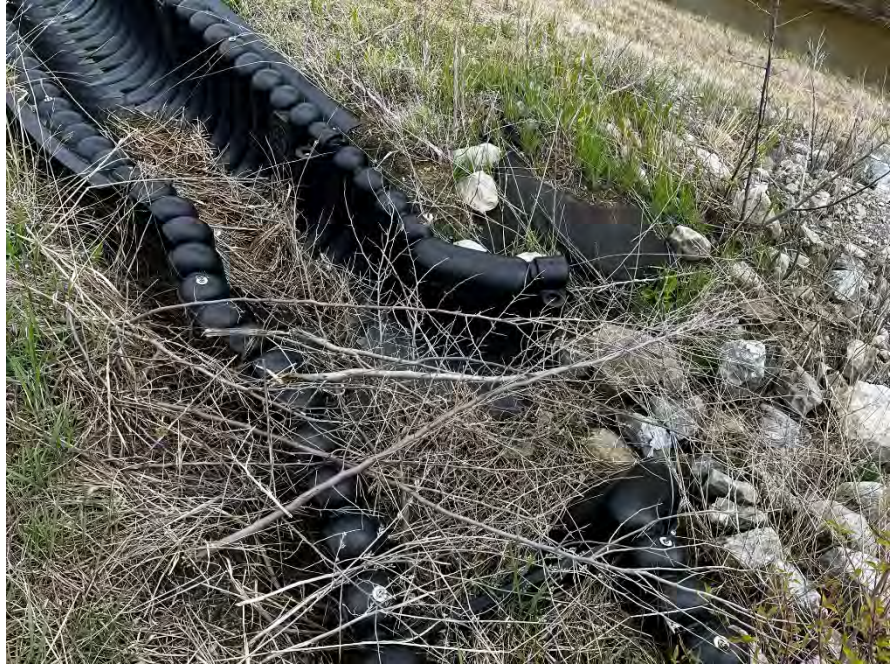
Comments: Over one foot of riprap appeared to have eroded from below the SmartDitch outlet into the riprap downchute at approximate Station 139+00. Some vegetation observed in the riprap downchute near Station 139+00. No adverse conditions were identified that appeared to affect the functionality of the riprap downchutes to convey stormwater.

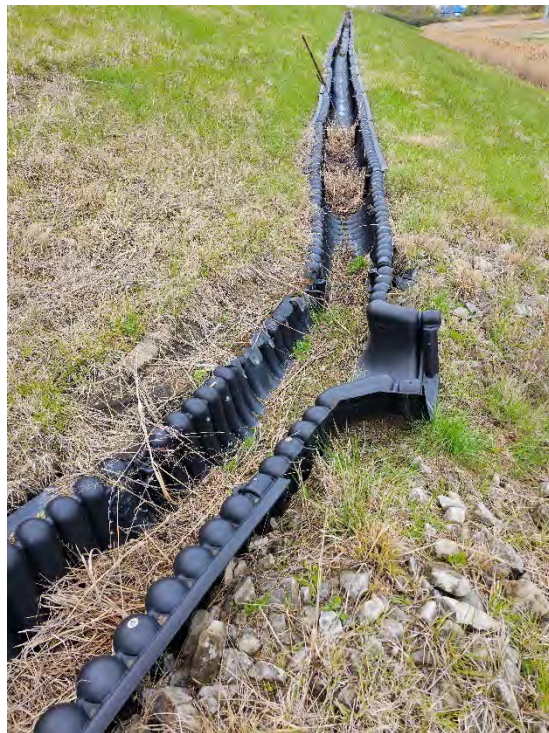
Comments: Over one foot of riprap appeared to have eroded from below the SmartDitch outlet into the riprap downchute at approximate Station 150+50.

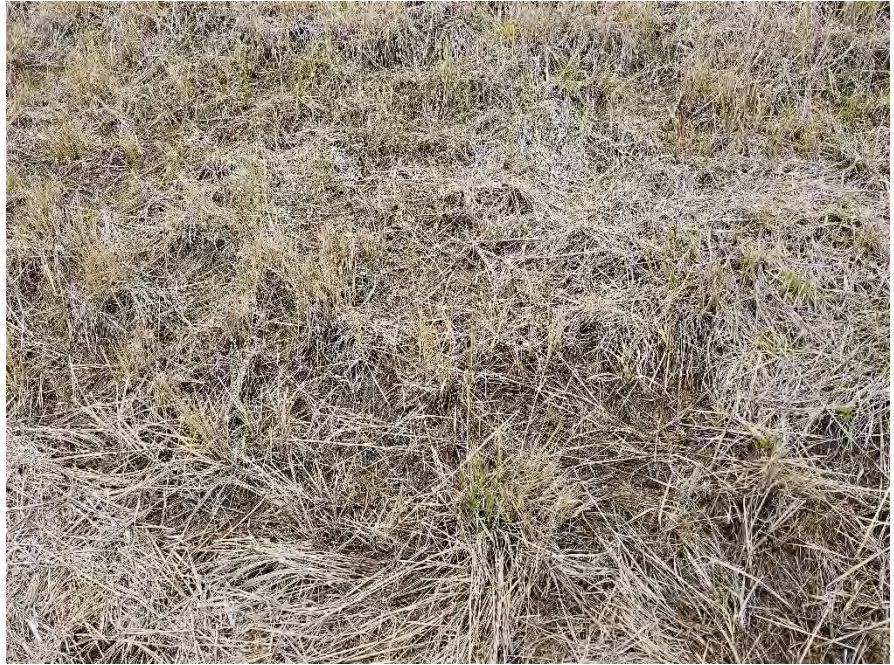
Comments: A prior wet area filled with gravel near approximate Stations 175+00 to 177+00 was not observed to be wet.

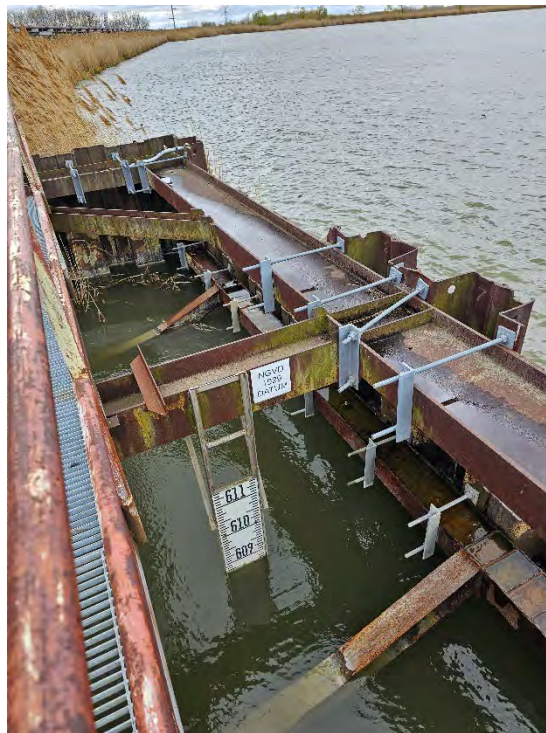
Photograph 48

13. The pool level within the Ash Basin at the time of the inspection was approximately 608.7 feet (Photograph #48), which is less than the maximum operating pool level of 609.0 feet.

Comments: The pool level within the Ash Basin at the time of the inspection was approximately 608.7 feet. No structural damage or obstructions were observed in the gates or stop logs.

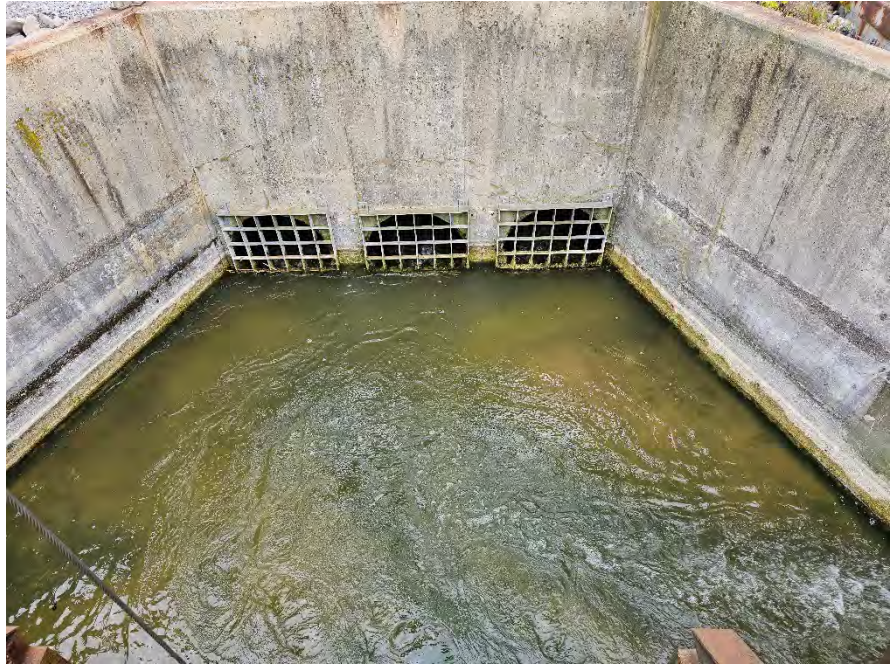
Comments: No structural damage was observed in the concrete or discharge pipes. No obstructions were observed in the discharge pipes.

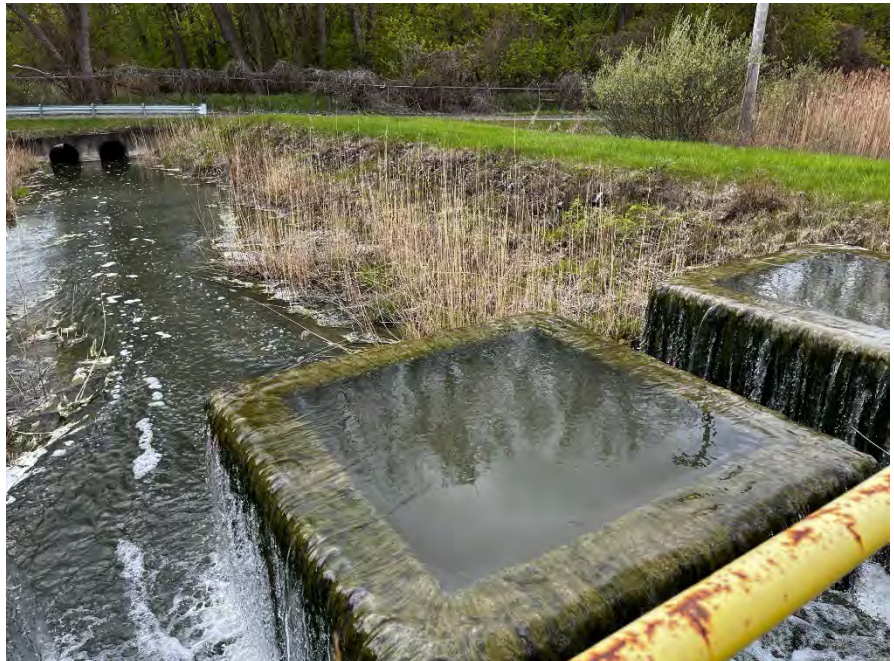
Photograph 50

Comments: No turbidity was observed in the outflow from the discharge structure.

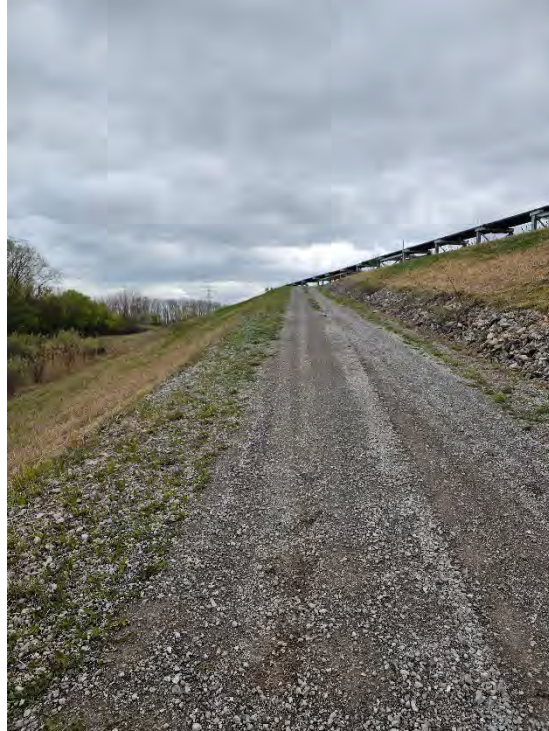
Comments: Access roads to the perimeter road atop the perimeter berm were in good condition with no erosion rills (east access road near Station 0+00 shown).

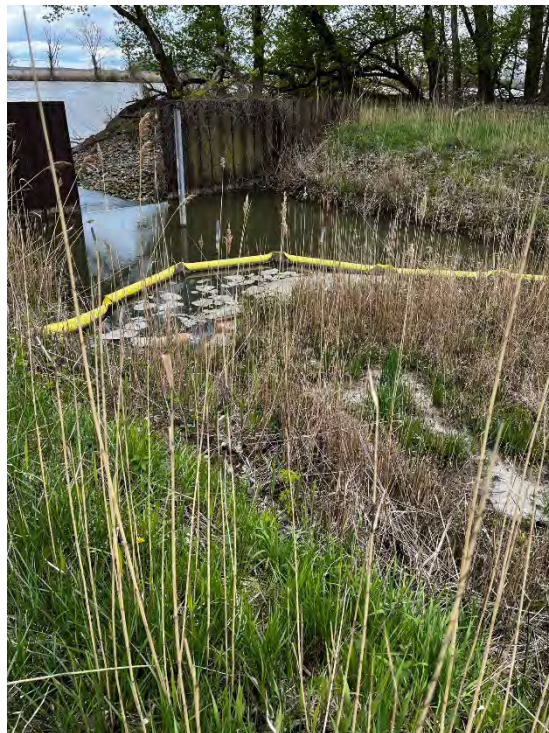
Photograph 52

15. The end of the discharge canal into Plum Creek was inspected. The silt curtain upstream of the weir and the weir were in satisfactory condition (Photographs #52, #53). There was some growth on top of the water within the discharge canal (Photograph #52); however, water was flowing out of the weir and was clear.

Comments: The silt curtain upstream of the weir was in satisfactory condition. There was some growth on top of the water within the discharge canal.

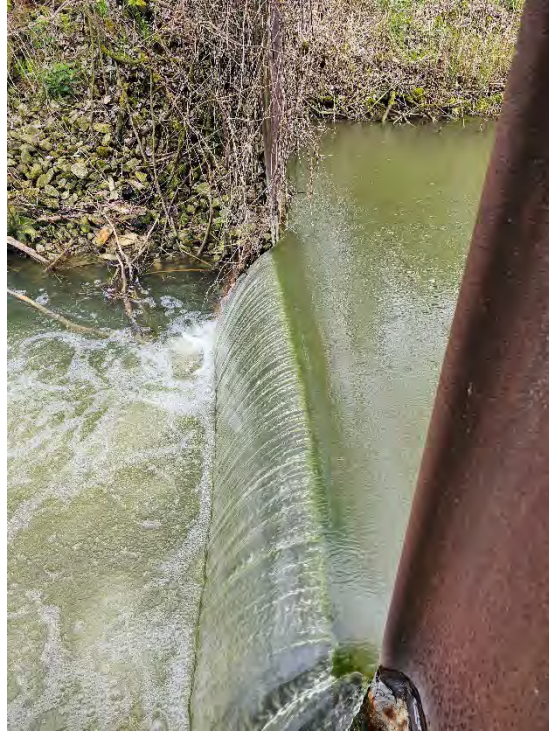
Comments: The weir outlet for the discharge canal was in satisfactory condition. Water was flowing out of the weir and was clear.

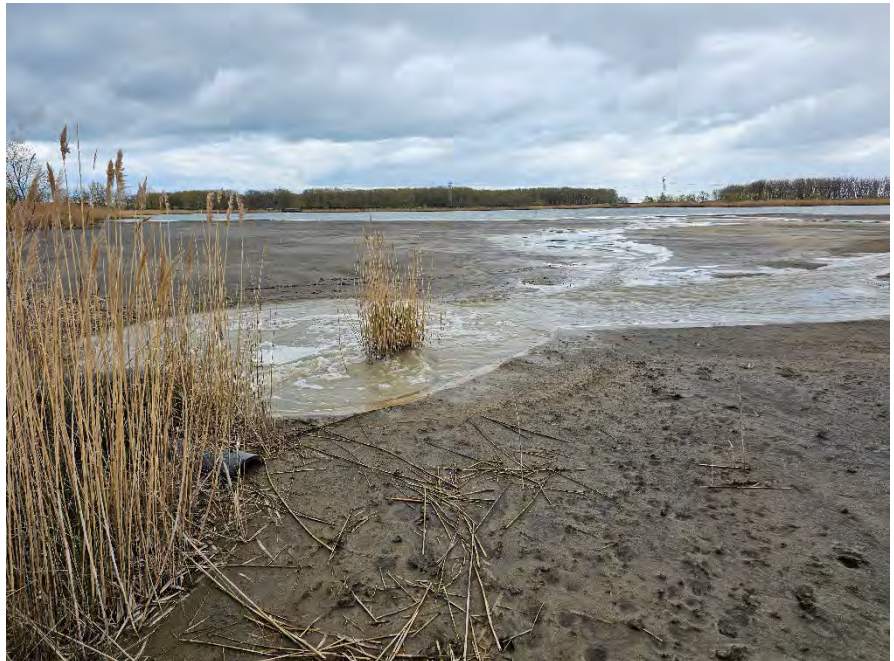
Photograph 54

Comments: Sluice line 5 on the north side of the Ash Basin was in good condition. The outlet was near open water and no breaks or leaks were observed in the line along the embankment. Line 5 was actively sluicing ash into the Ash Basin during the inspection.
