**2023 ANNUAL
INSPECTION REPORT
SIBLEY QUARRY LANDFILL**

TRENTON CHANNEL POWER PLANT

Trenton, Michigan

January 2024

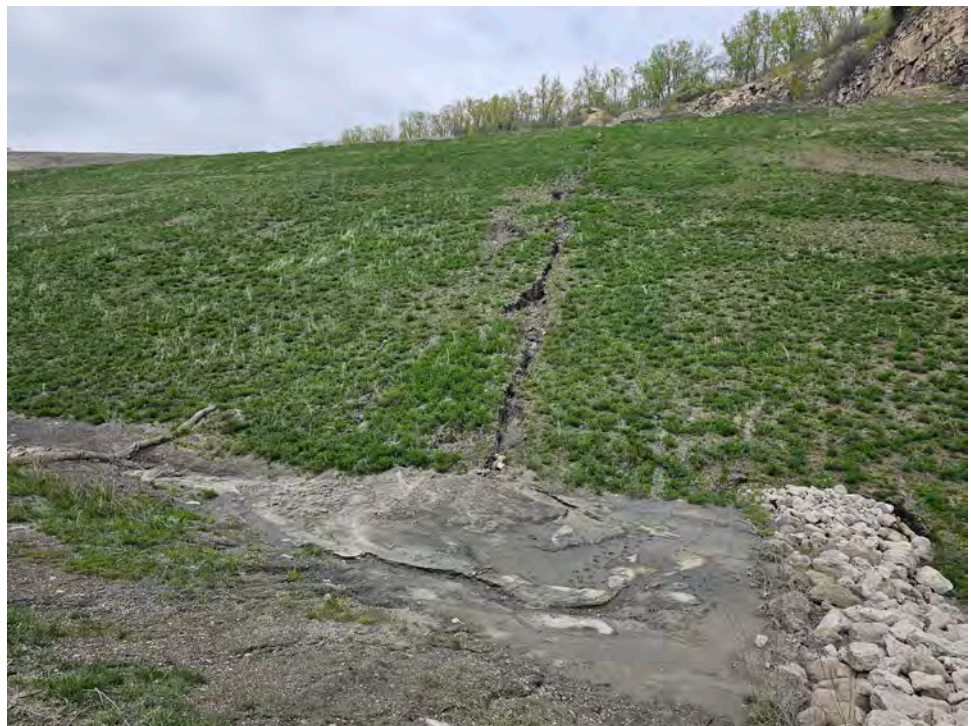
Comments: Coir log installed at cut in the diversion berm for soil erosion control along the switchback two haul road. (Southwest).

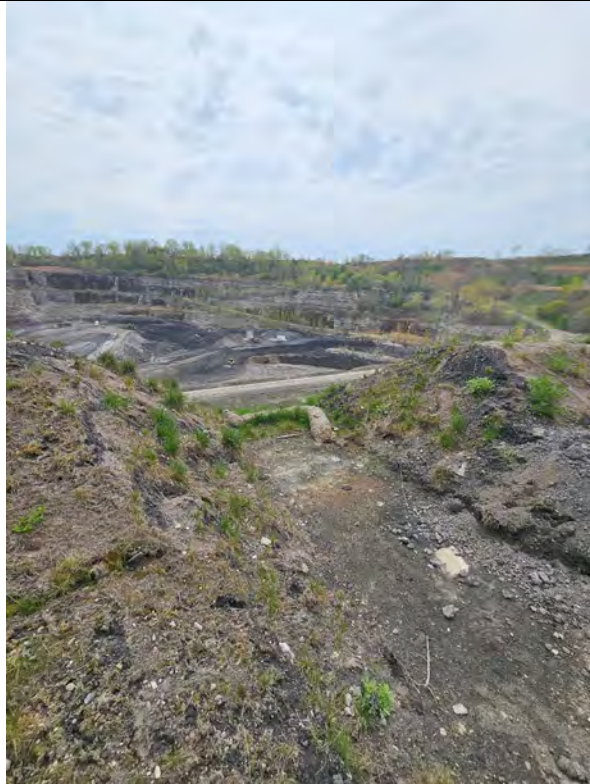
Comments: Drainage channel and diversion berm along the Switchback 2 haul road. (South)

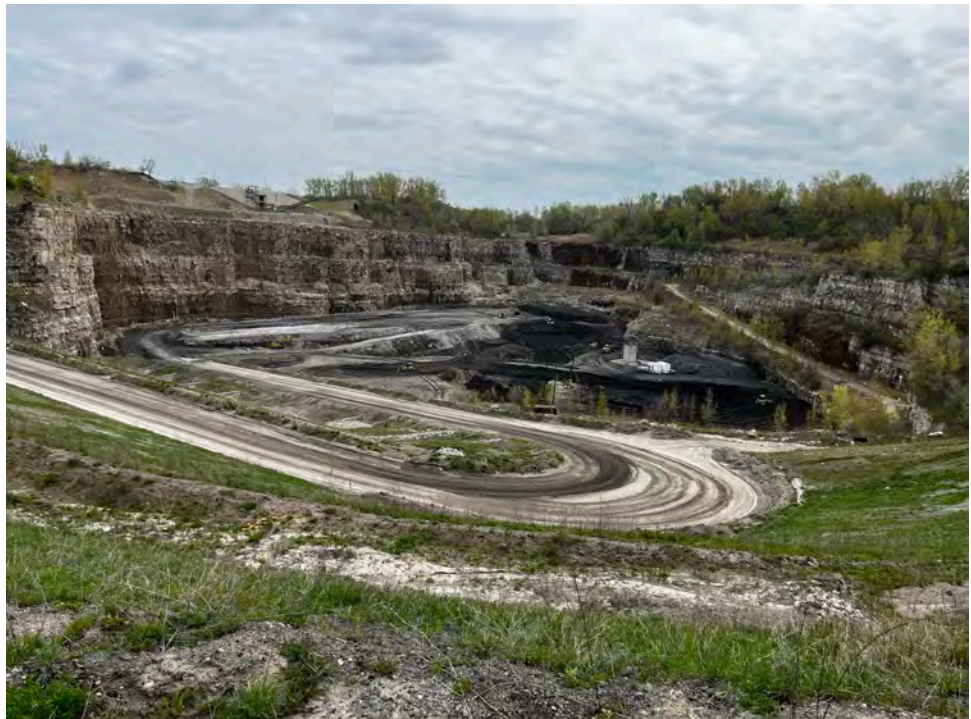
- 5) Erosion rills and gullies were observed on the Switchback 2 and northern CCR slopes during the inspection (Photographs #14, #17, #19, #20). Due to the incised nature of the Landfill, these erosion features do not represent an existing concern to the safety and operation of the Landfill.

- 1) The observed erosion rills and gullies on the northern CCR slopes and Switchback 2 slopes are not considered to represent a structural weakness due to the incised nature of the Landfill (i.e., eroded material is transported to the bottom of the Landfill). However, if additional rills and gullies form or existing features expand, these features have the potential to disrupt the operation and safety of the Landfill as eroded material or slope instabilities could block Switchback 2.

Comments: Erosion rills and gully on the northern CCR slopes above the quarry. (Northwest)

- 1) The northern CCR slopes and Switchback 2 slopes should continue to be monitored to assess the need for maintenance/repair of expansion of rills and gullies. If these erosion features continue to develop or expand, Geosyntec recommends DTE work with a professional engineer to develop additional stormwater management measure(s).

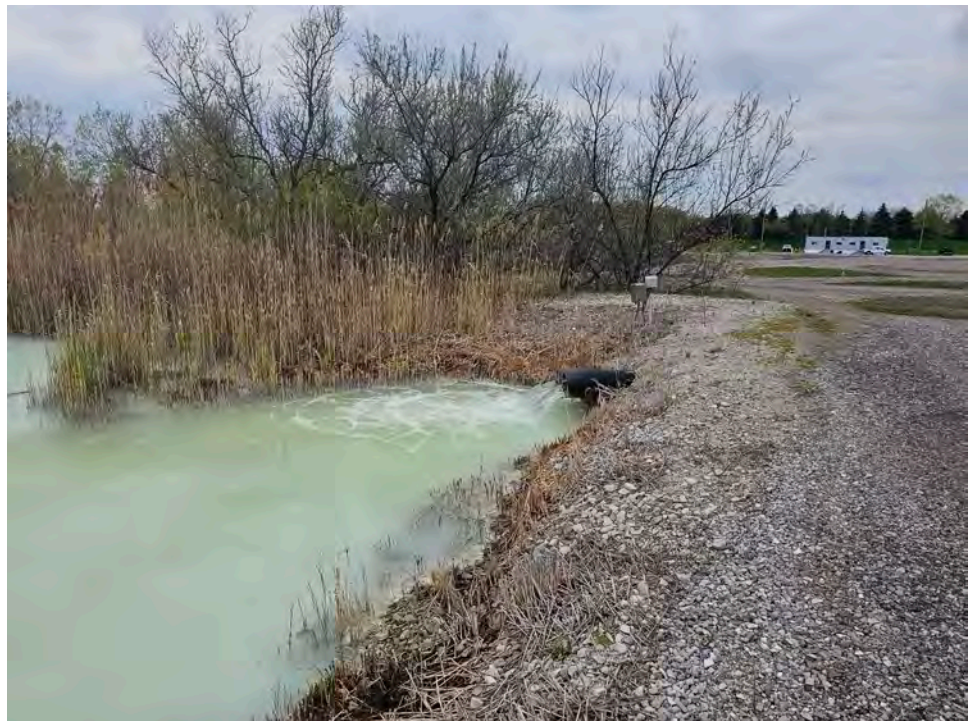
- 10) Outfalls of the pipes from the upper ponds into the conveyance channel (Photograph #24), the conveyance channel to Settling Pond #4 (Photograph #26), and Settling Pond #4 to Settling Pond #3 (Photograph #27) were observed to have some erosion of the riprap and surrounding soils.

- 4) Erosion of the riprap and surrounding soils was observed below the pipe outfalls from the upper ponds, conveyance channel, and Settling Pond #4. If erosion is allowed to continue, the leachate collection, conveyance, and treatment features could be compromised over time.

Comments: Discharge from upper ponds into conveyance channel. Some erosion is observed beneath the pipe. (North)

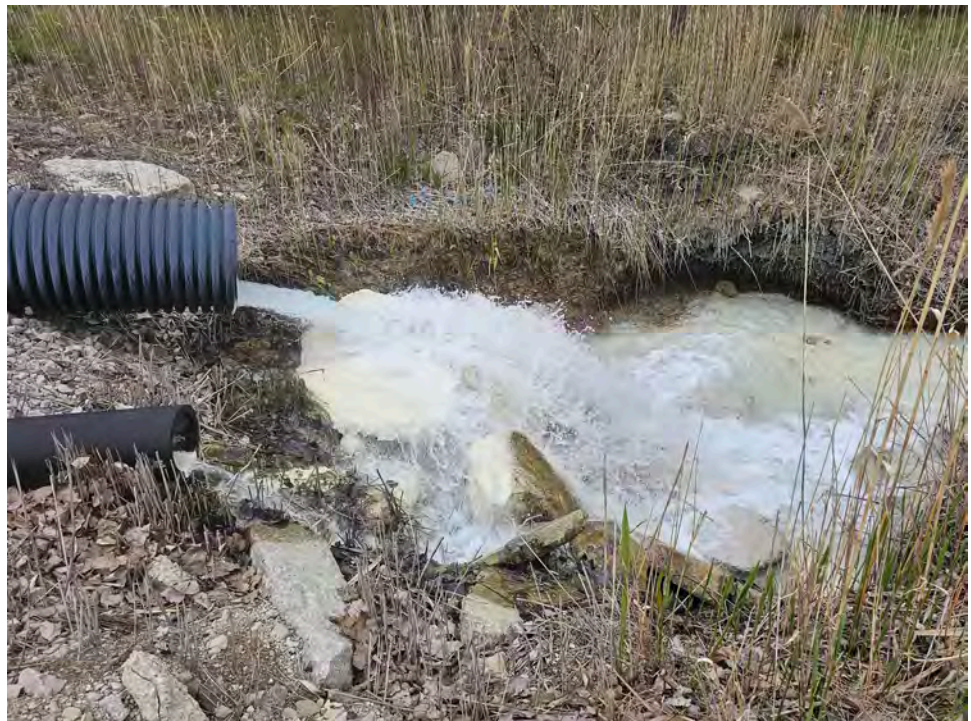
Comments: Discharge
from conveyance
channel into Settling
Pond #4. Some
erosion is observed
beneath the pipe.
(Southwest)
