2024 ANNUAL INSPECTION REPORT

FLY ASH BASIN

MONROE POWER PLANT

Monroe, Michigan

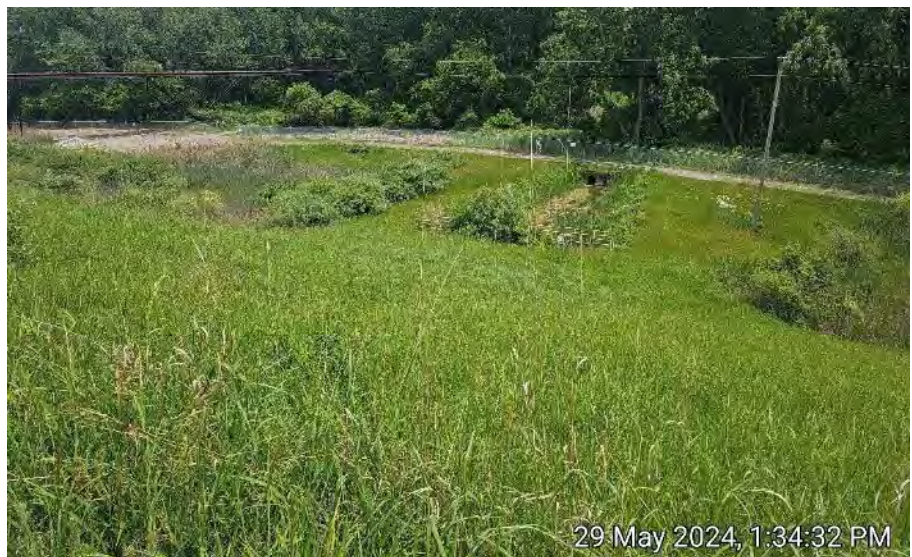
Comments: Sluicing operations at the Fly Ash Basin have stopped, so no outflow from the discharge structure was observed. The outfall structures and culverts to the discharge canal were in satisfactory condition with no obstructions observed.

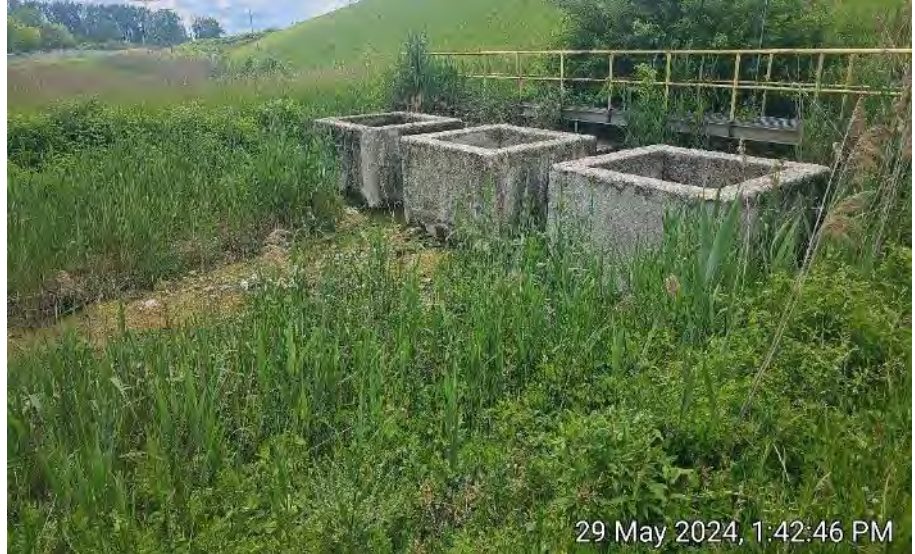
Photograph 50

The weir (Photo #51) and the silt curtain and discharge canal upstream of the weir (Photo #50) were in satisfactory condition. Significant vegetation was observed in the discharge canal and some debris was observed at the weir. Sluicing operations have stopped, so the minimal flow did not appear to be impeded.

Comments: The silt curtain upstream of the weir and the discharge canal were in satisfactory condition. Significant vegetation was observed within the canal. Sluicing operations have stopped at the Fly Ash Basin, so there is minimal flow within the canal that did not appear to be impeded by the vegetation.

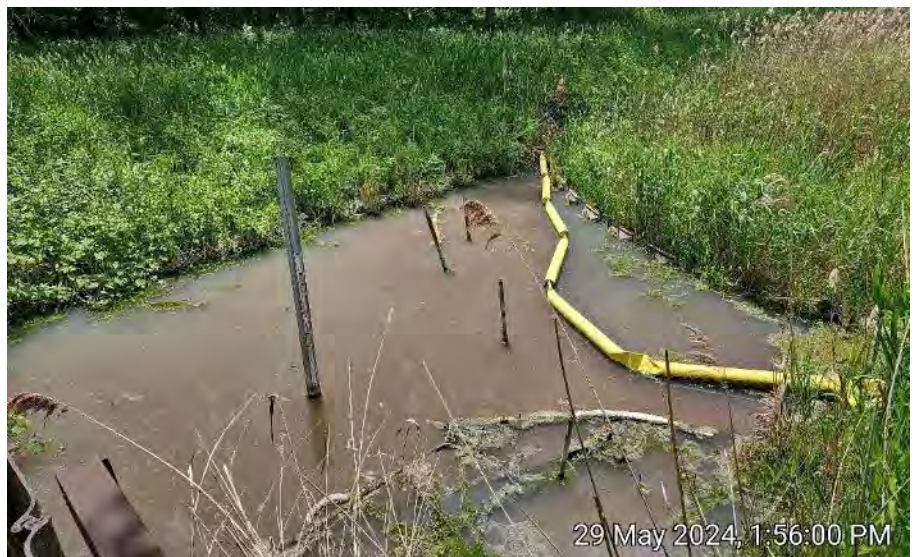
Comments: The weir outlet for the discharge canal was in satisfactory condition. Some debris was observed but did not appear to impede the discharge of the canal. Minimal discharge was observed as a result the sluicing operations having stopped at the Fly Ash Basin.
