2024 ANNUAL INSPECTION REPORT

RANGE ROAD LANDFILL

BELLE RIVER POWER PLANT

CHE8242V

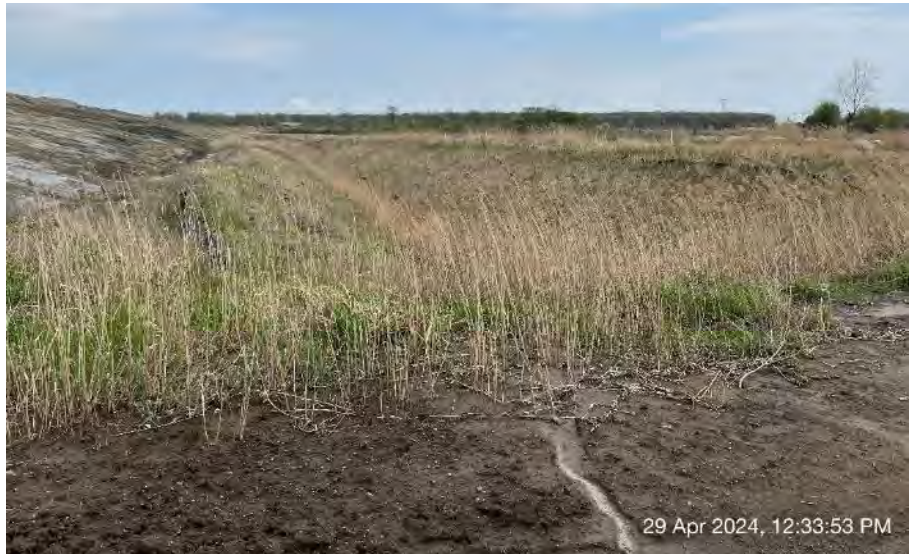
Photograph 52

Comments: Filling was active in Area G2 Phase II during the visual inspection. The traffic, waste unloading, and waste placement appeared to be in line with generally accepted engineering practices. The equipment was operating safely and at speeds to limit fugitive dust.

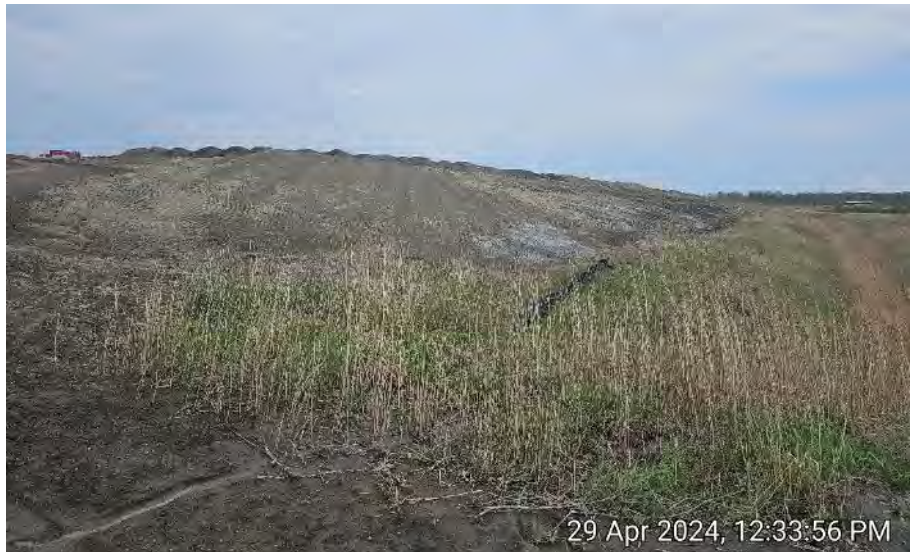
Direction: Northwest

Comments: Area G2 Phase III was in good condition. No active filling was observed in this area during the visual inspection.

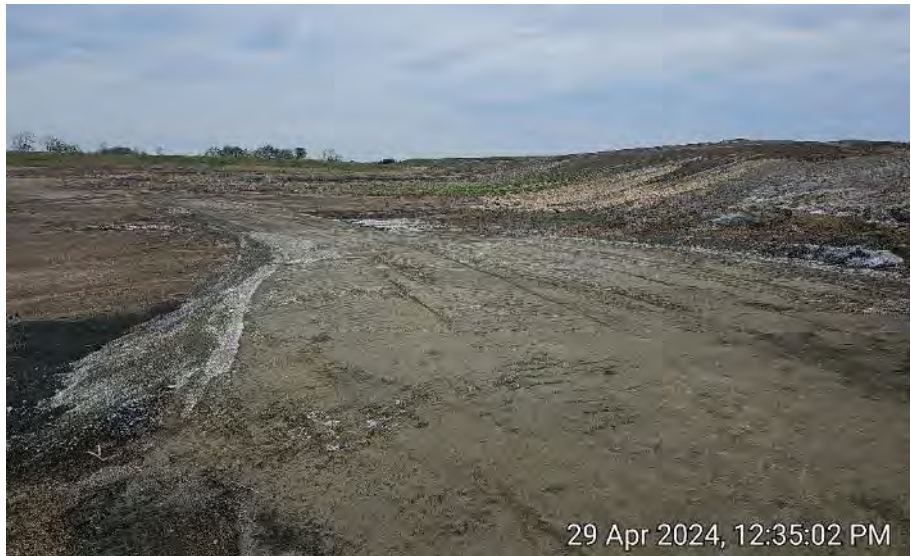
Photograph 54

17. The internal detention ponds by Area D3/F3 (Photograph #47) and south of Area G2 (Photograph #54) appeared to be in good condition. The side slopes were vegetated or covered with riprap armoring, and no erosion was observed.

Item	Condition			Related Photo # (s)	Notes and Comments (LDP=Landfill Development Plan, SDB = Stormwater Detention Basin)
	Good	Fair	Action Req'd.		
19. Internal Detention Ponds	<input checked="" type="checkbox"/>	<input type="checkbox"/>	<input type="checkbox"/>	47, 54	The interior ponds by Areas D3 and F3 (Photo #47) and south of Area G2 (Photo #54) appeared to be in good condition. No erosion was observed around the perimeter of these ponds and vegetation appeared to be well-maintained.

Comments: The internal detention pond south of Area G2 was in good condition. Erosion was not observed on the side slopes.
