**DTE Electric Company**

## **2025 ANNUAL INSPECTION REPORT FLY ASH BASIN**

**MONROE POWER PLANT**

January 2026

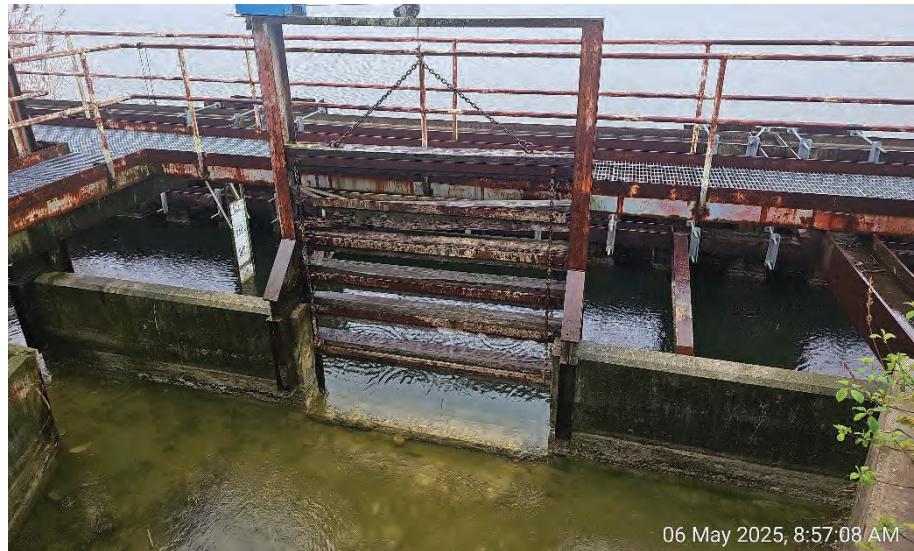
**Comments:** The gates of the discharge structure were in satisfactory condition with no significant damage or obstructions observed. The stop logs were in poor condition and in the raised position.

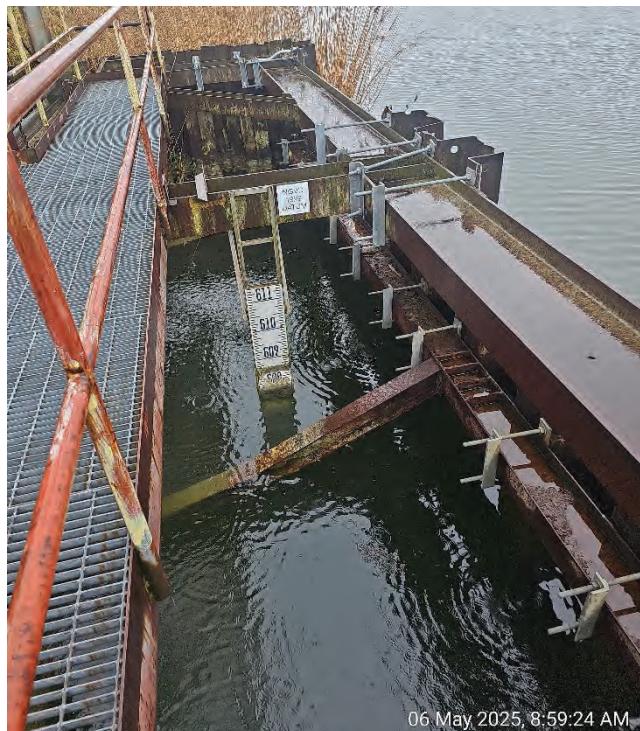
**Photograph 4**

**Comments:** Sluicing operations at the Fly Ash Basin have stopped, but the water level within the Fly Ash Basin was approximately 608 feet at the time of the inspection due to precipitation prior to and during the inspection.

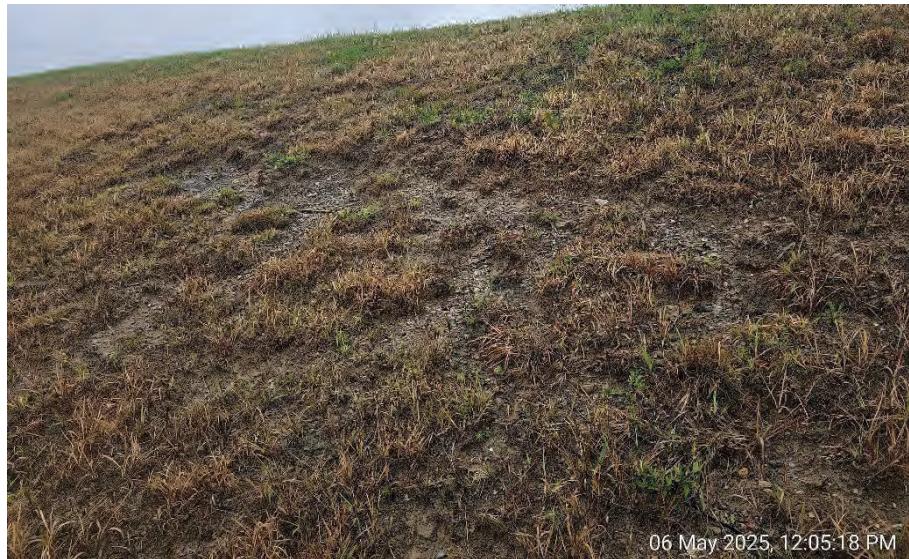
**Comments:** Previous sand-bentonite repairs to the perimeter embankment near Station 83+00 were still in satisfactory condition. There were some bare areas near this location that may have been caused by the fire in March 2023.

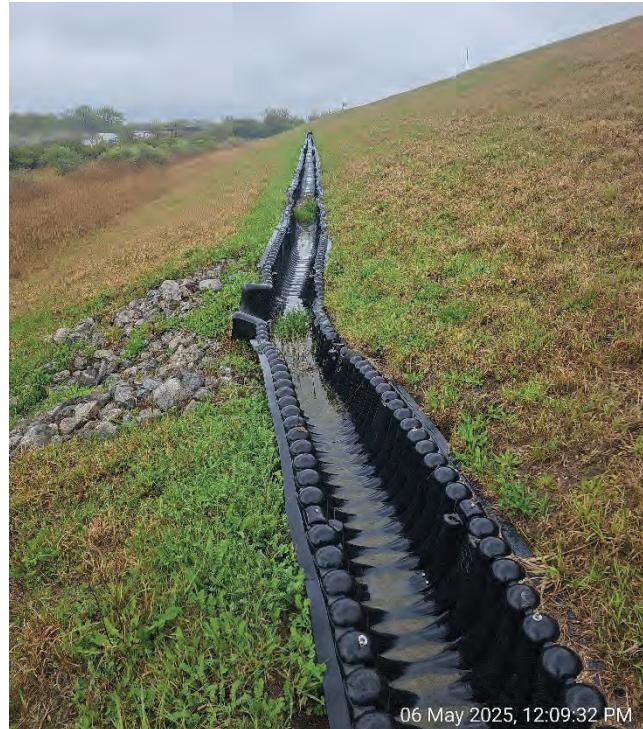
**Photograph 40**

- iii. The SmartDitch outlets at Stations 18+50 (Photograph #60), 32+50 (Photograph #55), 76+00 (Photograph #42), 82+00 (Photograph #40), 88+00 (Photograph #36), 139+50 (Photograph #25), 145+50 (Photograph #20), and 151+00 (Photograph #15) have been distorted due to settlements resulting from erosion below the outlets.

**Comments:** More than 1 foot of riprap has eroded from below the SmartDitch outlet at Station 82+00. The outlet has been distorted due to settlements.

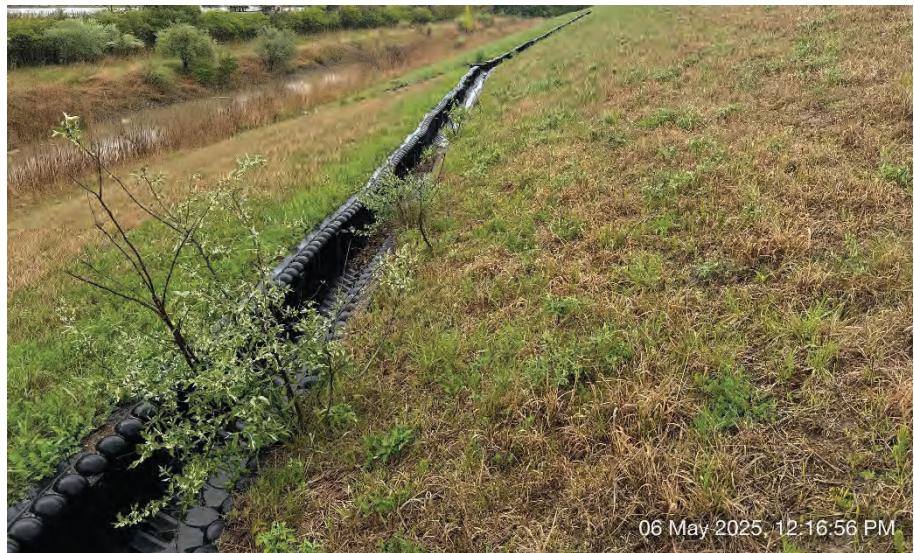
- f. Small, woody vegetation was observed on the upslope sides of the SmartDitch near Stations 62+00 (Photograph #47) and 76+50 (Photograph #41).
  - g. The aggregate placed on the perimeter embankment between Stations 67+00 and 68+00 has shown signs of erosion from the upper slope to the lower slope and exposed the covered high-density polyethylene (HDPE) slotted pipe (Photograph #44).

**Comments:** Small, woody vegetation was observed on the upslope side of the SmartDitch on the west side near Station 76+50.

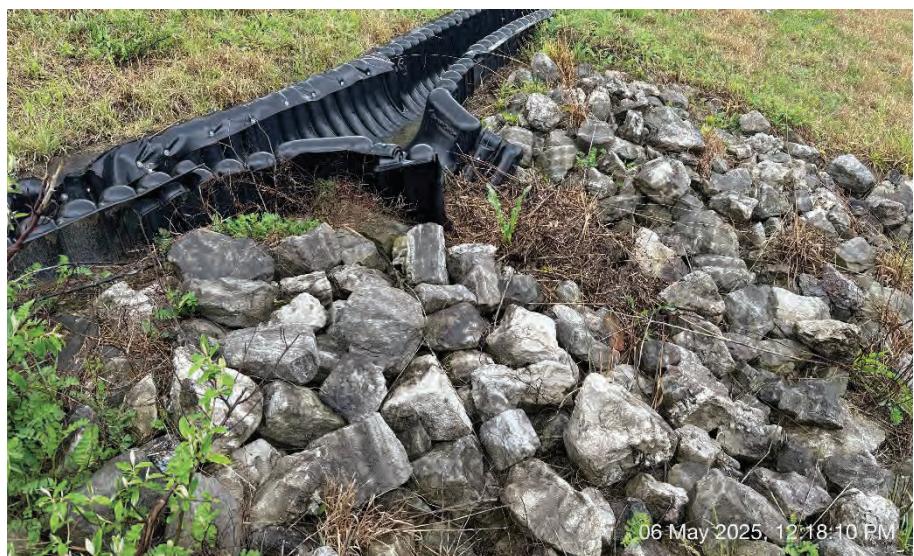
**Photograph 42**

**Comments:**  
Approximately 1 foot of riprap has eroded from below the SmartDitch outlet at Station 76+00. The outlet has been distorted due to settlements. Significant cut vegetation was observed within the outlet but did not appear to impede conveyance of stormwater flow into the riprap.

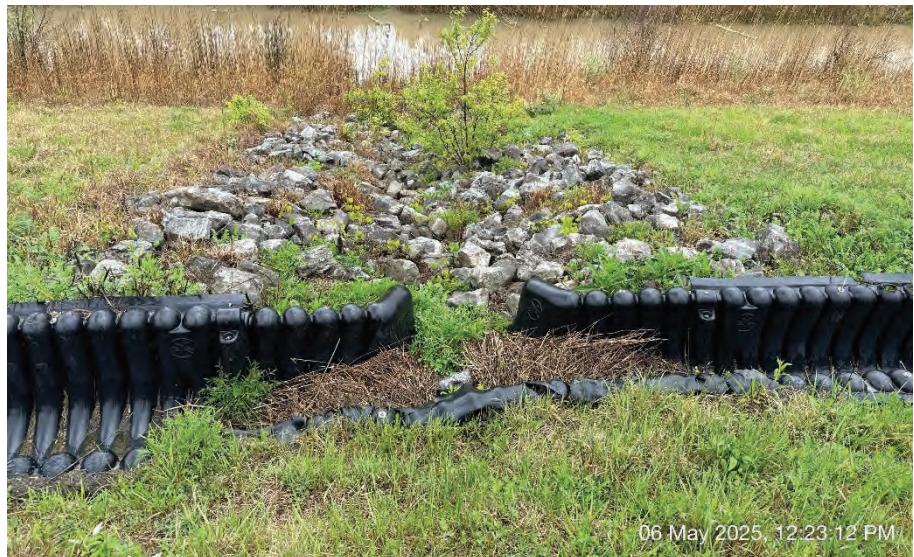
**Comments:** Small, woody vegetation was observed in the riprap downchute at Station 70+00.

Approximately 0.5 feet of riprap has eroded from below the SmartDitch outlet. Significant cut vegetation was observed within the outlet but did not appear to impede conveyance of stormwater flow into the riprap.

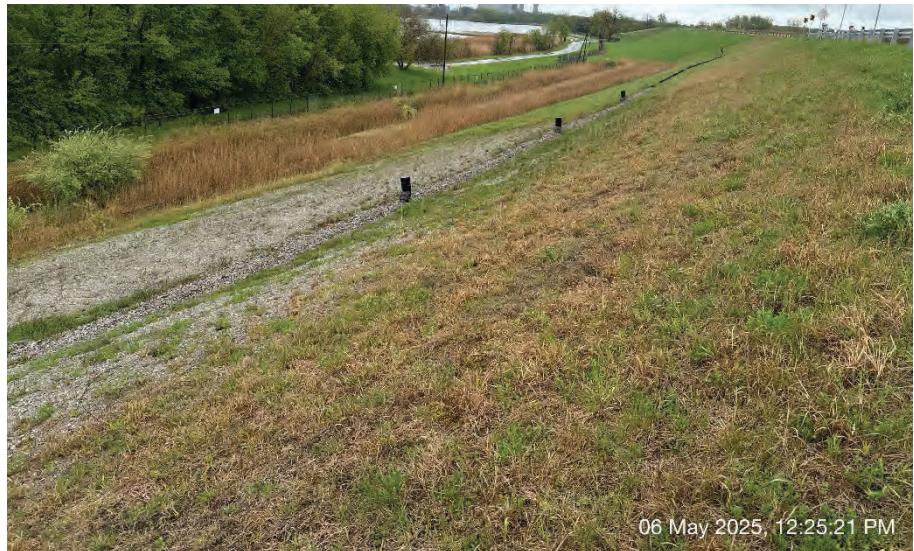
**Photograph 44**

- The aggregate placed on the slope between Stations 67+00 and 68+00 has shown signs of erosion from the upper slope to the lower slope and exposed the covered HDPE slotted pipe (Photo #44).

**Comments:** The aggregate along the previous slope repair between Stations 67+00 and 68+00 has migrated from the upper portion of the embankment to the bottom and exposed portions of the covered HDPE drainpipe. No bare areas were observed along the upper portion of the embankment.

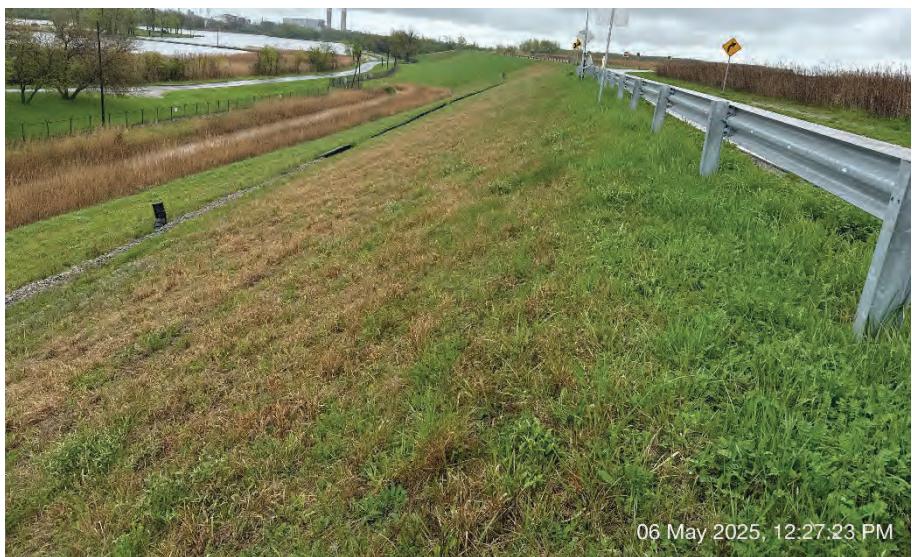
**Comments:** Exterior slopes of the perimeter embankment on the northwest side (Stations 61+00 to 67+00) were in good condition. No indicators of slope instabilities (e.g., cracks) or erosion were observed. Vegetation was well maintained. The SmartDitch was in fair condition: some cut vegetation, erosion around the edges, and settlement.

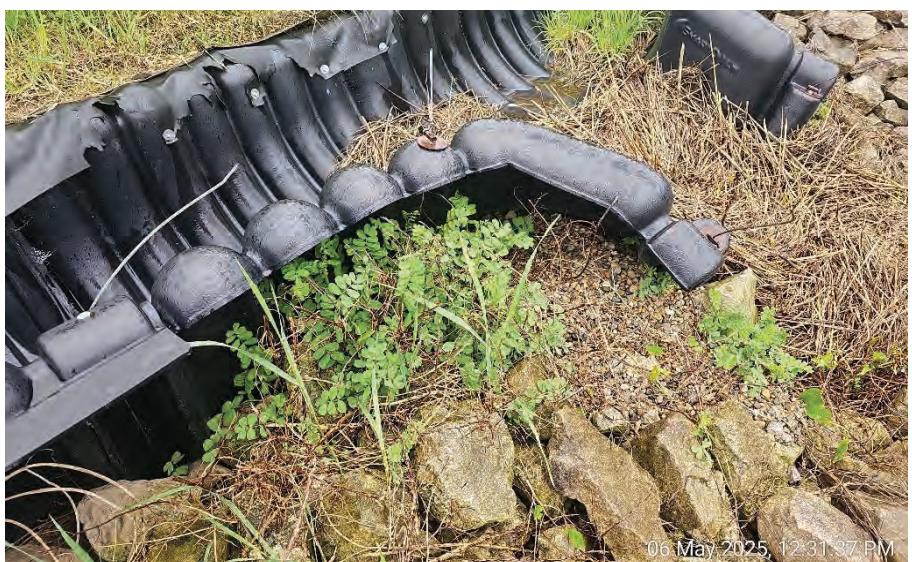
**Photograph 46**

**Comments:**  
 Approximately 0.5 feet of riprap has eroded from below the SmartDitch outlet at Station 64+00. Significant cut vegetation was observed within the outlet but did not appear to impede conveyance of stormwater flow into the riprap.

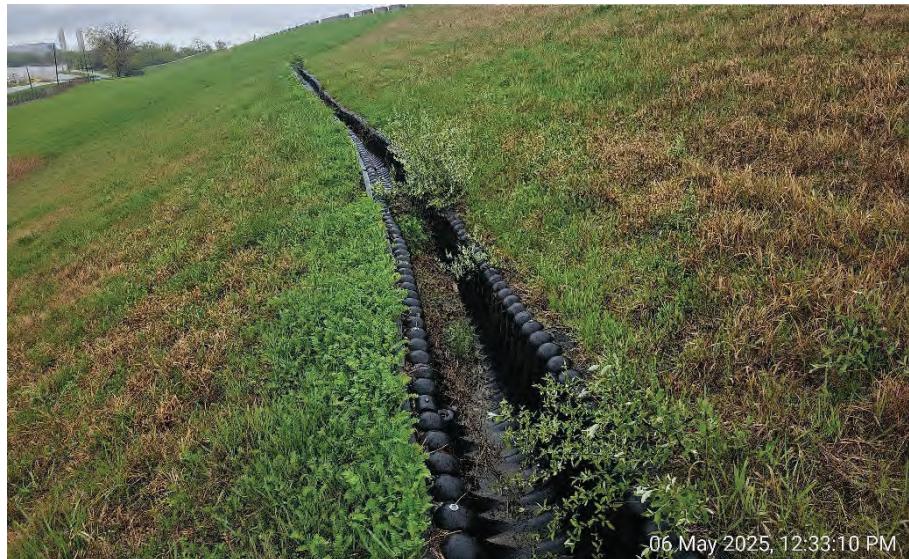
**Comments:** Small, woody vegetation was observed on the upslope side of the SmartDitch on the north side near Station 62+00.

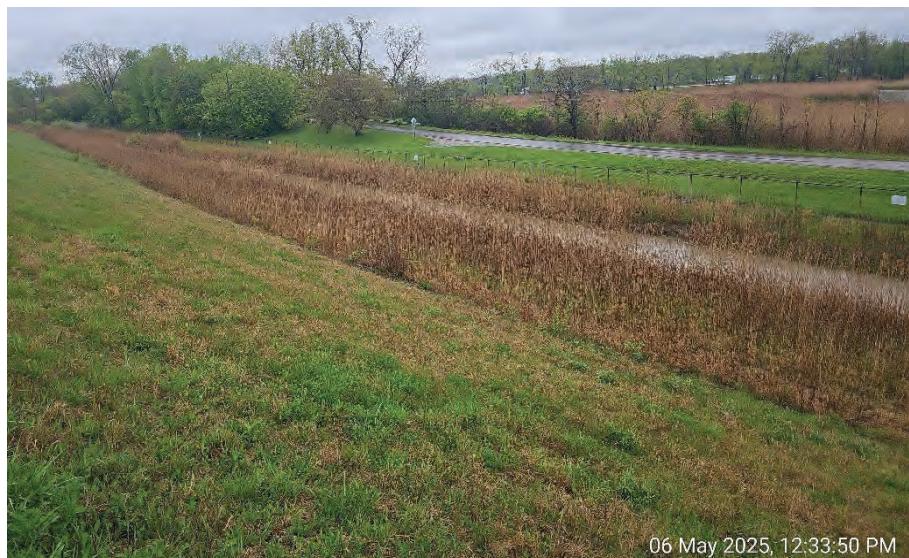
**Photograph 48**

- i. The perimeter swales along the perimeter embankment were in satisfactory condition (Photograph #48). Water was observed within the perimeter channels, but flow was minimal. The denser vegetation on the sides of the perimeter channels did not appear to impede the flow of water through the channels.

**Comments:** The perimeter channels were generally in satisfactory condition (north side near Station 62+00 shown in photograph). Water was observed within the perimeter channels with minimal flow. The denser vegetation on the sides of the perimeter channels did not appear to impede the flow of water through the channels.

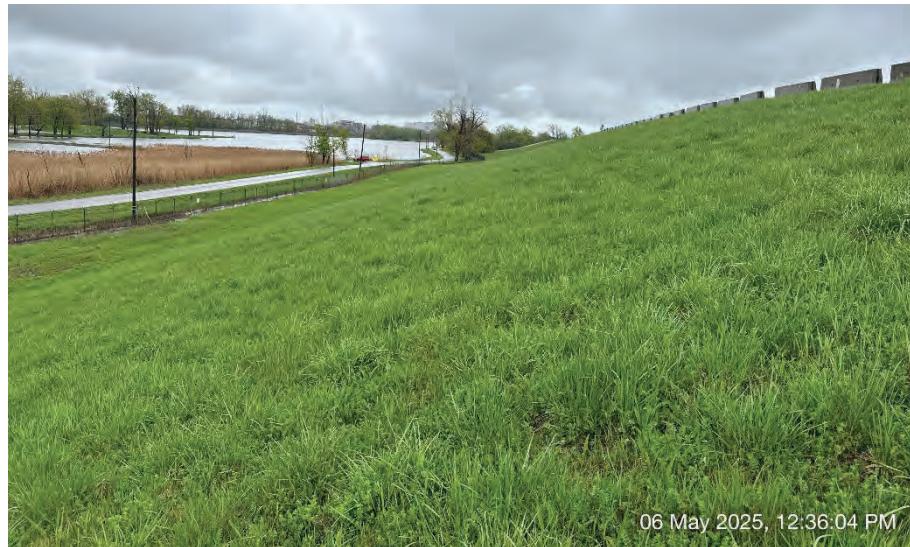
**Comments:** Exterior slopes of the perimeter embankment on the north side (Stations 46+50 to 61+00) were in good condition. No indicators of slope instabilities (e.g., cracks) or erosion were observed. Vegetation was well maintained.

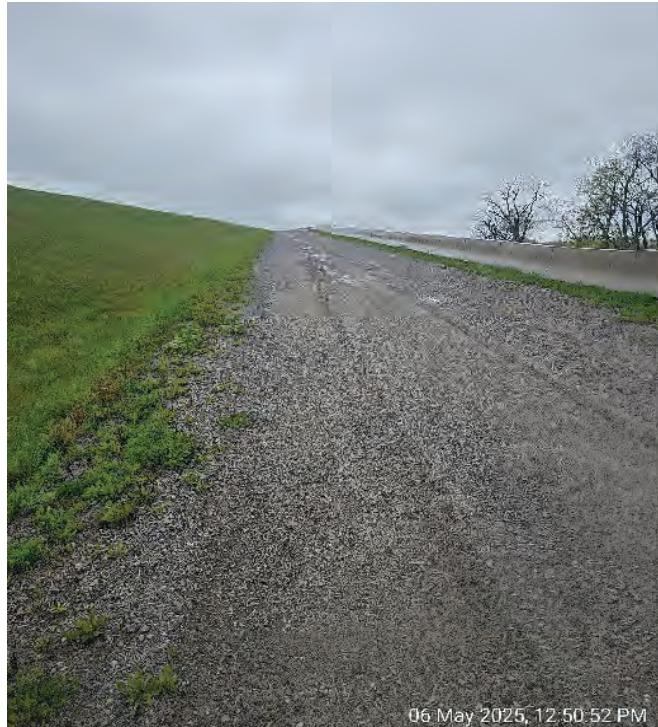
**Photograph 50**

**Comments:** North access road to the perimeter road atop the perimeter embankment was in good condition with no erosion rills and minimal rutting observed.

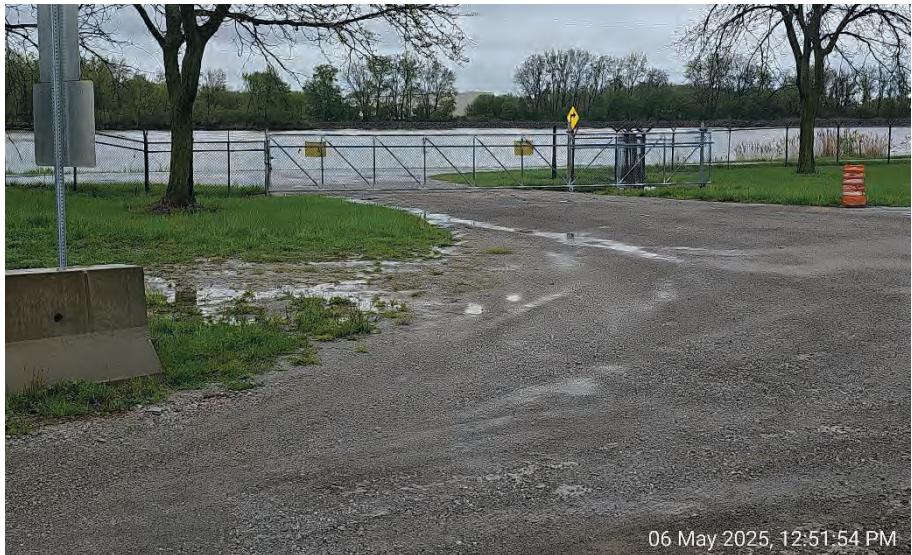
**Comments:** The security gates at the north (shown in photograph) and south entrances were in good condition and locked. Signs were posted for DTE private property. The perimeter fences around the Fly Ash Basin were also generally in satisfactory condition and had proper signage.

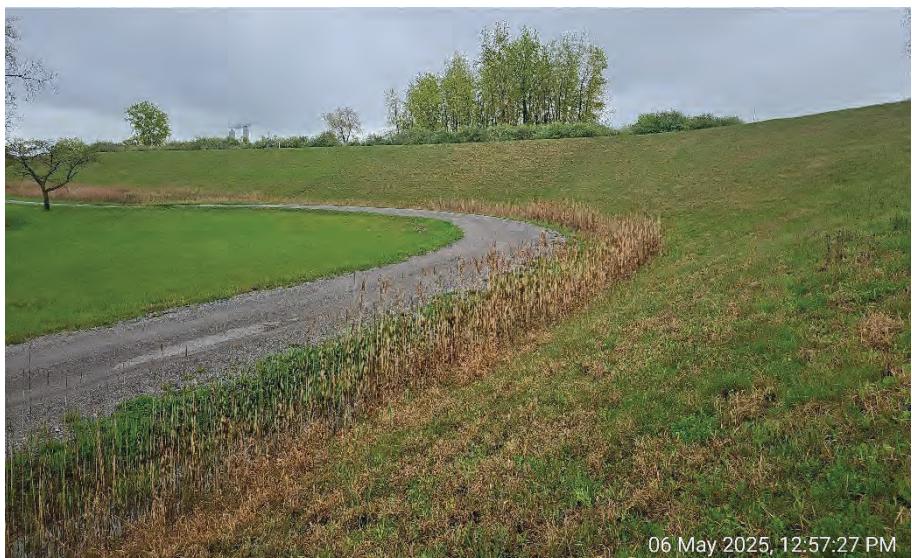
**Photograph 52**

**Comments:** Exterior slopes of the perimeter embankment by the north entrance (Stations 35+50 to 46+50) were in good condition. No indicators of slope instabilities (e.g., cracks) or erosion were observed. Vegetation was well maintained.

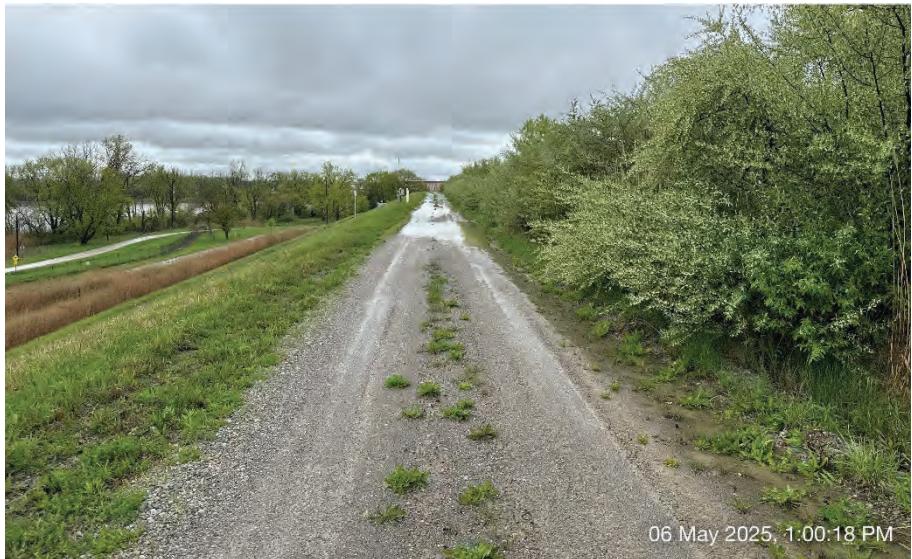
**Comments:** Perimeter road atop the perimeter embankment on the north side (Stations 20+00 to 38+00) had a couple low spots. Ponded water was observed in these low spots due to precipitation prior to and during the inspection.

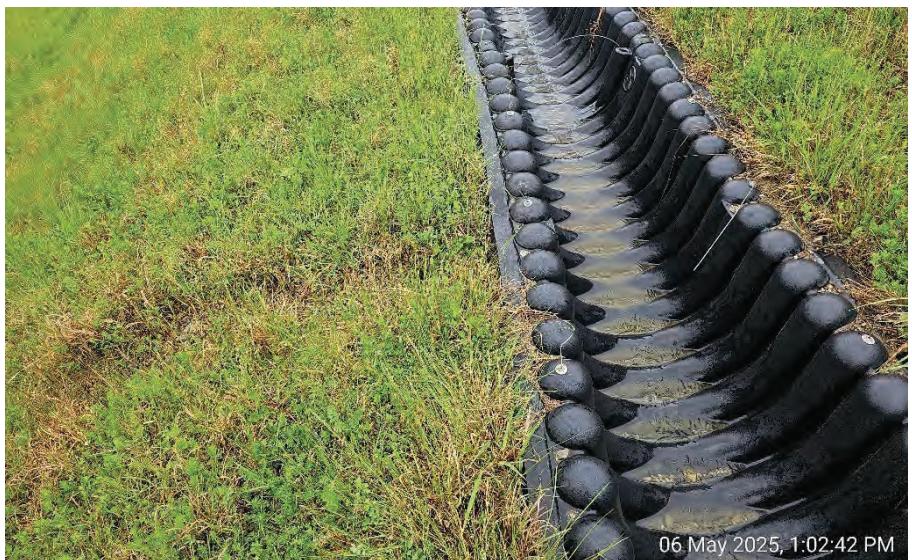
**Photograph 54**

- h. A small erosion rill was observed on the downslope side of the SmartDitch near Station 33+00 (Photograph #54). The erosion did not appear to have caused the SmartDitch to settle.

- A small erosion rill was observed on the downslope side of the SmartDitch near Station 33+00 (Photo #54).

**Comments:** A small erosion rill was observed on the downslope side of the SmartDitch near Station 33+00. The erosion did not appear to have caused the SmartDitch to settle.

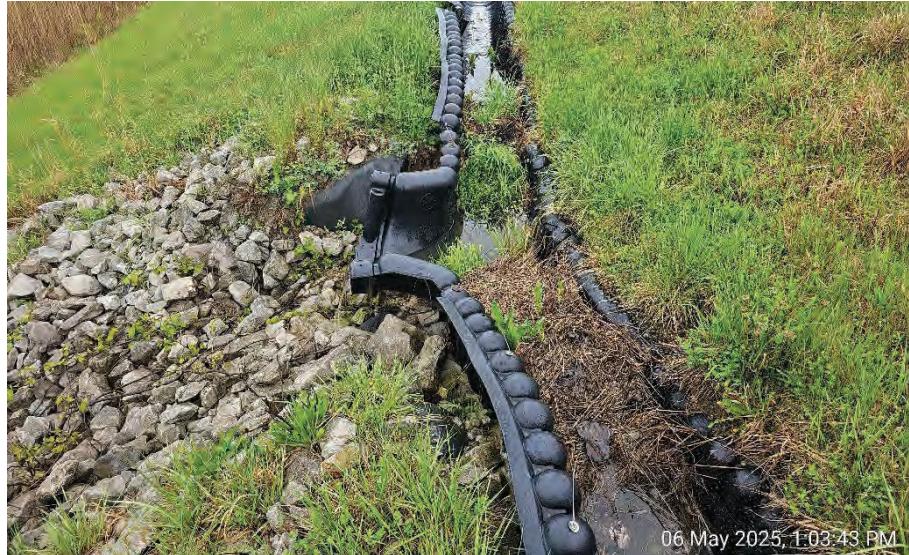
**Comments:** More than 1 foot of riprap has eroded from below the SmartDitch outlet at Station 32+50. The outlet has been distorted due to settlements. Significant cut vegetation was observed within the outlet but did not appear to impede conveyance of stormwater flow into the riprap.

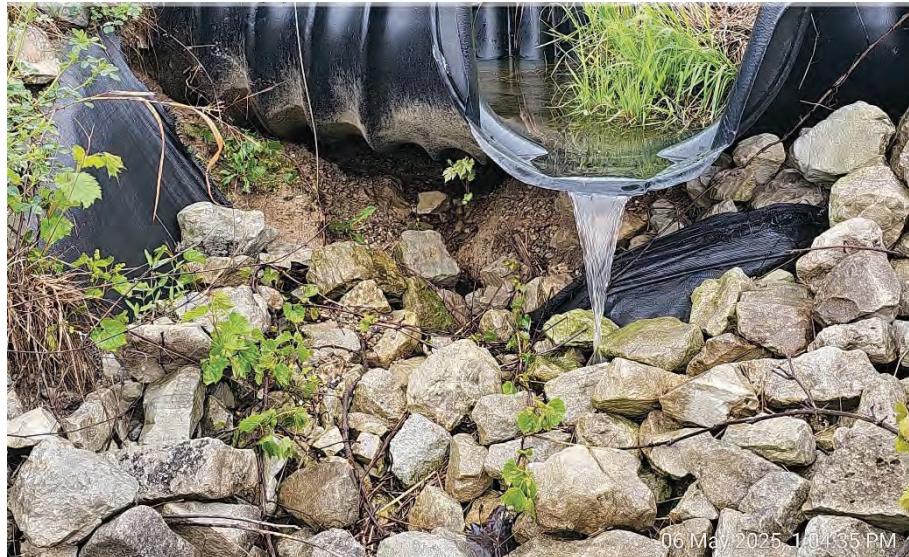
**Photograph 56**

- ii. The amount of erosion has exposed the geotextile below the SmartDitch outlets at Stations 18+50 (Photograph #61), 32+50 (Photograph #56), 145+50 (Photograph #20), 151+00 (Photograph #15), and 157+00

**Comments:** More than 1 foot of riprap has eroded from below the SmartDitch outlet at Station 32+50. The geotextile below the SmartDitch has been exposed and torn due to the erosion and settlements.

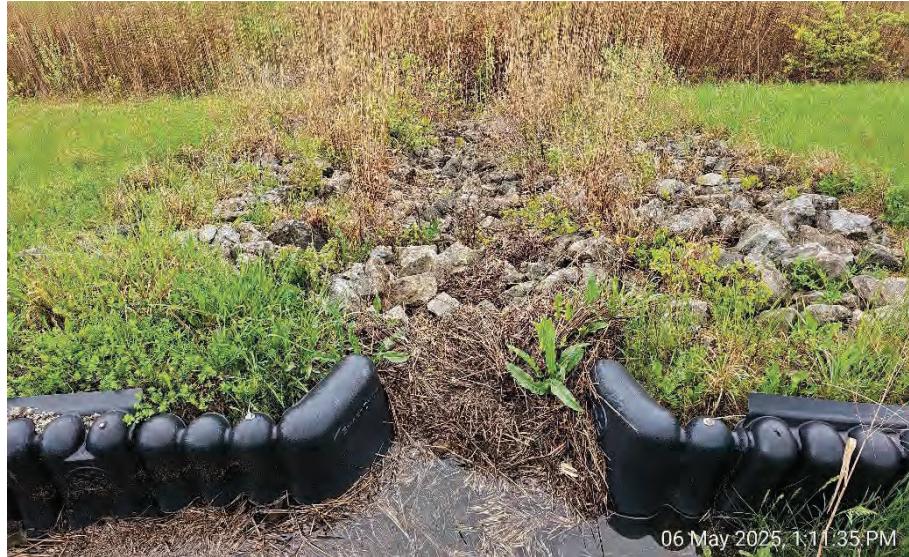
**Comments:** Denser vegetation was observed in the riprap downchute at Station 26+50. However, only minor erosion was observed in the riprap. Significant cut vegetation was observed within the outlet but did not appear to impede conveyance of stormwater flow into the riprap.

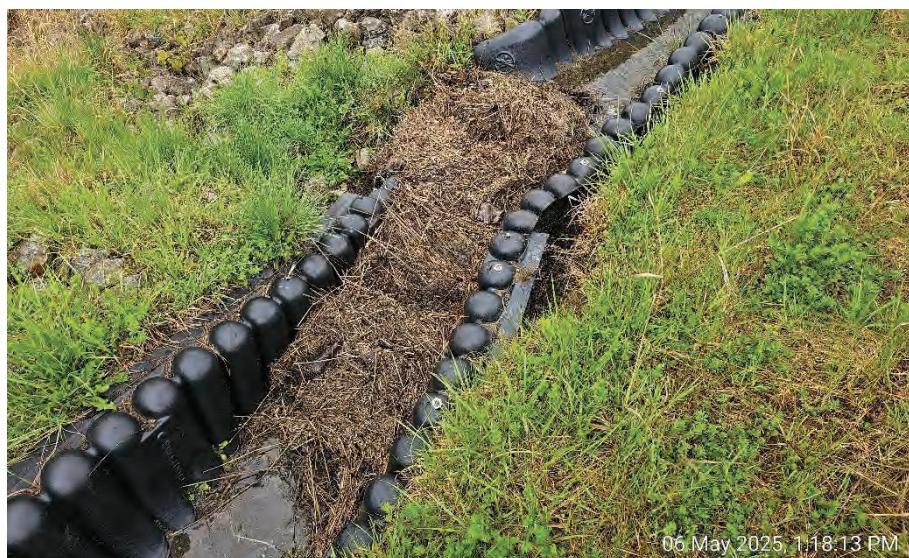
**Photograph 60**

**Comments:** More than 1 foot of riprap has eroded from below the SmartDitch outlet at Station 18+50. The outlet has been distorted due to settlements. Significant cut vegetation was observed within the outlet but did not appear to impede conveyance of stormwater flow into the riprap.

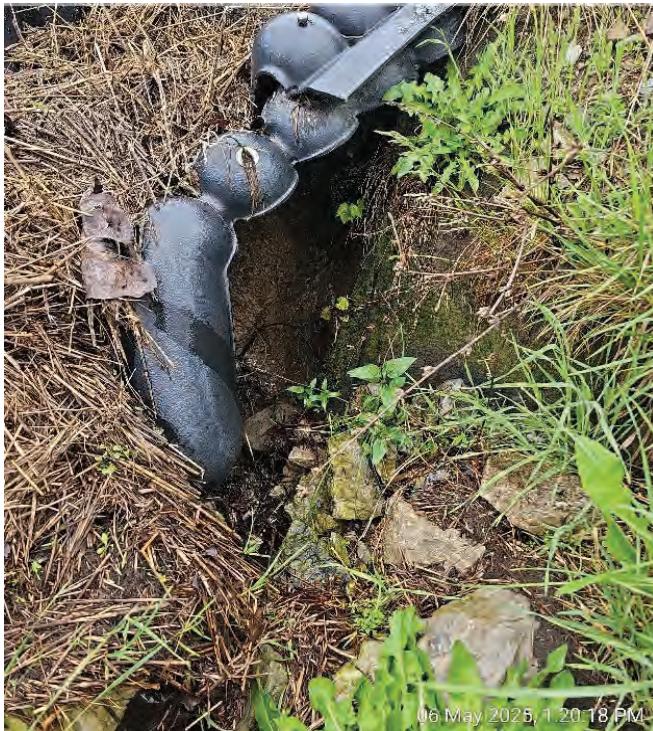
- i. At Station 18+50, concentrated flow beneath the outlet eroded over one foot of riprap and resulted in a hole (Photograph #61). Some flow into the hole was observed during the inspection due to precipitation prior to and during the inspection. Erosion was observed along the left side of the riprap downchute (facing downslope) (Photograph #62), which is down the slope from the hole. Finer sediments were observed near the bottom of the riprap downchute of this SmartDitch outlet (Photograph #63).

- At Station 18+50, water has eroded a hole beneath the SmartDitch outlet (Photo #61). Water was observed flowing into the hole at the time of the inspection. Erosion was observed along the left side of the riprap downchute (Photo #62), which is down the slope from the hole. Finer sediments were observed near the bottom of the riprap downchute (Photo #63).

**Comments:** Water has eroded a hole below the SmartDitch outlet at Station 18+50. The geotextile fabric below the SmartDitch has been exposed (right side of photo) and torn due to the erosion and settlement. Water was observed flowing into the hole at the time of the inspection.

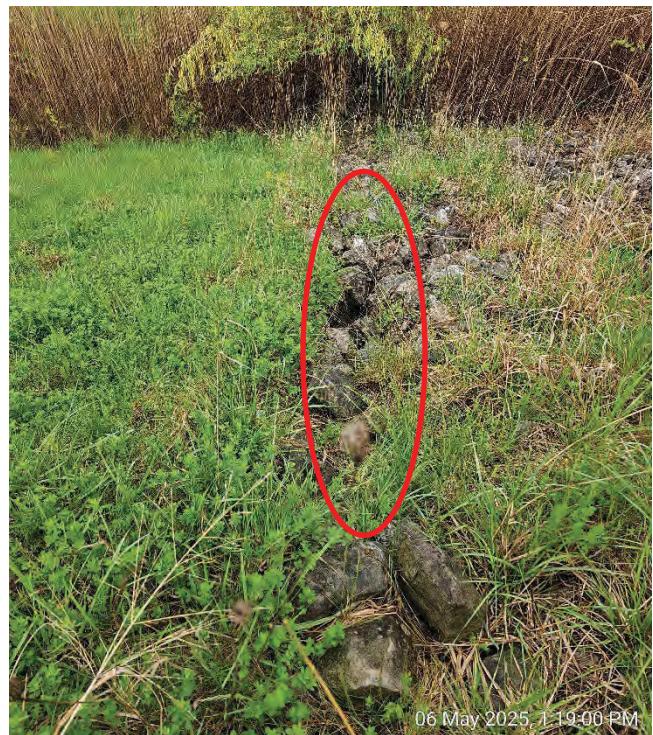
**Photograph 62**

**Comments:** Denser vegetation was observed in the riprap downchute at Station 18+50. Erosion of the riprap was observed on the left side of the downchute (facing downslope) downslope of the hole below the SmartDitch outlet.

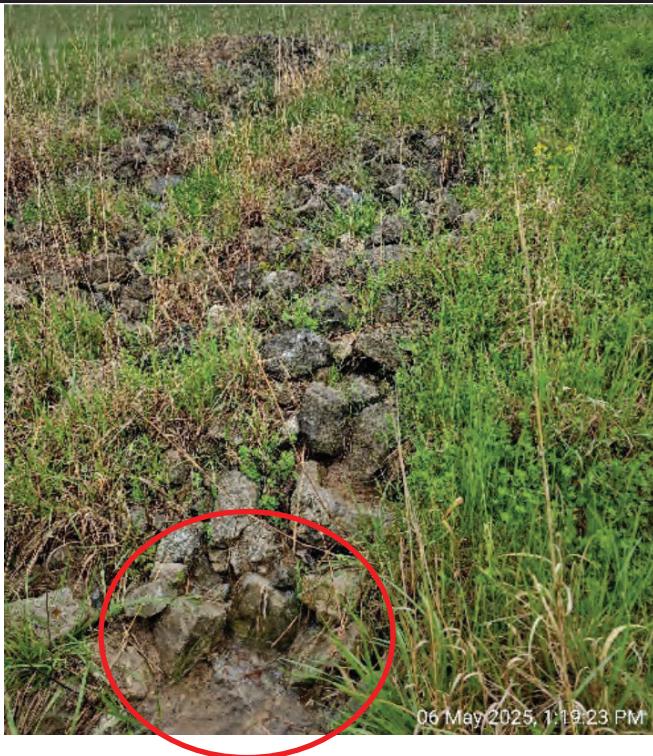
**Comments:** Finer sediments were observed within the riprap downchute (circled) downslope of the hole below the SmartDitch outlet at Station 18+50.

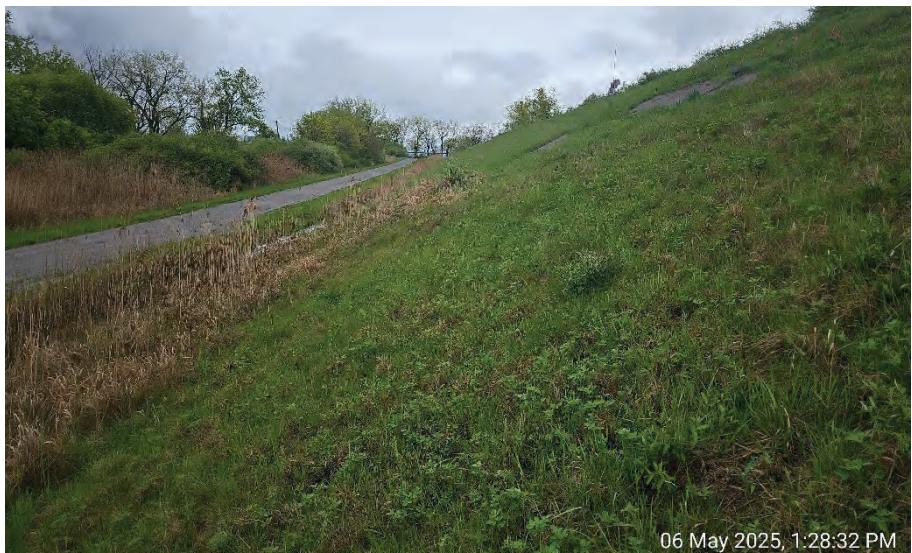
**Photograph 64**

- a. Sand-bentonite repairs made in September 2024 to the sloughing/cracking of the exterior slopes on the perimeter embankment near Station 12+00 had experienced erosion (Photograph #65). Existing "bunching" of materials at the toe of the embankment was still present (Photograph #64). The slope inclinometer at Station 11+50 did not indicate significant ground movements (i.e., less than 1.0 inch of cumulative movement), suggesting that only surficial movement has occurred.

**Comments:** Sloughing was observed on the exterior slopes of the perimeter embankment near Station 12+00. Recurrent sloughing has been noted at this location due to the 2H:1V slope and caused "bunching" of materials at the toe of the embankment. DTE has completed additional repairs in this area (Photograph #68).

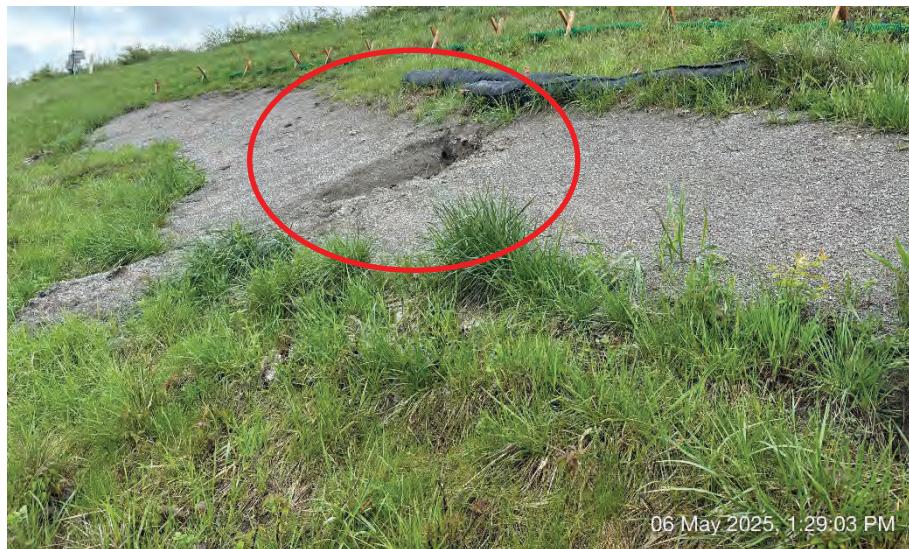
- The sloughing/cracking near Station 12+00 repaired with sand-bentonite showed some erosion within the repairs (Photo # 65). Recurrent sloughing has been noted at this location due to the 2H:1V slope and caused "bunching" of materials at the toe of the embankment (Photo #64). In June 2025, additional repairs and grading were made to the slope using clay materials from the on-site stockpile to address the erosion and establish vegetation (Photo #68). Erosion controls have been installed on the slope while vegetation becomes fully established. The slope and vegetation should continue to be monitored.

**Comments:** Repairs were made to the areas of sloughing using a sand-bentonite mix in September/October 2024. Erosion controls have been placed upslope of the repairs; however, areas of erosion were observed within the repairs. DTE has completed additional repairs in this area (Photograph #68).

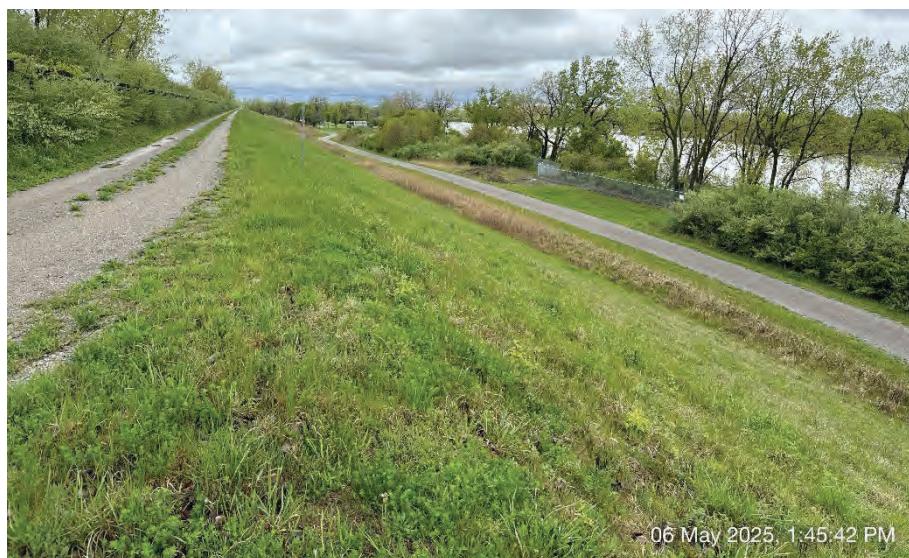
**Photograph 66**

**Comments:** Exterior slopes of the perimeter embankment on the northeast side (Stations 5+00 to 14+00) were generally in good condition. No indicators of slope instabilities (e.g., cracks) or erosion were observed (except near Station 12+00). Vegetation was well maintained.

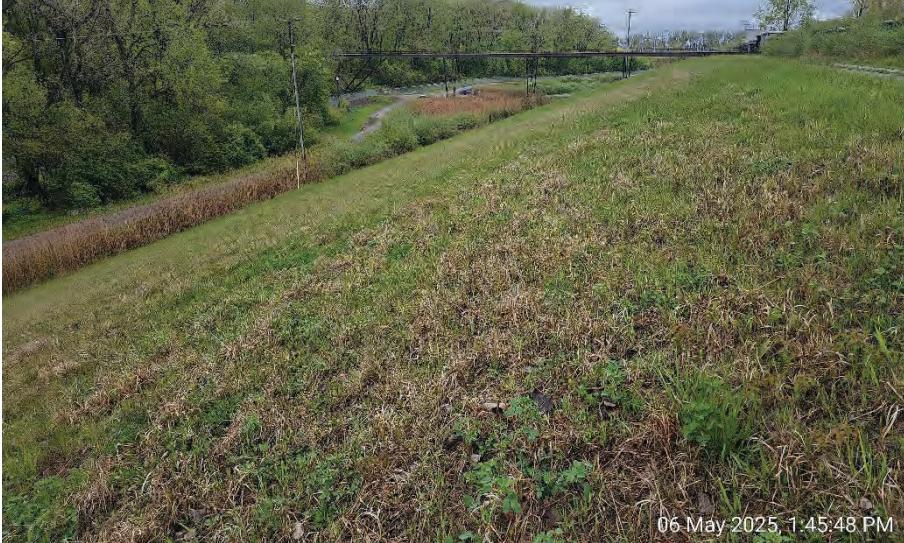
<p><b>Photograph 67</b></p> <p><b>Date:</b> 5/6/2025</p> <p><b>Direction:</b> South</p> <p><b>Comments:</b> Exterior slopes of the perimeter embankment on the northeast side (Stations 0+00 to 5+00) were in good condition. No indicators of slope instabilities (e.g., cracks) or erosion were observed. Vegetation was well maintained.</p>

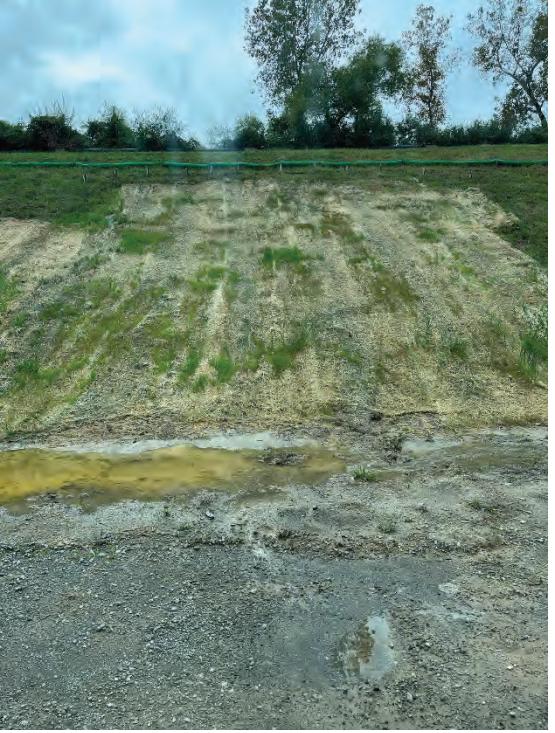
<p><b>Photograph 68</b></p> <p><b>Date:</b> 9/29/2025</p> <p><b>Direction:</b> Southeast</p> <p><b>Comments:</b> Additional repairs using clay materials from the on-site stockpile were made to the sloughing near Station 12+00 in June 2025. Erosion controls have been placed on and upslope of the repairs. Vegetation has started to grow within the repairs but has not become fully established.</p>

1. Additional repairs and grading were made to the sloughing near Station 12+00 in June 2025 using clay materials from the on-site stockpile (Photograph #68). Erosion controls have been placed on the slope while vegetation becomes fully established. The repairs and vegetation on the exterior slopes near Station 12+00 should continue to be monitored. DTE and Geosyntec are currently monitoring this area.
2. The exposed HDPE pipe near Station 67+00 should be covered with aggregate and the area should continue to be monitored for additional erosion.
3. Apply approved chemical sprays (for woody vegetation) and remove small, woody vegetation from the upslope side of the SmartDitch and within the riprap downchutes.

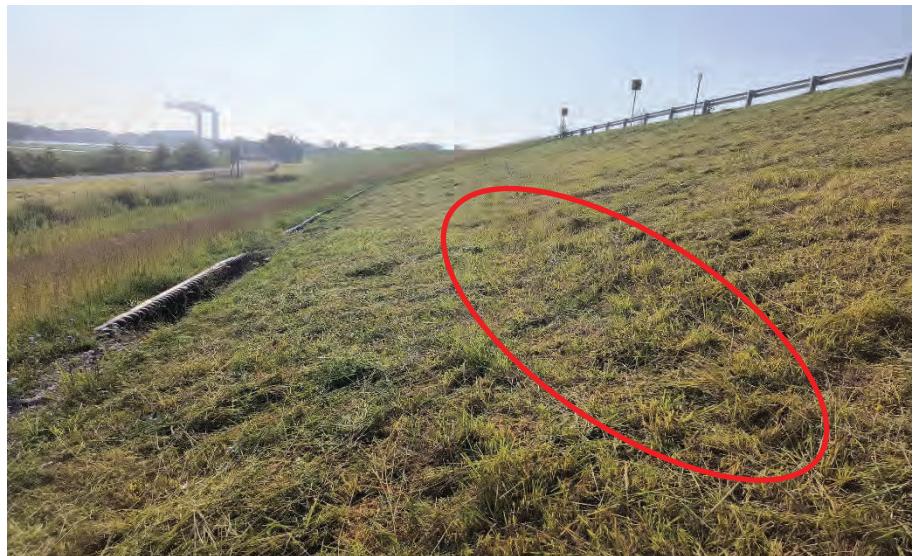
- In August 2025, DTE personnel observed some sloughing of previous sand-bentonite repairs near Station 65+00. Geosyntec inspected the sloughing and determined the sloughing extended approximately 100 feet (Photo #69). DTE personnel continued to monitor these conditions during weekly inspections and plan to repair the sloughing in Spring 2026 based on Geosyntec's recommendation.

**Comments:** The exterior slopes of the perimeter embankment near Station 65+00 showed some sloughing of previous sand-bentonite repairs. This was originally identified by DTE personnel on August 8, 2025. Geosyntec inspected the area and determined that the extent of the sloughing was approximately 100 feet.
