2025 ANNUAL INSPECTION REPORT RANGE ROAD LANDFILL

BELLE RIVER POWER PLANT

China Township, Michigan

January 2026

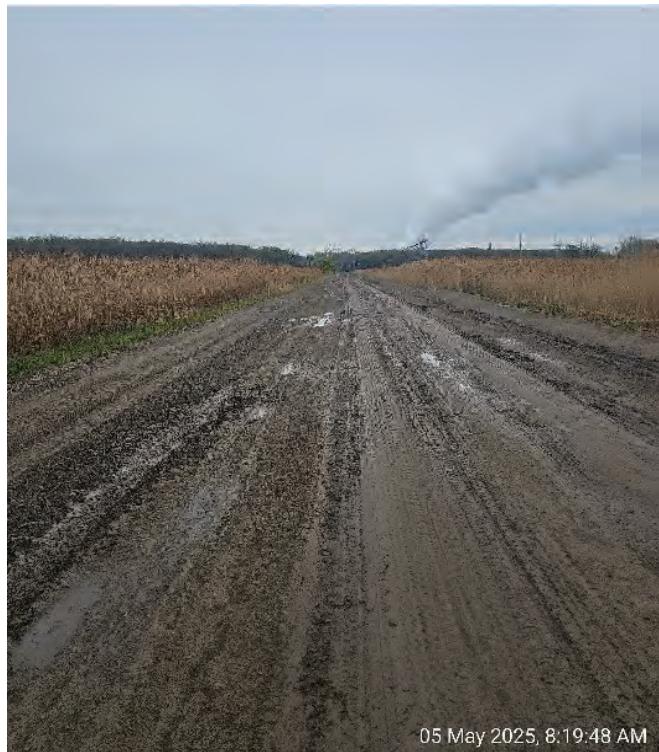
Comments: The perimeter road on the southeast side of the Landfill was generally in good condition with minimal low spots and rutting.

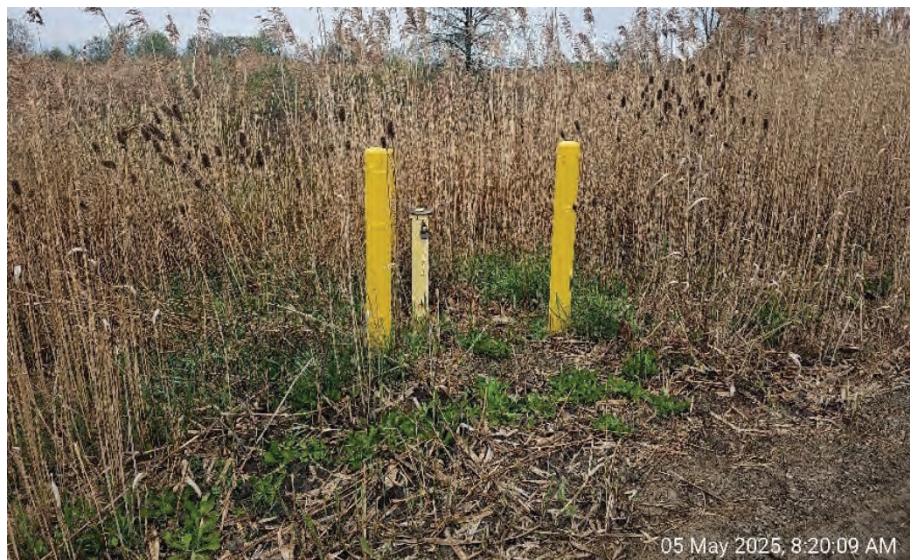
Photograph 6

25. Monitoring Well/Piezometer Conditions	<input checked="" type="checkbox"/>	<input type="checkbox"/>	<input type="checkbox"/>	6, 18	Monitoring wells and piezometers around the perimeter road were in good condition. Wells and piezometers near the road were generally protected by bollards (Photographs #6, #18), which were also in good condition.

Comments: Monitoring wells and piezometers around the perimeter road were in good condition and generally protected by bollards (typical).

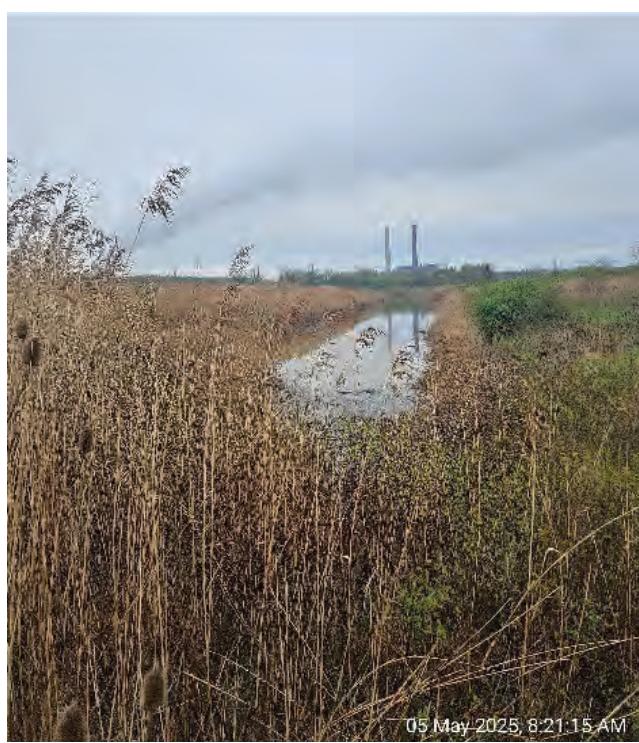
Comments: The perimeter ditch leading to the SDB had some vegetation on the side slopes but no erosion was observed. Flow toward the SDB was observed within the perimeter ditch during the visual inspection.

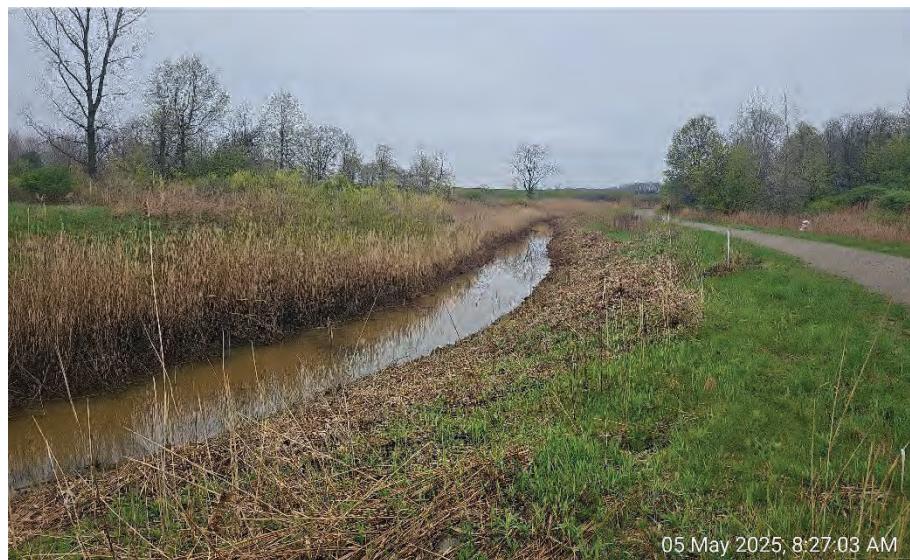
Photograph 8

Comments: The perimeter ditch on the east side of the Landfill had some vegetation on the western side slope but no erosion was observed. Flow within the perimeter ditch was observed to be in the proper direction during the visual inspection.

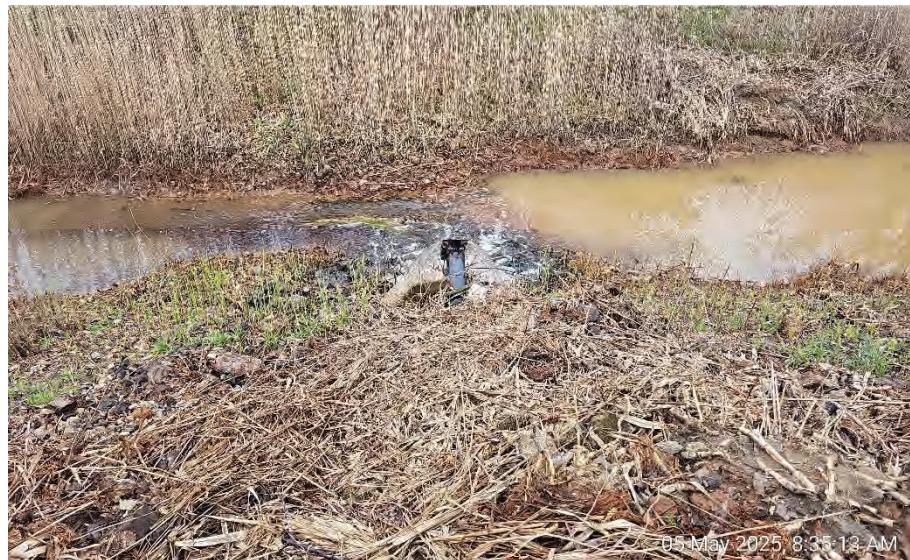
Comments: The discharge pipe connected to the pump house located on the east side of the Landfill for the perimeter slurry wall was observed to be in good condition and flowing during the visual inspection.

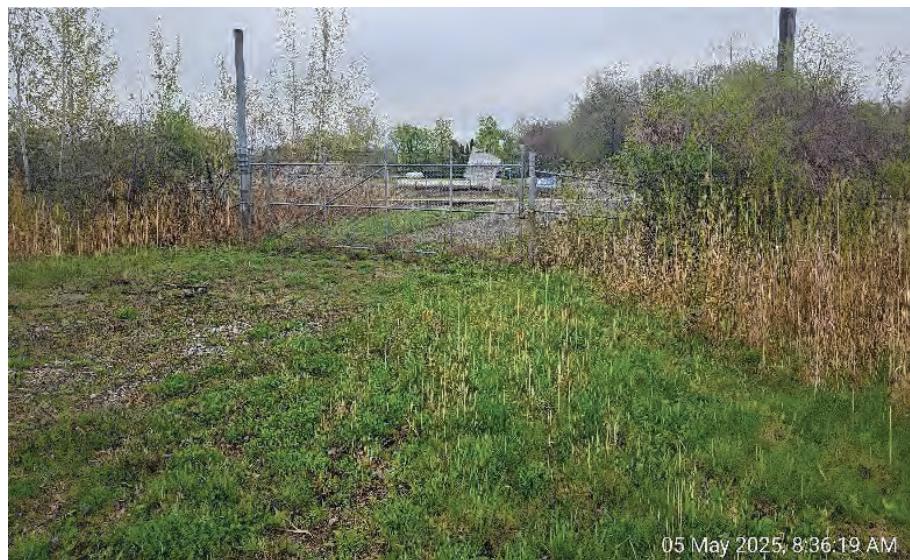
Photograph 12

7. The security fences and gates were locked and generally in good condition (Photographs #12, #36). The perimeter fence was damaged in a few locations along the north side

2. Security Fence / Gates		<input checked="" type="checkbox"/>	<input type="checkbox"/>	<input checked="" type="checkbox"/>	12, 21, 28, 33, 36		The perimeter gates surrounding the Landfill were locked and in good condition (Photographs #12, #36). While the majority of the perimeter fence was in satisfactory or good condition, there are specific locations along the north (Photograph #21), northwest corner (Photograph #28), and west (Photograph #33) of the Landfill where the fence is damaged. The damage included bending of top rails and damage to the link mesh.

3. Signs and Markers		<input checked="" type="checkbox"/>	<input type="checkbox"/>	<input type="checkbox"/>	12, 36		Security fences had signs noting DTE property and no trespassing (Photographs #12, #36). Markers for the perimeter slurry wall were observed and generally in good condition.

Comments: Perimeter fence gates were locked and generally in good condition (gate on east side shown). Signs for DTE property and "No Trespassing" were observed at the gates.

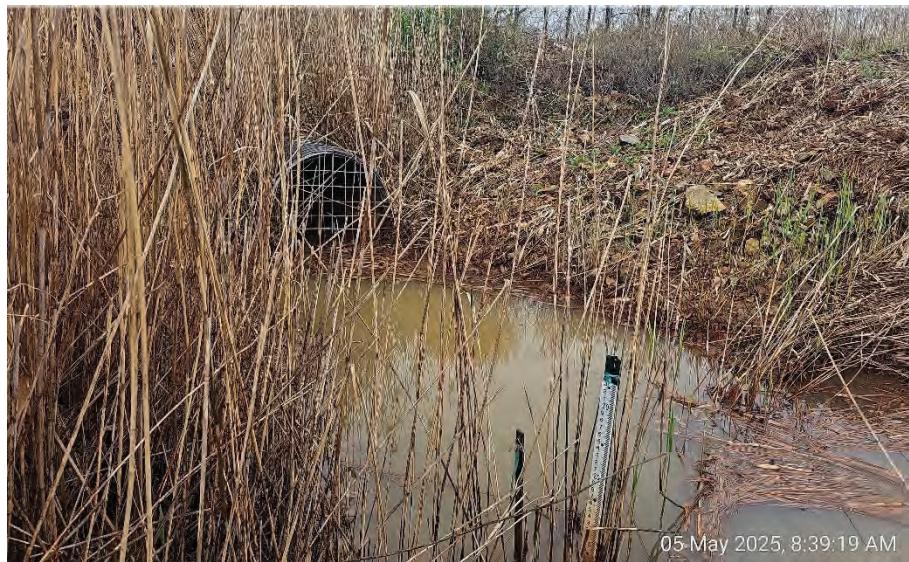
Comments: The culvert located within the east perimeter ditch was in good condition. Although there was some vegetation present at the inlet, it did not impede the flow. Flow within the perimeter ditch was observed to be in the proper direction during the visual inspection. Staff gauge-05, also shown, was in good condition.

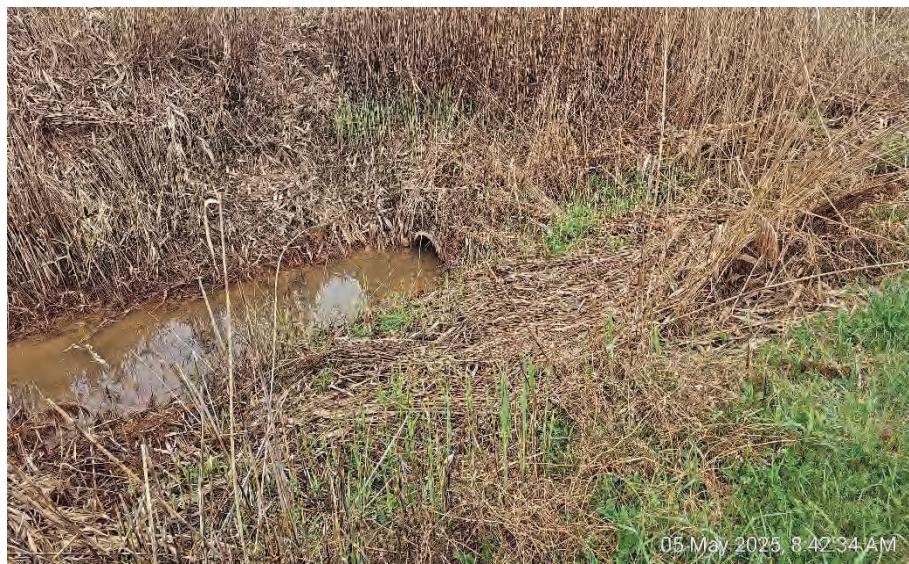
Photograph 14

Comments: The concrete culvert located within the east perimeter ditch was in good condition. The outlet of this culvert was free of obstructions. Flow within the perimeter ditch was observed to be in the proper direction during the visual inspection.

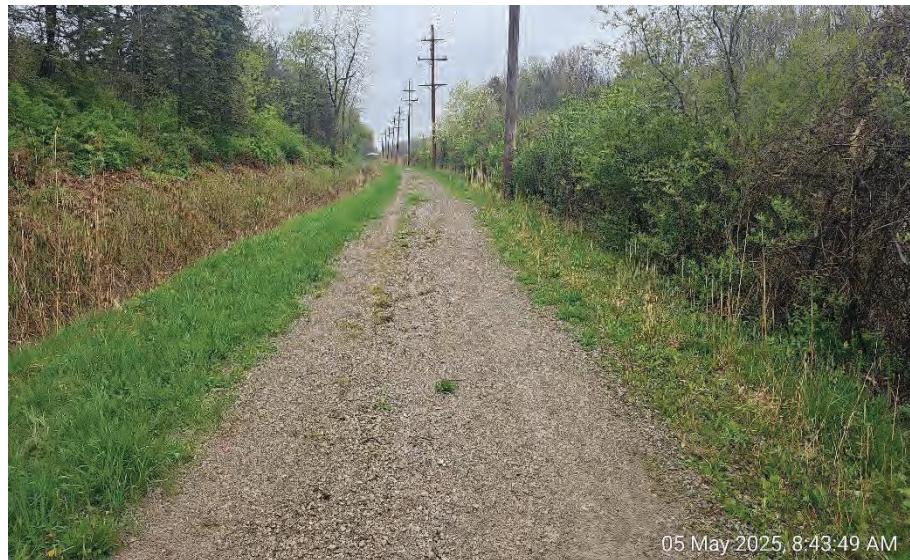
Comments: The perimeter road on the east side of the Landfill was in good condition with no rutting and minimal low spots.

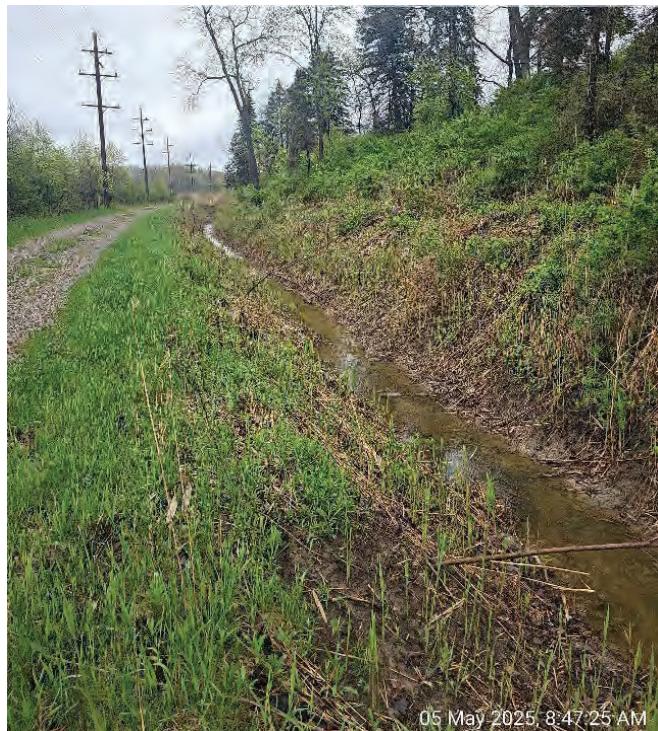
Photograph 16

Comments: Side slopes on the northeast side of the Landfill (Area B1) were covered in trees. MDEQ (EGLE) approved leaving the trees in place along these slopes. No indicators of slope instabilities were observed.

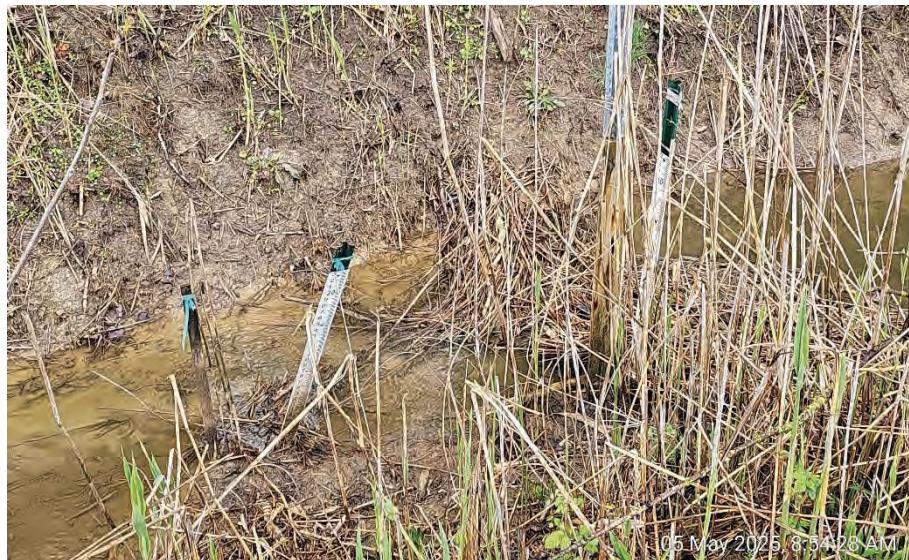
Comments: The staff gauges located within the north perimeter ditch were generally in satisfactory condition (typical) (staff gauge-02 shown).

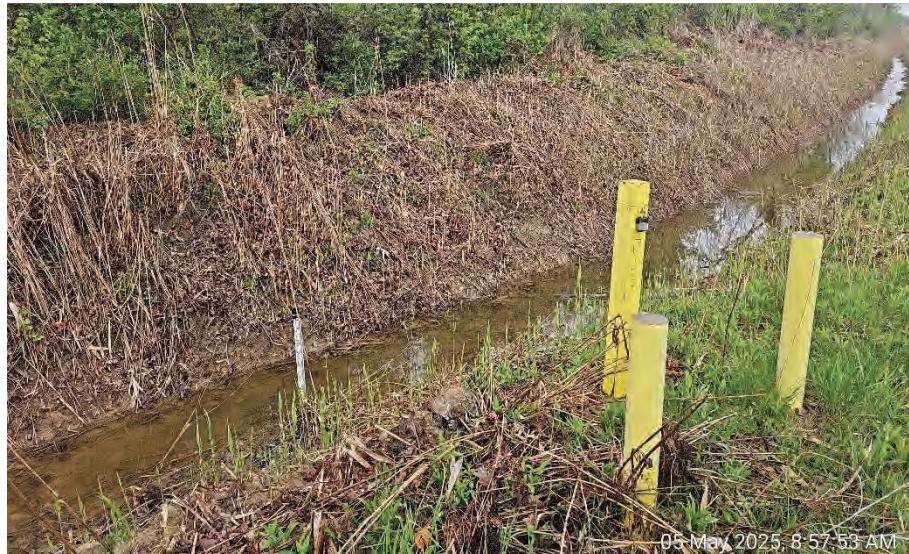
Photograph 18

Comments: The perimeter ditch on the north side of the Landfill was in good condition with no erosion observed on the side slopes. Flow within the perimeter ditch was observed to be in the proper direction during the visual inspection.

Monitoring wells and piezometers and staff gauges were generally in satisfactory condition.

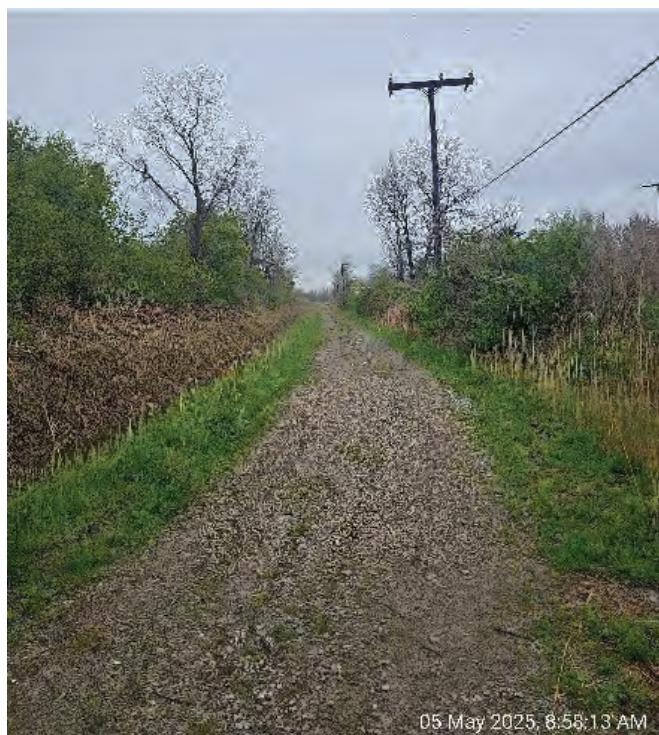
Comments: The perimeter road on the north side of the Landfill was in good condition with no rutting and minimal low spots.

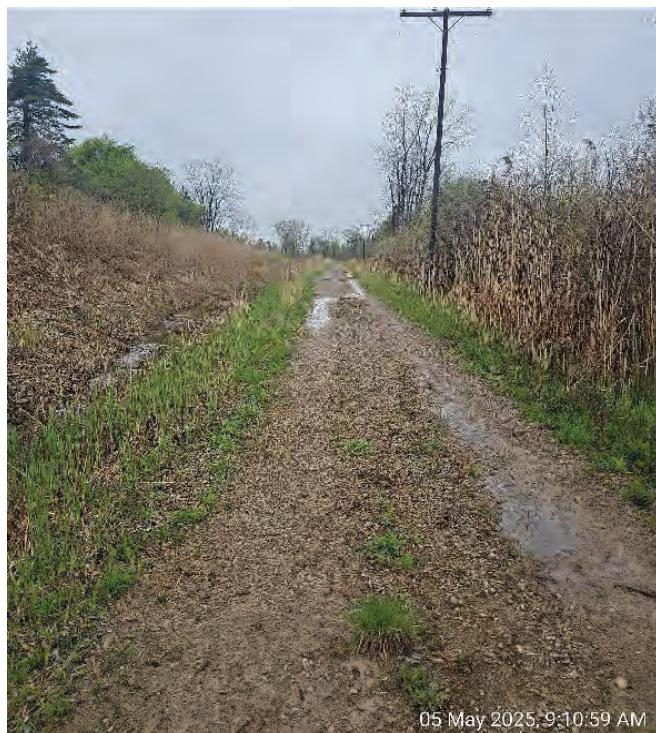
Comments: Side slopes on the north side of the Landfill (Area A) were covered in trees. MDEQ (EGLE) approved leaving the trees in place along these slopes. No indicators of slope instability were observed along the north side of the Landfill.

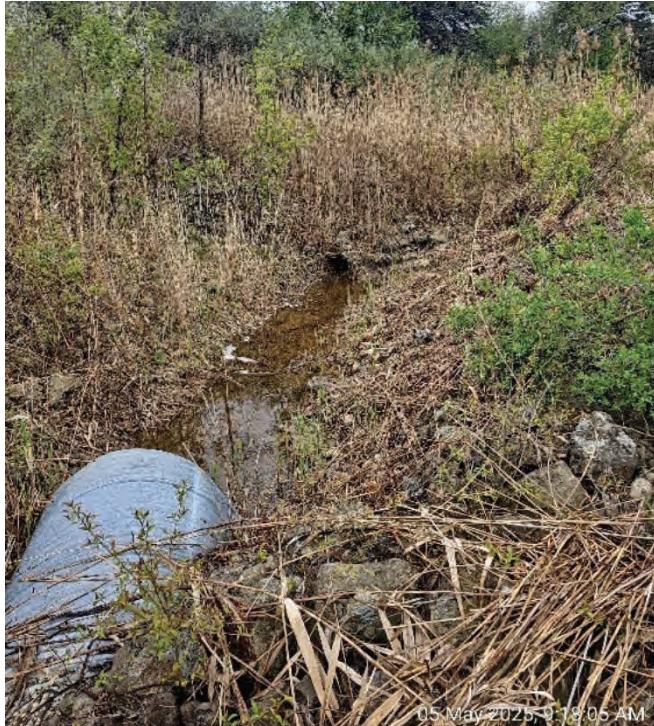
Comments: The corrugated metal culverts within the north perimeter ditch were observed to be in good condition and not obstructed. Flow within the perimeter ditch was observed to be in the proper direction during the visual inspection.

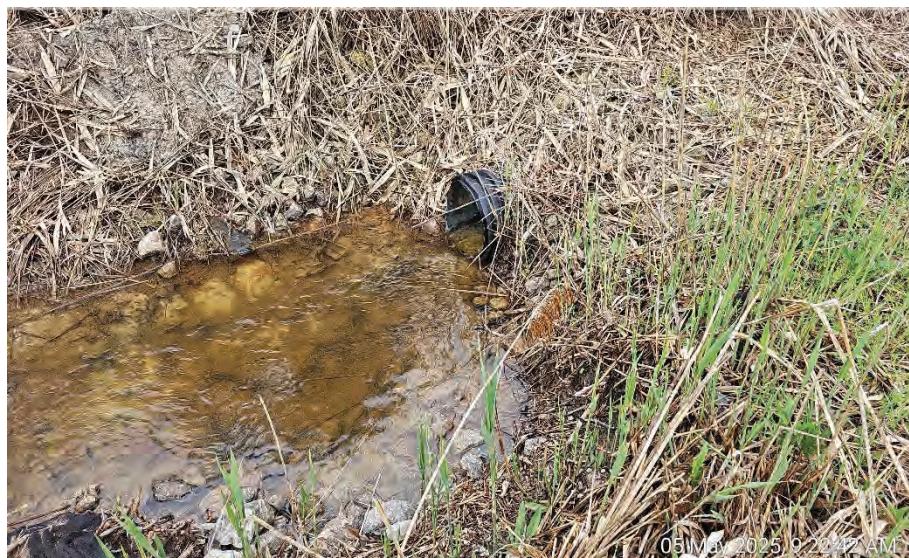
Photograph 24

Comments: The discharge pipe from the lift station was free of obstructions and flowing into the upper perimeter ditch during the visual inspection.

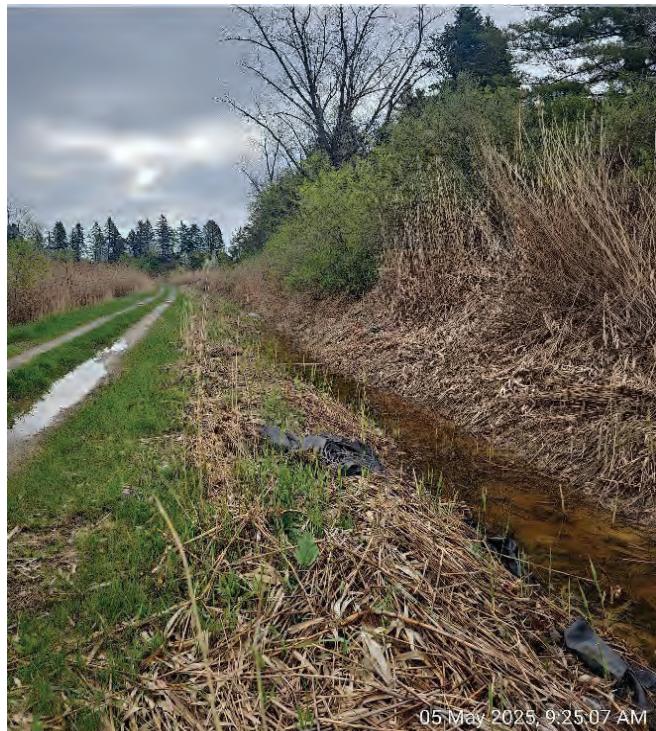
Comments: The upper perimeter ditch along the northwest side of the Landfill was in good condition with no observed erosion. Flow within the perimeter ditch was observed to be in the proper direction during the visual inspection.

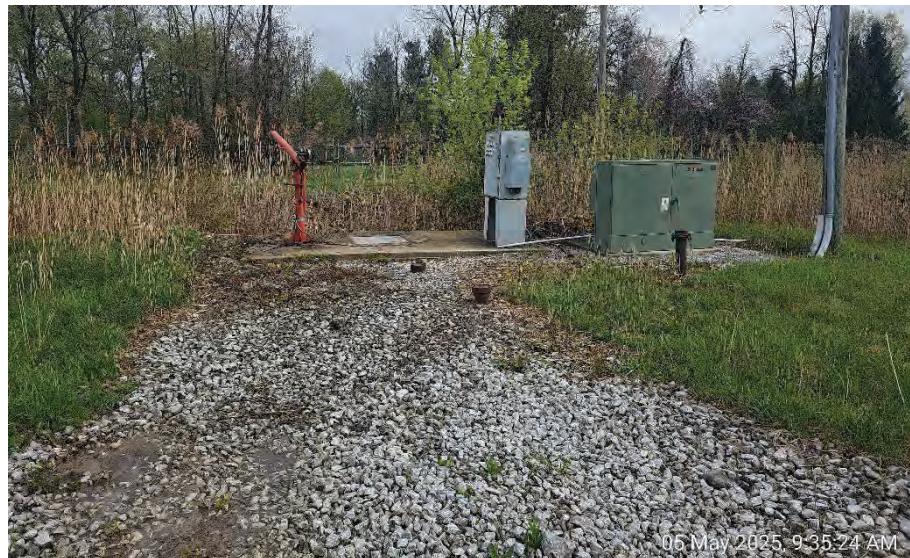
Photograph 26

Comments: The control panel, hoist, concrete pad, and manhole of the lift station at the northwest corner of the site were in good condition. The manhole was not accessed during the inspection. However, pumps were operational according to DTE personnel.

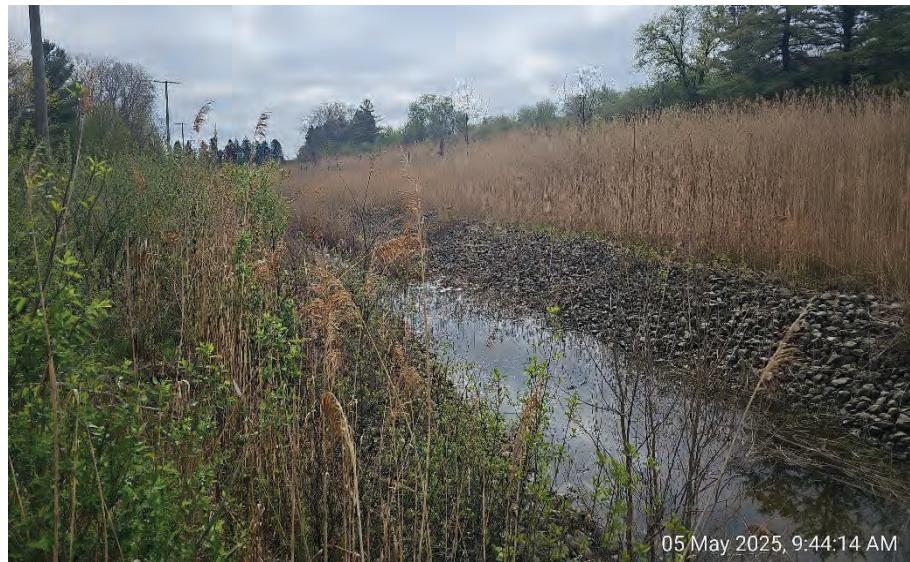
Comments: The lower perimeter ditch of the lift station at the northwest corner of the site was in good condition and had riprap armoring the side slopes. No erosion was observed within the riprap.

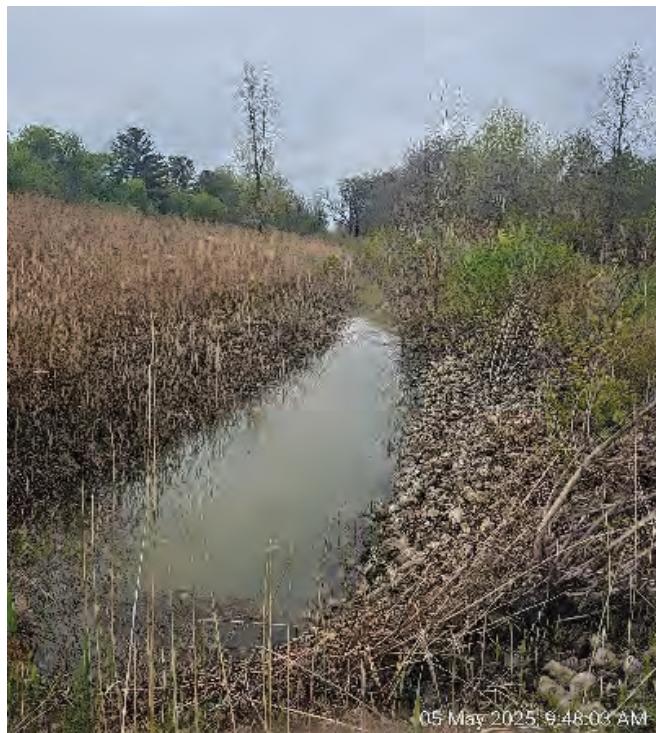
Comments: The perimeter ditch on the northwest side of the Landfill was in good condition and had riprap armoring the side slopes. No erosion was observed in the riprap. Flow within the perimeter ditch was observed to be in the proper direction during the visual inspection.

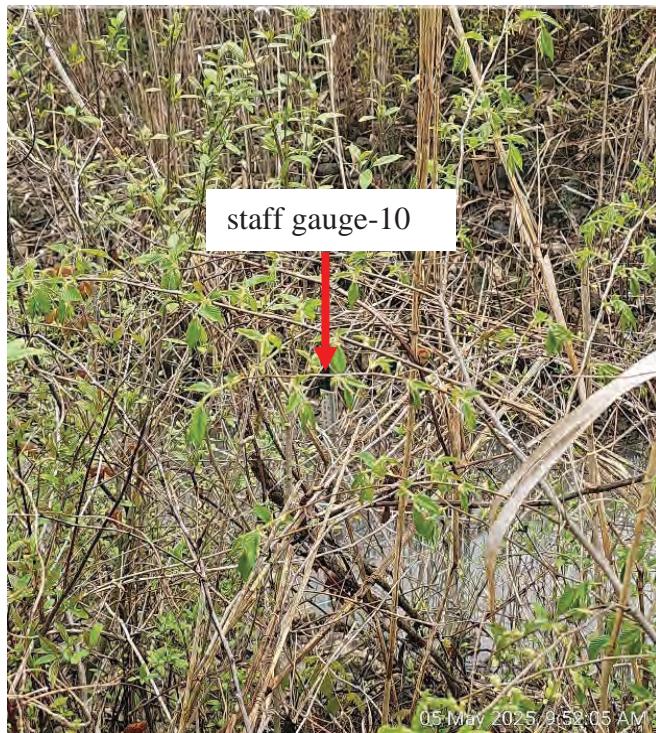
Photograph 32

Comments: The staff gauges located within the northwest perimeter ditch were observed and generally in satisfactory condition (typical) (staff gauge-10 shown). The perimeter ditch on the northwest side of the Landfill had some vegetation on the side slopes but no erosion was observed.

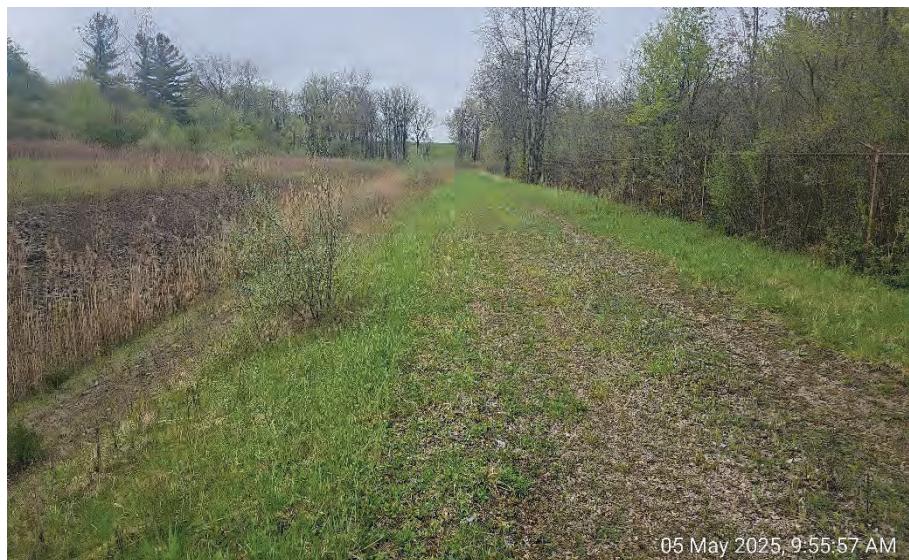
Comments: The perimeter roads, ditch and fence on the northwest side of the Landfill were generally in good condition. The perimeter ditch had riprap armoring the side slopes. Minor vegetation and no erosion were observed along the side slopes of the perimeter ditch.

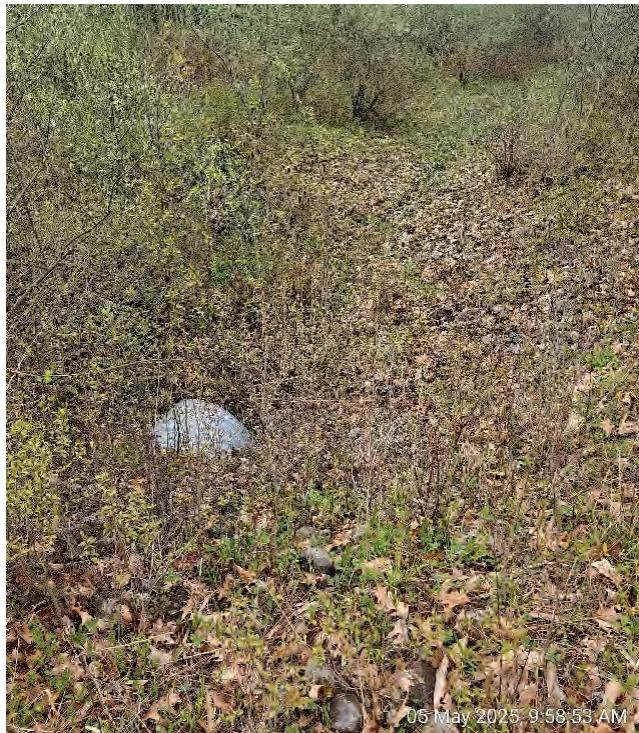
Comments: The corrugated metal culvert located on the northwest side of the landfill, directing stormwater runoff from Areas B and F1 to the perimeter ditch was in satisfactory condition.

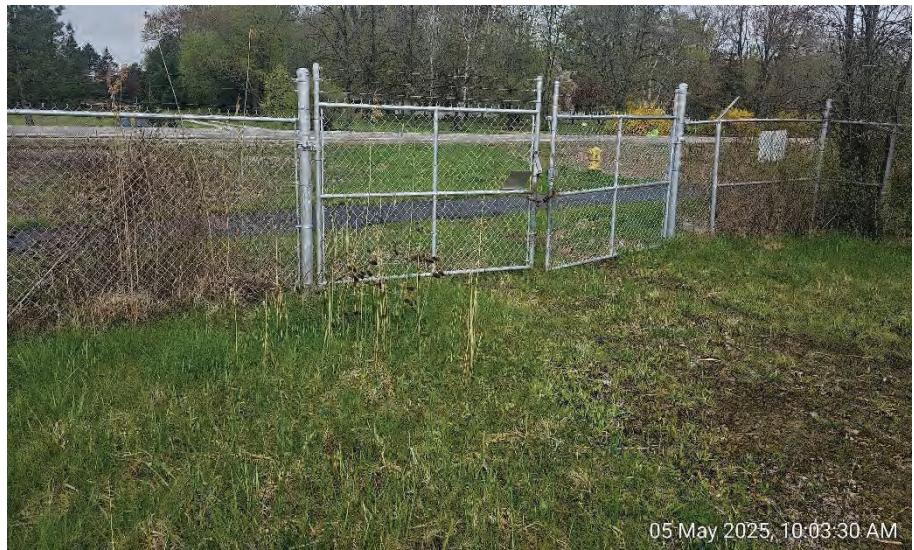
Photograph 36

Comments: Perimeter fence gates were locked and generally in good condition (gate on east side shown). Signs for DTE property and "No Trespassing" were observed at the gates.

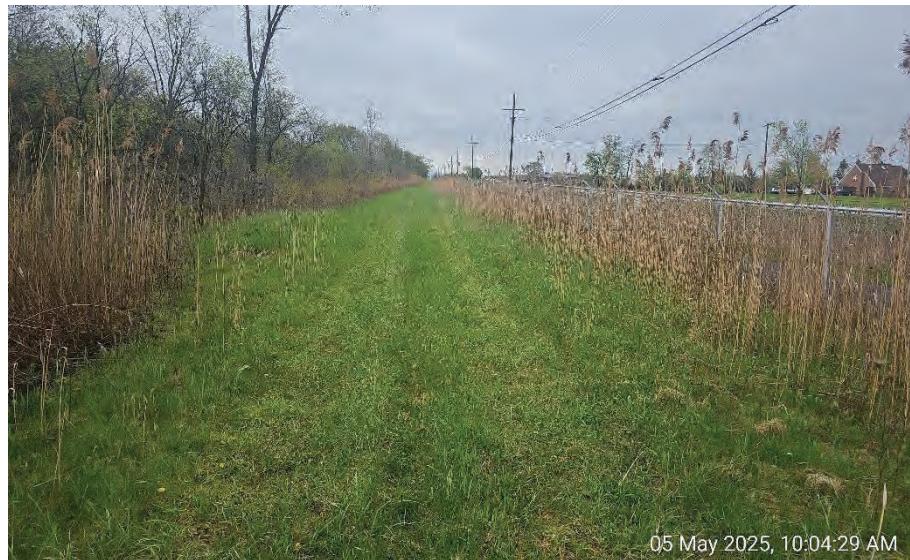
Comments: The perimeter roads and fence on the west side of the Landfill were in good condition. The roads were not covered in aggregate but were still accessible, though not traveled during the inspection.

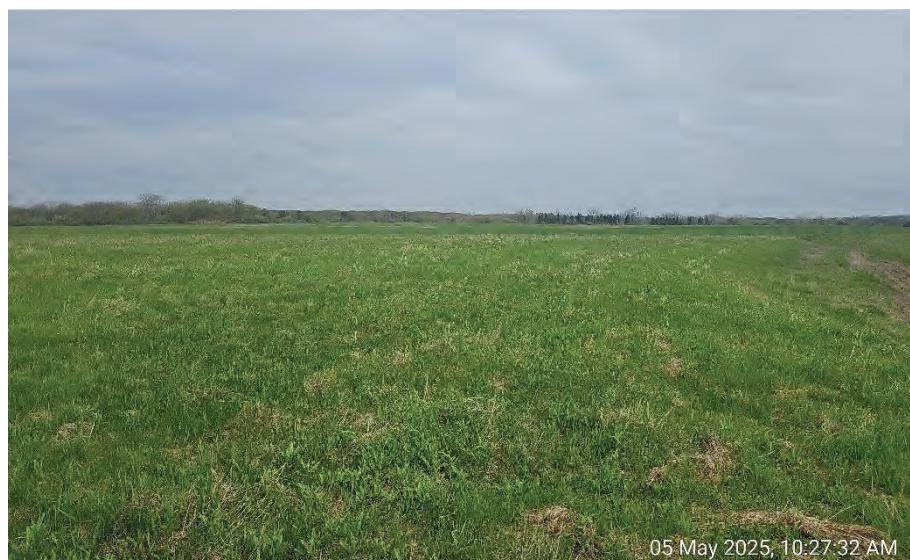
Photograph 38

Comments: The top deck of Areas F3 and B was in good condition. The vegetation was well maintained. No low spots with water ponding were visible.

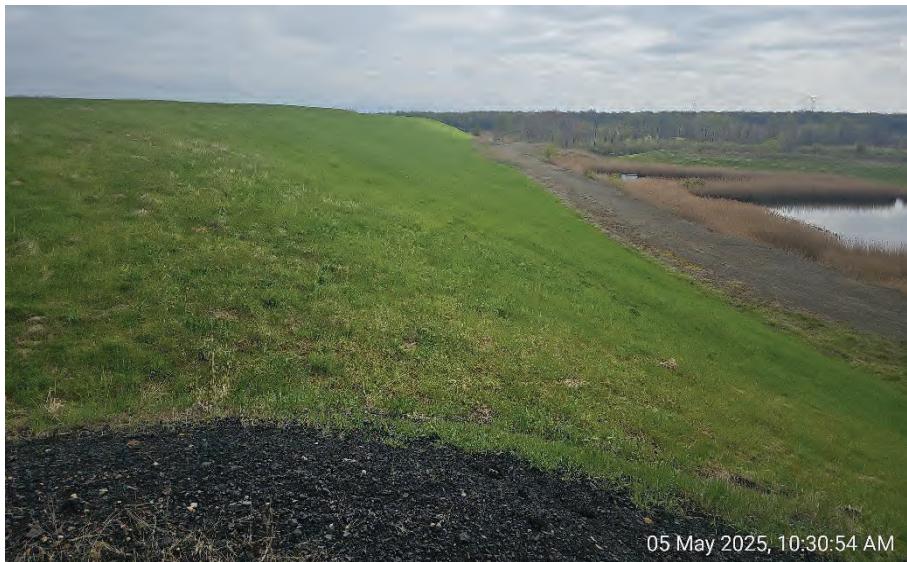
Comments: The side slopes of Areas D2 and D3 and top deck of Area D2 were in good condition. Vegetation was well maintained. No erosion or indicators of slope instability were observed on the slopes. No low spots with water ponding were visible.

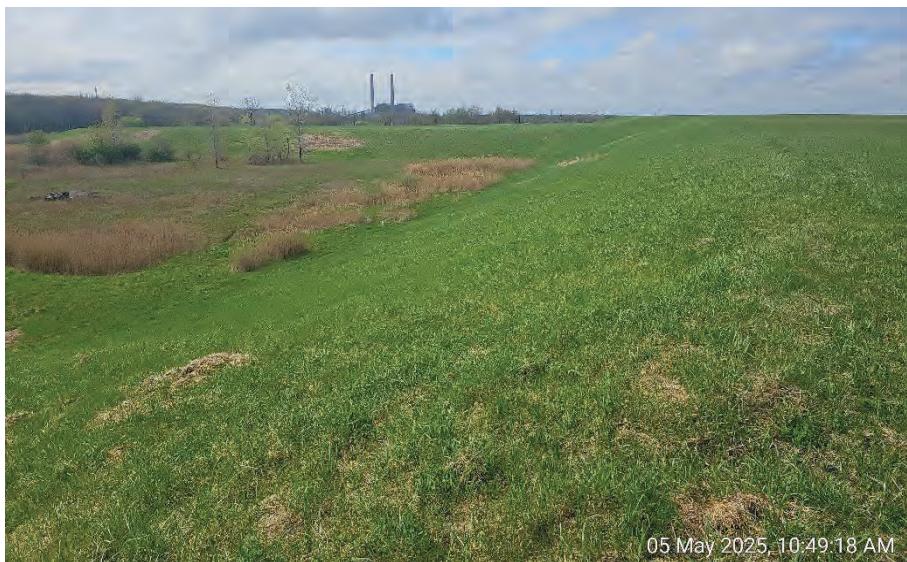
Photograph 40

Comments: The top deck and side slopes of Areas C and D1 were in good condition. The vegetation was well maintained. No low spots with water ponding were visible. No erosion or indicators of slope instability were observed on the slopes.

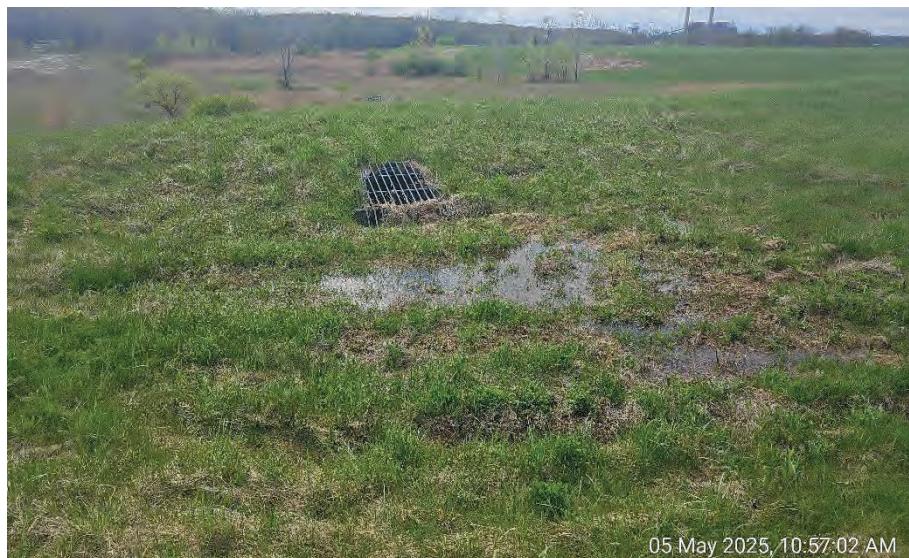
Comments: Stormwater runoff was observed flowing toward and into the downchute at the boundary between Areas B and D1. Some vegetation was observed at the inlet of the downchute but did not appear to obstruct the flow.

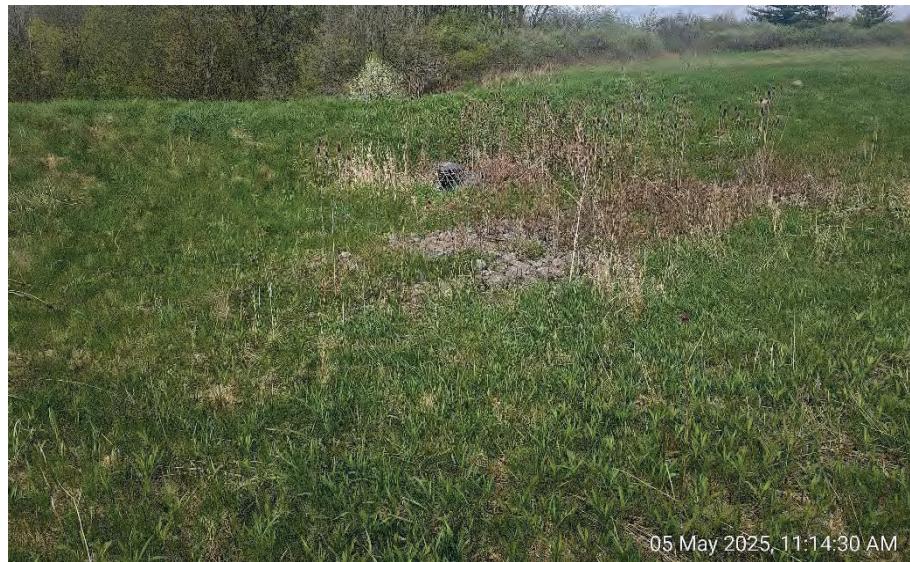
Comments: The downchute at the boundary between Areas B and F1 was generally in good condition. Some vegetation was observed in the inlet and the riprap near the downchute.

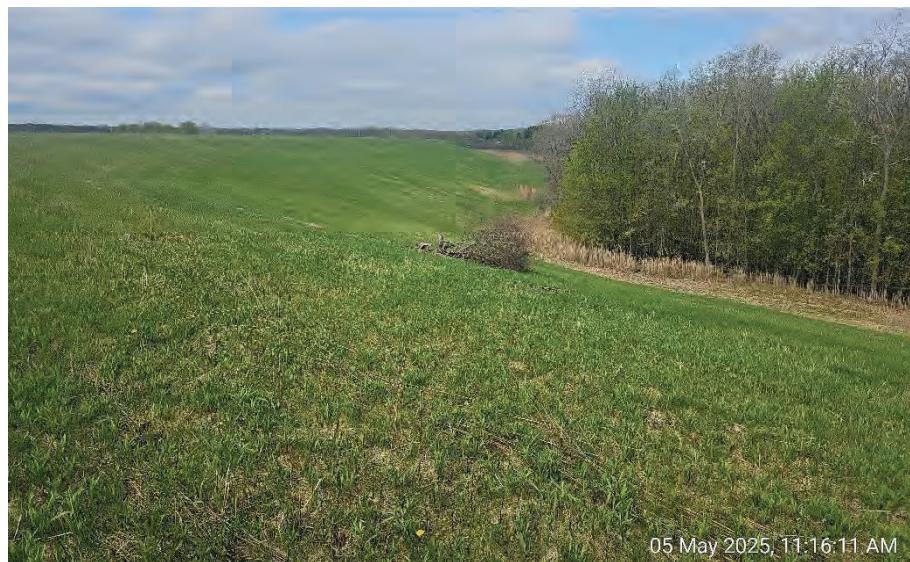
Photograph 44

Comments: The side slopes outside Area F1 were in good condition with no erosion or indicators of slope instability observed. Vegetation was well maintained.

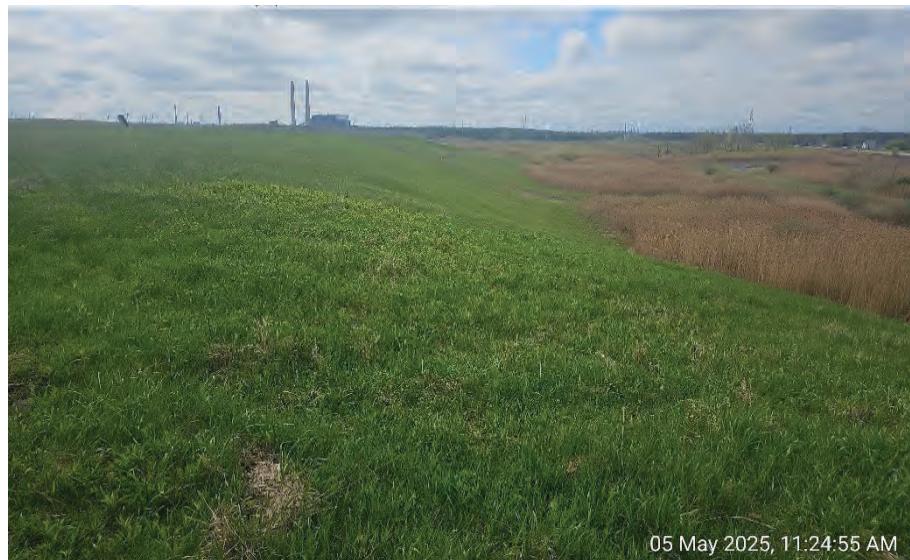
Comments: The side slopes of Area F1 were in good condition with no erosion or indicators of slope instability observed. Vegetation was well maintained.

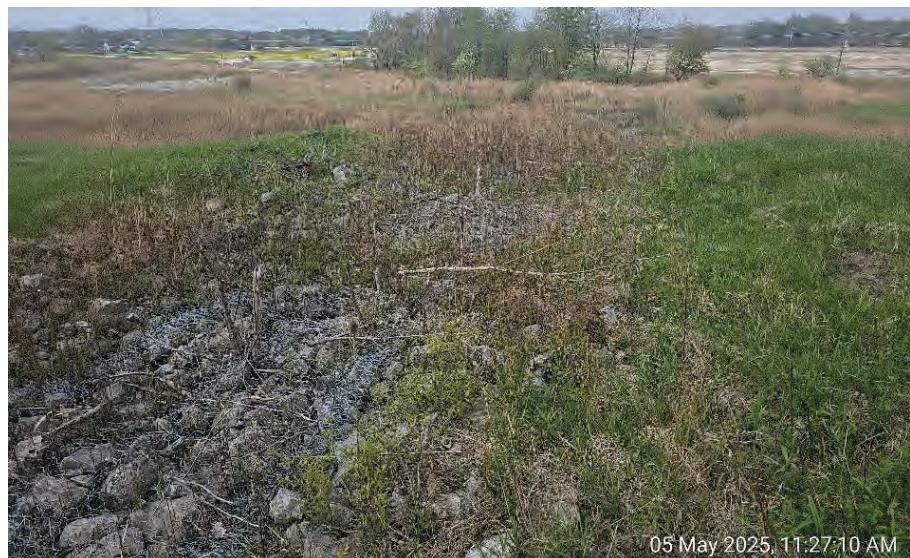
Photograph 46

Comments: The top of the riprap-lined stormwater downchute at the southwest corner of Area F1 was in satisfactory condition. Some vegetation was observed at the top of the downchute but no erosion was observed in the riprap.

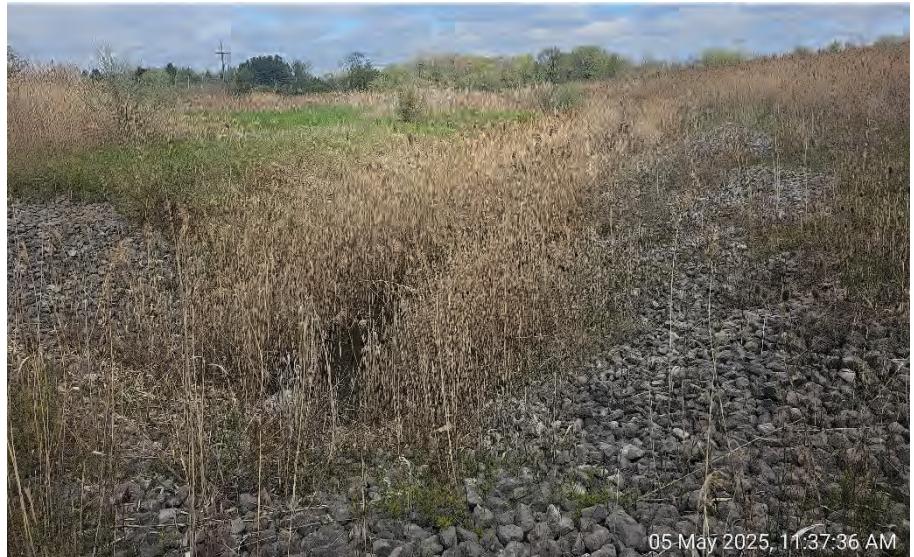
Comments: The perimeter ditch along the west side of the Landfill was in satisfactory condition. There was some vegetation but no erosion was observed in the riprap on the side slopes of the ditch and no obstructions were observed in the culverts.

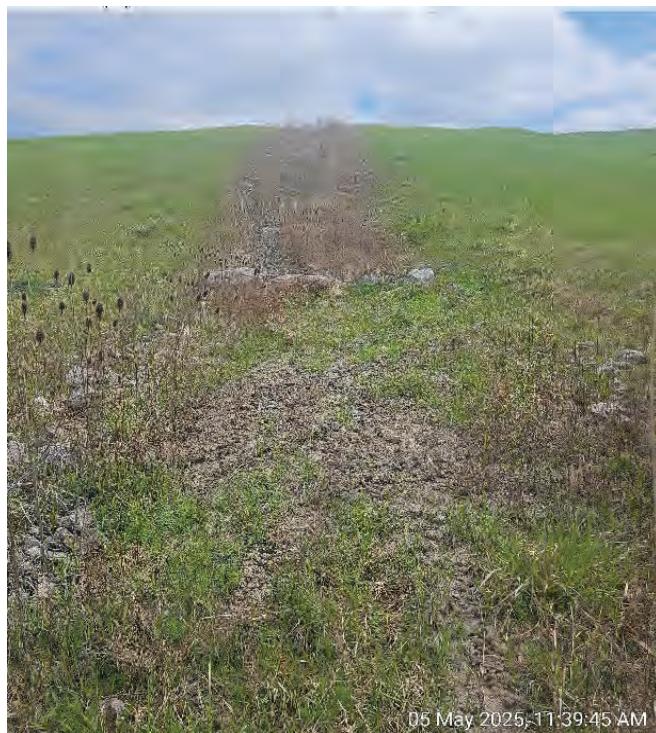
14. The stormwater downchute at the southwest corner of Area F1 has had the riprap along the left side (facing downslope) eroded, resulting in damage to the mesh wiring around the riprap (Photograph #47). It appears finer soil particles have been transported from the mid-slope to the bottom of the downchute (Photograph #49). The erosion at the downchute appears to have progressed slightly over the last year. The riprap at the top of the stormwater downchute was in satisfactory condition with some vegetation but no erosion observed (Photograph #46).

Item	Condition			Related Photo # (s) (LDP=Landfill Development Plan, SDB = Stormwater Detention Basin)	Notes and Comments
	Good	Fair	Action Reqd.		
					Stormwater downchute at the southwest corner of Area F1 had some vegetation along the top deck (Photograph #46) and noticeable erosion along the left side (facing downslope) which had caused the wire mesh to become distorted (Photograph #47). Finer particles likely from erosion had accumulated downslope of the riprap at the bottom of the downchute (Photograph #49).

Comments: Finer soil particles were observed at the bottom of the stormwater downchute at the southwest corner of Area F1. The particles appear to originate from erosion along the left side of the stormwater downchute (facing downslope).

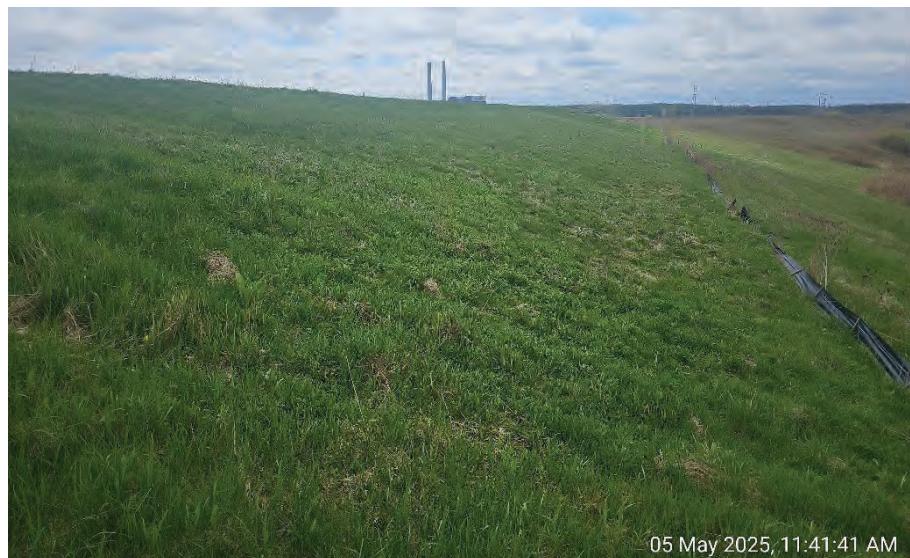
Photograph 50

Comments: The side slopes of Area G2 Phase I were in good condition. No erosion or indicators of slope instability were observed on the slopes. Vegetation was well maintained.

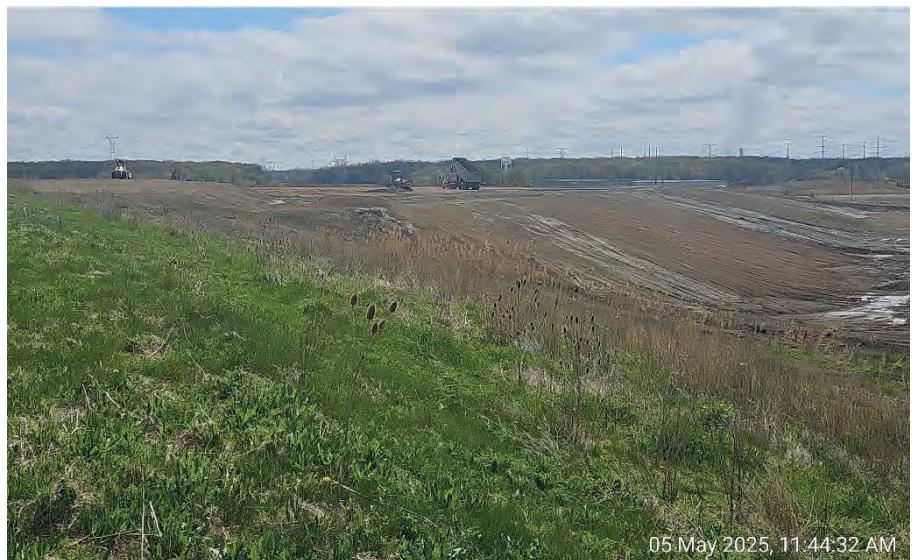
Comments: Active filling was observed in Area G2 Phase II during the visual inspection. The traffic, material unloading, and material placement appeared to be in line with generally accepted engineering practices. The equipment was operating safely and at speeds to limit fugitive dust.

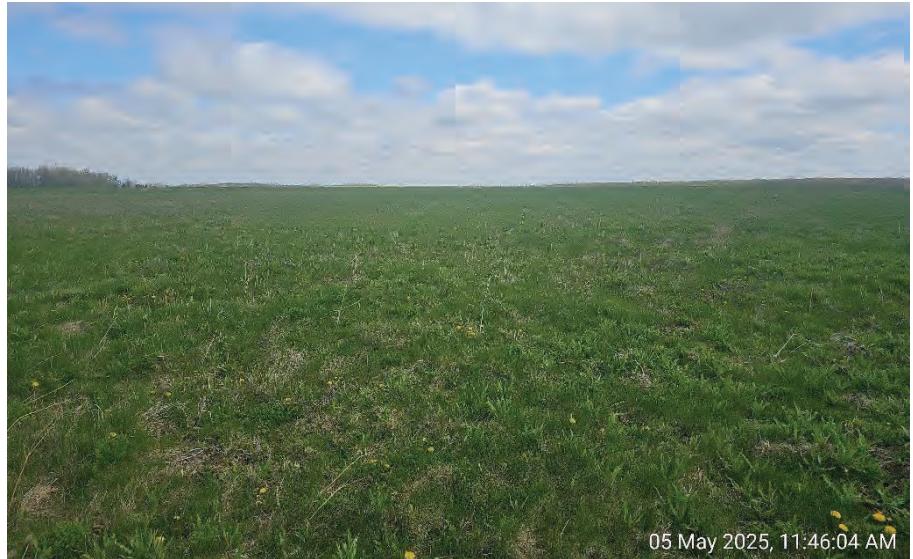
Comments: The top decks of Areas F1, F2, and G2 Phase I were in good condition. The vegetation was well maintained. No low spots with water ponding were visible.

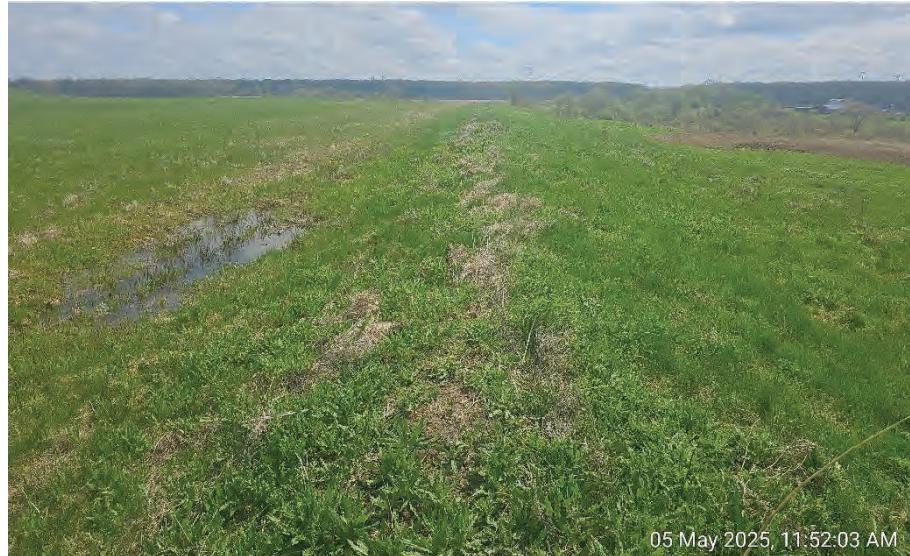
Comments: The side slopes of Area G2 Phase I above Area G2 Phase II were in good condition. No erosion or indicators of slope instability were observed. The vegetation was well maintained. Water was observed behind the diversion berm separating Area G2 Phase I and Phase II preventing surface water from flowing onto the active Area G2 Phase II.
