2025 ANNUAL INSPECTION REPORT RANGE ROAD LANDFILL

BELLE RIVER POWER PLANT

China Township, Michigan

January 2026

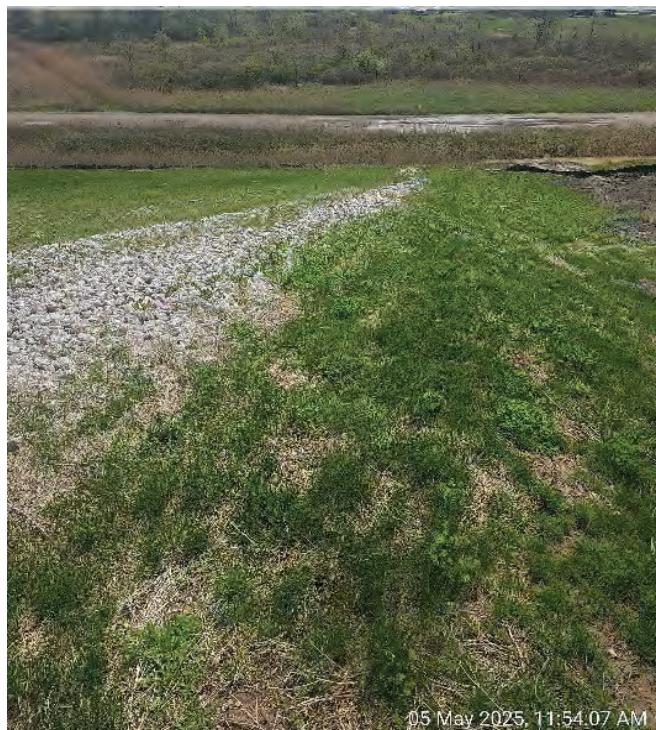
Photograph 54

15. The other stormwater downchutes between Areas B and D1 (Photograph #42), between Areas B and F1 (Photograph #43), and within Area G2 Phase I (Photographs #54, #55)

28. Stormwater Downchutes	<input checked="" type="checkbox"/>	<input type="checkbox"/>	<input checked="" type="checkbox"/>	42, 43, 46, 47, 49, 54, 55	The riprap-lined stormwater downchutes were generally in good condition. The downchute located between Areas B and D1 had some vegetation at the inlet but was observed to have stormwater flowing through it during the inspection (Photograph #42). The downchute at the northwest corner of Area F1 had some vegetation at the top; however, it did not appear to obstruct the flow of stormwater (Photograph #43). The downchutes in Area G2 Phase I were in satisfactory condition (Photographs #54, #55). The

Comments: The riprap-lined stormwater downchute at the southeast corner of Area G2 Phase I was in good condition. Some vegetation was observed but no erosion was observed in the riprap.

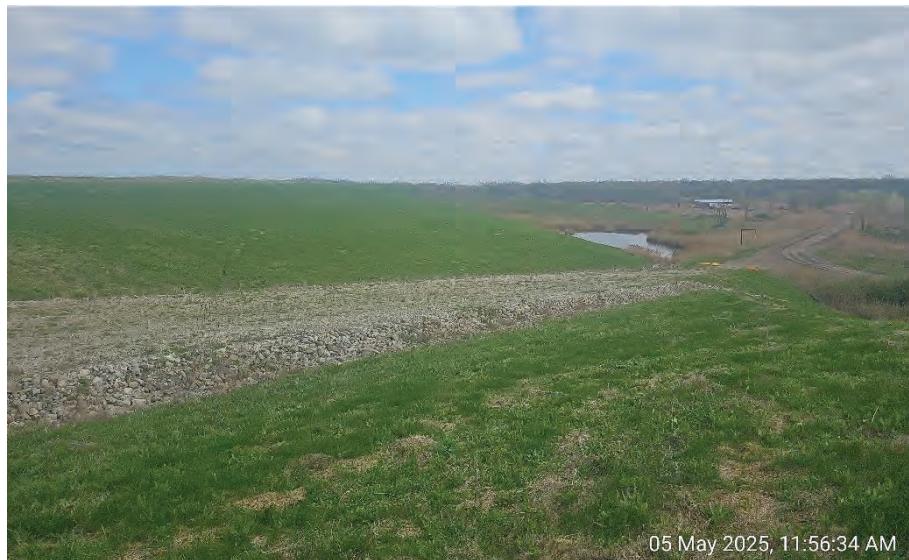
Comments: The access road to Area G2 Phase I was in good condition. The stormwater channel along the access road was in good condition.

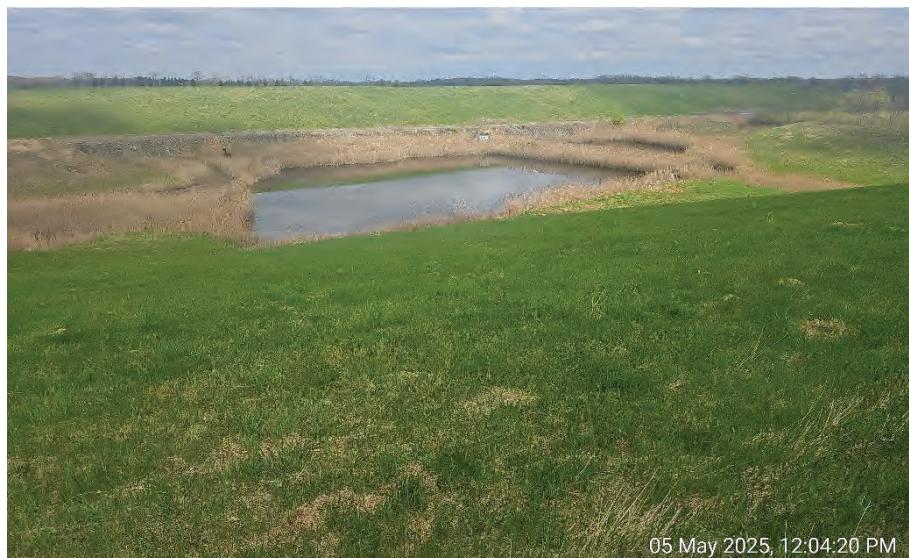
Photograph 56

18. The detention ponds near Area D3/F3 (Photograph #56) and south of Area G2 (Photograph #60) were in good condition. The side slopes have vegetation or riprap armoring, and there were no signs of erosion.

19. Internal Detention Ponds	<input checked="" type="checkbox"/>	<input type="checkbox"/>	<input type="checkbox"/>	39, 56, 60	The internal detention ponds by Areas D3 and F3 (Photographs #39, #56) and south of Area G2 (Photograph #60) appeared to be in good condition. No erosion was observed on the perimeter side slopes of these ponds and vegetation appeared to be well maintained.

Comments: The internal detention pond by Area D3/F3 was in good condition. There is some vegetation around the perimeter of the pond, but no erosion was observed on the side slopes. The side slopes of Area F3 were in good condition. Vegetation was well maintained. No erosion or indicators of slope instability were observed.

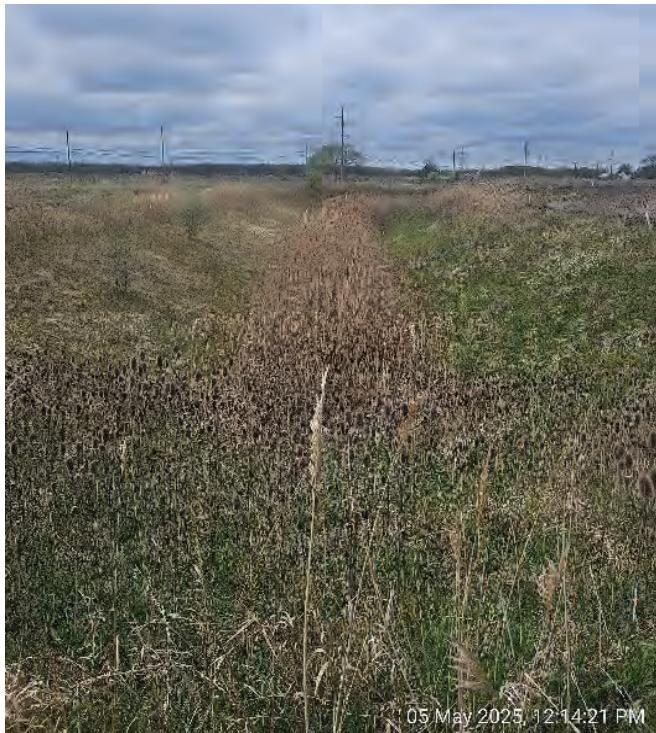
Comments: The perimeter ditch on the south side of the Landfill had some vegetation on the bottom of the ditch, but no erosion was observed on the side slopes. No flow was observed within the south perimeter ditch during the visual inspection.

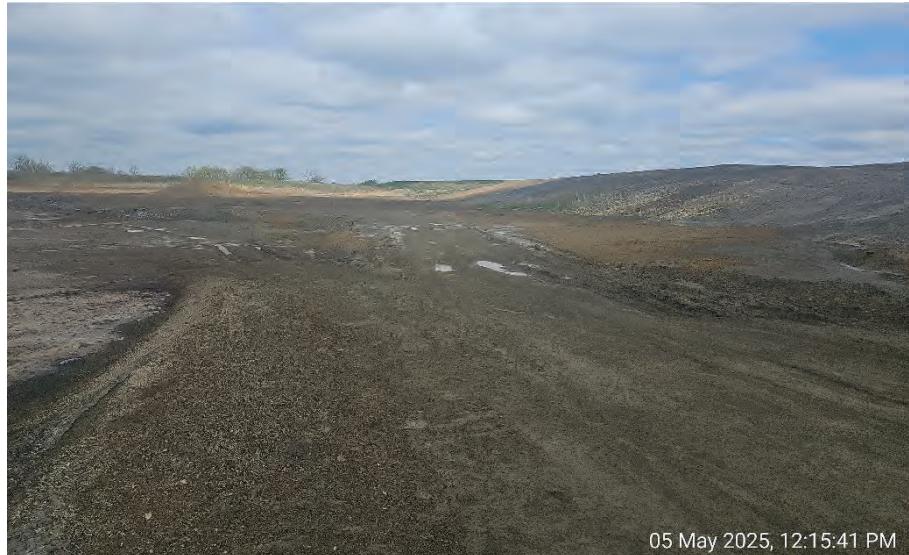
Photograph 58

16. Active filling operations at the Landfill within Area G2 Phase II were observed during the inspection (Photograph #51). The traffic, material unloading, and placement were conducted in accordance with generally accepted engineering practices. The equipment was functioning safely and at controlled speeds to minimize the generation of fugitive dust. The side slopes of the active Area G2 Phase II were in good condition with no erosion or indicators of slope instability observed (Photograph #59). The diversion berm separating Area G2 Phase I and Phase II was observed preventing surface water from flowing onto the active Area G2 Phase II (Photograph #53). Area G2 Phase III was noted to be in good condition (Photograph #58); although not observed during the annual inspection, this area has begun active filling.

Comments: Area G2 Phase III was in good condition. No active filling was observed in this area during the visual inspection, though this area has begun active filling.

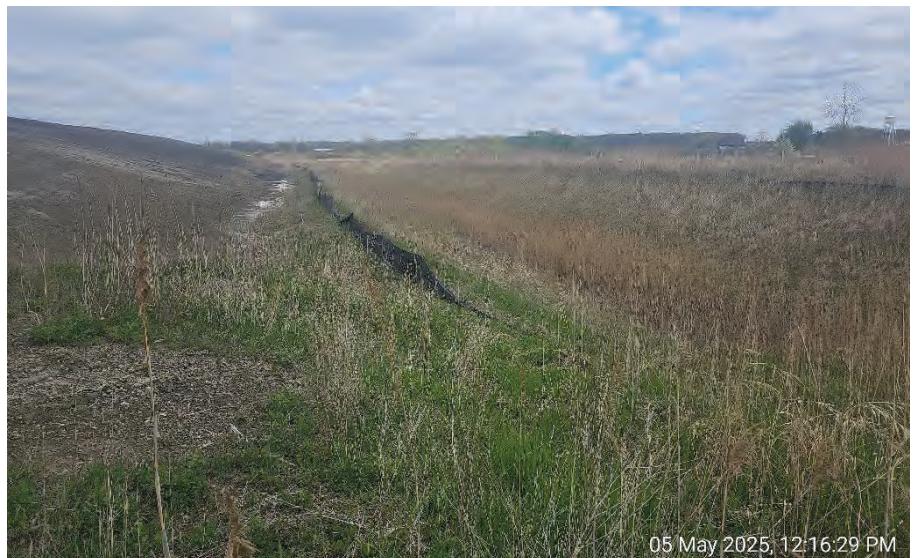
Comments: The side slopes of the active Area G2 Phase II were in good condition. No erosion or indicators of slope instability were observed on the side slopes.

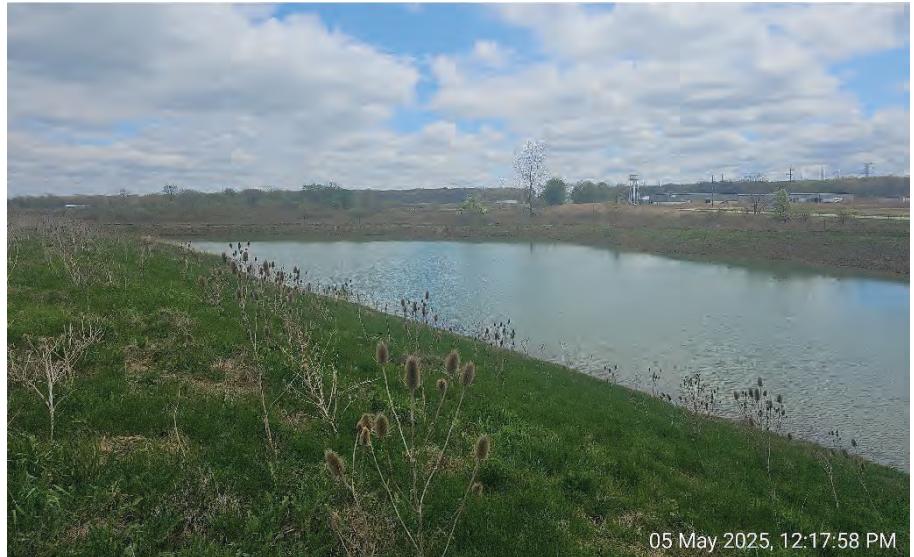
Photograph 60

Comments: The internal detention pond south of Area G2 was in good condition. No erosion was observed on the side slopes.

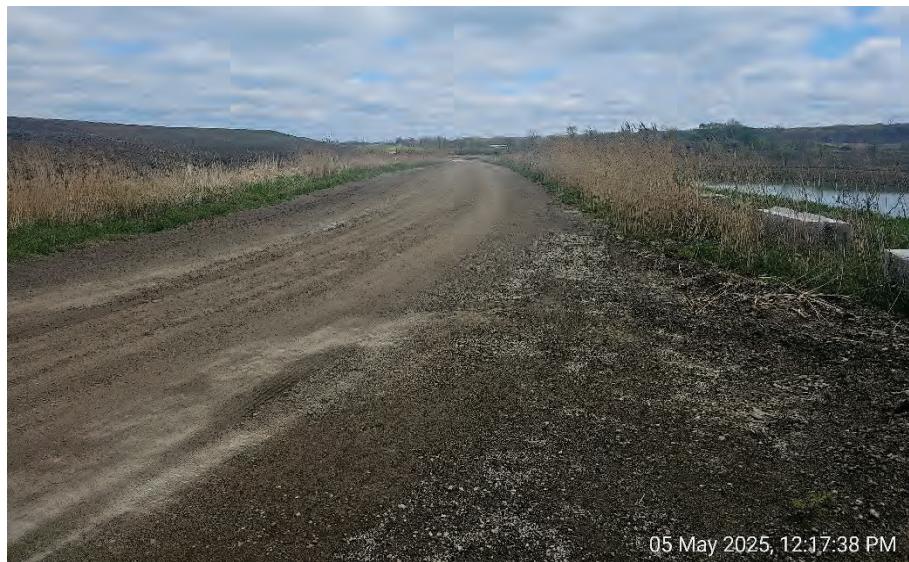
Comments: The haul road to the active filling area in Area G2 Phase II on the south side of the Landfill was generally in good condition with minimal low spots and rutting. No fugitive dust was observed during the visual inspection.

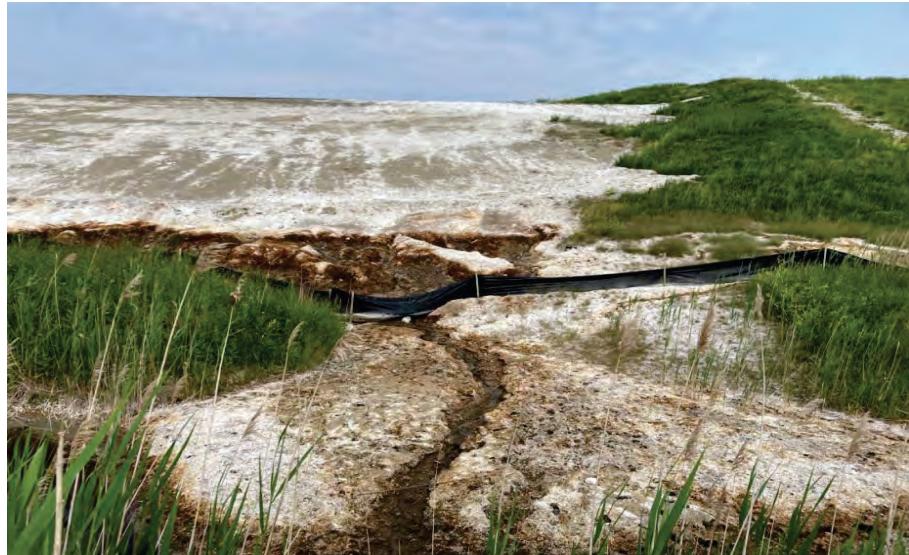
Photograph 62

Comments: Erosion observed on the southern slope of G2 Phase II in June 2025. (Photograph taken from the EGLE 3rd Quarter Part 115 Inspection).
