Submitted to
DTE Energy, Inc.

Submitted by
AECOM
1300 East 9th Street, Suite 500
Cleveland, OH 44114
August 2024
AECOM Project No. 60516675

Periodic Safety Factor Assessment

Area 15 Inactive Bottom Ash Impoundment DTE Monroe Power Plant

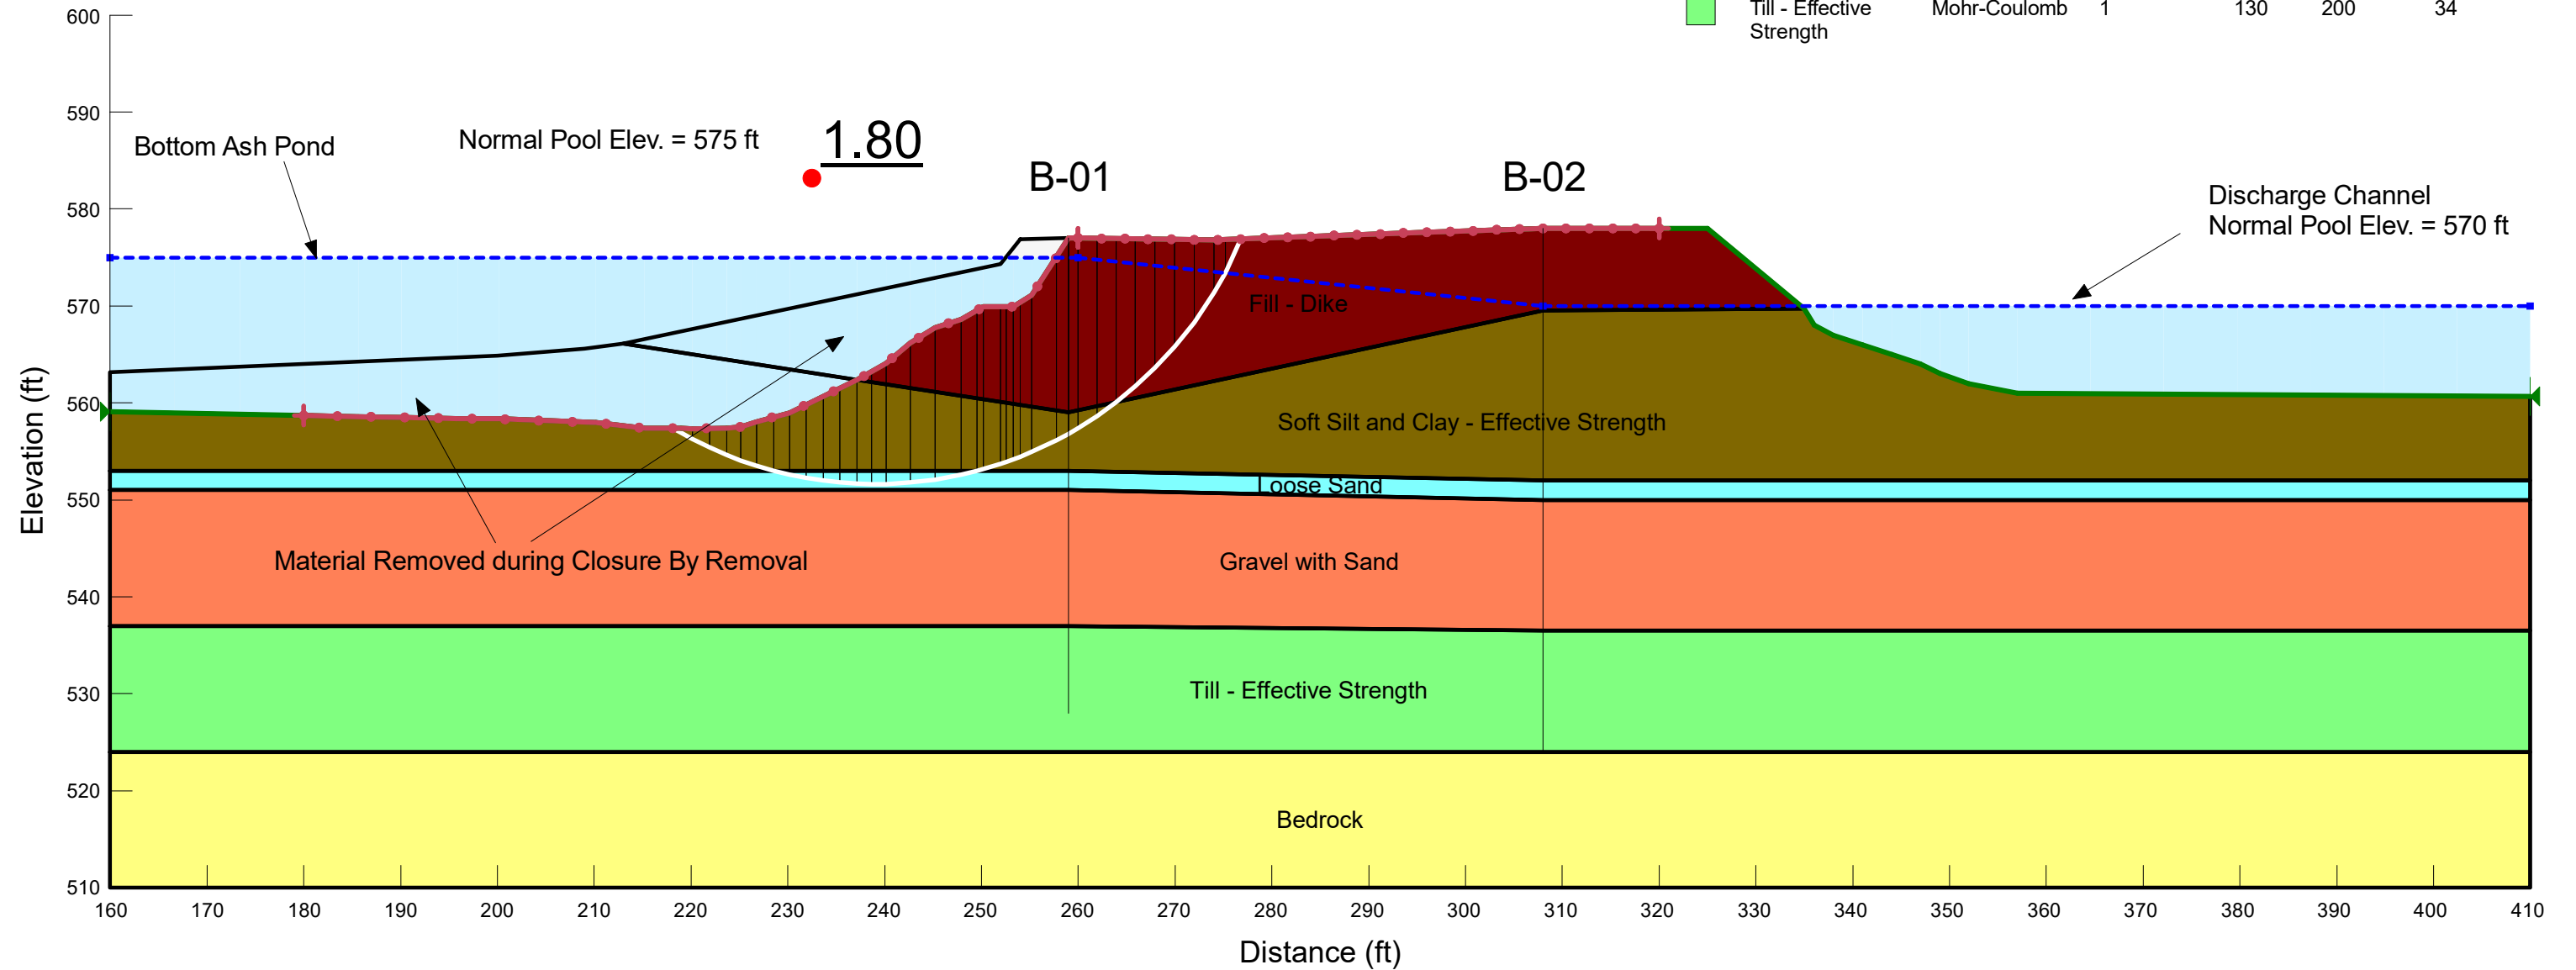
Cross Section A-A'

Color	Name	Slope Stability Material Model	Piezometric Surface	Unit Weight (pcf)	Effective Cohesion (psf)	Effective Friction Angle (°)
Yellow	Bedrock	Bedrock (Impenetrable)	1			
Dark Red	Fill - Dike	Mohr-Coulomb	1	120	0	30
Orange	Gravel with Sand	Mohr-Coulomb	1	125	0	33
Cyan	Loose Sand	Mohr-Coulomb	1	120	0	28
Olive Green	Soft Silt and Clay - Effective Strength	Mohr-Coulomb	1	100	100	30
Light Green	Till - Effective Strength	Mohr-Coulomb	1	130	200	34

The static analysis conditions include the steady-state normal pool and maximum surcharge pool loading conditions. Static stability was evaluated for steady-state conditions using a normal pool elevation of 575 ft, and a flood pool surcharge elevation of the lower of 577 ft or the peak elevation of the dike crest at the cross section location (whichever was lower).

For the steady-state normal pool condition, drained (effective stress) shear strength parameters, as shown in **Table 3-2**, were used for all materials.

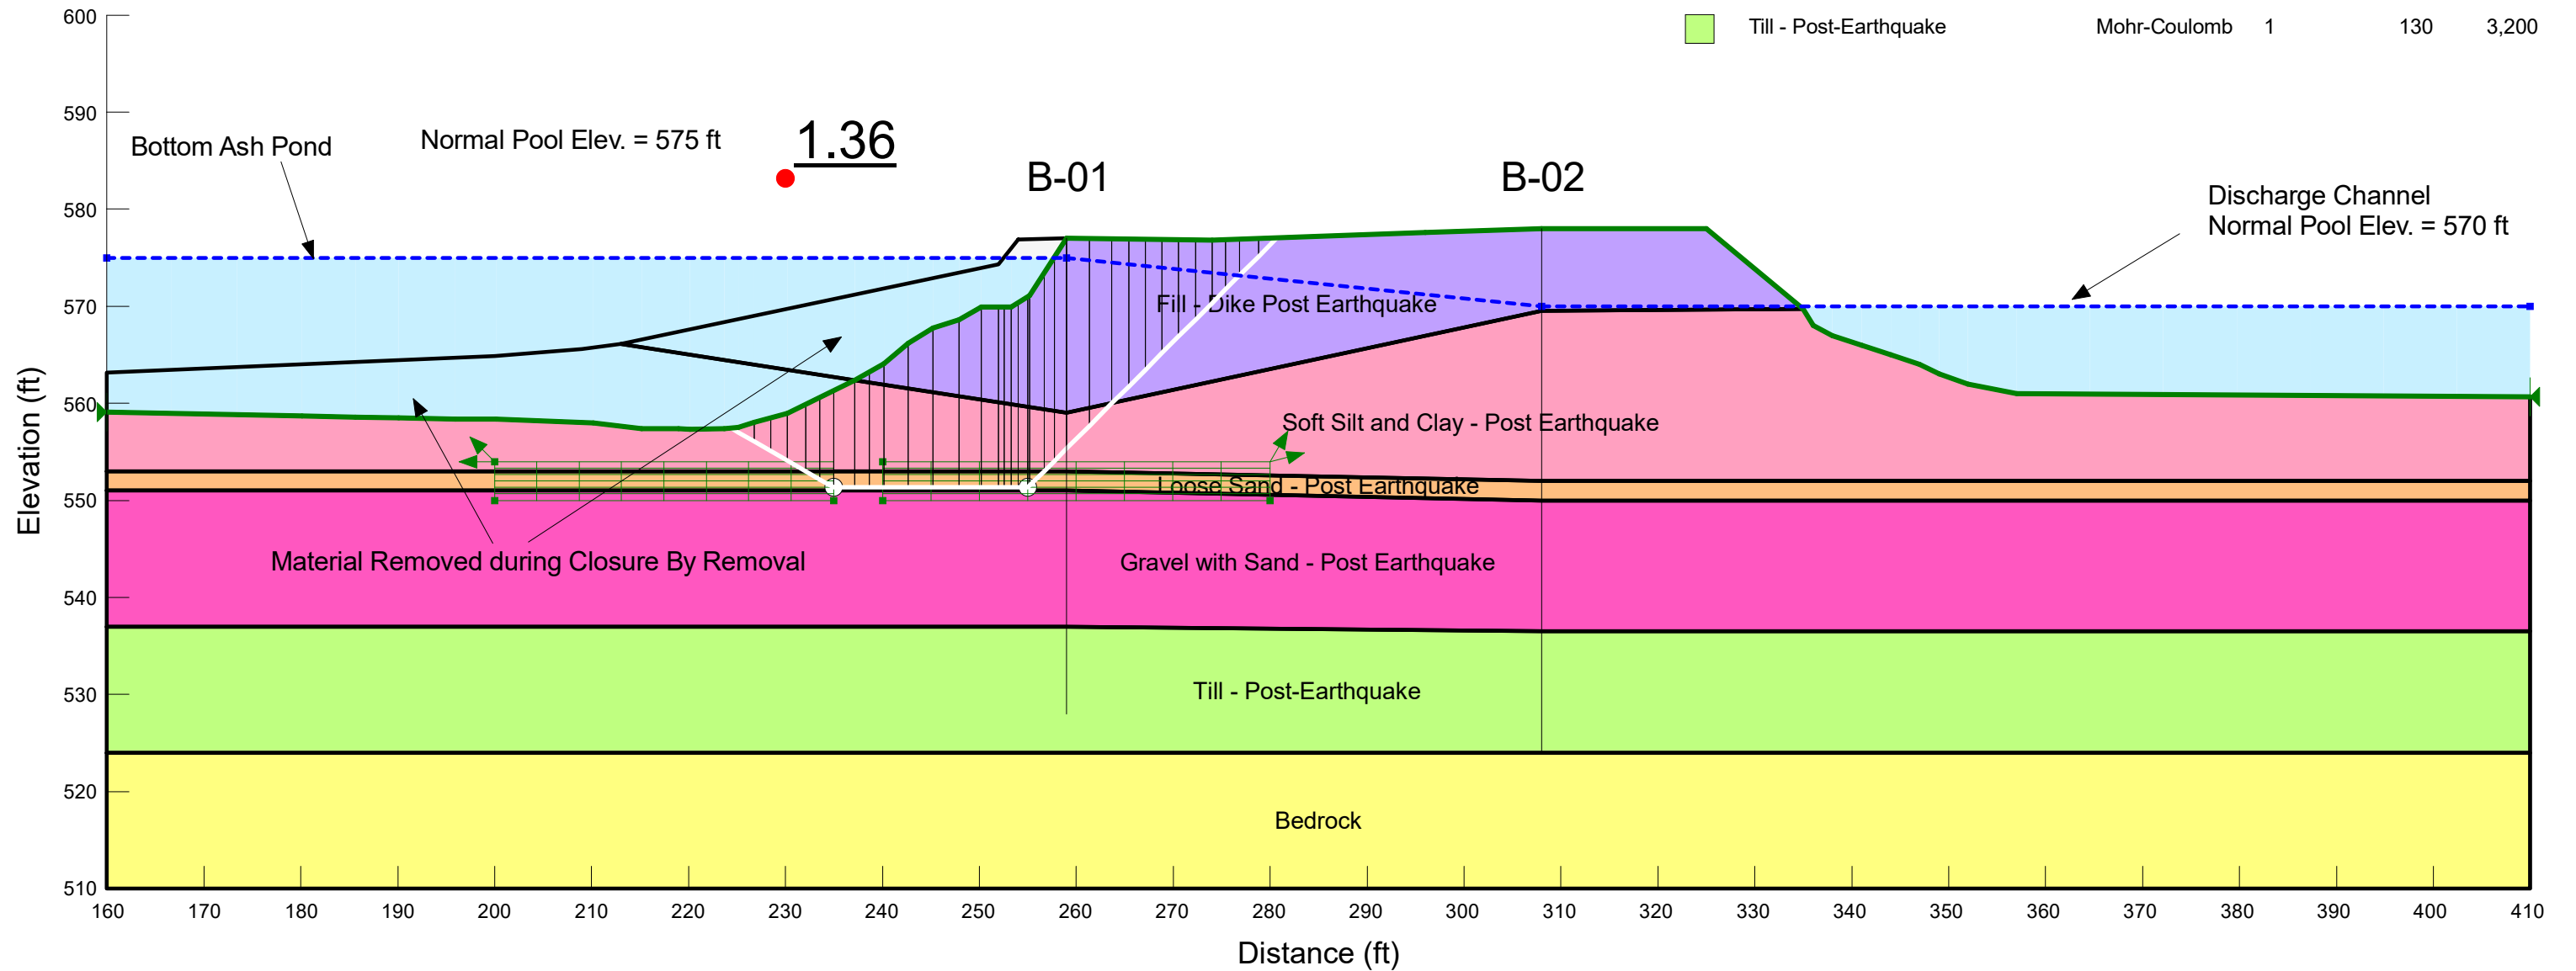
Cross Section C-C'

Post-Earthquake (Post-Liquefaction) Analysis Block Failure

Color	Name	Slope Stability Material Model	Piezometric Surface	Unit Weight (pcf)	Effective Cohesion (psf)	Effective Friction Angle (°)
Yellow	Bedrock	Bedrock (Impenetrable)	1			
Light Purple	Fill - Dike Post Earthquake	Mohr-Coulomb	1	120	0	25
Pink	Gravel with Sand - Post Earthquake	Mohr-Coulomb	1	125	0	28
Light Orange	Loose Sand - Post Earthquake	Mohr-Coulomb	1	120	250	0
Light Pink	Soft Silt and Clay - Post Earthquake	Mohr-Coulomb	1	100	176	13.2
Light Green	Till - Post-Earthquake	Mohr-Coulomb	1	130	3,200	0

- The Loose Sand stratum was assumed to liquefy under the design earthquake, so liquefied strengths in this layer were assumed in the post-earthquake analysis case. The embankment fill soils and the Soft Clay foundation soils were generally soft to stiff. Based on that, the peak undrained shear strength used for these soils were reduced by 20% to account for the possibility of cyclic-softening of these materials. See **Table 3-3** for strengths used in post-liquefaction load condition.

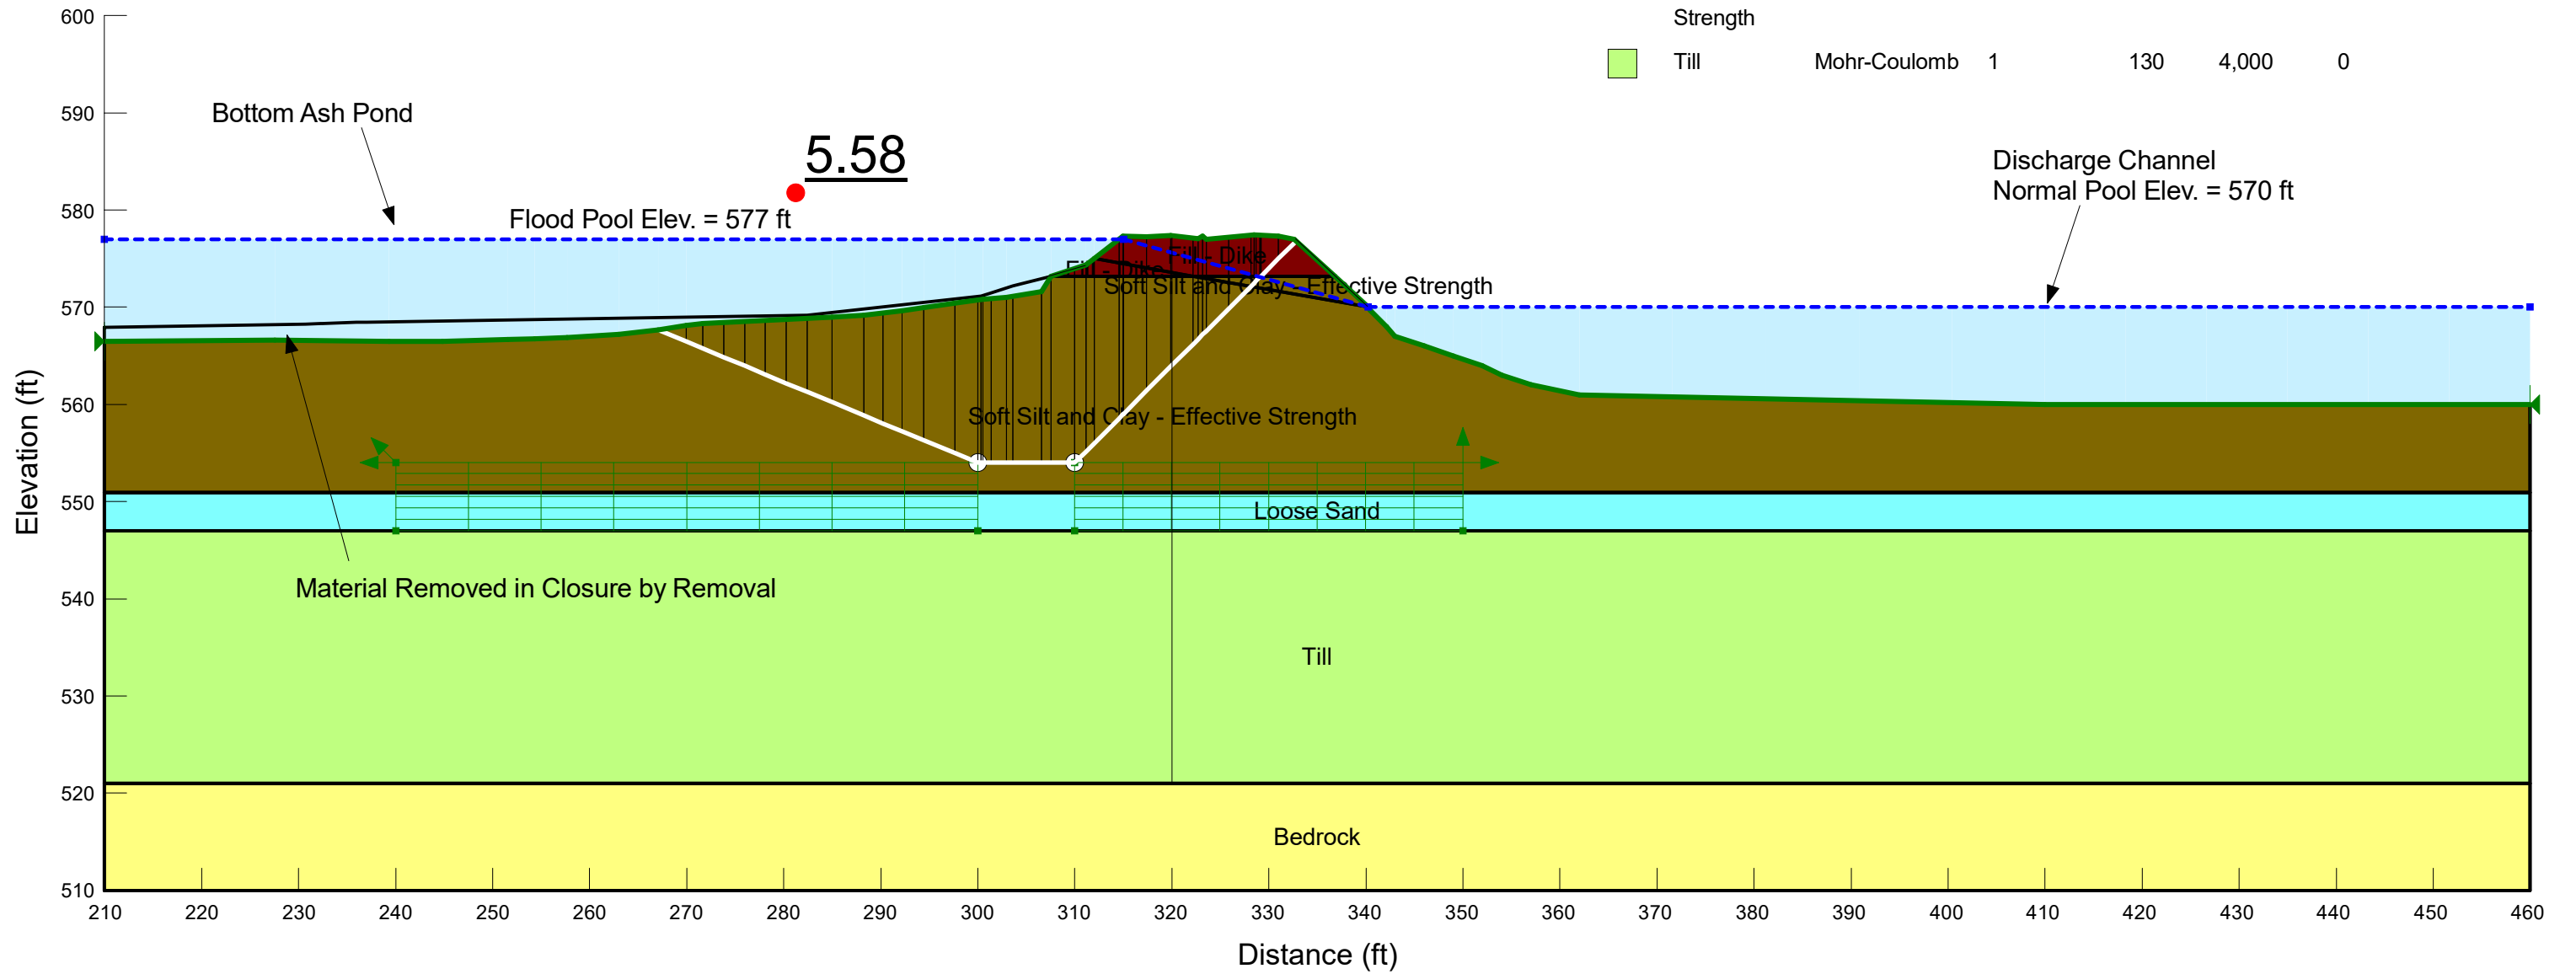
Cross Section C-C'

Static Analysis with Flood Pool Surcharge
Block Failure

Color	Name	Slope Stability Material Model	Piezometric Surface	Unit Weight (pcf)	Effective Cohesion (psf)	Effective Friction Angle (°)
Yellow	Bedrock	Bedrock (Impenetrable)	1			
Dark Red	Fill - Dike	Mohr-Coulomb	1	120	0	30
Cyan	Loose Sand	Mohr-Coulomb	1	120	0	28
Brown	Soft Silt and Clay - Effective Strength	Mohr-Coulomb	1	100	100	30
Light Green	Till	Mohr-Coulomb	1	130	4,000	0

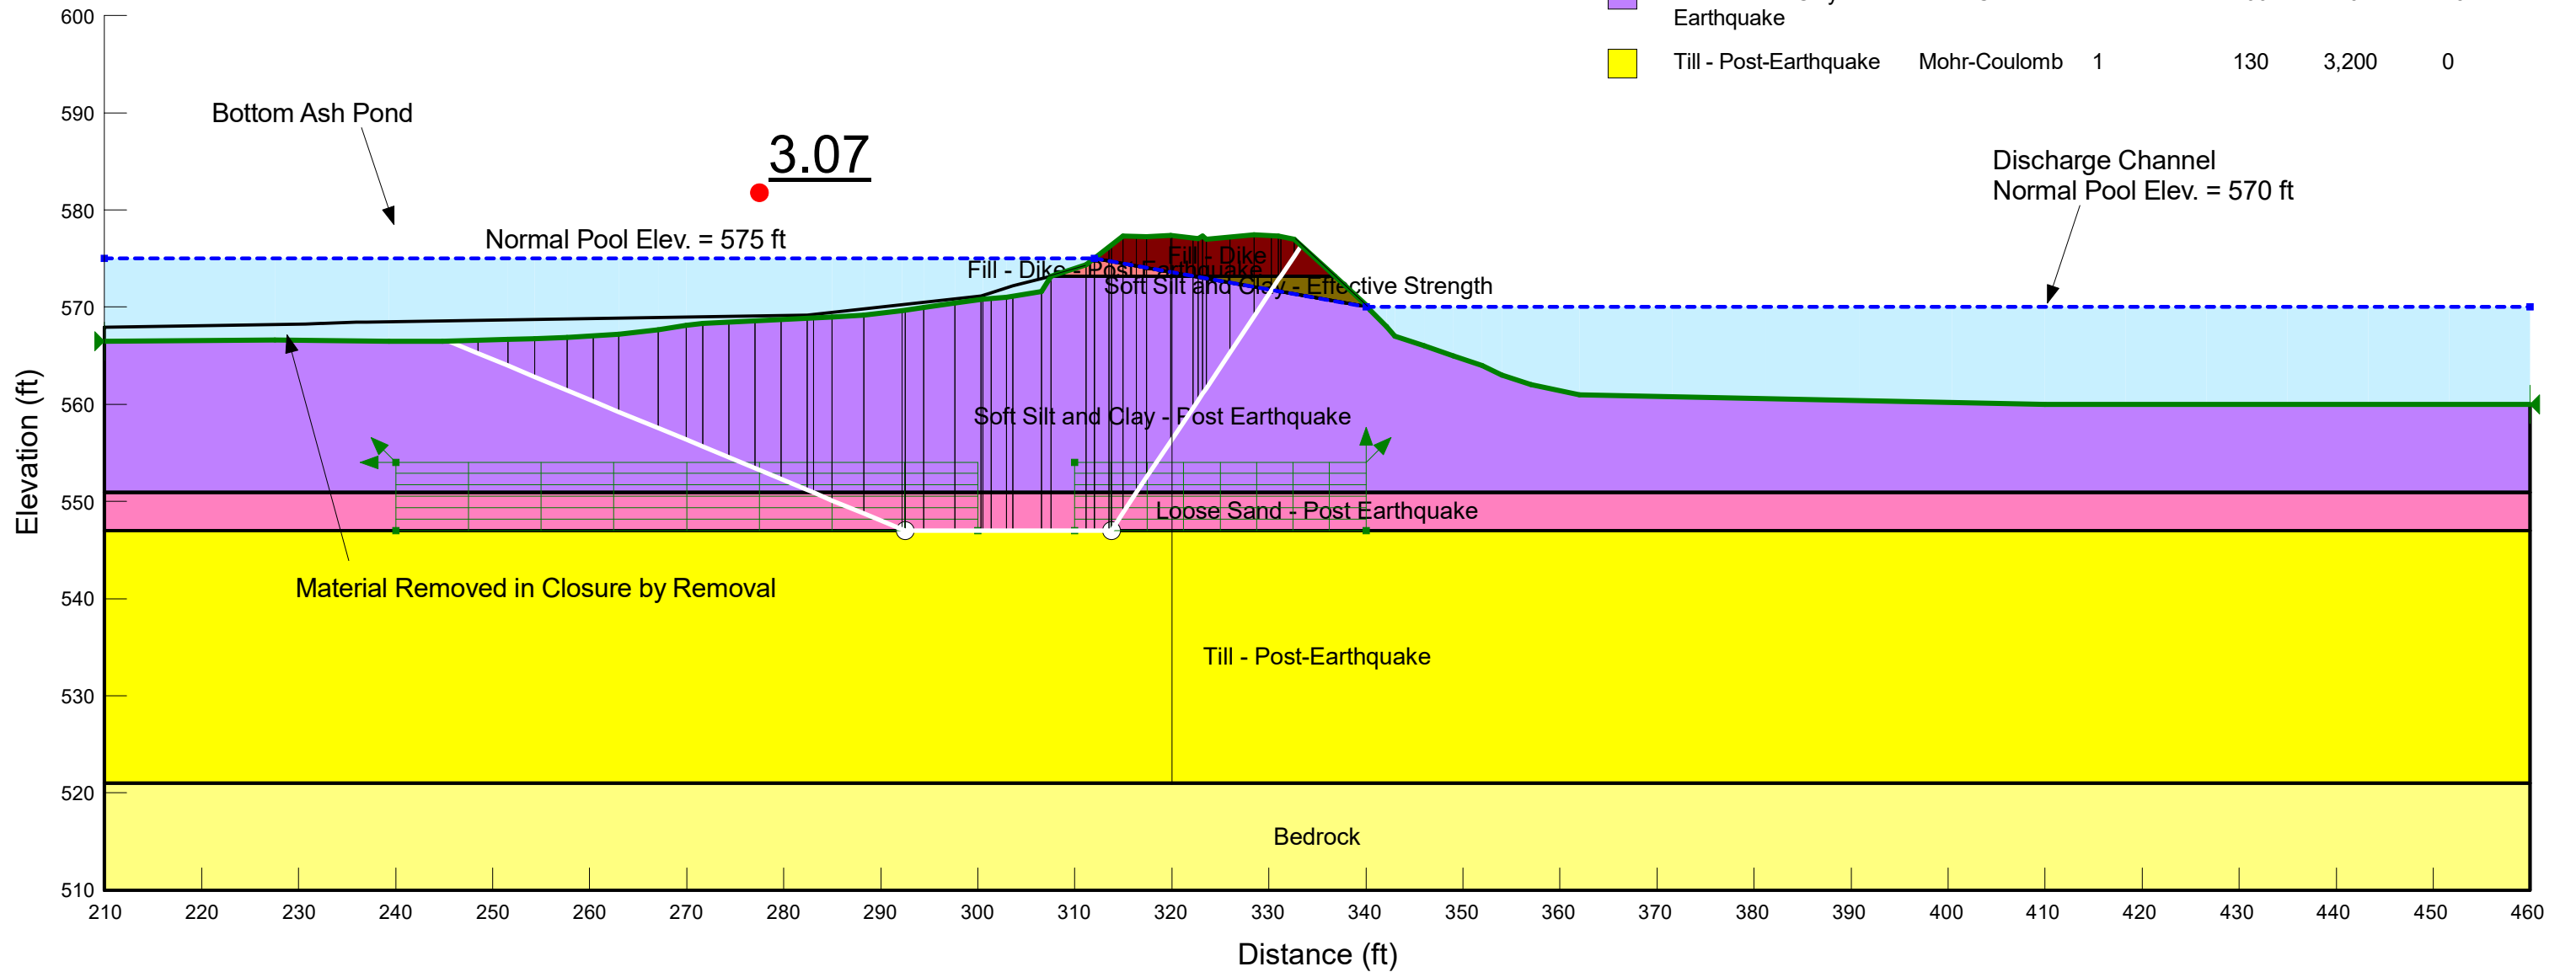
Post-Earthquake (Post-Liquefaction) Analysis Block Failure

Color	Name	Slope Stability Material Model	Piezometric Surface	Unit Weight (pcf)	Effective Cohesion (psf)	Effective Friction Angle (°)
Yellow	Bedrock	Bedrock (Impenetrable)	1			
Dark Red	Fill - Dike	Mohr-Coulomb	1	120	0	30
Pink	Fill - Dike - Post Earthquake	Mohr-Coulomb	1	120	0	25
Purple	Loose Sand - Post Earthquake	Mohr-Coulomb	1	120	250	0
Dark Purple	Soft Silt and Clay - Effective Strength	Mohr-Coulomb	1	100	100	30
Light Purple	Soft Silt and Clay - Post Earthquake	Mohr-Coulomb	1	100	176	13
Yellow-Green	Till - Post-Earthquake	Mohr-Coulomb	1	130	3,200	0

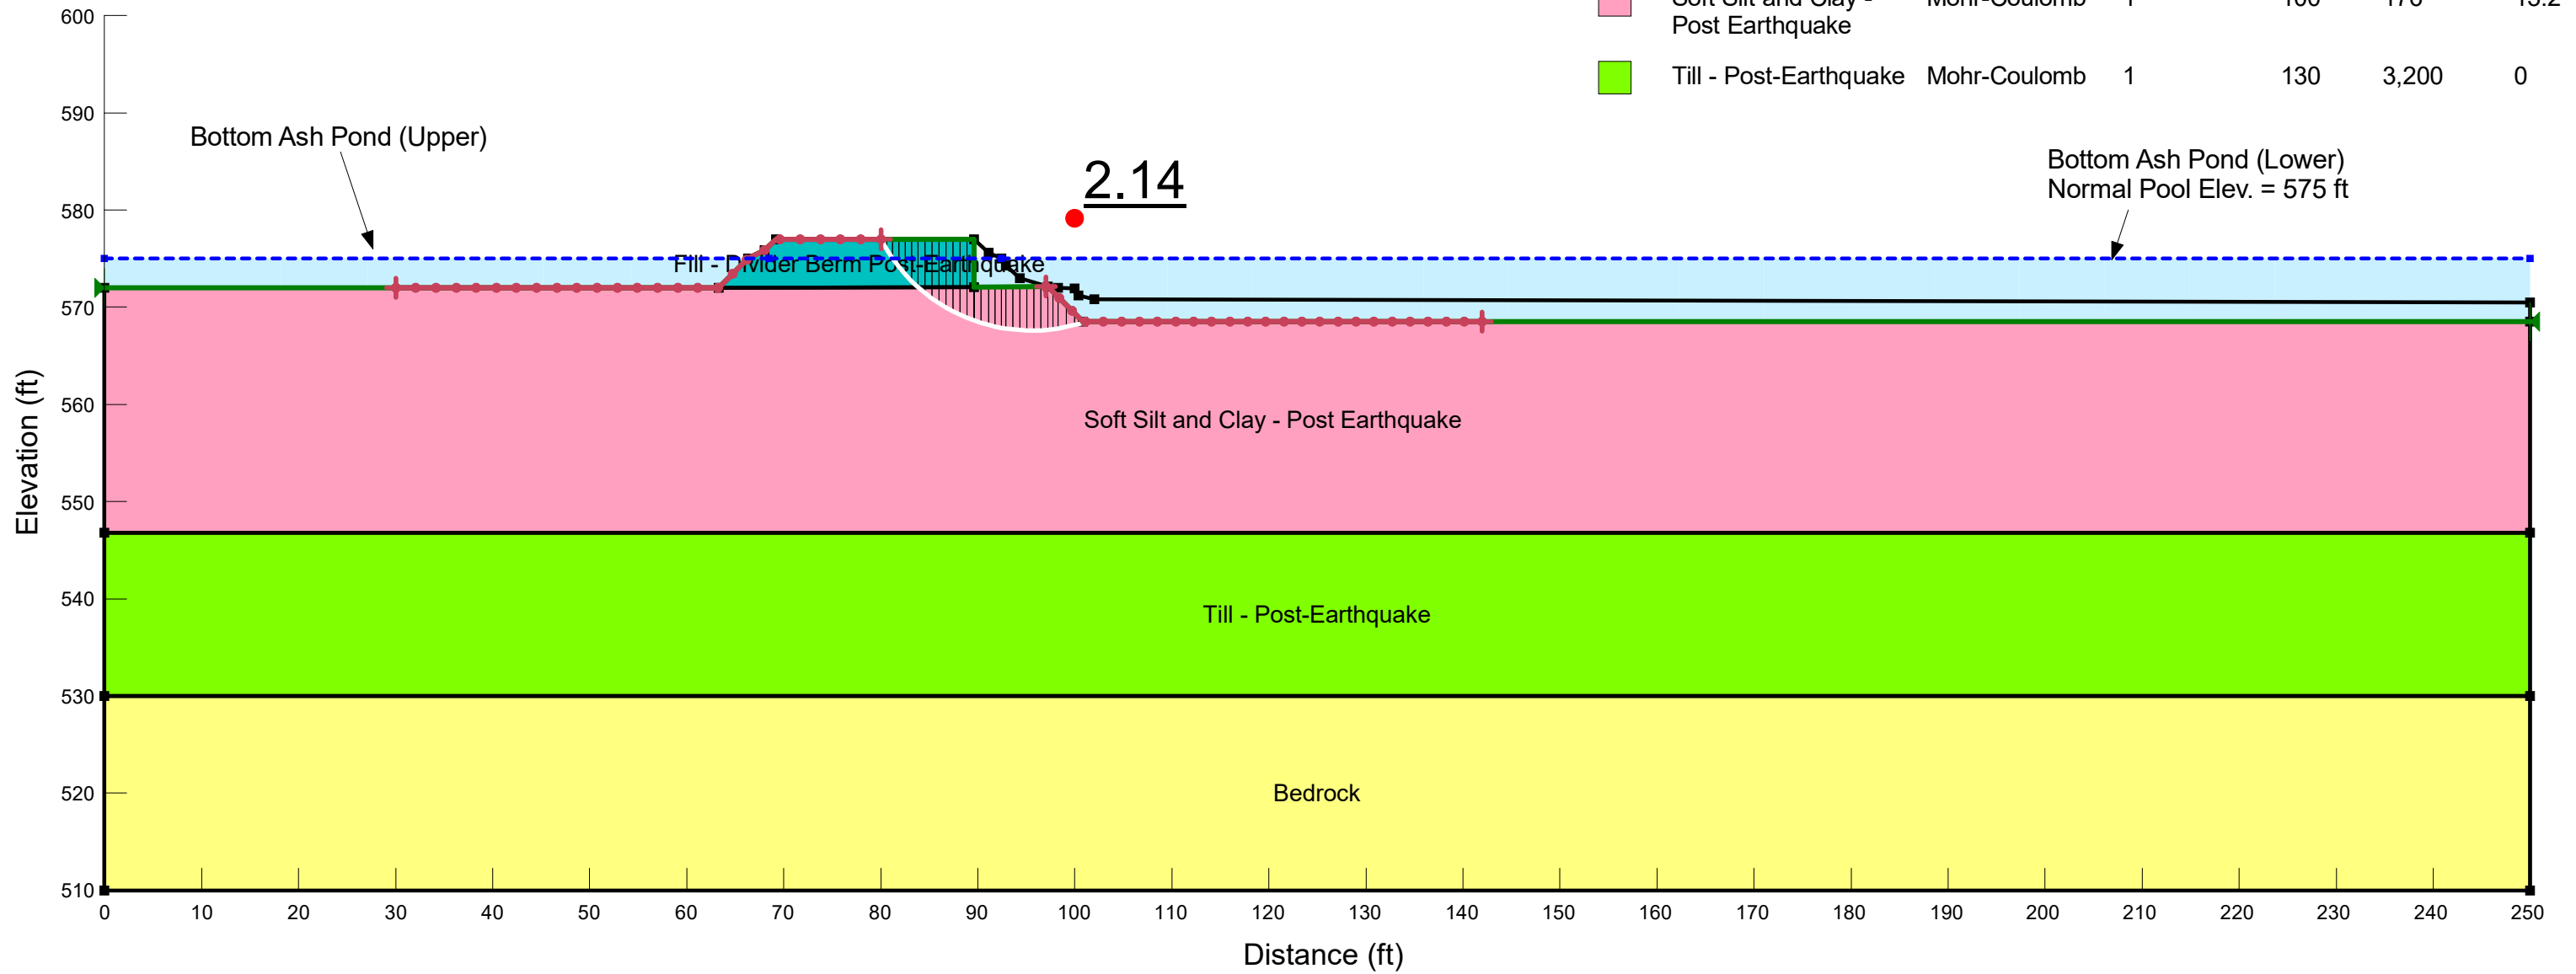
Color	Name	Slope Stability Material Model	Piezometric Surface	Unit Weight (pcf)	Effective Cohesion (psf)	Effective Friction Angle (°)
Light Yellow	Bedrock	Bedrock (Impenetrable)	1			
Purple	Fill - Divider Berm	Mohr-Coulomb	1	130	0	33
Brown	Soft Silt and Clay - Pseudostatic	Mohr-Coulomb	1	100	220	16
Yellow	Till - Pseudostatic	Mohr-Coulomb	1	130	4,000	0

Post-Earthquake Analysis Circular Slip Surfaces

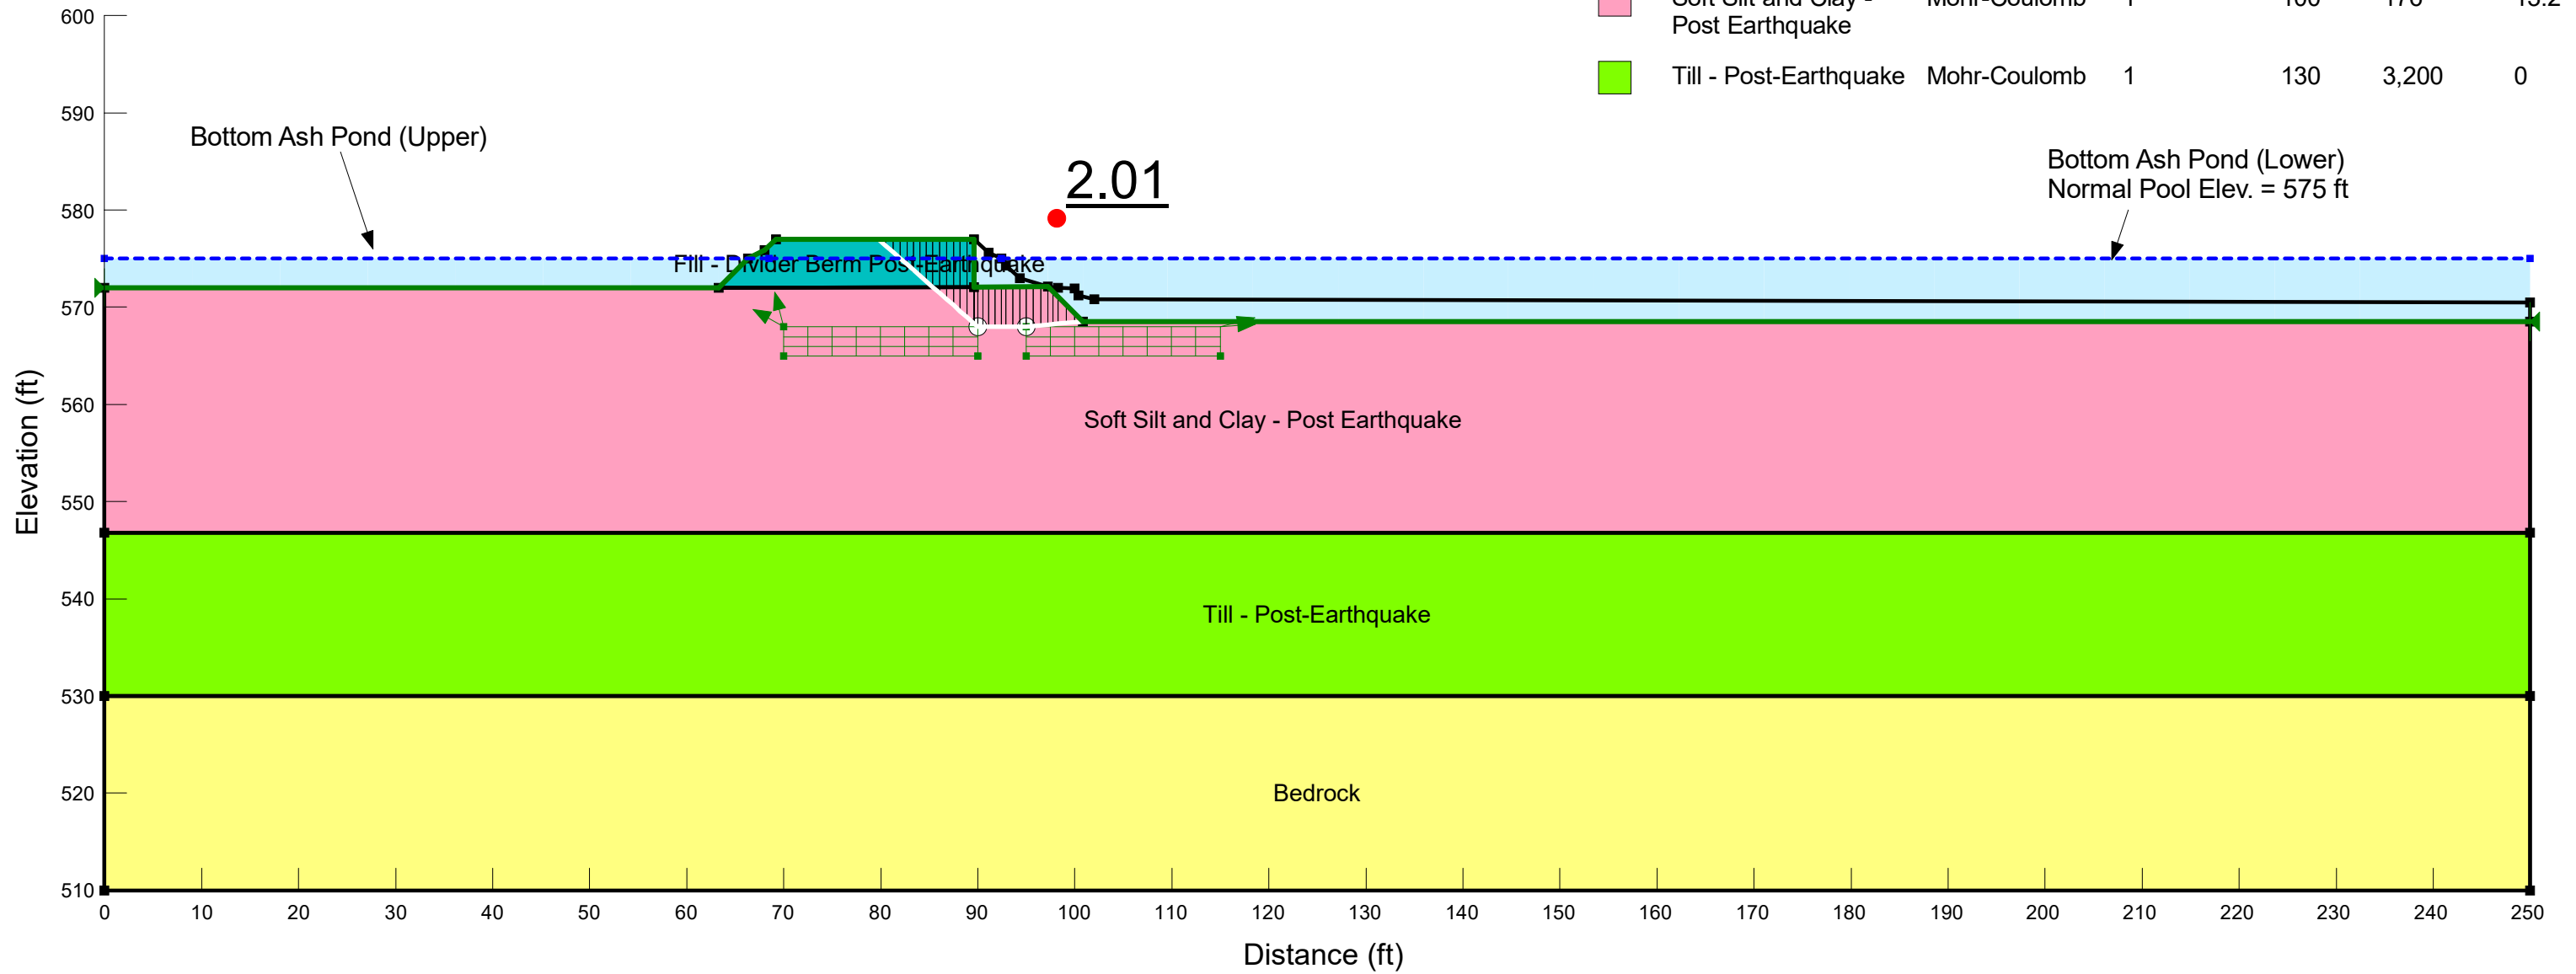
Slope Stability Analysis - Section D-D'

Post-Earthquake Analysis Block-Defined Slip Surfaces

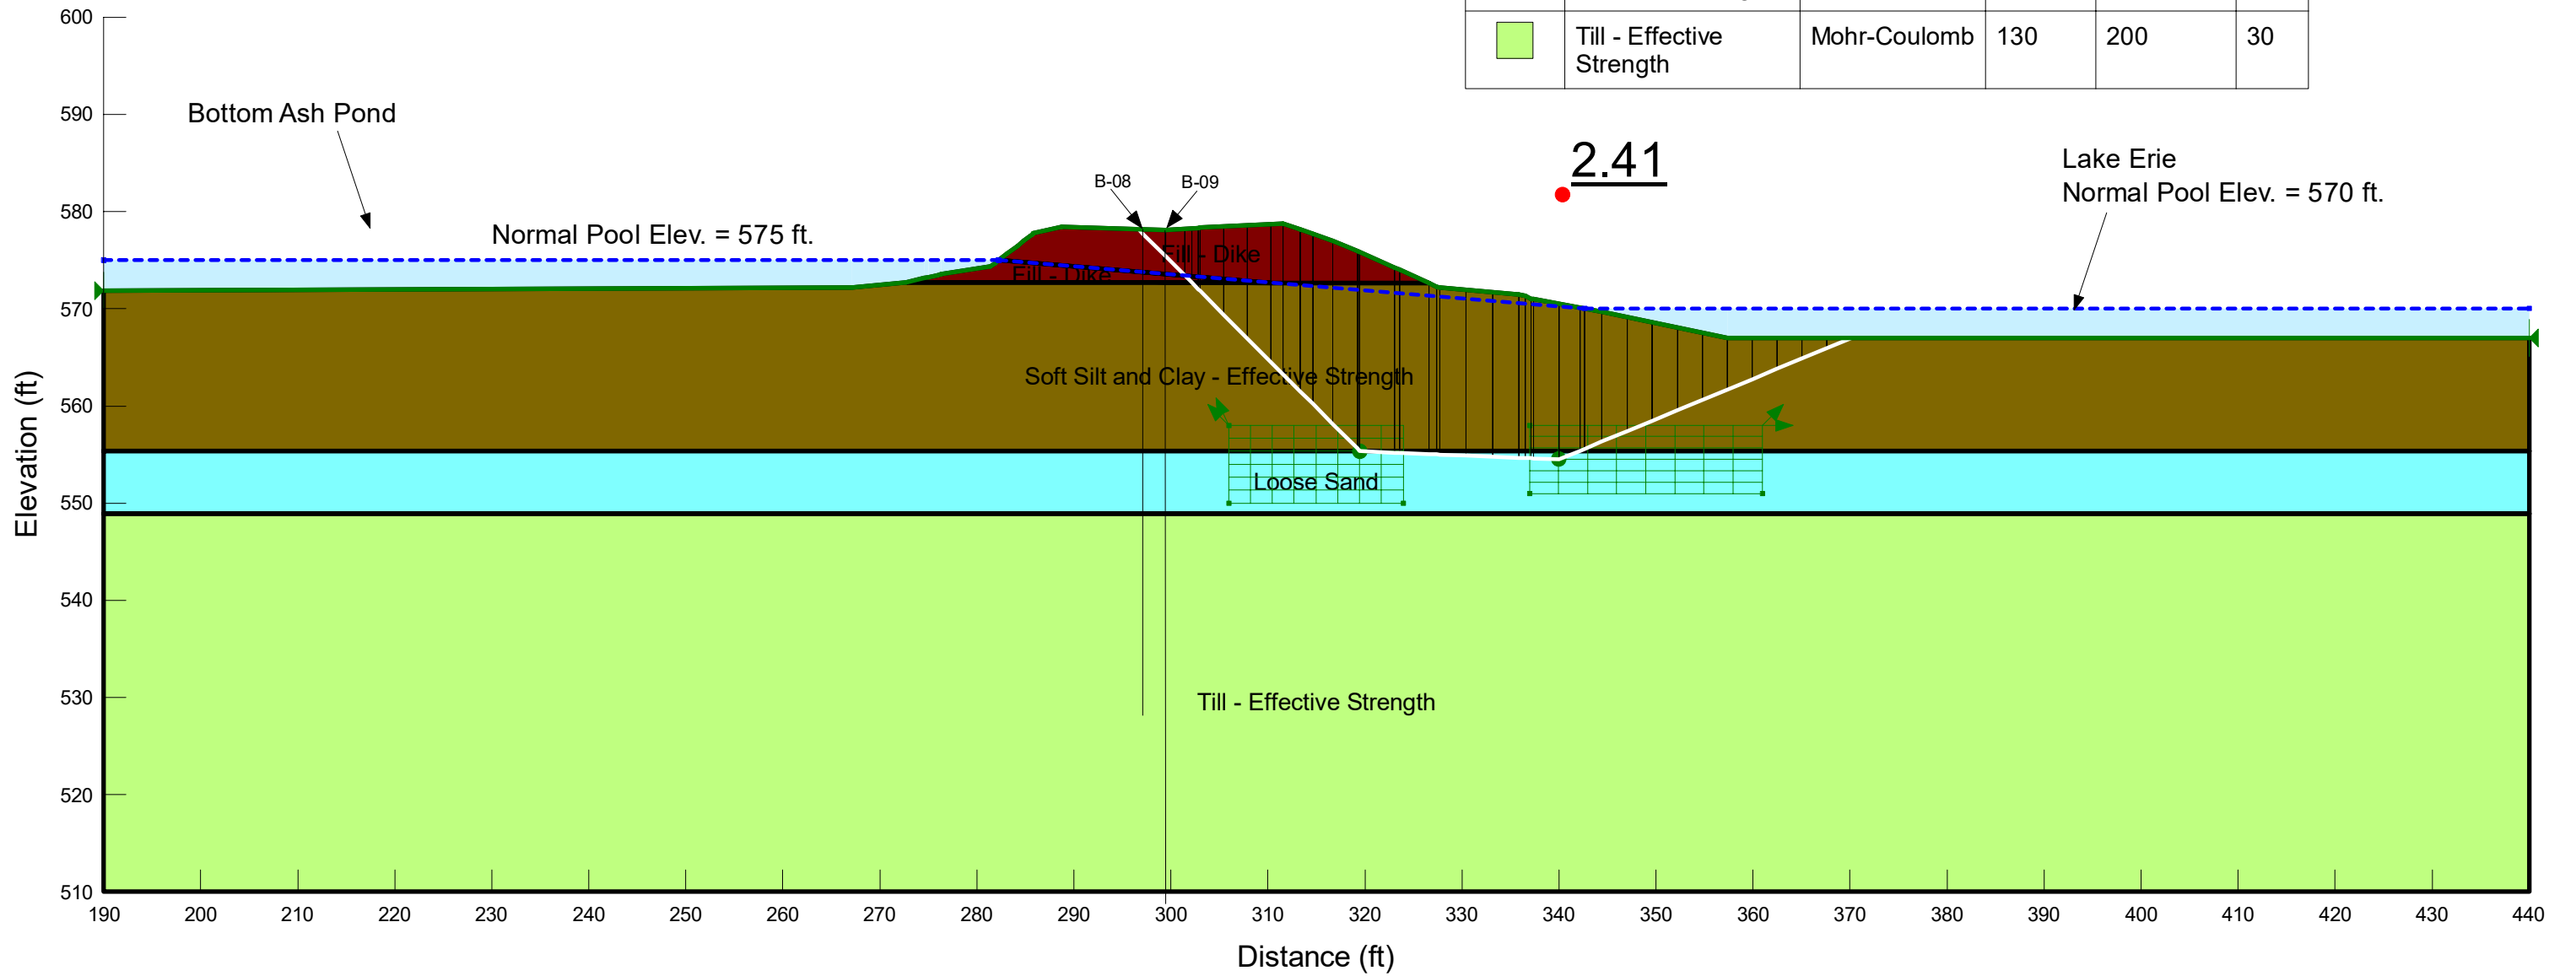
Cross Section E-E'

Static Analysis
 Block Failure

Color	Name	Model	Unit Weight (pcf)	Cohesion' (psf)	Phi' (°)
Dark Red	Fill - Dike	Mohr-Coulomb	120	0	30
Cyan	Loose Sand	Mohr-Coulomb	120	0	28
Brown	Soft Silt and Clay - Effective Strength	Mohr-Coulomb	100	100	30
Light Green	Till - Effective Strength	Mohr-Coulomb	130	200	30

DTE Monroe - Inactive BAI Safety Factor Analysis
