Submitted to
DTE Electric Company

Submitted by
AECOM
1300 East 9th Street, Suite 500
Cleveland, OH 44114
August 2024

CCR Certification:
Periodic Structural Stability
Assessment
Inactive Bottom Ash Impoundment
DTE Monroe Power Plant

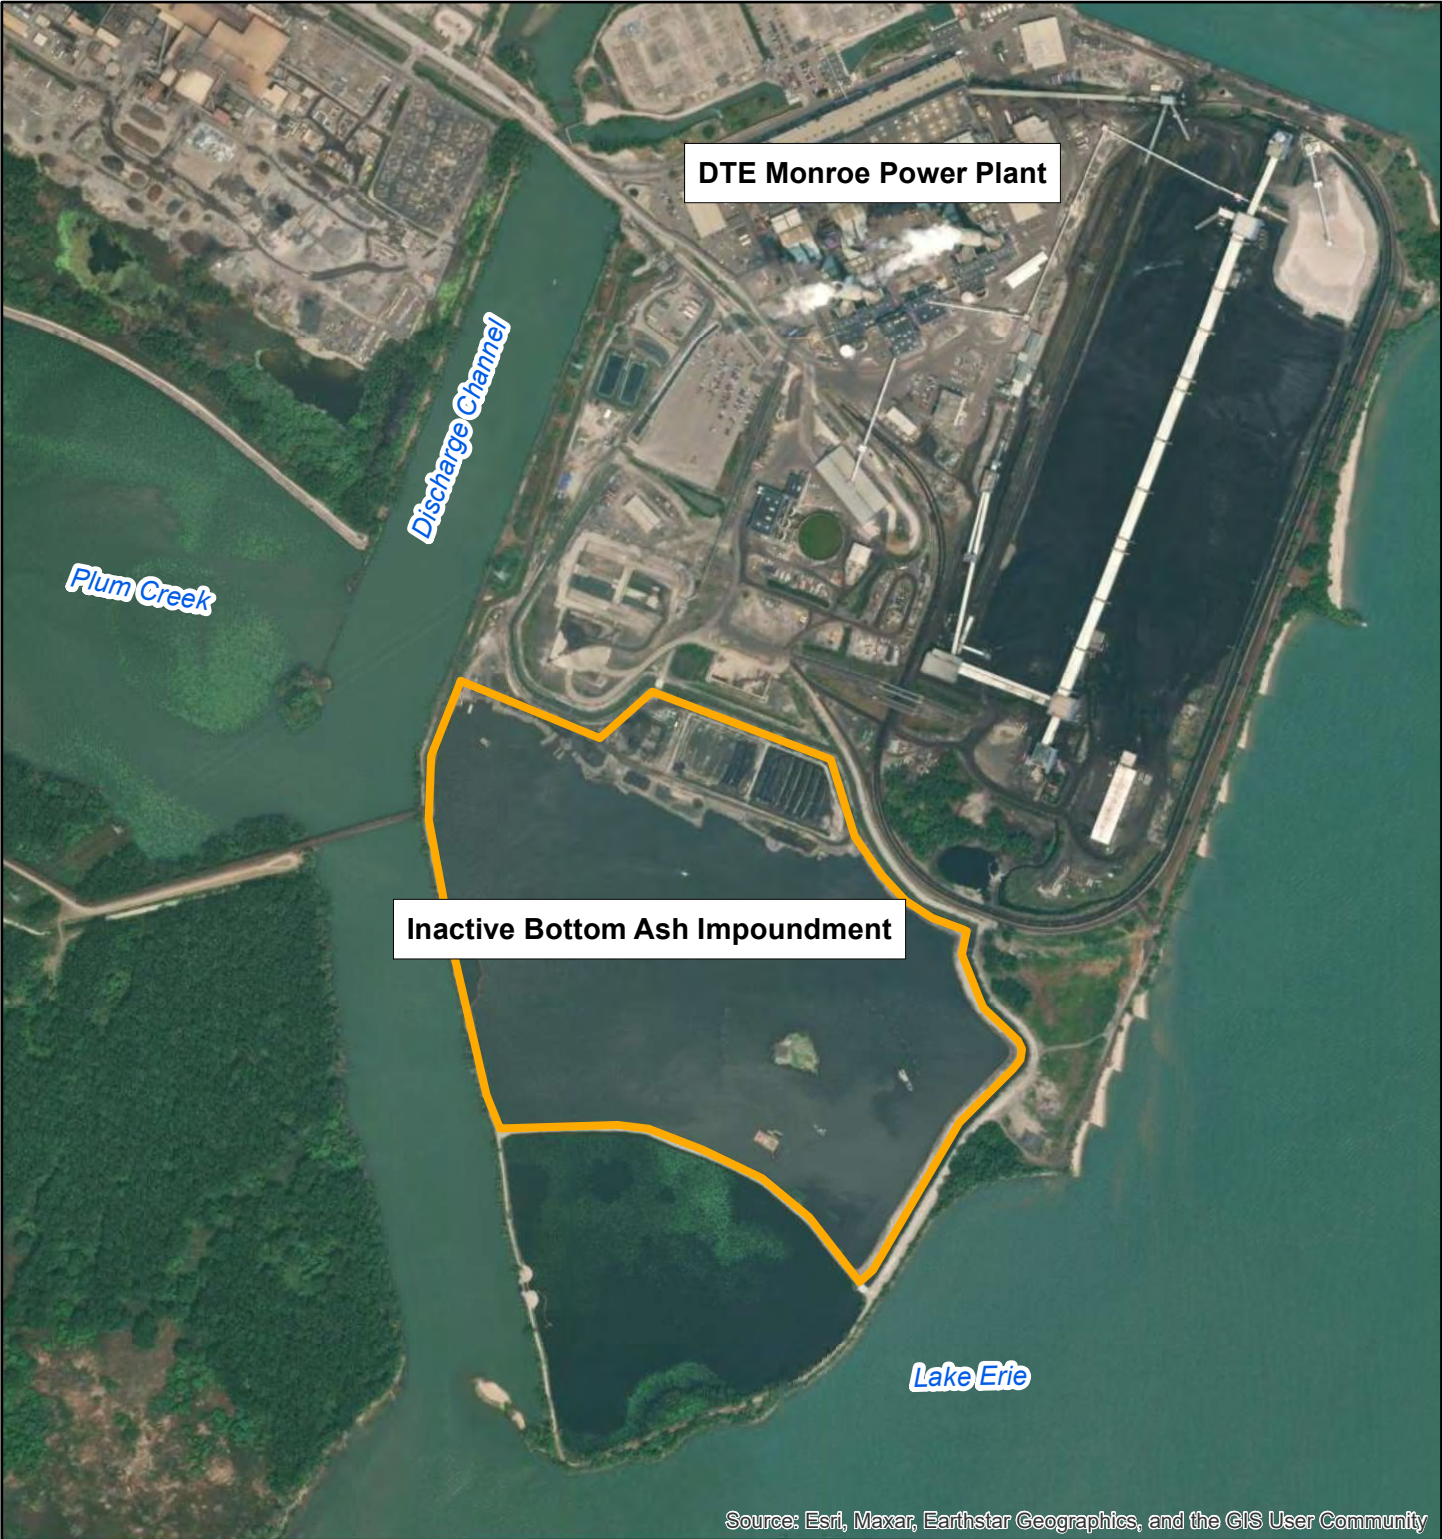
**FIGURE 2
AERIAL SITE MAP**

— Ash Impoundment Boundary

The Inactive BAI is located to the south of the main Monroe Plant area and encompasses an area approximately 86.4 acres in size. The Inactive BAI area was constructed in the late 1960s by building a perimeter dike to surround a low area of the adjacent Lake Erie. The area south of the plant was removed from the Waters of the United States by an Act of Congress prior to plant construction. CCR materials have been placed and allowed to drain into the impoundment from the north, and previously formed a delta that extended about 1/3 of the way into the impoundment. However, at the time of this assessment a majority of the CCR material has been removed as part of ongoing closure of the impoundment. Wastewater flow into the pond ceased on October 21, 2020. Appendix A provides a Site Location Map showing the general location of the project site (**Figure 1**) and an Aerial Site Map of the Inactive BAI (**Figure 2**).
